STORMWATER MANAGEMENT PLAN FOR SHELDON

FINAL REPORT

Stone Project ID 12-145

January 24, 2014

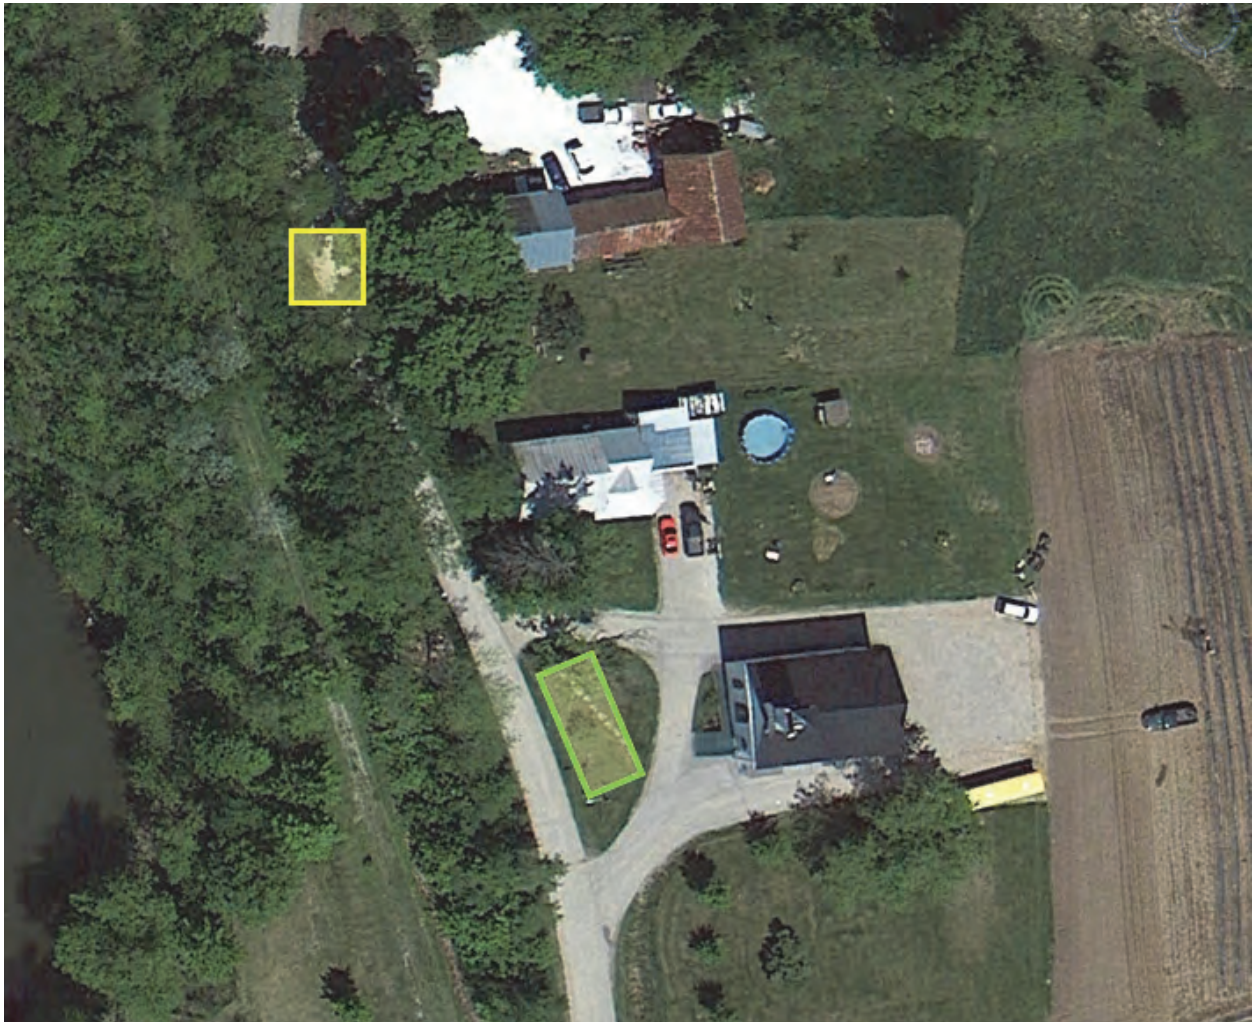
Church Street is a narrow paved road serving three buildings, with a paved parking lot along the east side of a church and a steep bank leading down the rail trail to the west. The culvert that drains a large portion of this area is crushed and clogged with debris. The culvert outlets onto the steep bank, approximately 150 feet from the Black Creek. Due to the condition of the culvert, most of the runoff from the area appears to run over the road, and is eroding the top of the bank. The guard-posts along the top of the bank have begun to fall over the edge.

Figure 2. The location of a potential bioretention practice location on Church Street is highlighted in green; a culvert replacement opportunity is highlighted in yellow.

While there is not enough space in this narrow section of road to provide adequate ditching, there is an opportunity to install a bioretention practice at the church. Such a practice could capture, slow, and treat the runoff from a significant portion of the area's impervious surface. Since the existing culvert is crushed and clogged, it should be replaced with one that meets current standards.

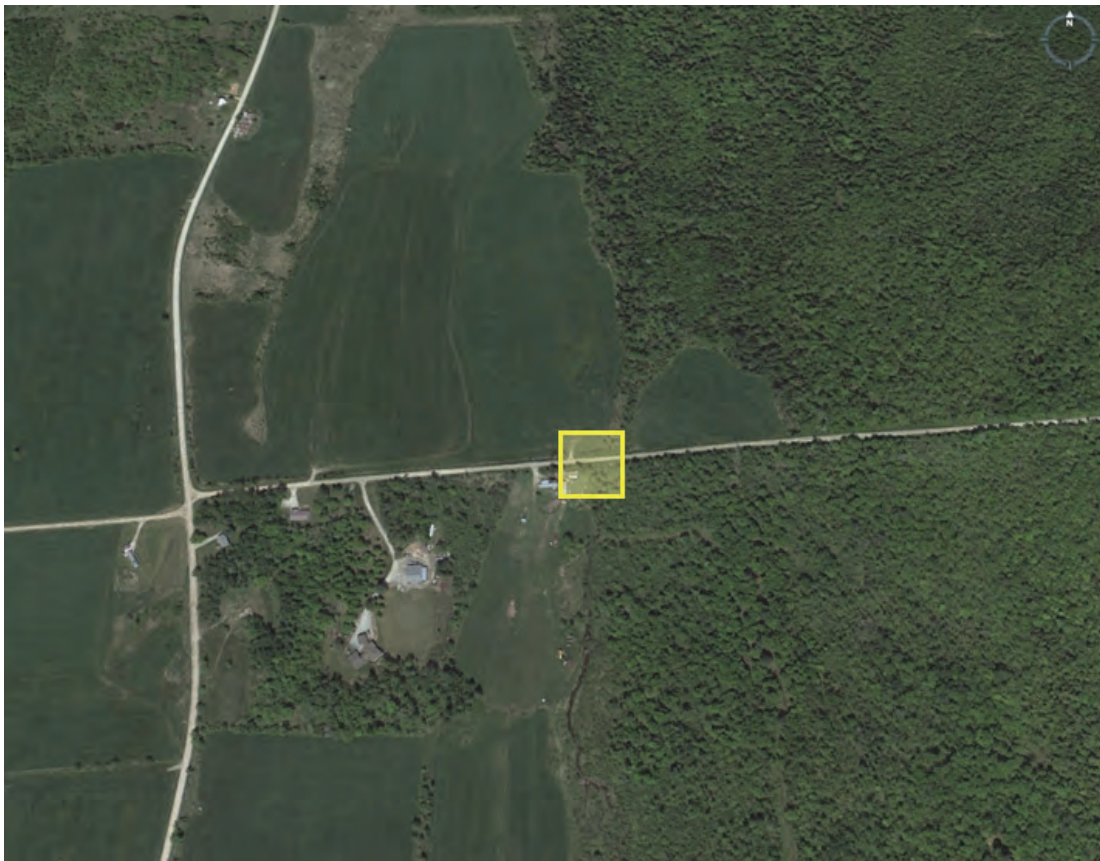
A culvert that conveys Goodsell Brook under Swamp Road is too short for the current width of the road. The resulting over-steepened slope, coupled with unmanaged stormwater runoff from the road surface, has created unstable conditions at both the inlet and outlet of the culvert. Generally, vegetated slopes should be limited to 2:1 (horizontal to vertical) to maintain stable conditions. Erosion of this slope will likely soon lead to deteriorating road conditions. In addition, the existing culvert pipe is undersized (approximately one-half bankfull width), and a large scour pool has formed on the downstream side of the culvert. The location of the culvert is indicated in Figure 3.

Figure 3. The location of a culvert replacement opportunity on Swamp Road.

Given the deteriorating condition of the culvert and surrounding banks, it is a good candidate for replacement. The replacement culvert should be long enough to accommodate 2:1 (H:V) slopes at the inlet and outlet, and sized such that it matches the stream's bankfull width, and so that 1/6th of the culvert can be buried at bankfull stream width to provide a natural bottom.

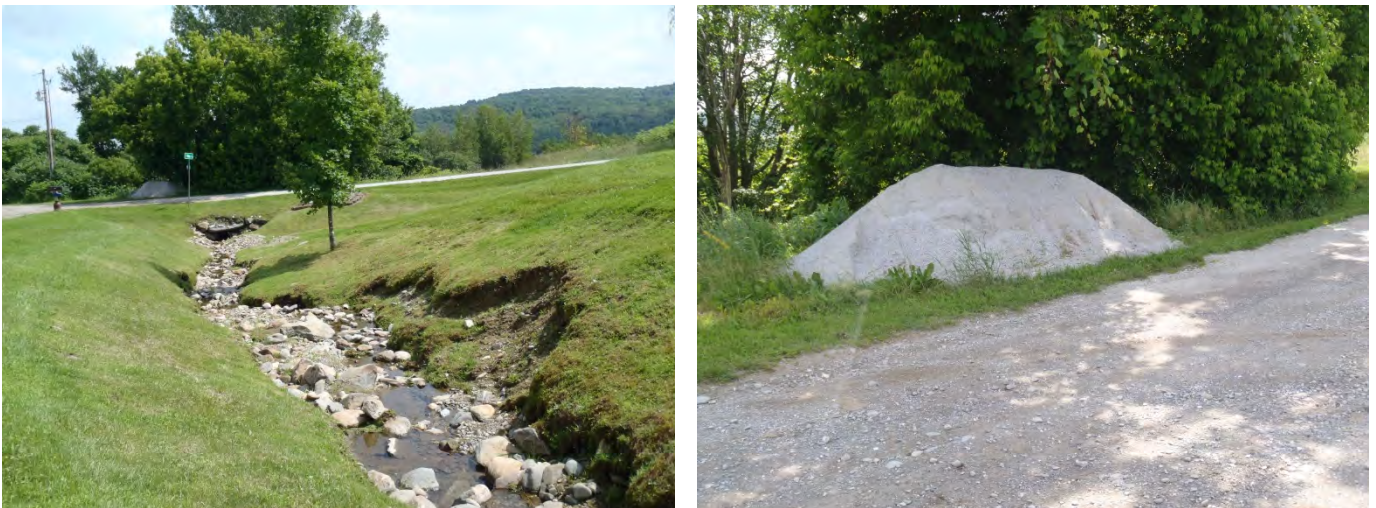
Additionally, a gravel stockpile sits at the southeast corner of Kittell Road and Riley Road. Sediment from the gravel pile appears to be washing into the unnamed tributary, about 10 feet away. The pile should be moved or covered to prevent further loss of material.

Figure 4. At left, eroding stream banks are sloughing into the stream. Vegetation is mowed up to the edge of the banks. At right, a large gravel stockpile sits 10 feet from the stream.

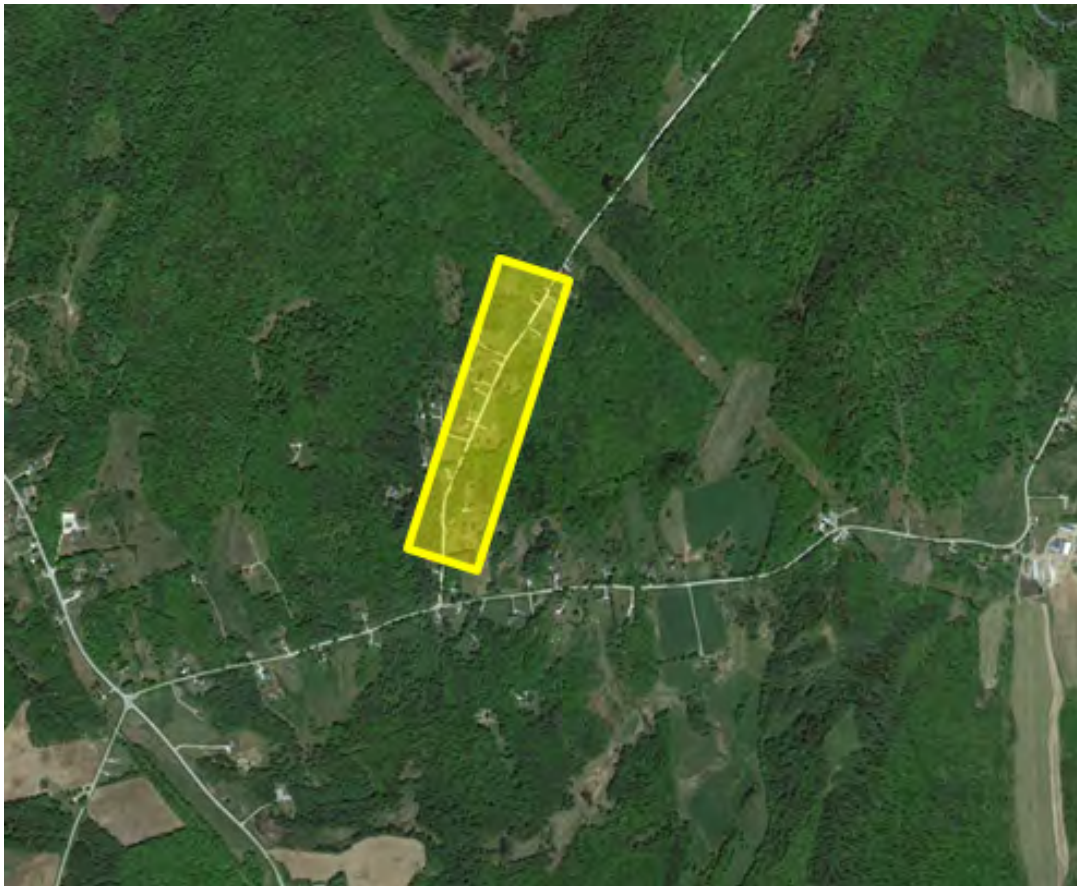
As with many of the roads in Sheldon, sections of Dutton Road have a shoulder lip, which prevents runoff from leaving the road surface and entering the ditches as sheetflow. In this case, the excess water has caused a secondary swale on the road surface, leading to accelerated erosion near the edge of the road and, where water does break through, large deposits of road sediment in local ditches (Figure 5). Measures to prevent this type of erosion include:

Figure 5. Road grading and crowning improvement opportunity on Dutton Road.

The Federal Highway Administration's *Gravel Roads: Maintenance and Design Manual* is a good reference guide.

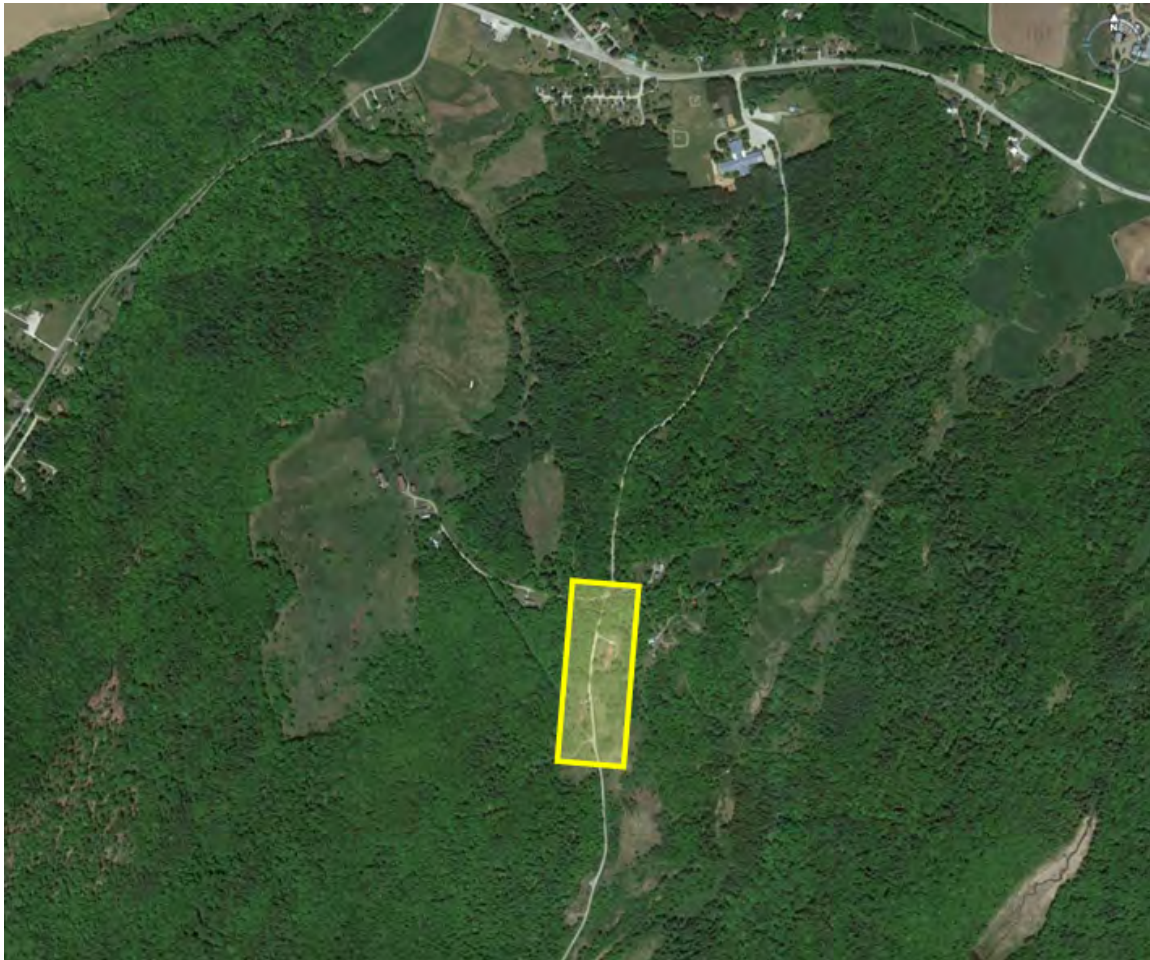
Sections of Maple Glen Road near the intersection with Poor Farm Road (Figure 6) have a ridge between the road crown and the ditch, which prevents runoff from leaving the road surface and entering the ditches as sheetflow. Similar to Dutton Road, the excess water has formed a “secondary swale” in the roadway near the edge of the travel surface, leading to increased sediment transport and accelerated erosion. Again, this is an opportunity where additional road maintenance could vastly reduce the erosive conditions and have a dramatic impact on water quality.

Figure 6. Road grading and crowning improvement opportunity on Maple Glen Road.

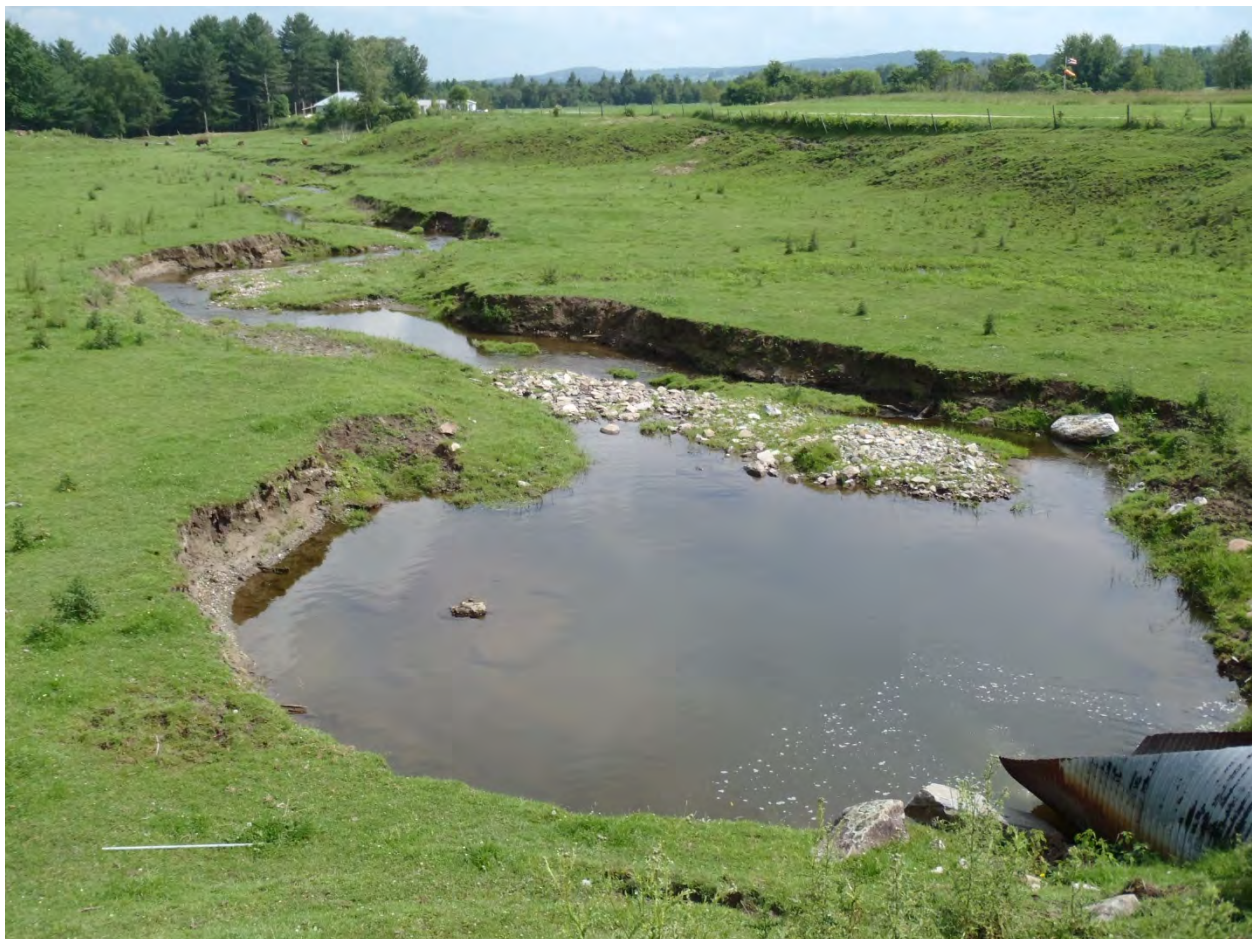
The culvert conveying Morrow Brook under East Sheldon Road is significantly undersized (approximately 1/8th bank-full width), and the bank above the culvert inlet is over-steepened (approximately 1:1 slope). As a result, stormwater runoff from East Sheldon Road has eroded large portions of the bank around the culvert. The inlet portion of the culvert has broken and water is beginning to wash around and below the exterior of the pipe. It appears that the culvert has begun to settle and will soon affect the road. Further, there is a large scour pool at the culvert's outlet. The culvert outlets into a pasture where farm animals have direct access to the stream. The banks downstream from the culvert are vertical and unstable (see Figure 7).

Figure 7. A large scour pool has formed at the outlet of an undersized culvert. Additionally, animals are grazed in this pasture and have direct access to the stream.

In general terms, the replacement culvert should be long enough to accommodate 2:1 slopes at the inlet and outlet, and sized such that it matches the stream's bankfull width and can be buried at 1/6th bankfull stream width to provide a natural bottom. Additionally, animal access to the stream should be addressed (e.g., restricted to a stabilized crossing).

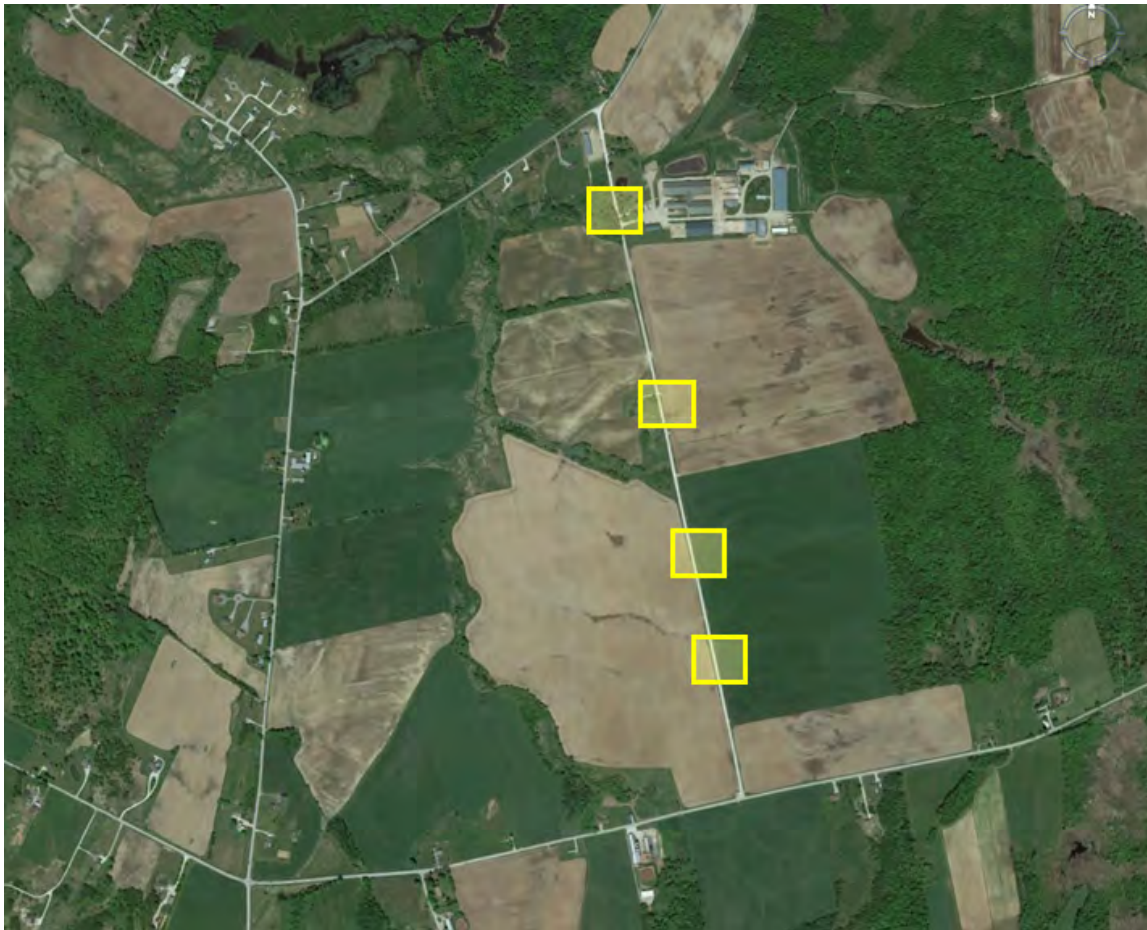
The section of Morey Road between Woodshill Road and Heald Road has four culverts (Figure 8) that are too short for the current width of the road, resulting in unstable conditions at both the inlets and outlets. Erosion of the over-steepened slopes surrounding the culvert by stormwater runoff from the road surface will lead to deteriorating road shoulder conditions in the near- to medium-term. A replacement culvert should be long enough to accommodate vegetated slopes which are at least 2:1 (H:V) to maintain stable conditions. Another option may be to construct headwalls at the inlets and outlets of each culvert in order to stabilize and protect the banks from further erosion.

Figure 8. The locations of four undersized culverts along Morey Road.

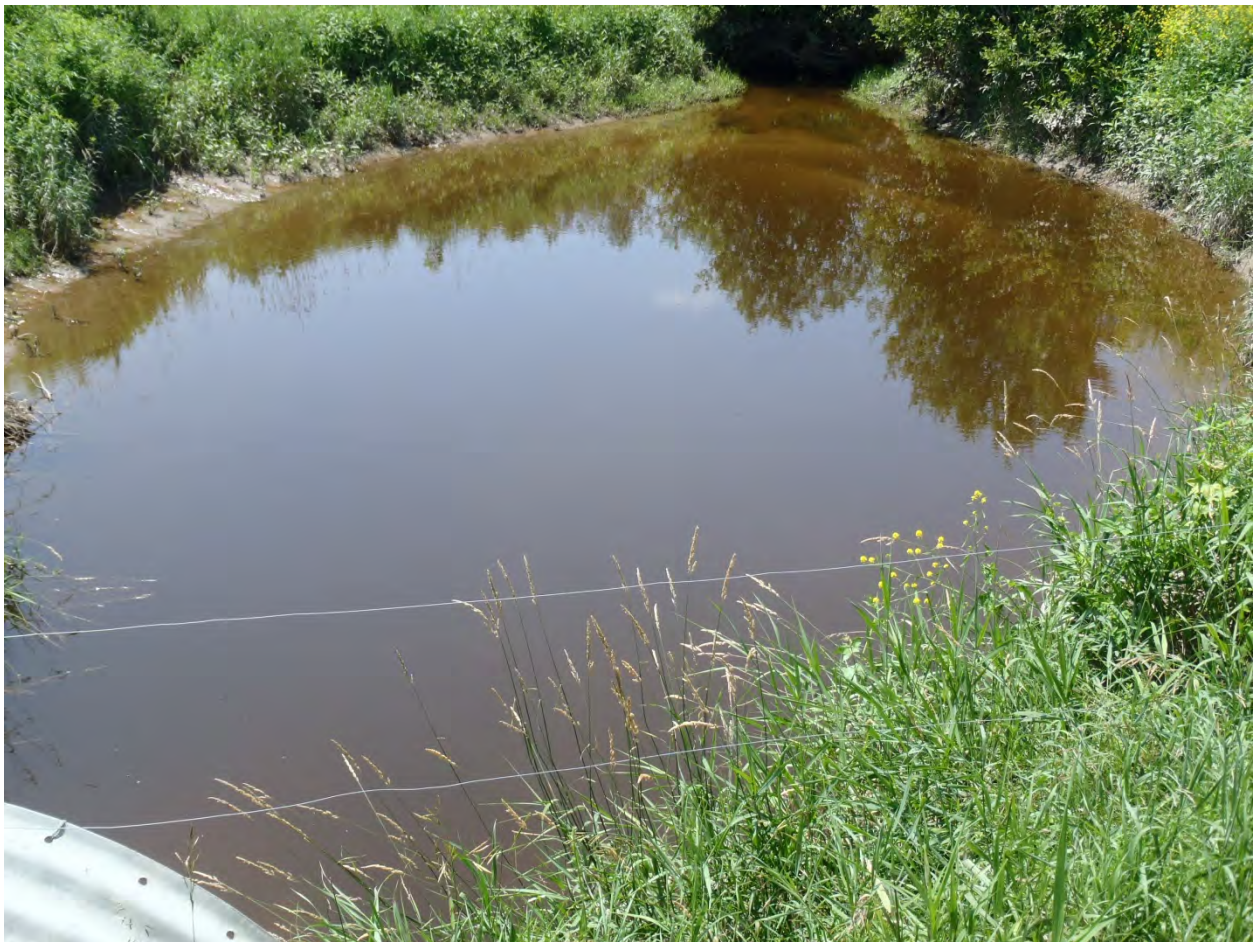
A culvert that conveys an unnamed tributary of the Hungerford Brook under Bushey Road is too short for the current width of the road. The resulting embankment slope, coupled with stormwater runoff from the road surface, has created unstable conditions on the banks. Generally, vegetated slopes should be limited to 2:1 (horizontal to vertical) to maintain stable conditions. The erosion of this over-steepened slope will likely soon lead to deteriorating road conditions. The existing culvert pipe is undersized (approximately one-half bankfull width), resulting in a large scour pool on the downstream side (Figure 9).

Figure 9. A large scour pool immediately downstream from the undersized culvert beneath Bushey Road.

Any replacement culvert should be long enough to accommodate 2:1 slopes at the inlet and outlet, and sized such that it matches the stream’s bankfull width and can be buried at 1/6th of the bankfull stream width to provide a natural bottom.

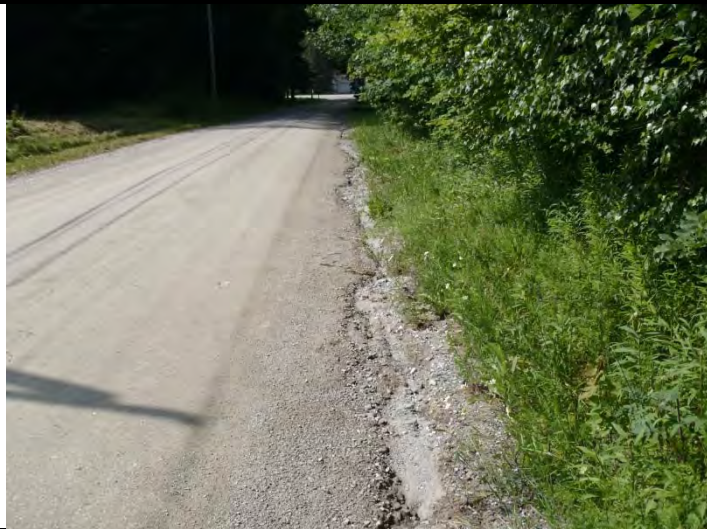
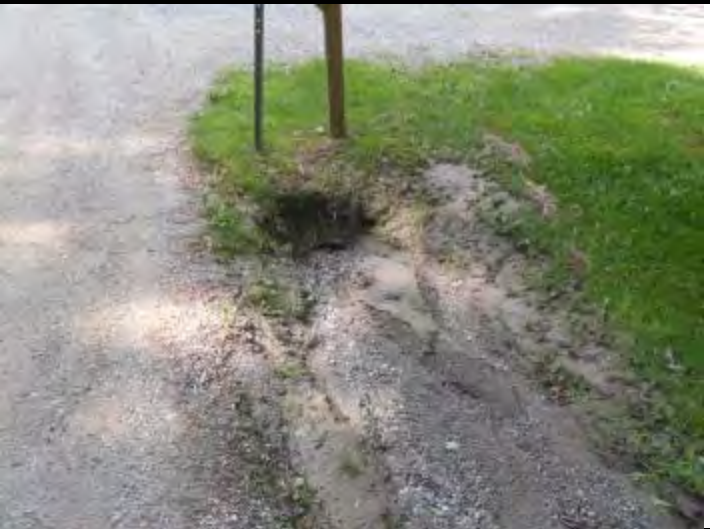
Photo 1. Road-edge erosion

Photo 2. Ditch and culvert full of sediment

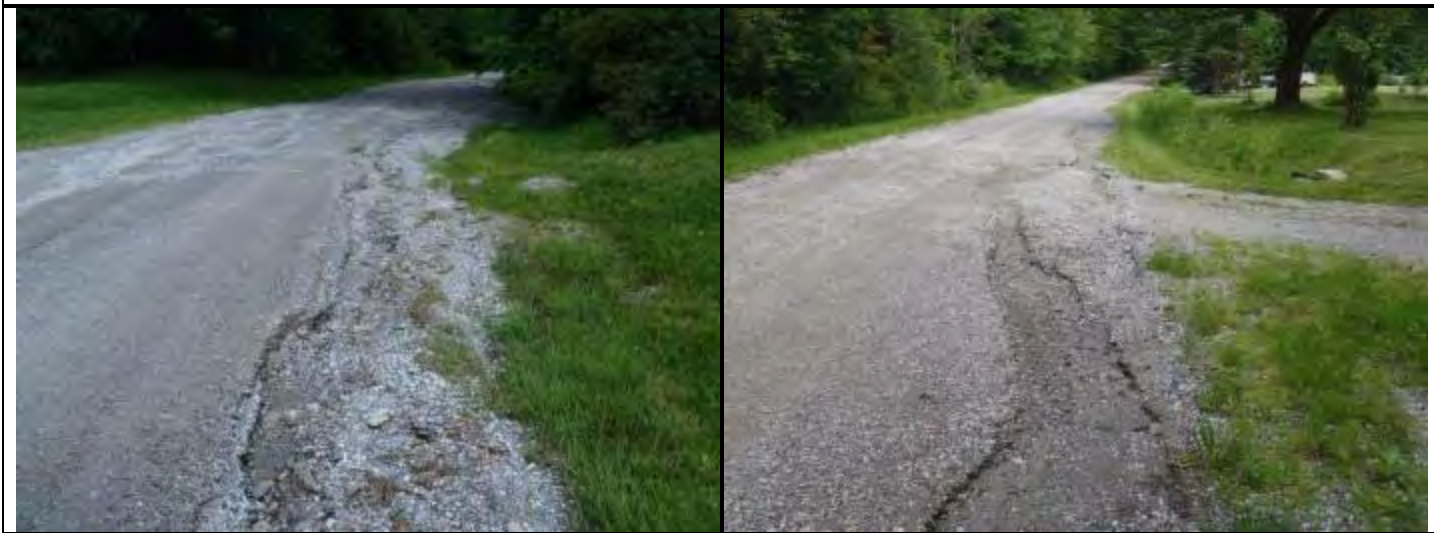
Photo 1. Road-edge erosion

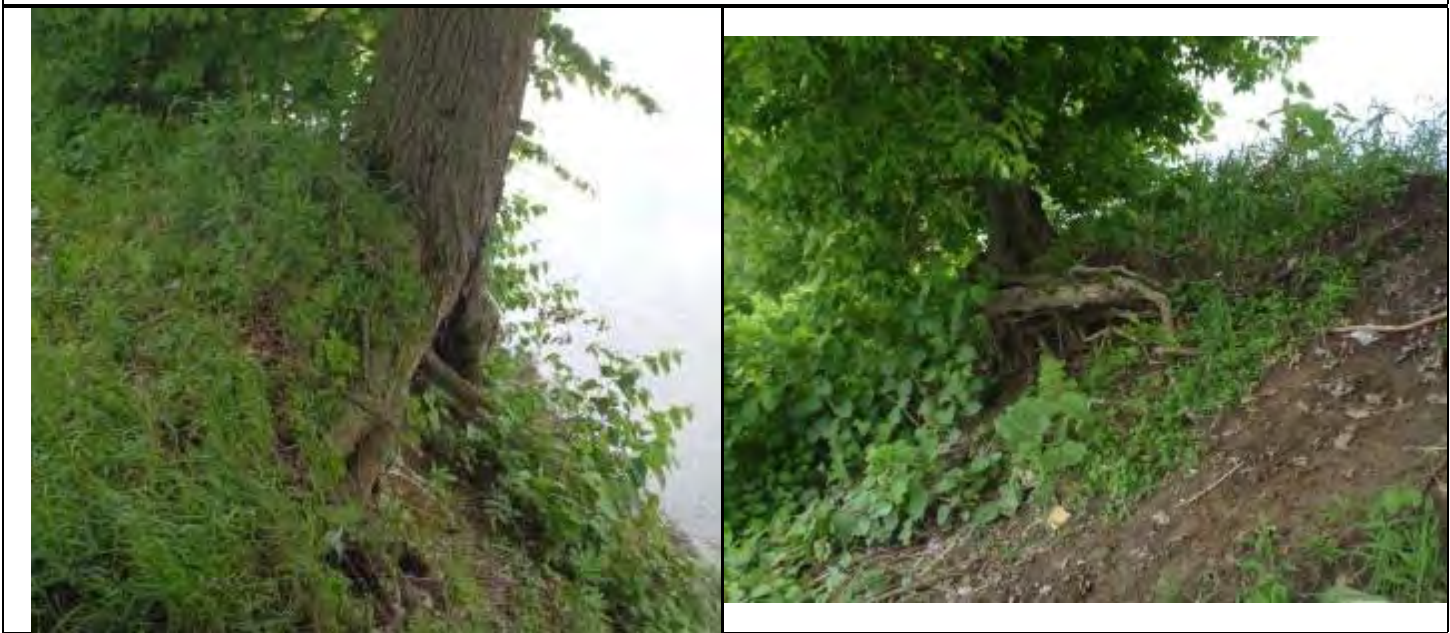
Photo 1. Eroded bank

Photo 2. Eroded bank

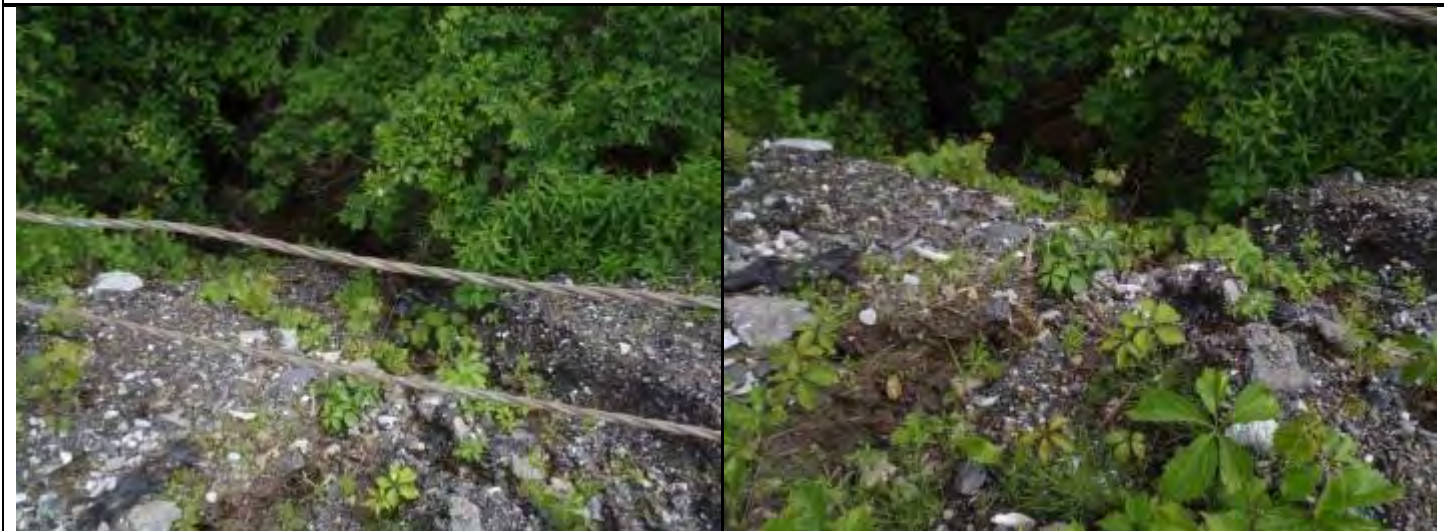
Photo 1. Trenching on road shoulder above culvert inlet

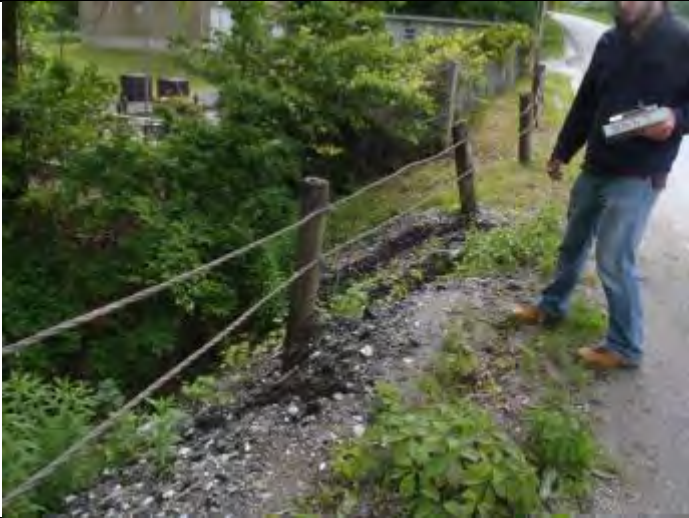
Photo 3 Shoulder above culvert inlet

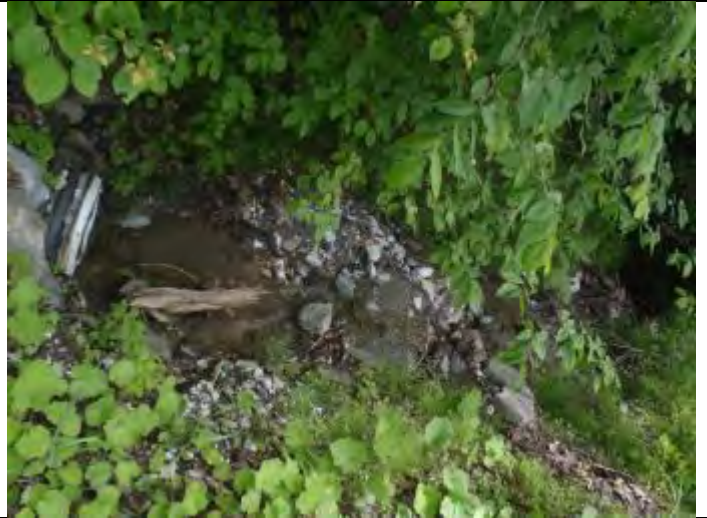
Photo 4. Sediment deposited in ditch

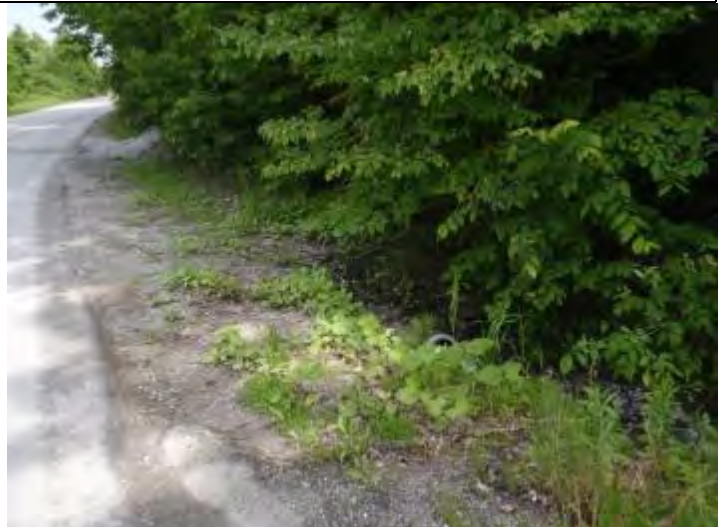
Photo 6 Ditch bank collapse and sediment deposit

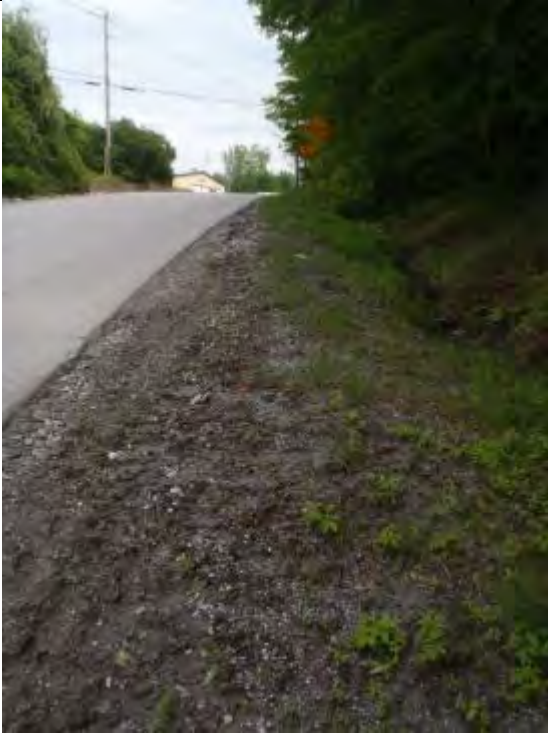
Photo 9 Erosion along road shoulder

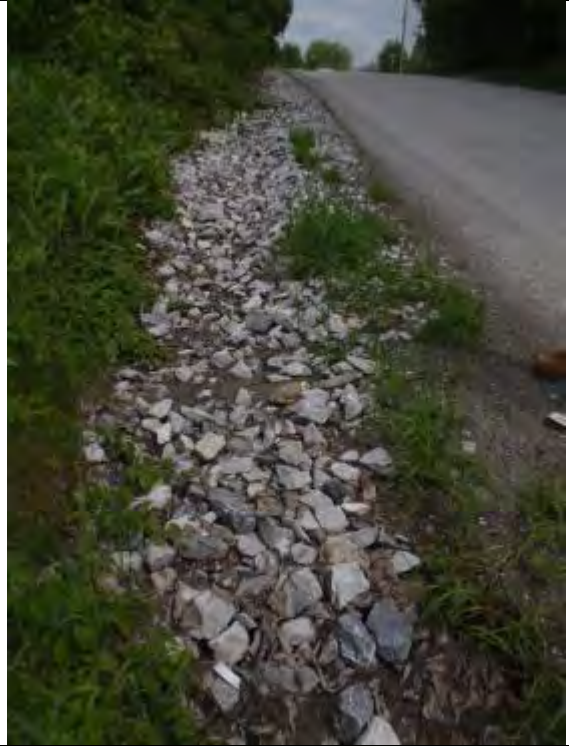
Photo 10. Rock-lined ditch, sediment choked

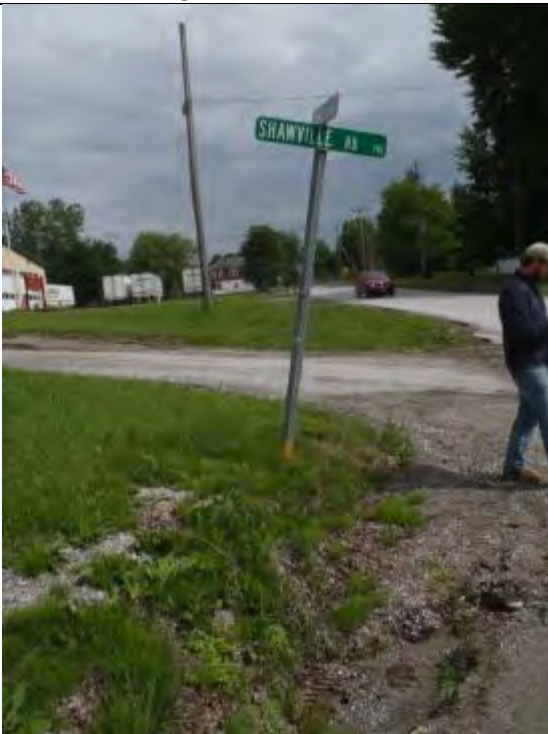
Photo 11. Shoulder erosion

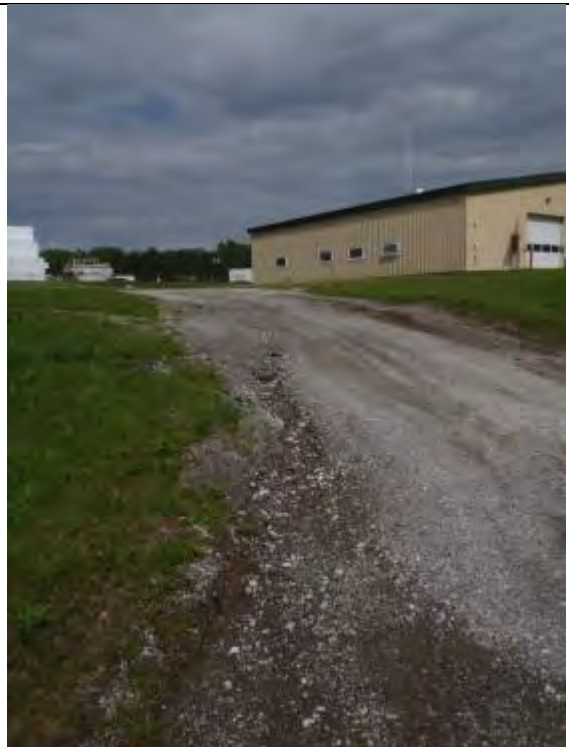
Photo 12. Trenching on gravel driveways subject to heavy truck traffic

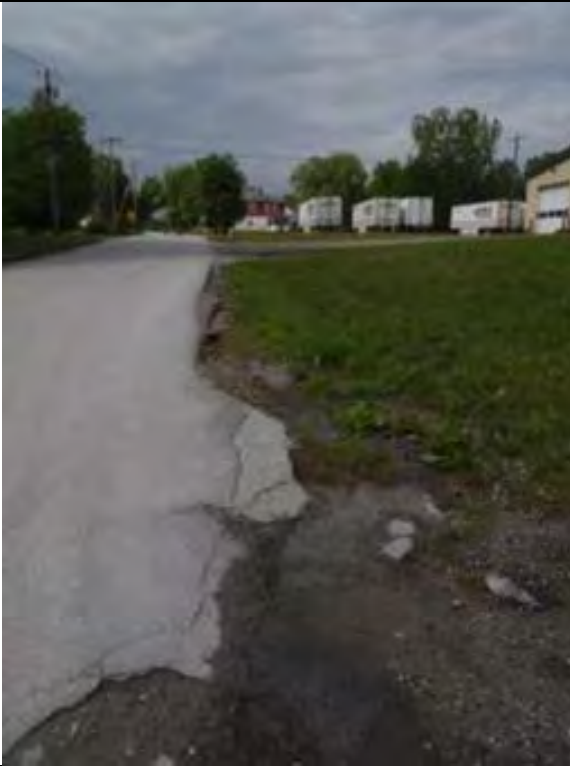
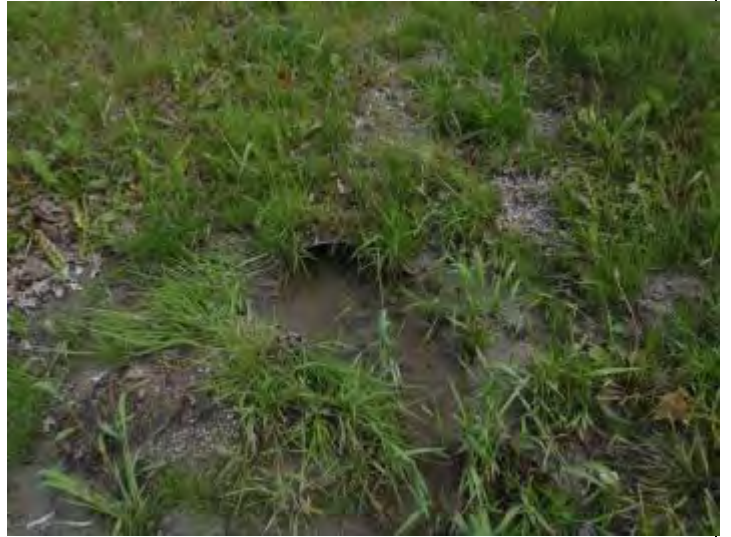
Photo 13. Roadway deterioration and shoulder trenching

Photo 14. Ditch and culvert full of sediment

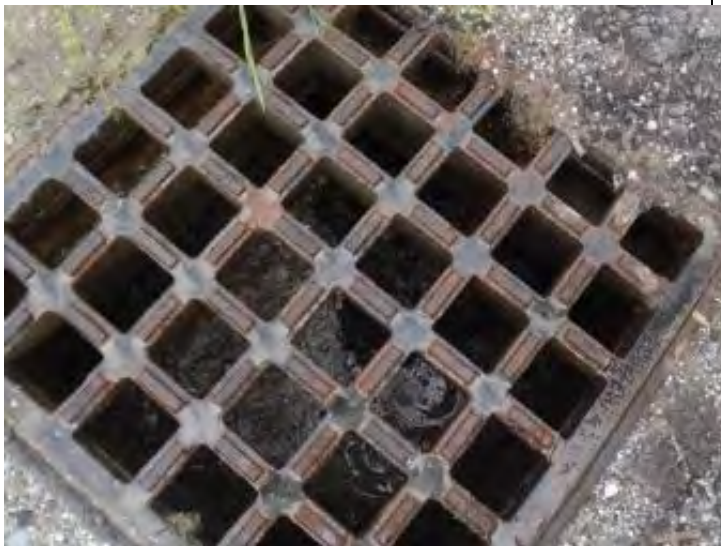
Photo 15. Catch basin filled with sediment

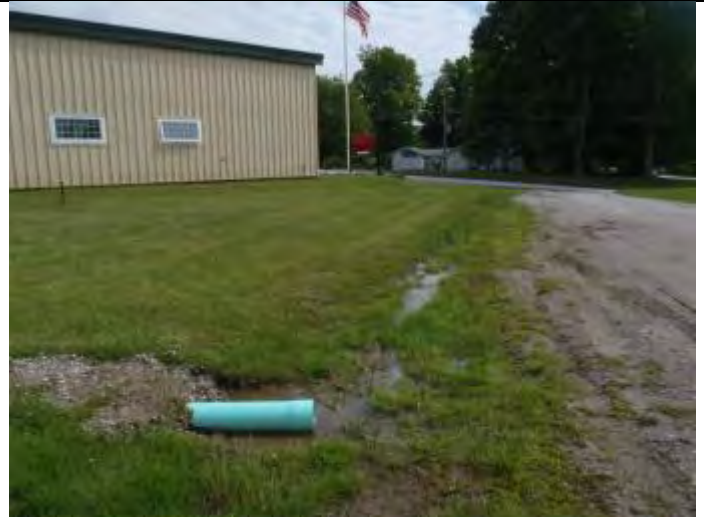
Photo 18. New drainage structure connected to parking lot behind fire station

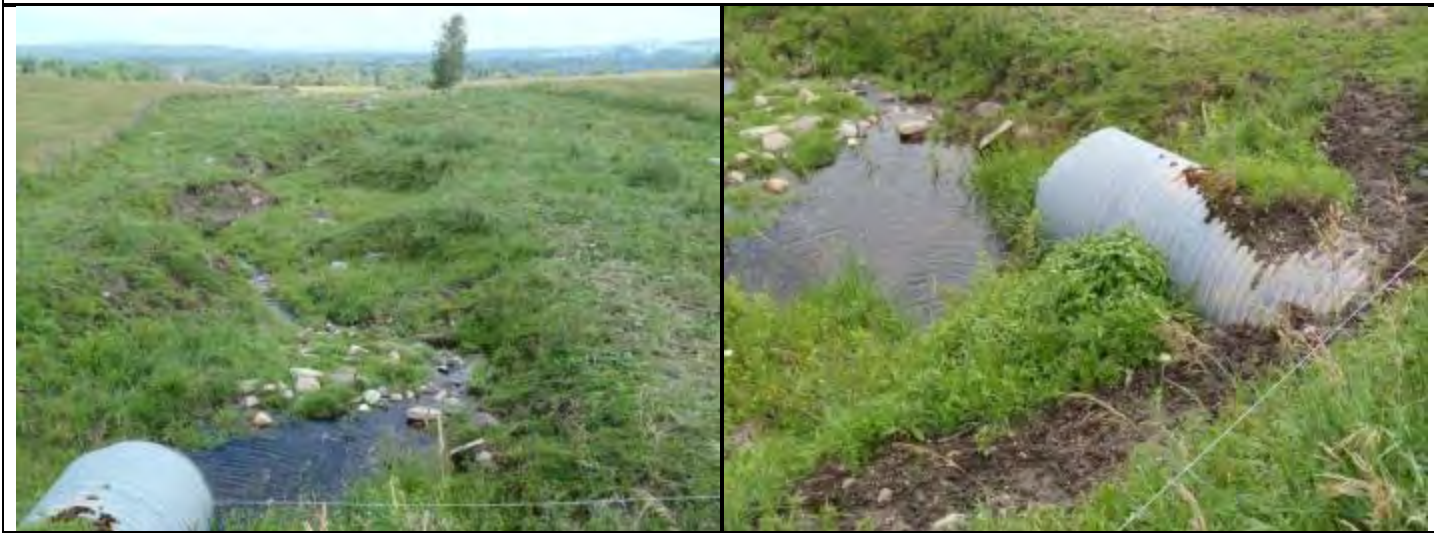
Photo 1. View downstream of culvert

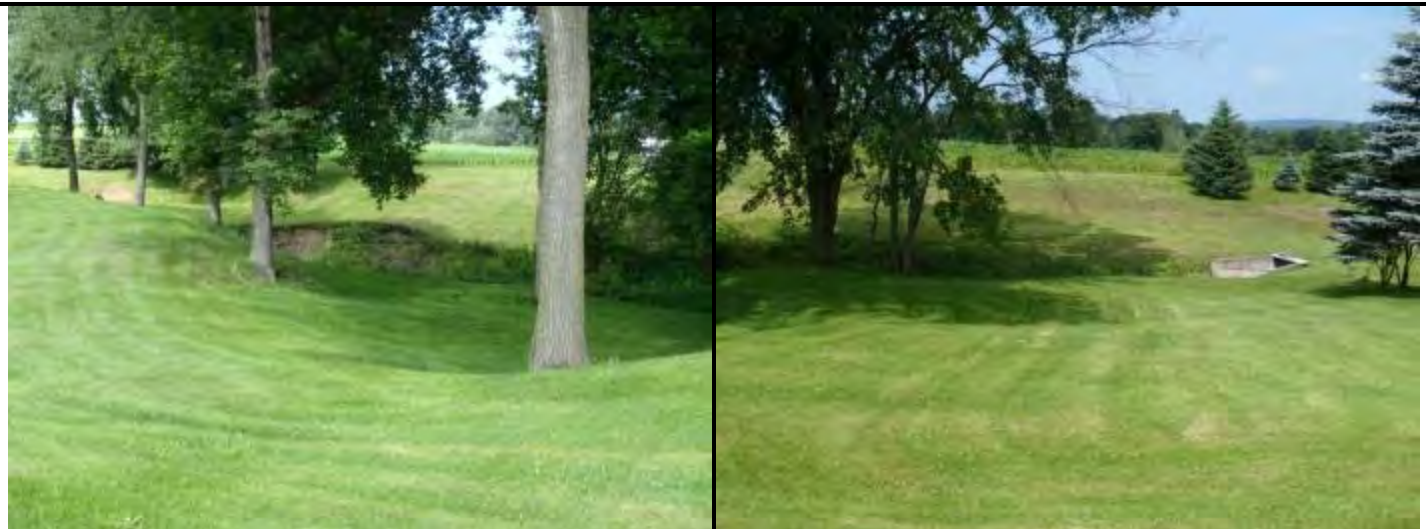
Photo 1. Eroded stream bank downstream from culvert

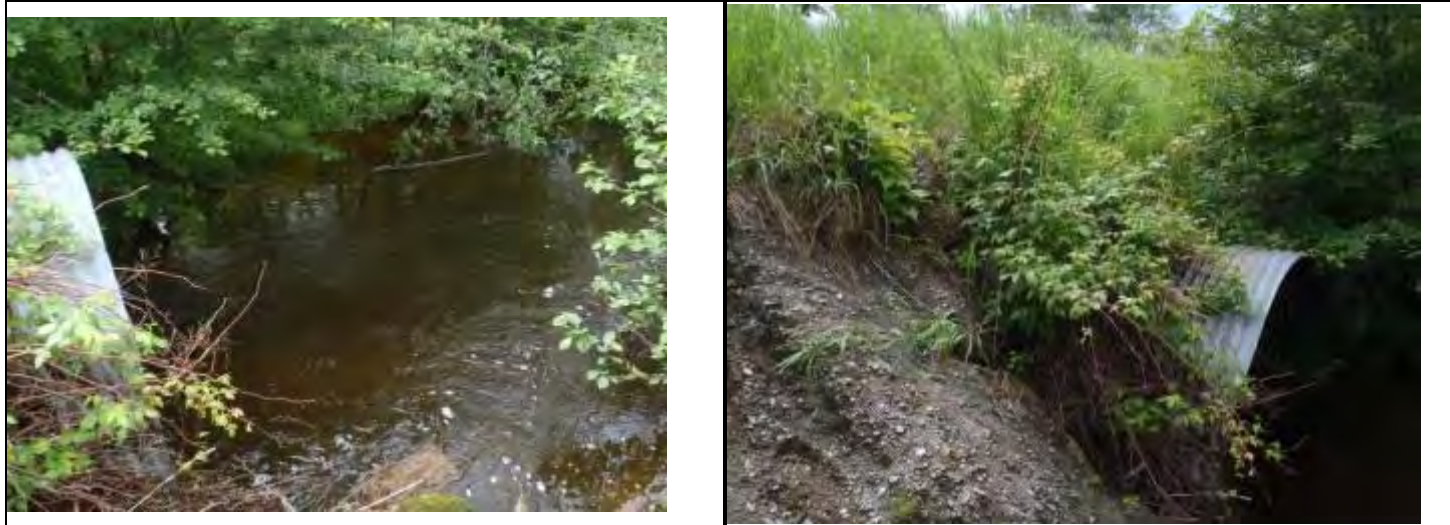
Photo 1. Scour pool	Photo 2. Bank erosion around culvert
----------------------------	---

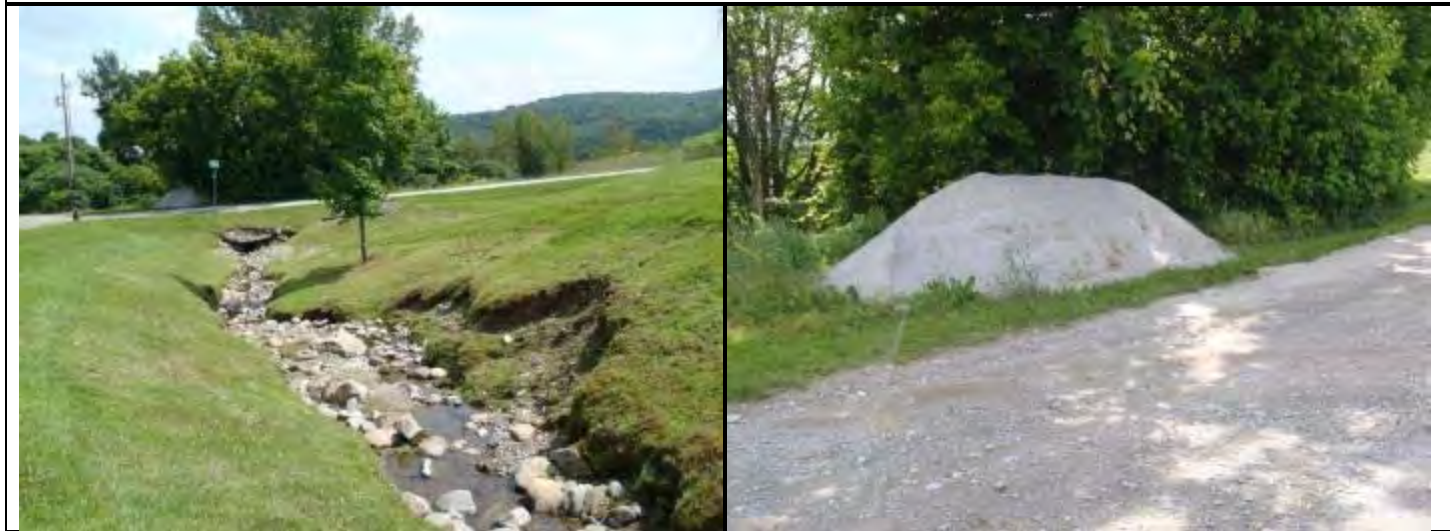
Photo 1. Ditch bank slumping	Photo 2. Gravel pile directly above culvert
-------------------------------------	--

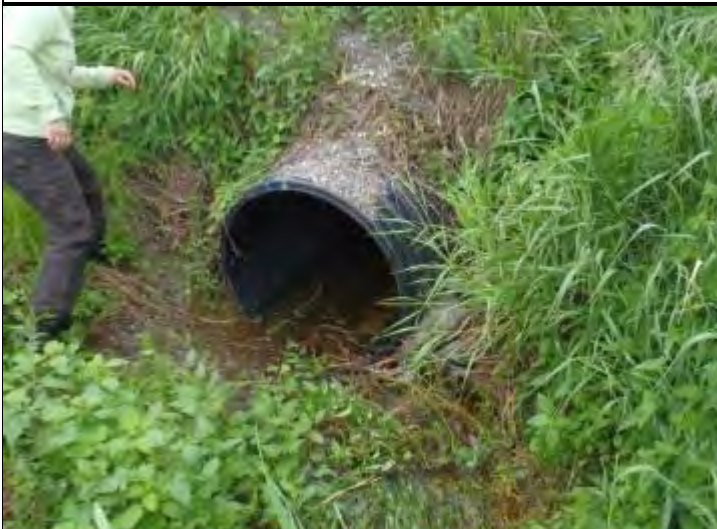
Photo 1. Undersized culvert

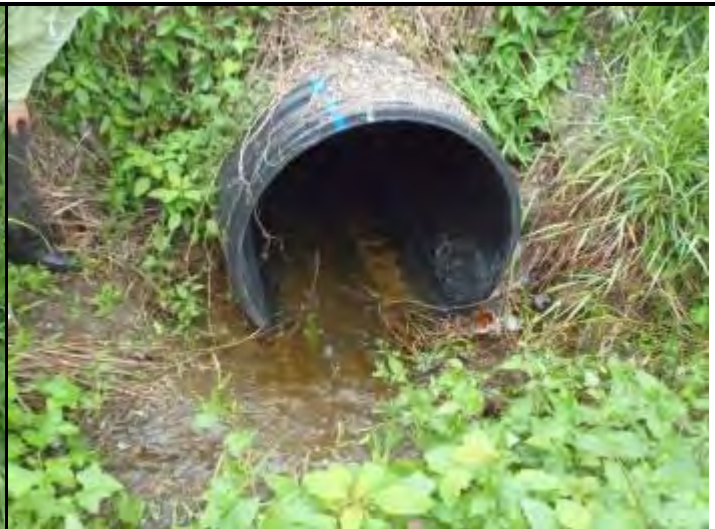
Photo 2. Stream bed is eroded 2 inches below invert of culvert inlet.

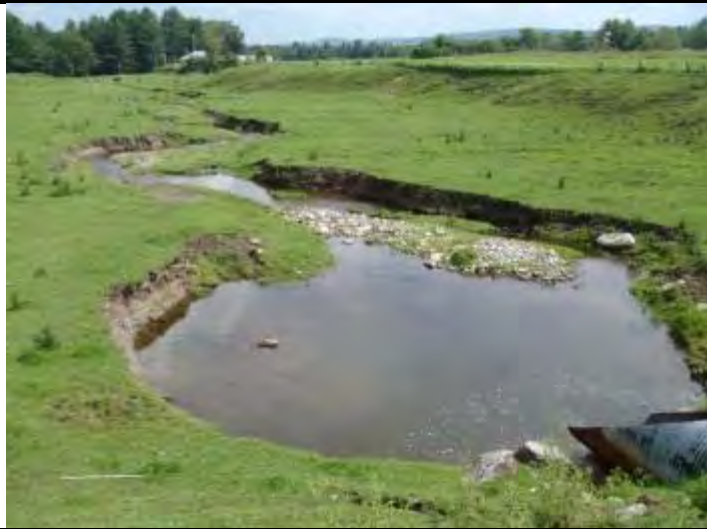
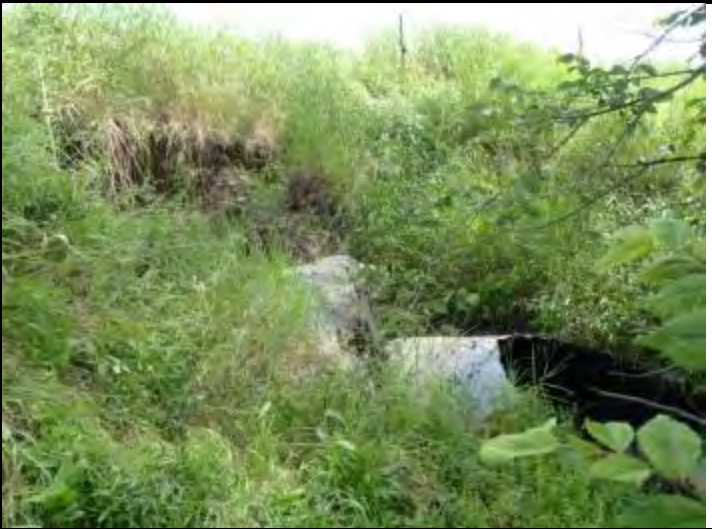
Photo 1. View downstream of culvert **Photo 2.** Bank slump above culvert
