STORMWATER MANAGEMENT PLAN FOR SHELDON

FINAL REPORT

Stone Project ID 12-145

January 24, 2014

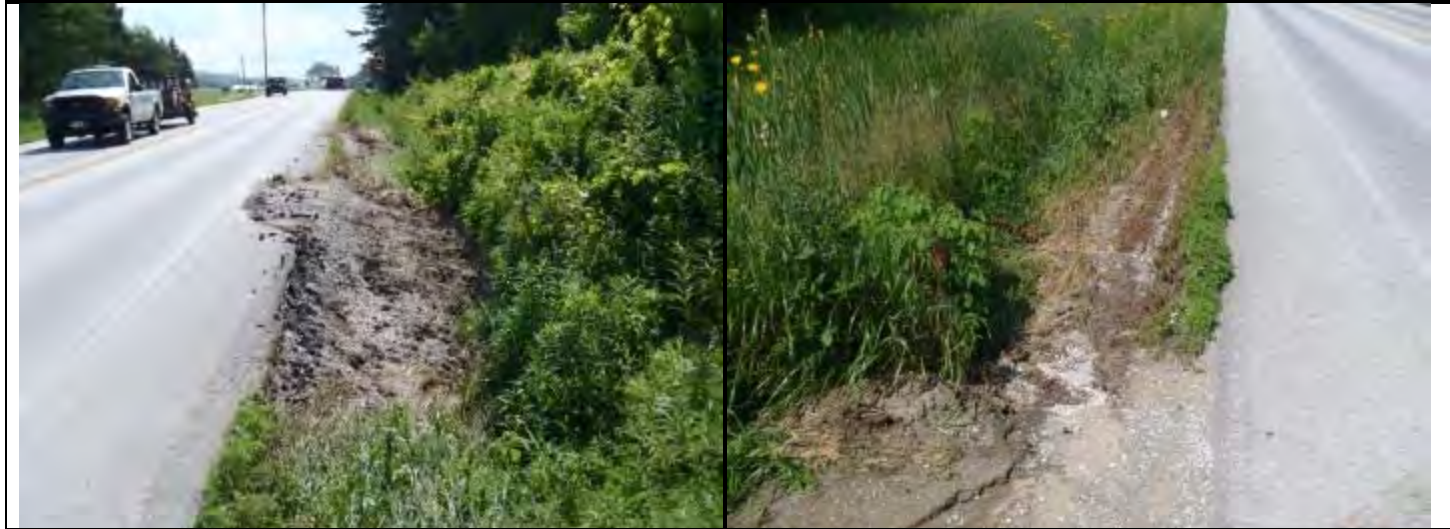
Photo 1. Road shoulder erosion **Photo 2.** Sediment in ditch

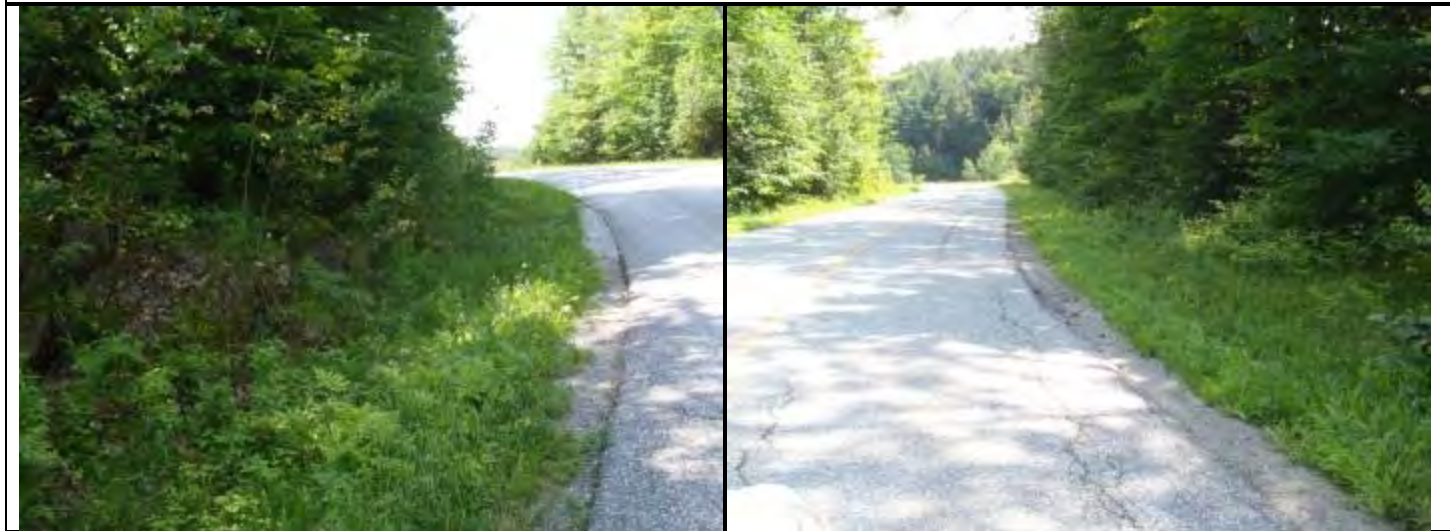
Photo 1. Erosion at edge of road **Photo 2.** Erosion at edge of road

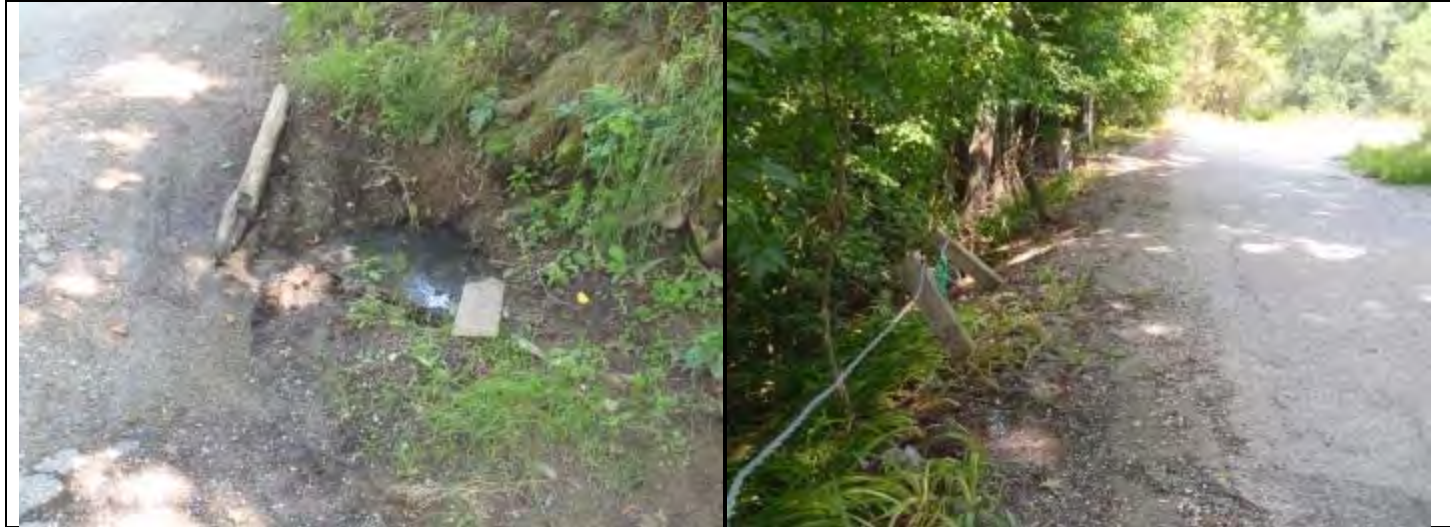
Photo 1. Pool (2' dia.) at culvert inlet **Photo 2.** Western edge of Church St.

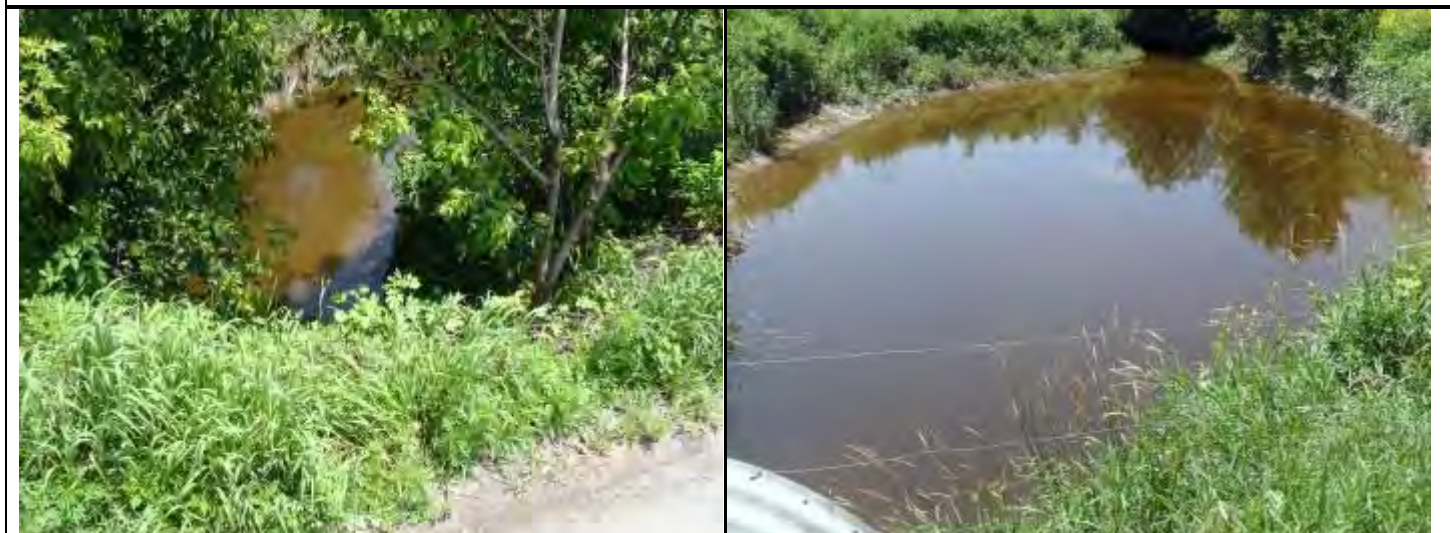
Photo 1. Stream widening upstream of culvert **Photo 2.** Scour pool downstream of culvert

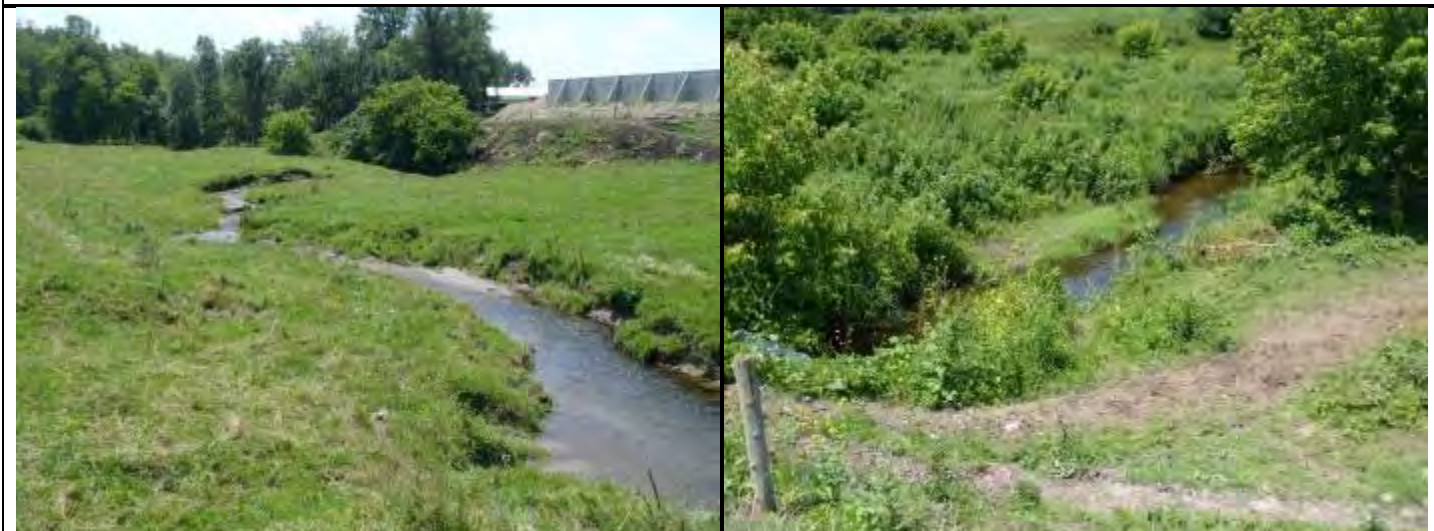
Photo 1. Upstream of culvert
