STORMWATER MANAGEMENT PLAN FOR ST. ALBANS TOWN

FINAL REPORT

Stone Project ID 14-053

March 25, 2015

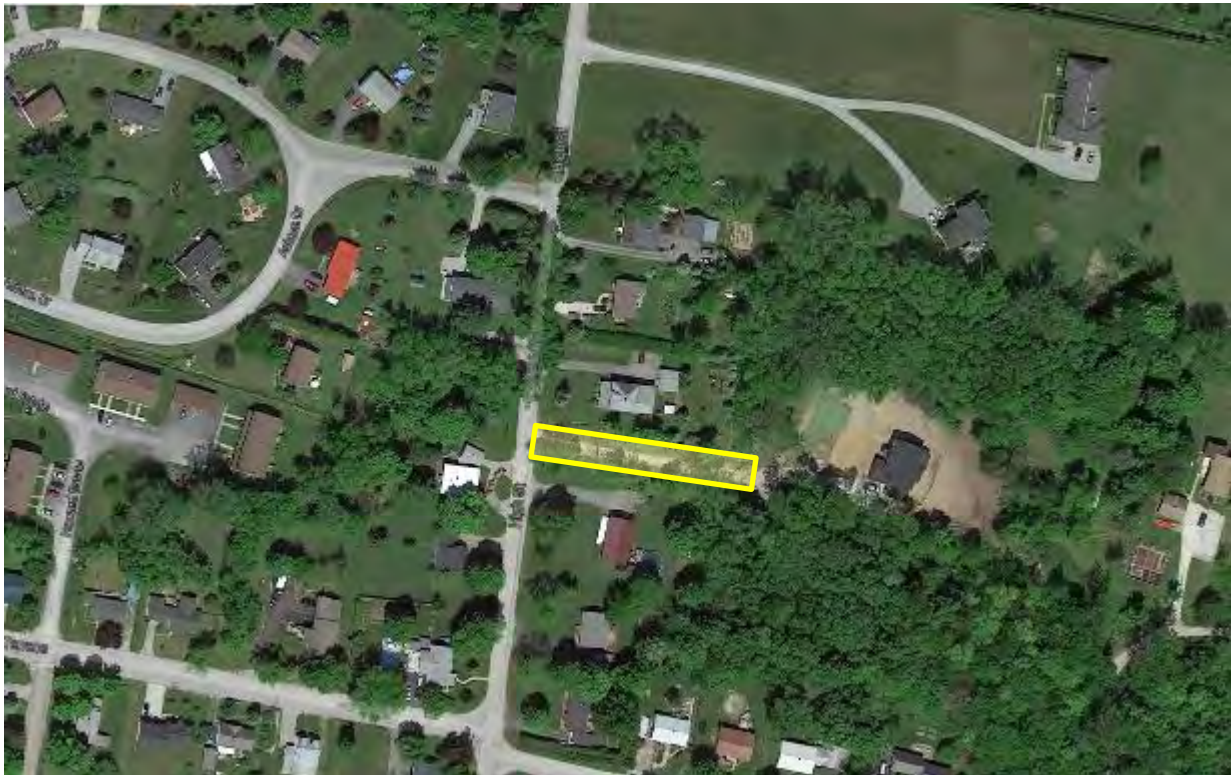
Figure 1. La Cresta Drive Problem Area. Significant roadside erosion was observed in the area highlighted in yellow.

Conditions along La Cresta Drive could be improved by reshaping the roadside ditch and applying appropriate stabilization measures. La Cresta Drive has a slope in excess of 5%, so the ditch should be stone lined. Timber or stone check dams could also be used to slow runoff. In addition, installing headwalls at the inlet to the cross-culvert, and providing a rock-lined splash pool at the culvert outlet, would help address the erosion concern. It may be that these measures will sufficiently slow the stormwater runoff to mitigate the erosion between Howard Estates and Ashton Drive, but this area should be more fully evaluated, assuming access to private property can be obtained.

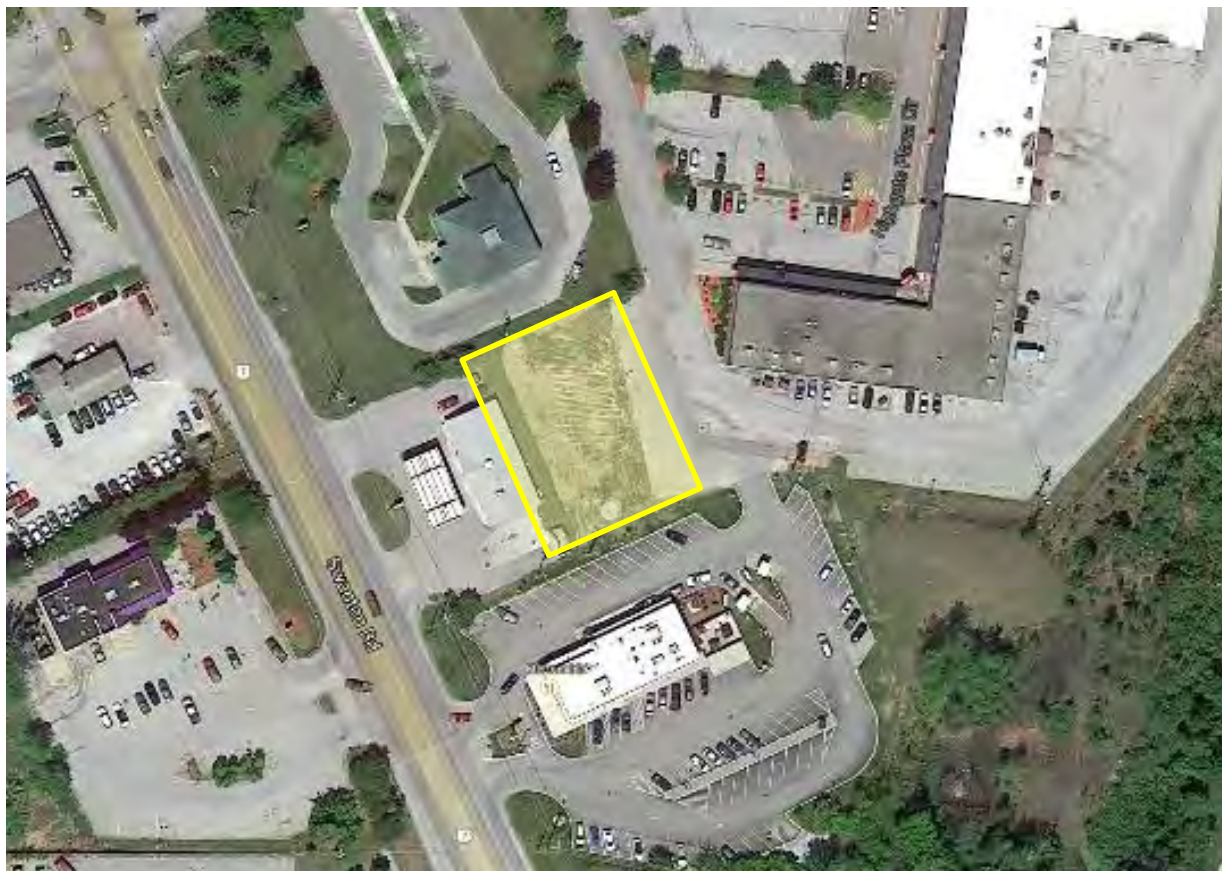
Although there is a curb cut along the back edge of the Key Bank parking lot, stormwater runoff simply flows through the curb cut as concentrated flow, and travels over the grass to a drop inlet. If the grass area were reshaped to create a depression, runoff from a significant proportion of the adjoining impervious areas could be attenuated before being discharged to the unnamed tributary to Stevens Brook. However, it will be important to evaluate the depth to seasonal high groundwater as part of any design, as the NRCS soil survey maps for this area indicate that groundwater could be as high as within 12 inches of the ground surface.

Figure 2. High priority problem area at Highgate Commons Plaza; evidence of recent removal of impervious surface is visible in the aerial image.

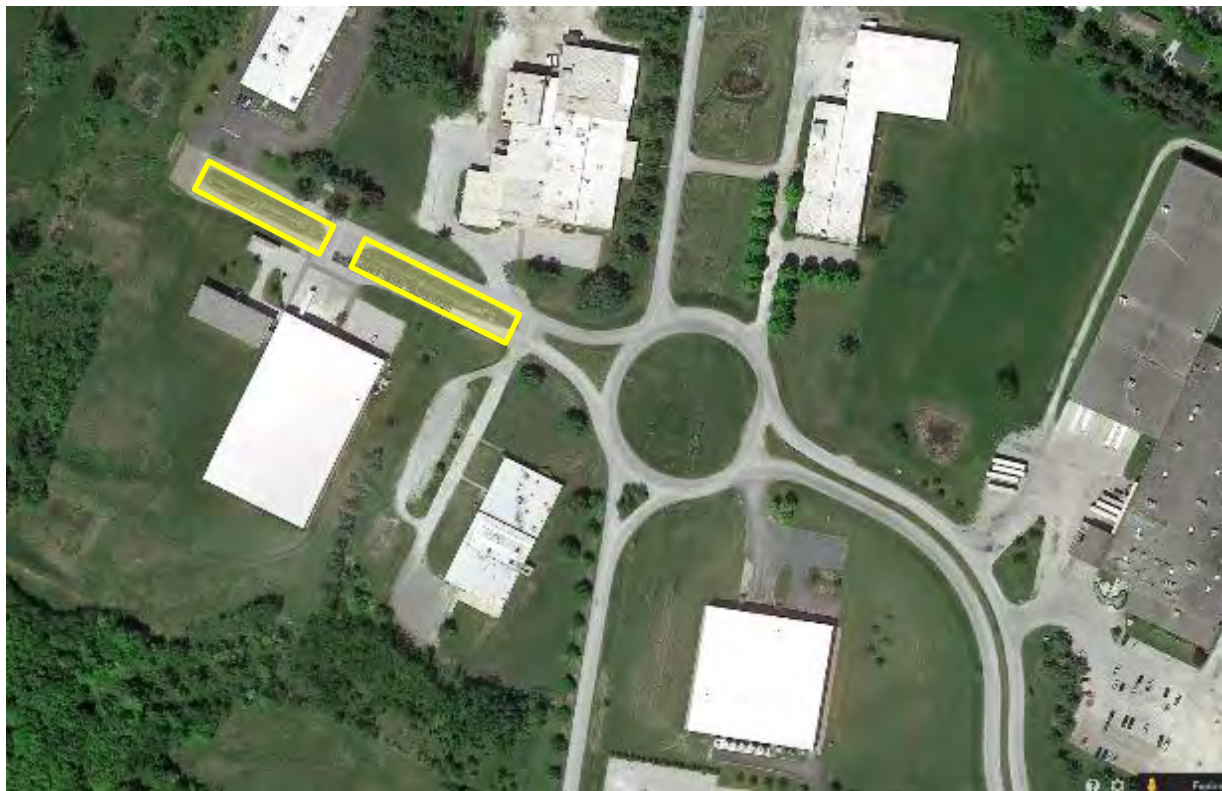
Runoff from slightly less than seven acres within the St. Albans Town Industrial Park is eventually captured and conveyed via a swale in the median of Industrial Park Road, as shown in Figure 3. A stormwater discharge permit was issued for the Industrial Park (4262-9010), and several entities are identified as permit-holders, including the Town of St Albans. The existing swale has a V-shape, as opposed to the preferable parabolic shape, and is eroding at the bottom. In addition, several failed check dams within the western section of swale are causing the swale banks to slump.

Figure 3. Industrial Park Road Problem Area. Priority areas for stormwater retrofits are highlighted in yellow.

The ditches should be reshaped and new check dams installed. It may be that timber check dams will be better suited to this application. The NRCS soil survey maps for this area indicate that the underlying soils may be poorly drained, and thus solutions that encourage infiltration, such as the construction of a bioswale, are unlikely to be viable.

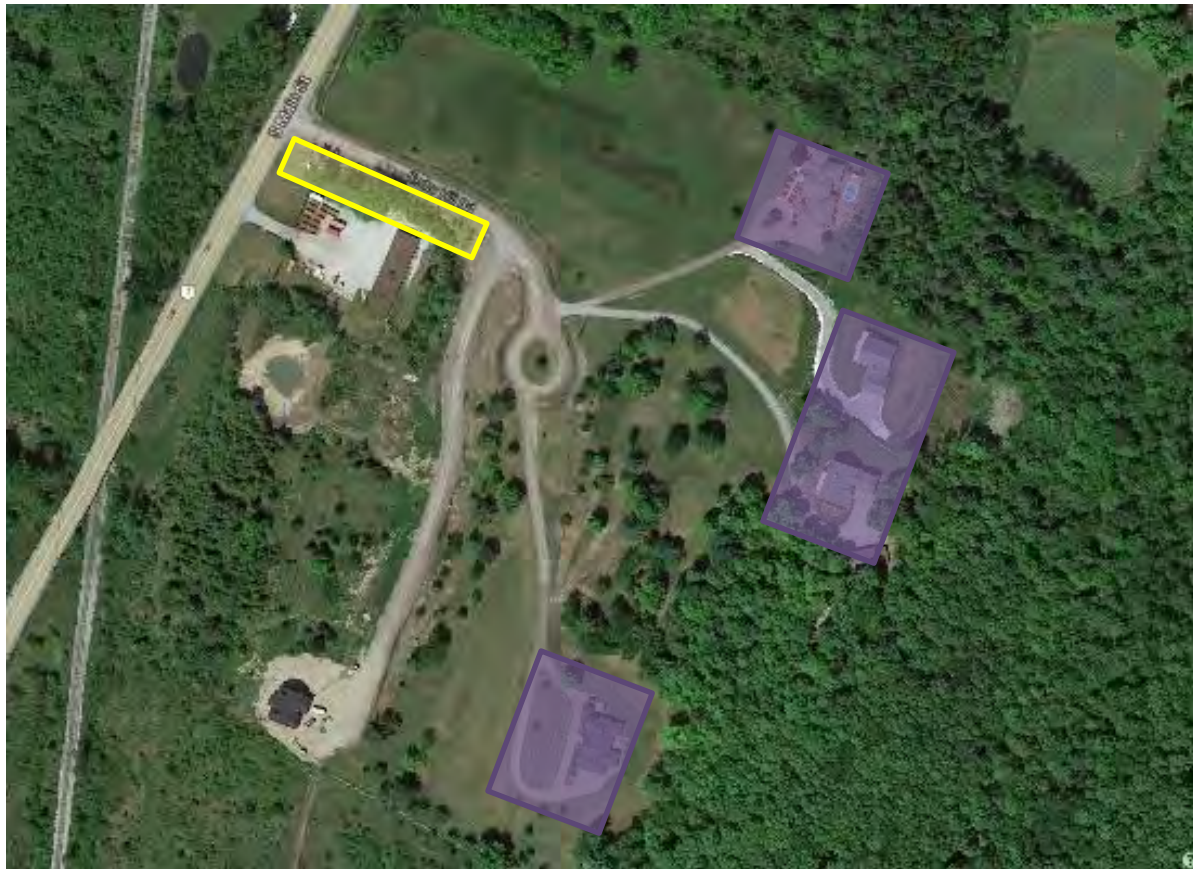
Active erosion was observed in the ditch that runs along Cedar Hill Road from Charbonneau Drive to Route 7 (shown in yellow on Figure 4). In addition, the headwalls at the culvert inlet and outlet appear to be improperly installed, and insufficient backfill behind the headwalls is exacerbating erosion.

Figure 4. Cedar Hill Road Problem Area. A priority area for stormwater retrofits is highlighted in yellow; areas suitable for rain gardens or other simple disconnection practices are shown in purple.

Soils in this area are characterized by the NRCS soil survey maps as having significant infiltrative capacity, but also as being highly erodible. The ditch should be reshaped and additional stabilization measures, including rock lining and check dams, should be added. Given the quality of soils in the vicinity of Cedar Hill Road, the homeowners should be encouraged to consider rain gardens or other simple disconnection practices that would allow rainwater to infiltrate on site; potential areas are indicated in purple in Figure 4.

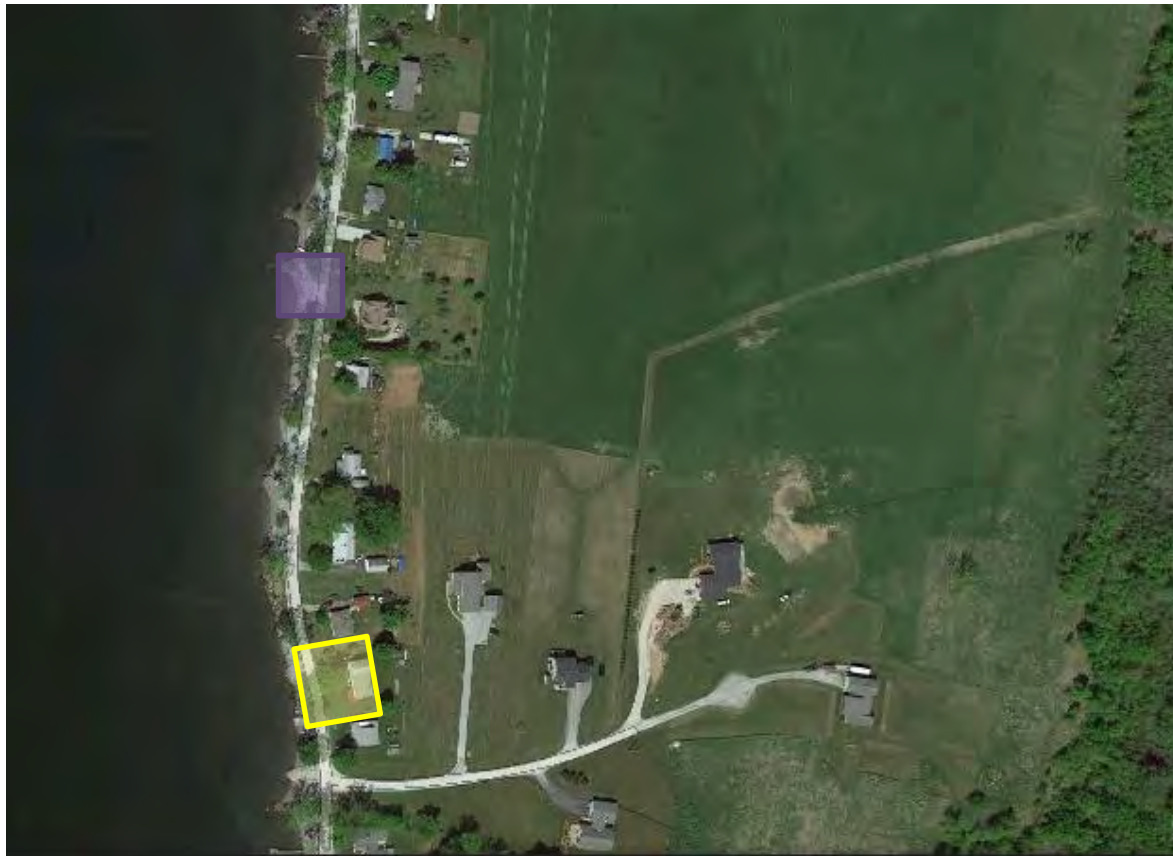
Figure 5. Samson Road Problem Areas.

Four culverts along Samson Road were identified in the VTrans bridge and culvert inventory as being in “critical” condition. During the field work completed as part of this project, it was observed that the culverts had been recently replaced and that the areas around two of the new culverts – including a catch basin inlet located approximately 120 feet north of Waters Edge Drive, as well as the culvert outlet to Lake Champlain located approximately 720 feet north of Waters Edge Drive – were actively eroding.

The culvert outlet (location highlighted in purple in Figure 5) needs a robust headwall, capable of withstanding wave action. It is unclear if a headwall was constructed when the culvert was installed and has already failed, or if gravel piled over the downstream end of the culvert at the road shoulder was moved by lake waters.

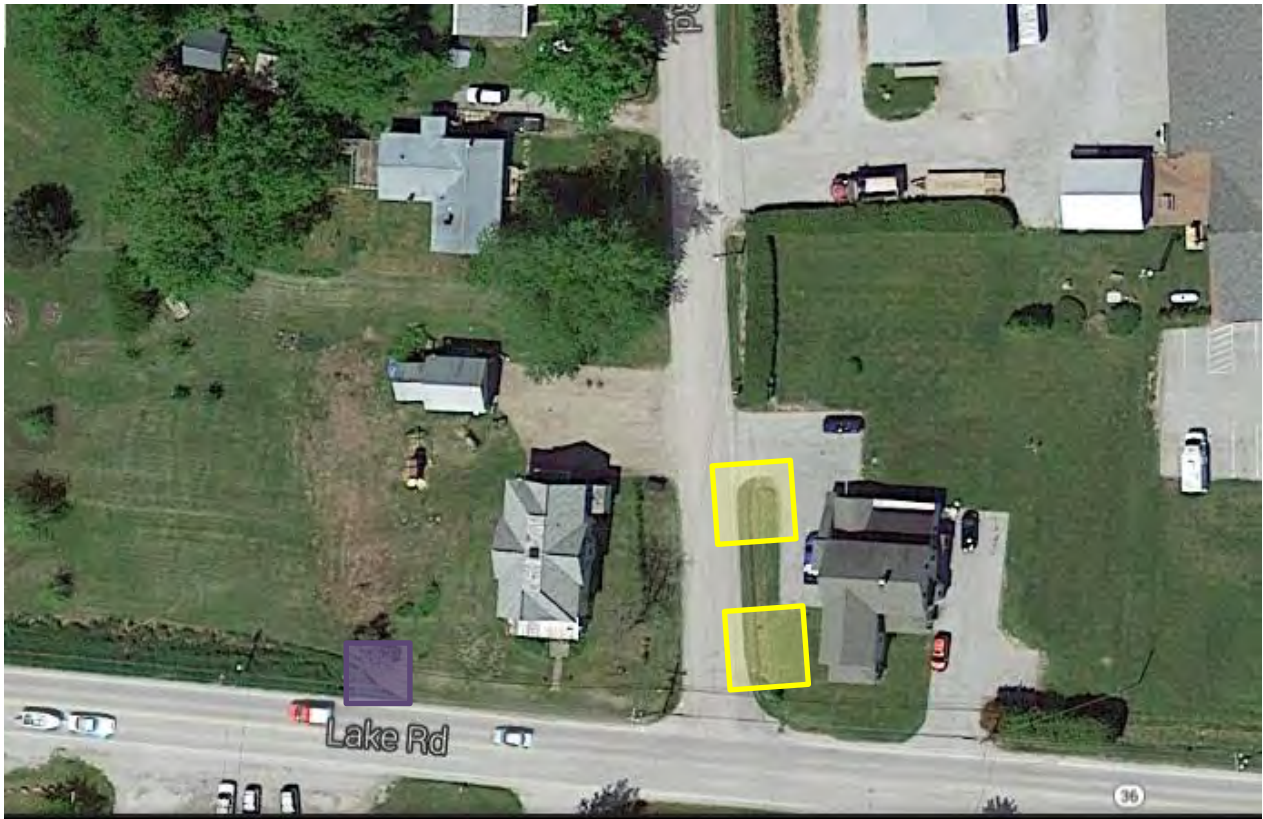
Figure 6. Stormwater Problem Areas near the intersection of Brigham Road and Lake Road.

There is active erosion at the outlet of the cross-culvert to the west of Brigham Road (indicated in purple in Figure 6), that takes flow under Lake Road. The culvert is too short, and erosion has begun to undermine the road shoulder. The culvert should be replaced with a longer culvert, and a splash pad should be installed at the outlet.

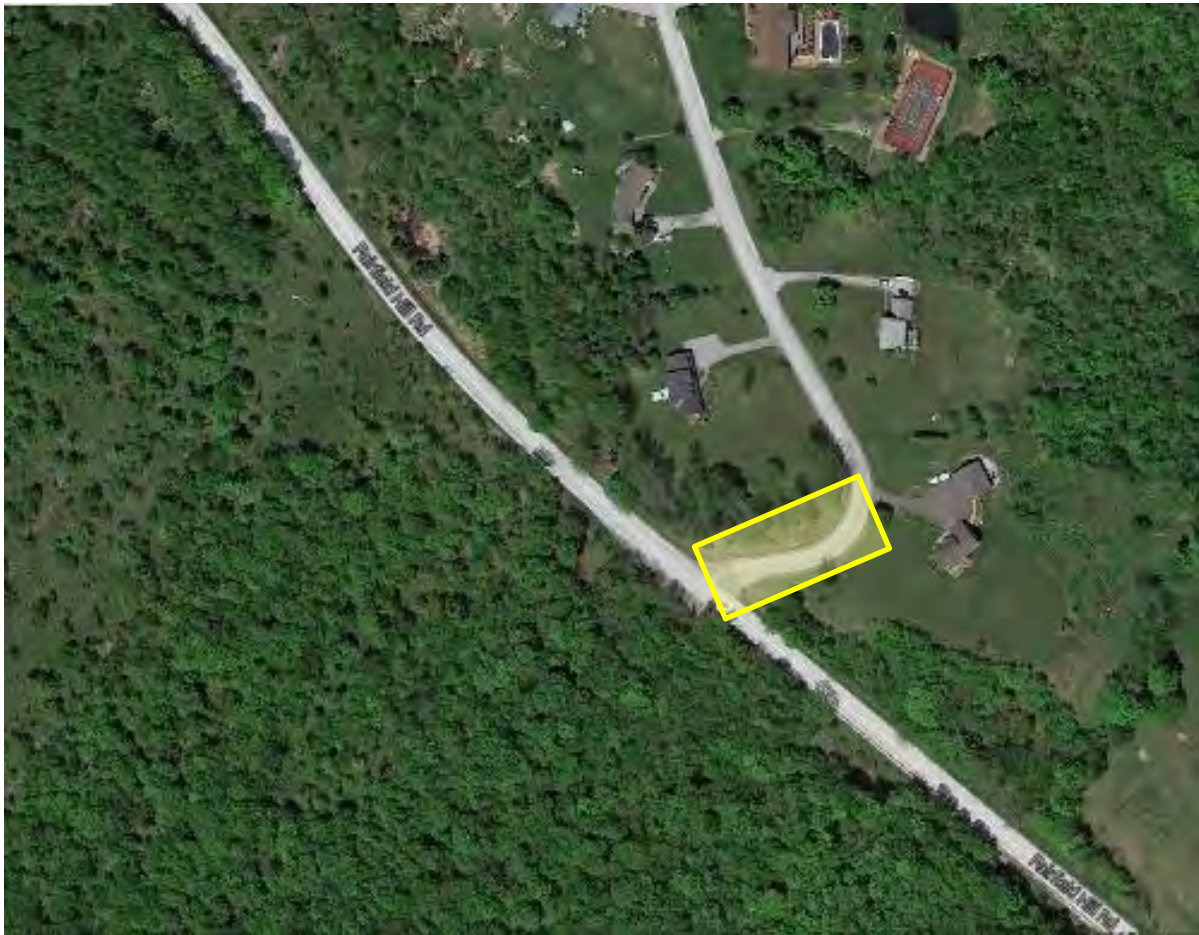
Significant and recent sediment deposits were observed where Lakemont Drive joins Fairfield Hill Road (Route 36). It appears that these deposits are largely caused by stormwater runoff flowing along the road shoulder as opposed to in the ditch. It also appears that the road shoulder at the intersection is being undermined by stormwater flows.

Figure 7. Area of active erosion near the intersection of Lakemont Drive at Fairfield Hill Road.

The ditches along the section of Lakemont Drive highlighted in Figure 7, below, should be reshaped to ensure that runoff can access the ditch. In addition, the ditch should be stone lined since the road slope is in excess of 5%. It may also be desirable to incorporate check dams to further slow flows. The NRCS soil survey maps for this area indicate that the underlying soils are likely to be poorly drained, suggesting that solutions that encourage infiltration, such as the construction of a bioswale, are unlikely to be viable.

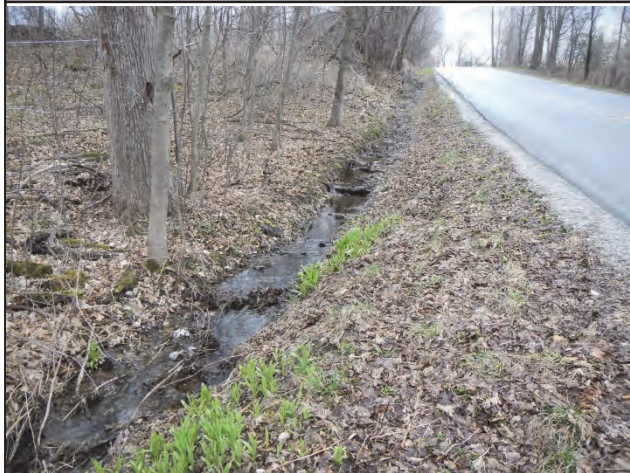
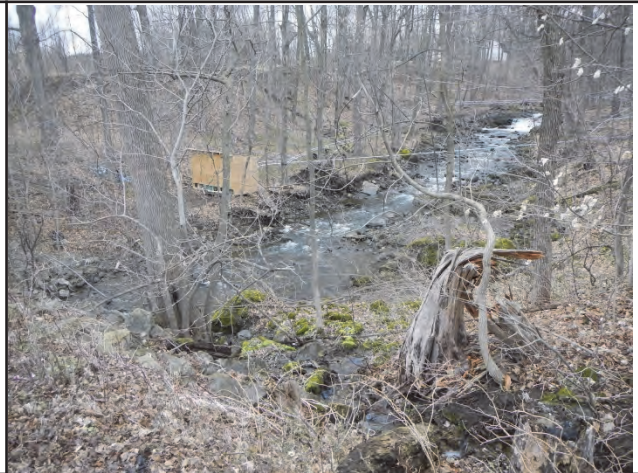
Photo 1. Incised ditch bottom Photo 2. Ditch path to Stevens Brook

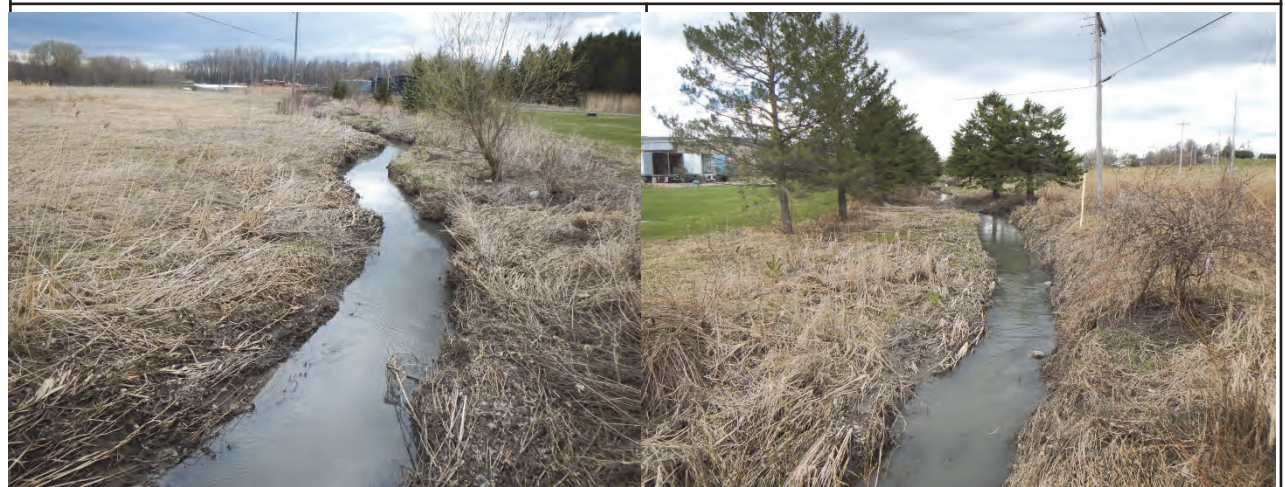
Photo 1. Straightened section of stream Photo 2. Straightened section of stream

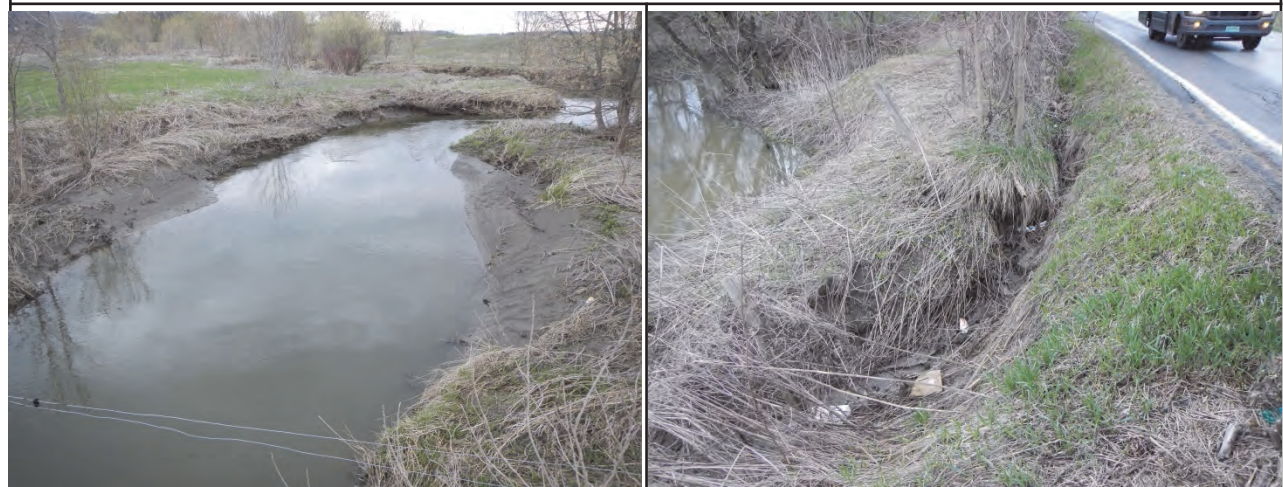
Photo 1. Scour pool at outlet Photo 2. Ditch erosion along Lower Newton Rd.

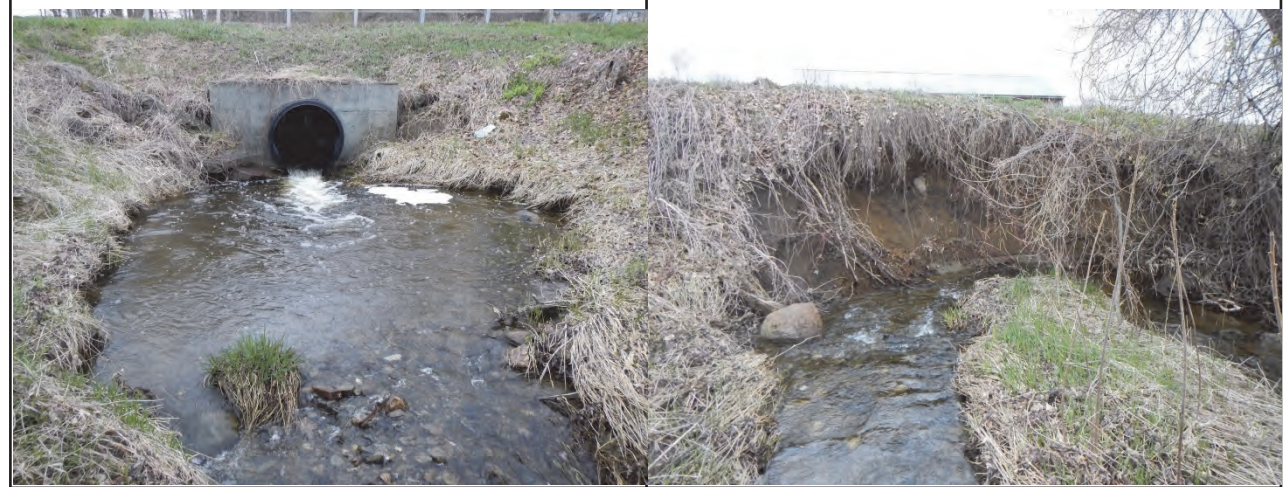
Photo 1. Scour pool at outlet Photo 2. Bank slough

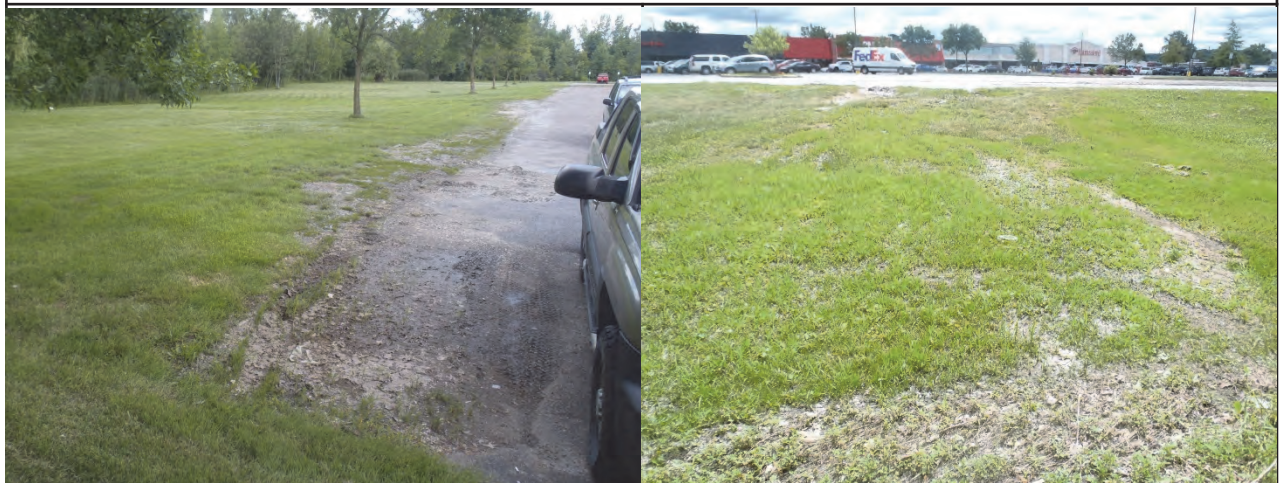
Photo 1. Evidence of stormwater draining off wet edge of parking area

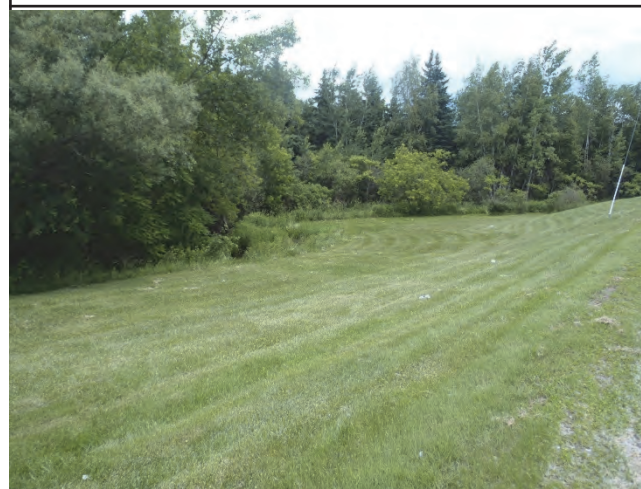
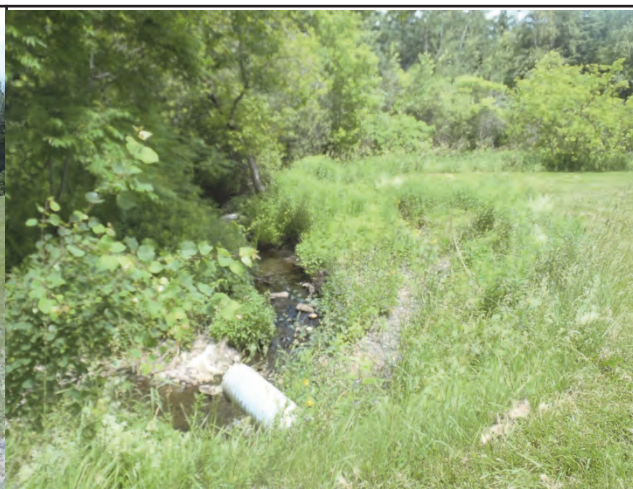
Photo 1. Buffer area is mowed to "top of bank"

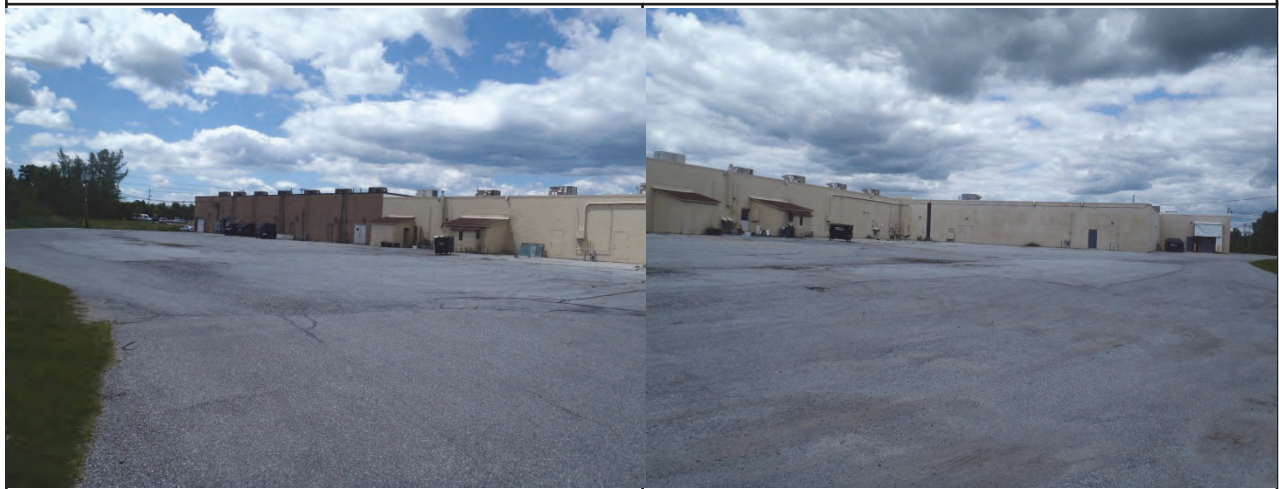
Photo 1. Underutilized impervious area behind Peebles.

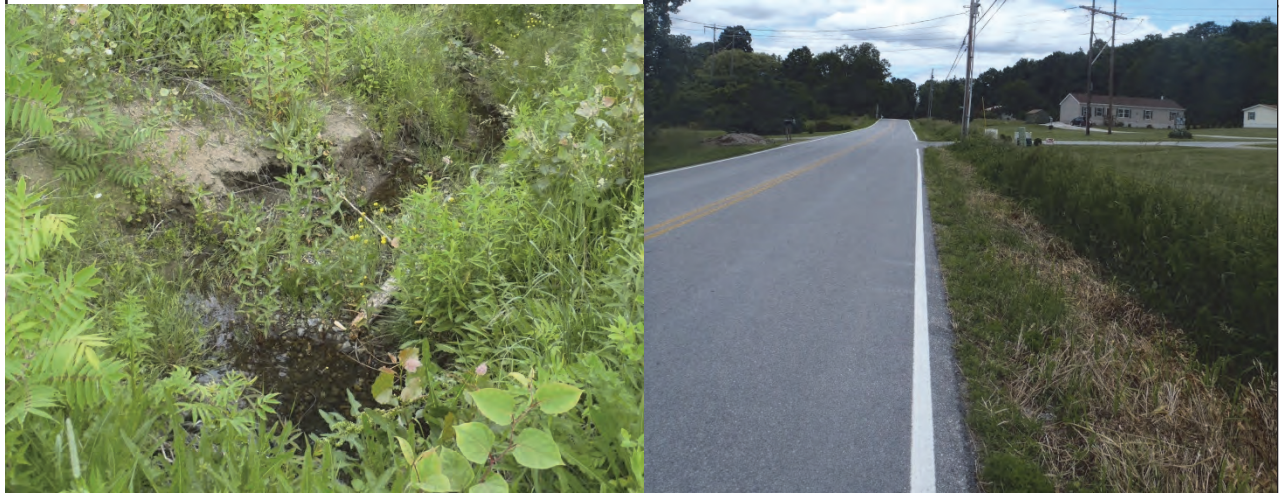
Photo 1. Active erosion at outlet to cross-culvert

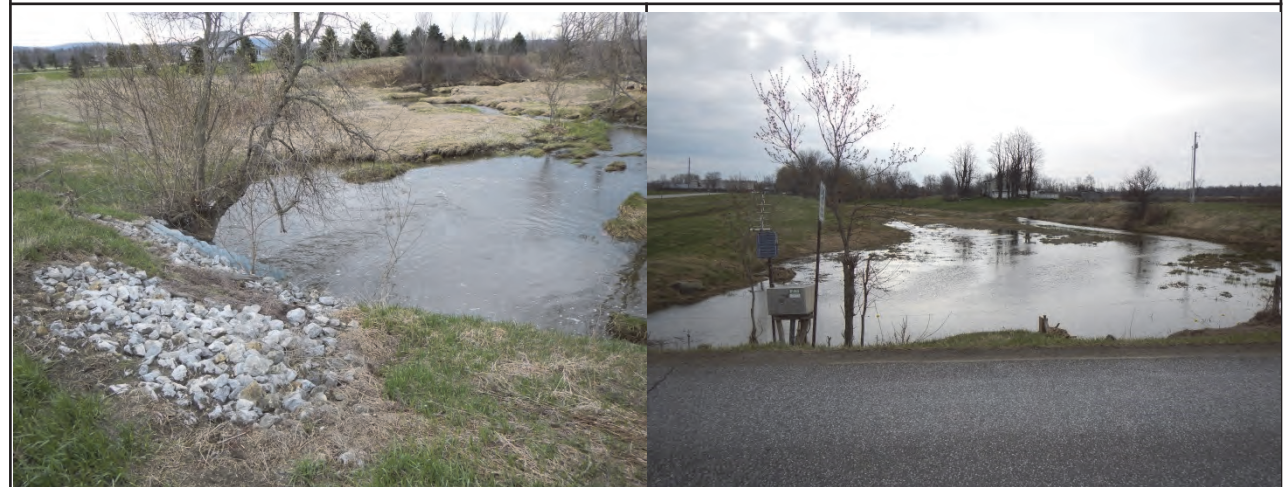
Photo 1. Scour pool at culvert outlet Photo 2. Flooded area and USGS station at inlet.

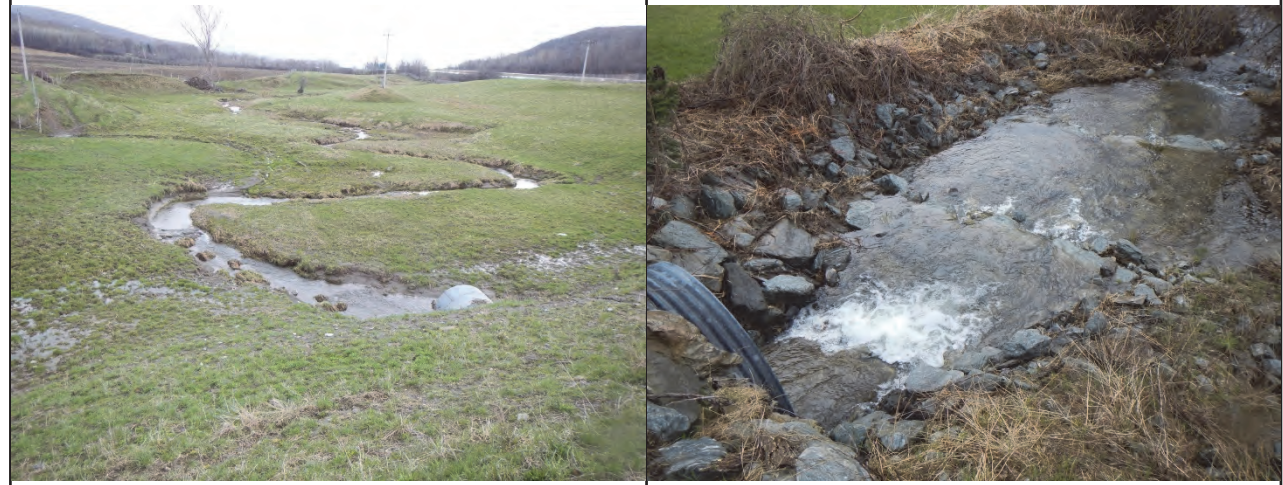
Photo 1. Upstream from culvert Photo 2. Culvert outlet.

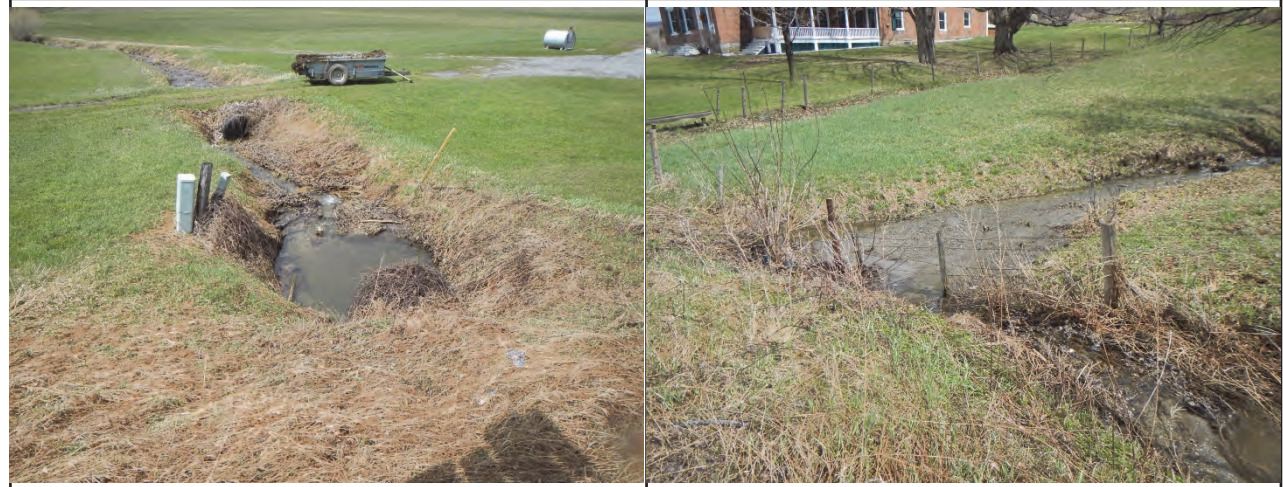
Photo 1. Scour pool at outlet Photo 2. Water ponding at inlet

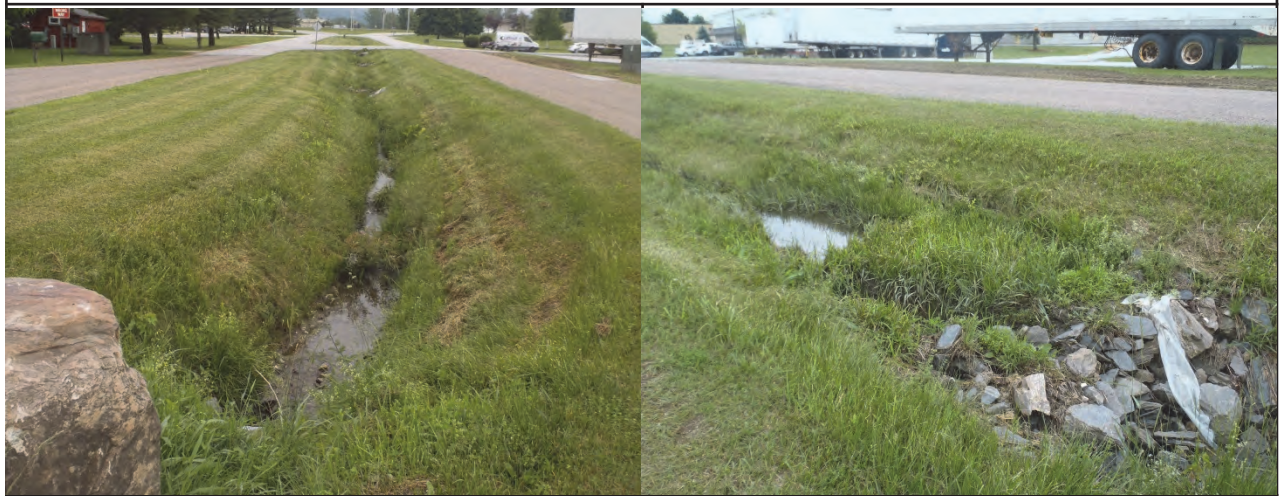
Photo 1. Swale, with some evidence of erosion

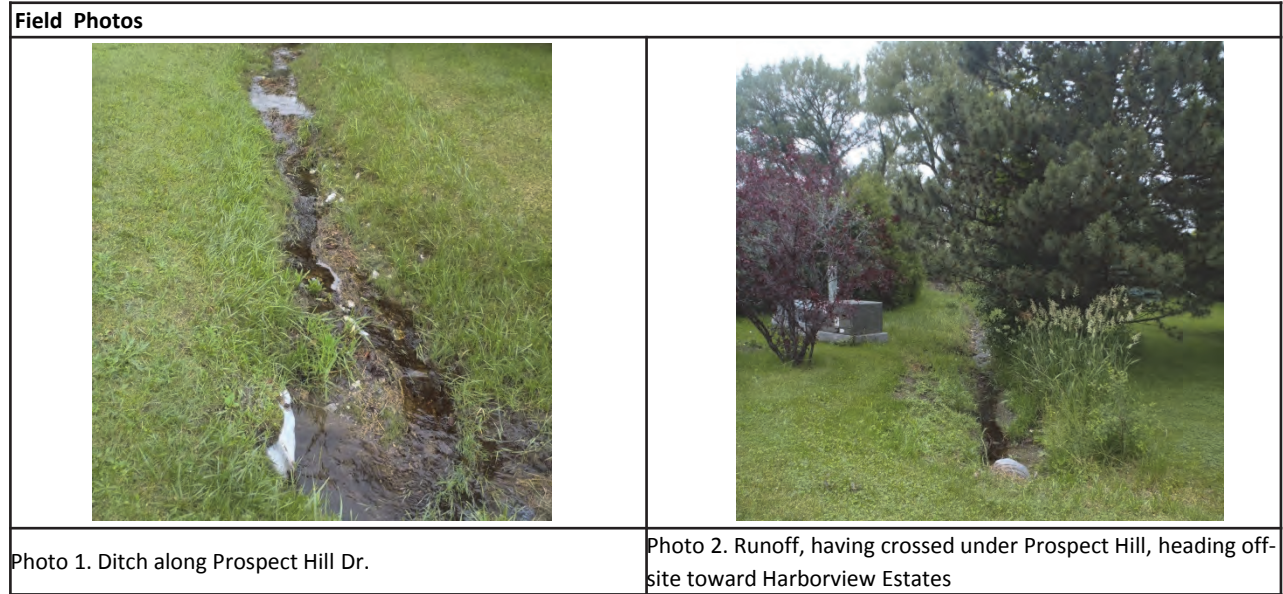
Description of Observed Conditions:
 A series of eroding roadside ditches are carrying runoff along Prospect Hill Rd., before turning northwest toward Harborview Estates.

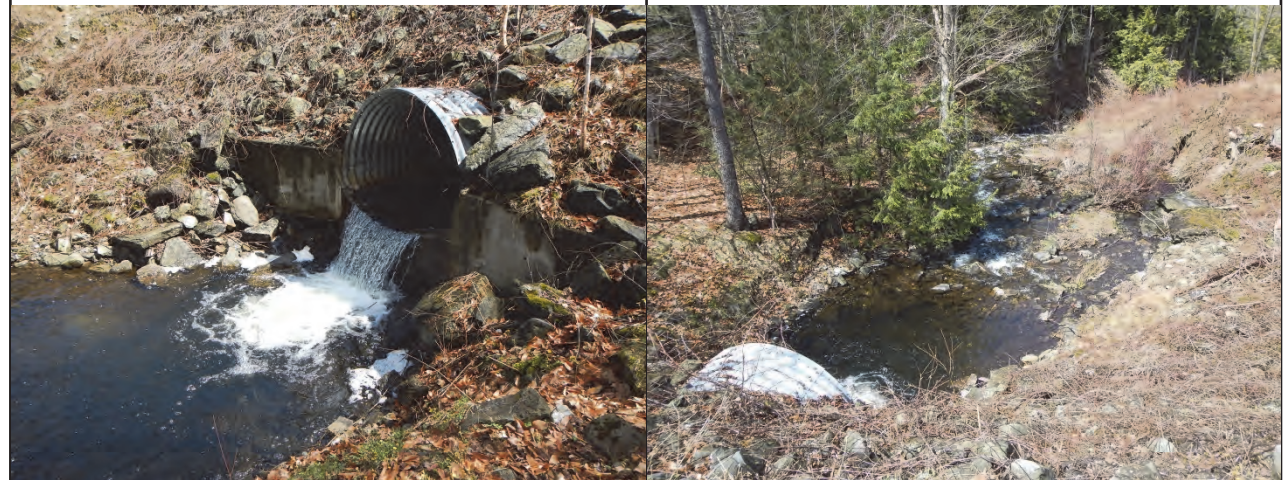
Photo 1. Perched culvert outlet Photo 2. Bank erosion downstream from culvert

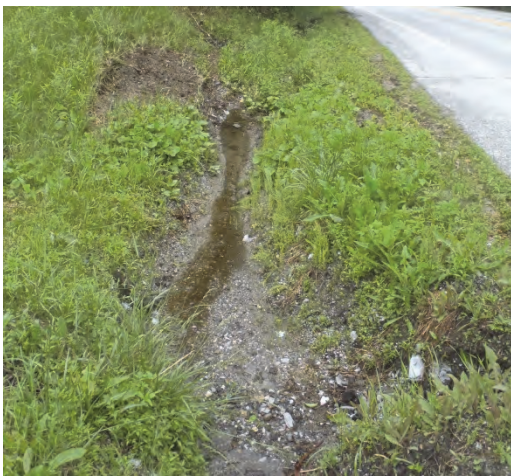
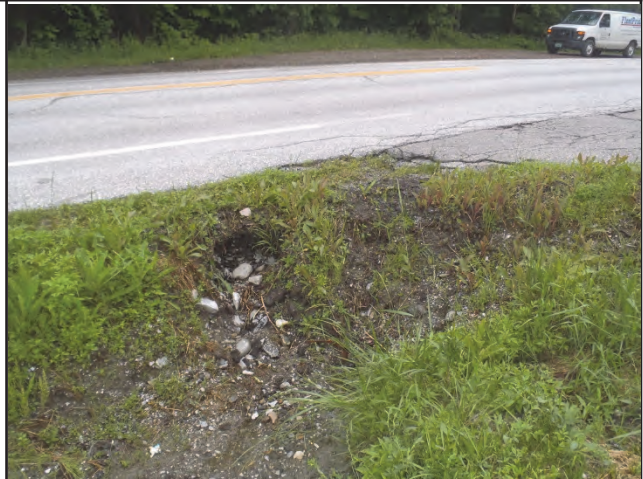
Photo 1. Evidence of sediment from Lakemont Drive being deposited in ditch along Route 36

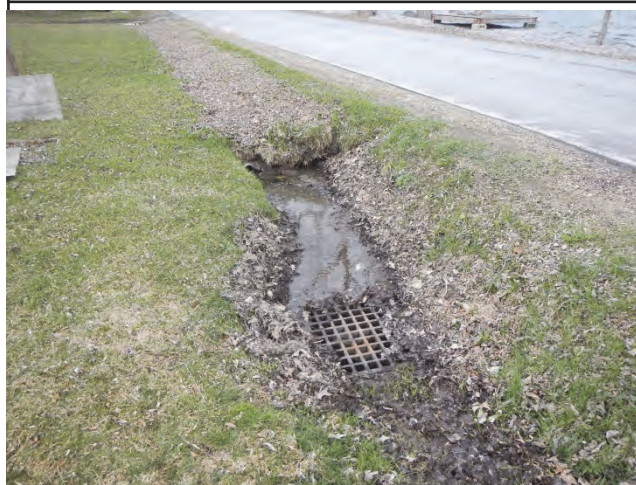
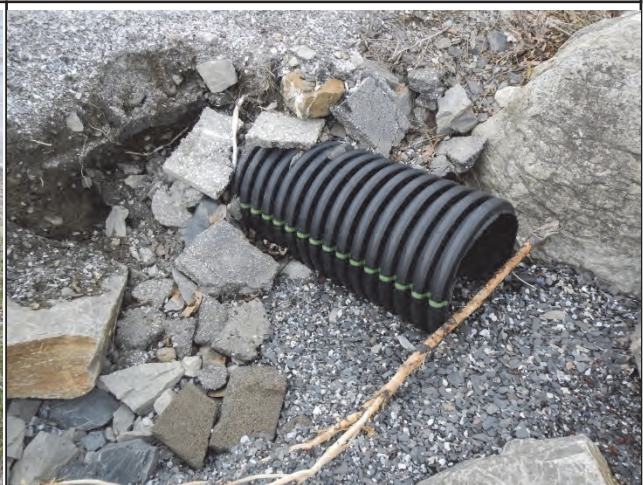
Photo 1. Erosion near catch basin

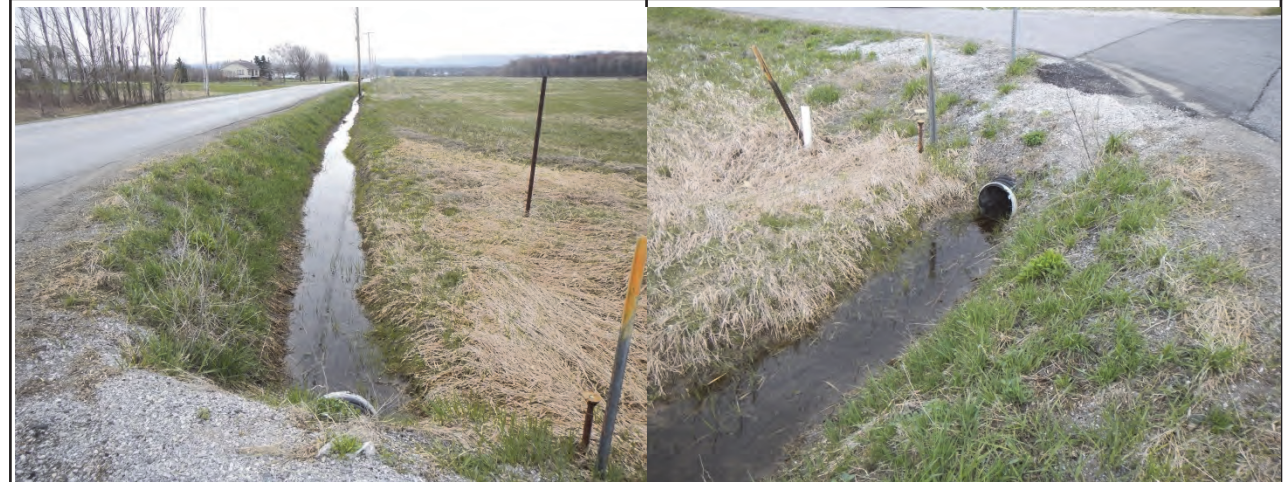
Photo 1. Narrow ditch upstream from culvert Photo 2. Culvert inlet

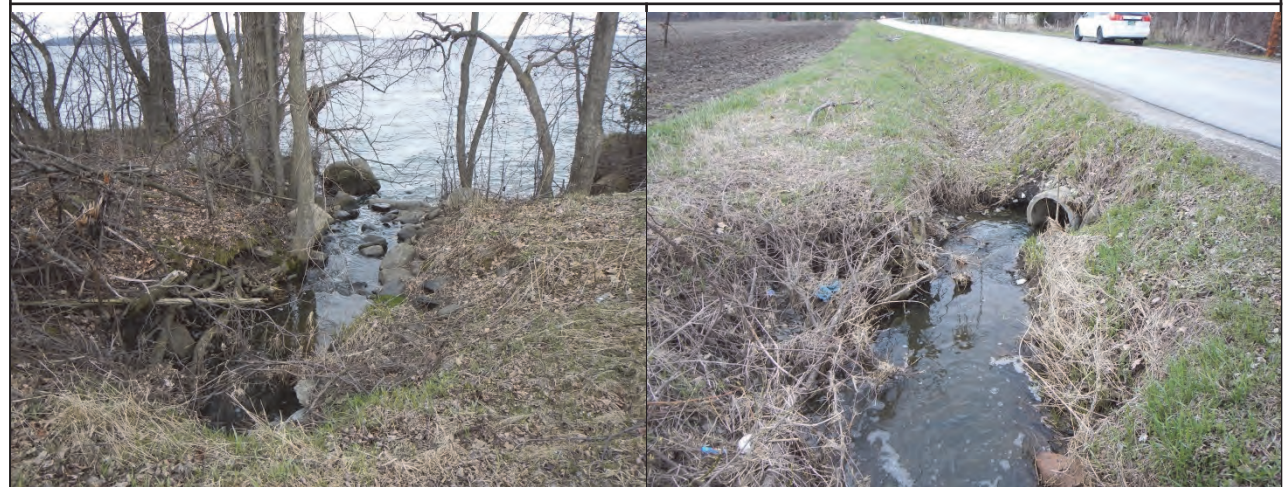
Photo 1. Erosion at culvert outlet Photo 2. Narrow buffer is visible in background of inlet

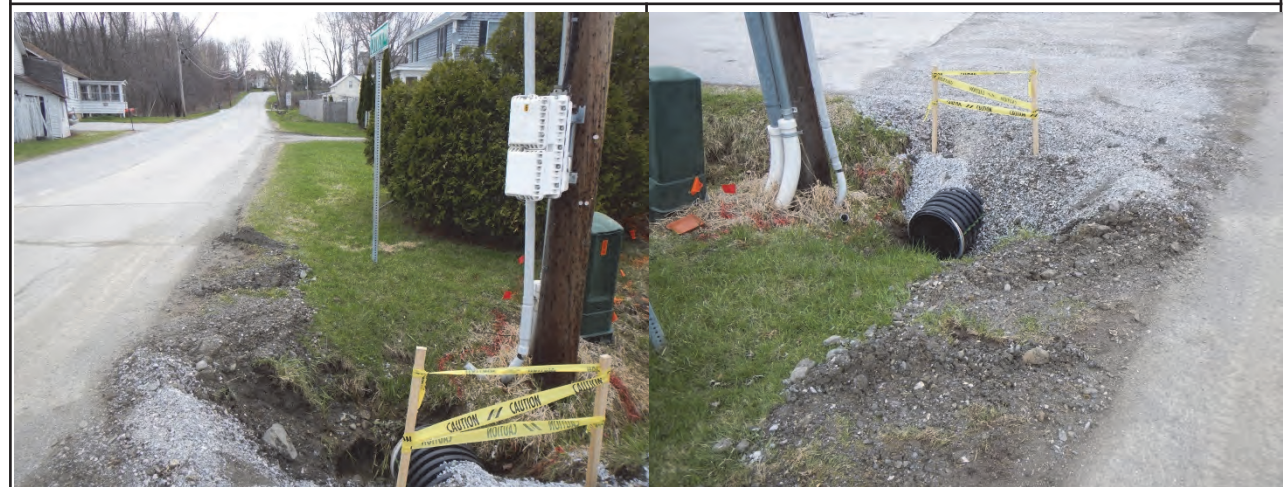
Photo 1. Culvert outlet from Church St. is buried, but visible Photo 2. Erosion will be an issue with nearby utilities

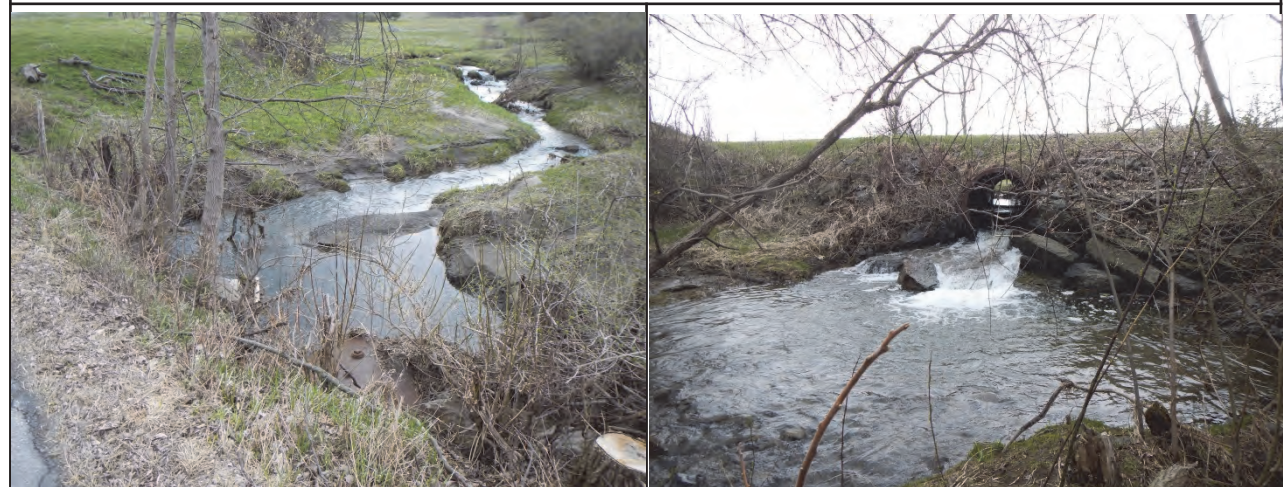
Photo 1. Upstream banks are unstable and meandering Photo 2. Culvert outlet and scour pool

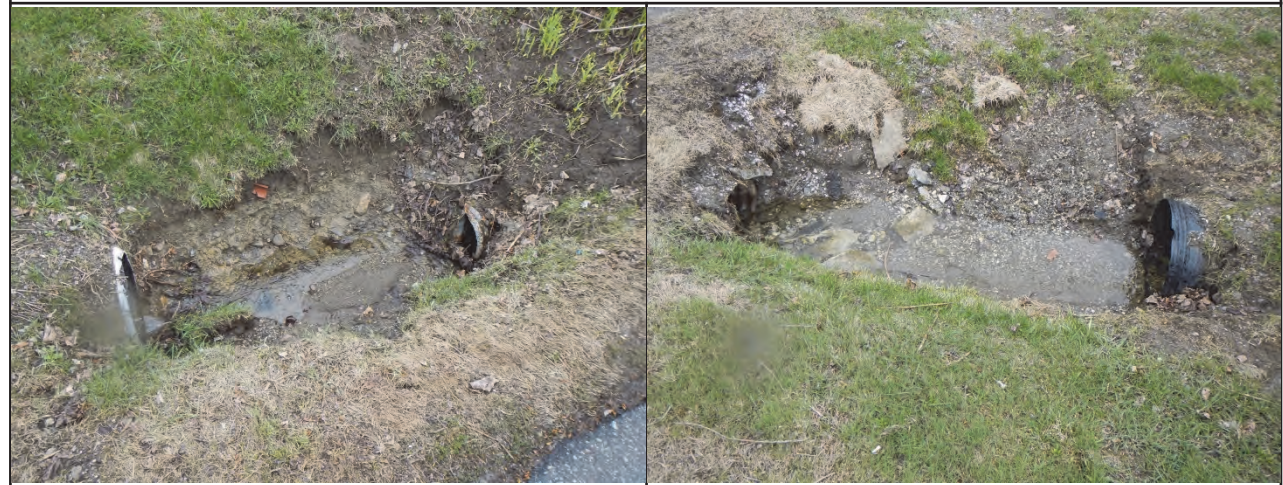
Photo 1. Discontinuous culvert sections and scour hole

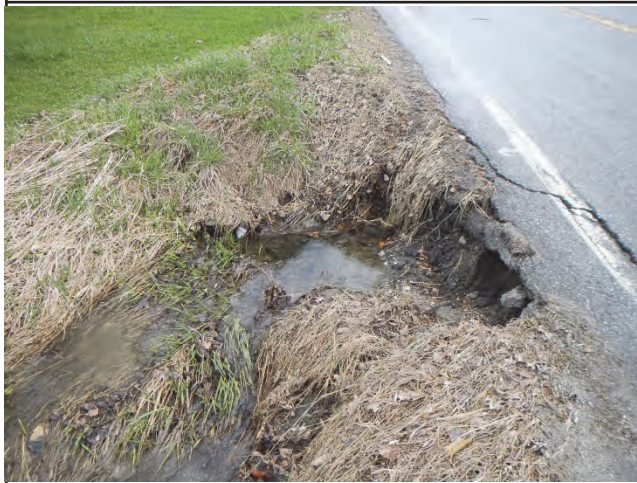
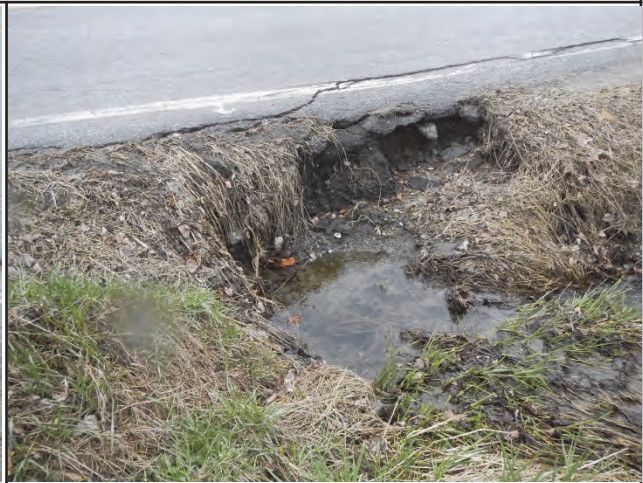
Photo 1. Pavement erosion at culvert outlet
