STORMWATER MANAGEMENT PLAN FOR ST. ALBANS TOWN

FINAL REPORT

Stone Project ID 14-053

March 25, 2015

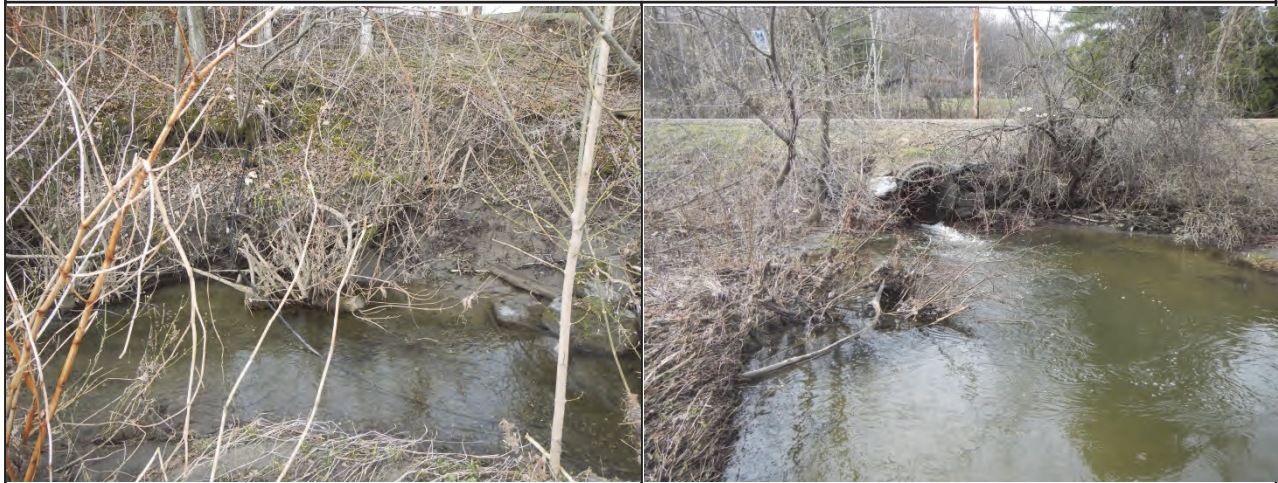
Photo 1. Bank erosion near the culvert inlet Photo 2. Large scour pool at culvert outlet.

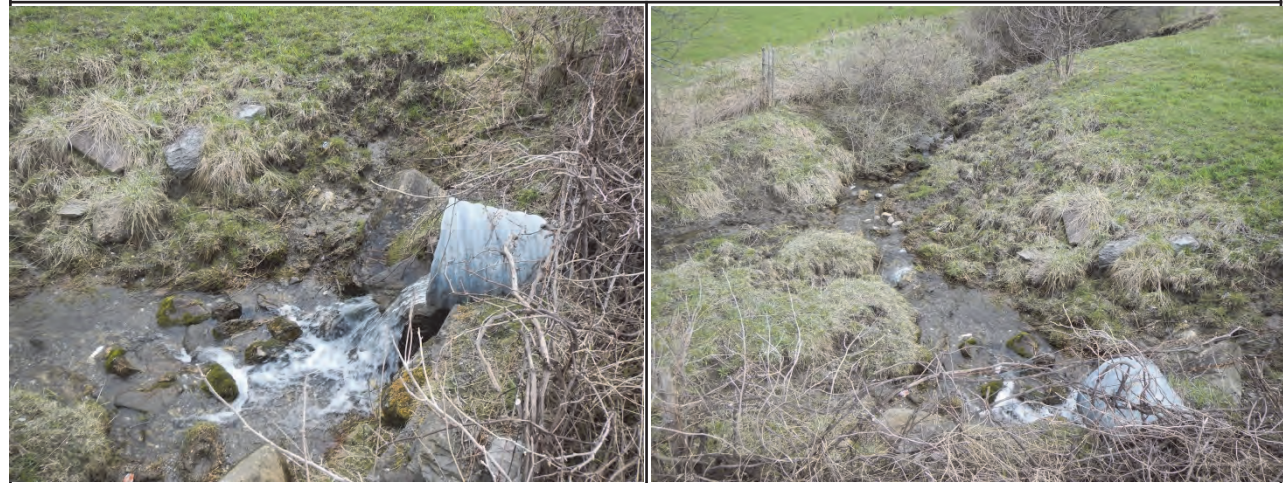
Photo 1. Culvert outlet from Church St. is buried, but visible Photo 2. Erosion will be an issue with nearby utilities
