Inn Brook, Stowe, Vermont

Stowe, VT

DEC Stormwater Infrastructure Mapping Project

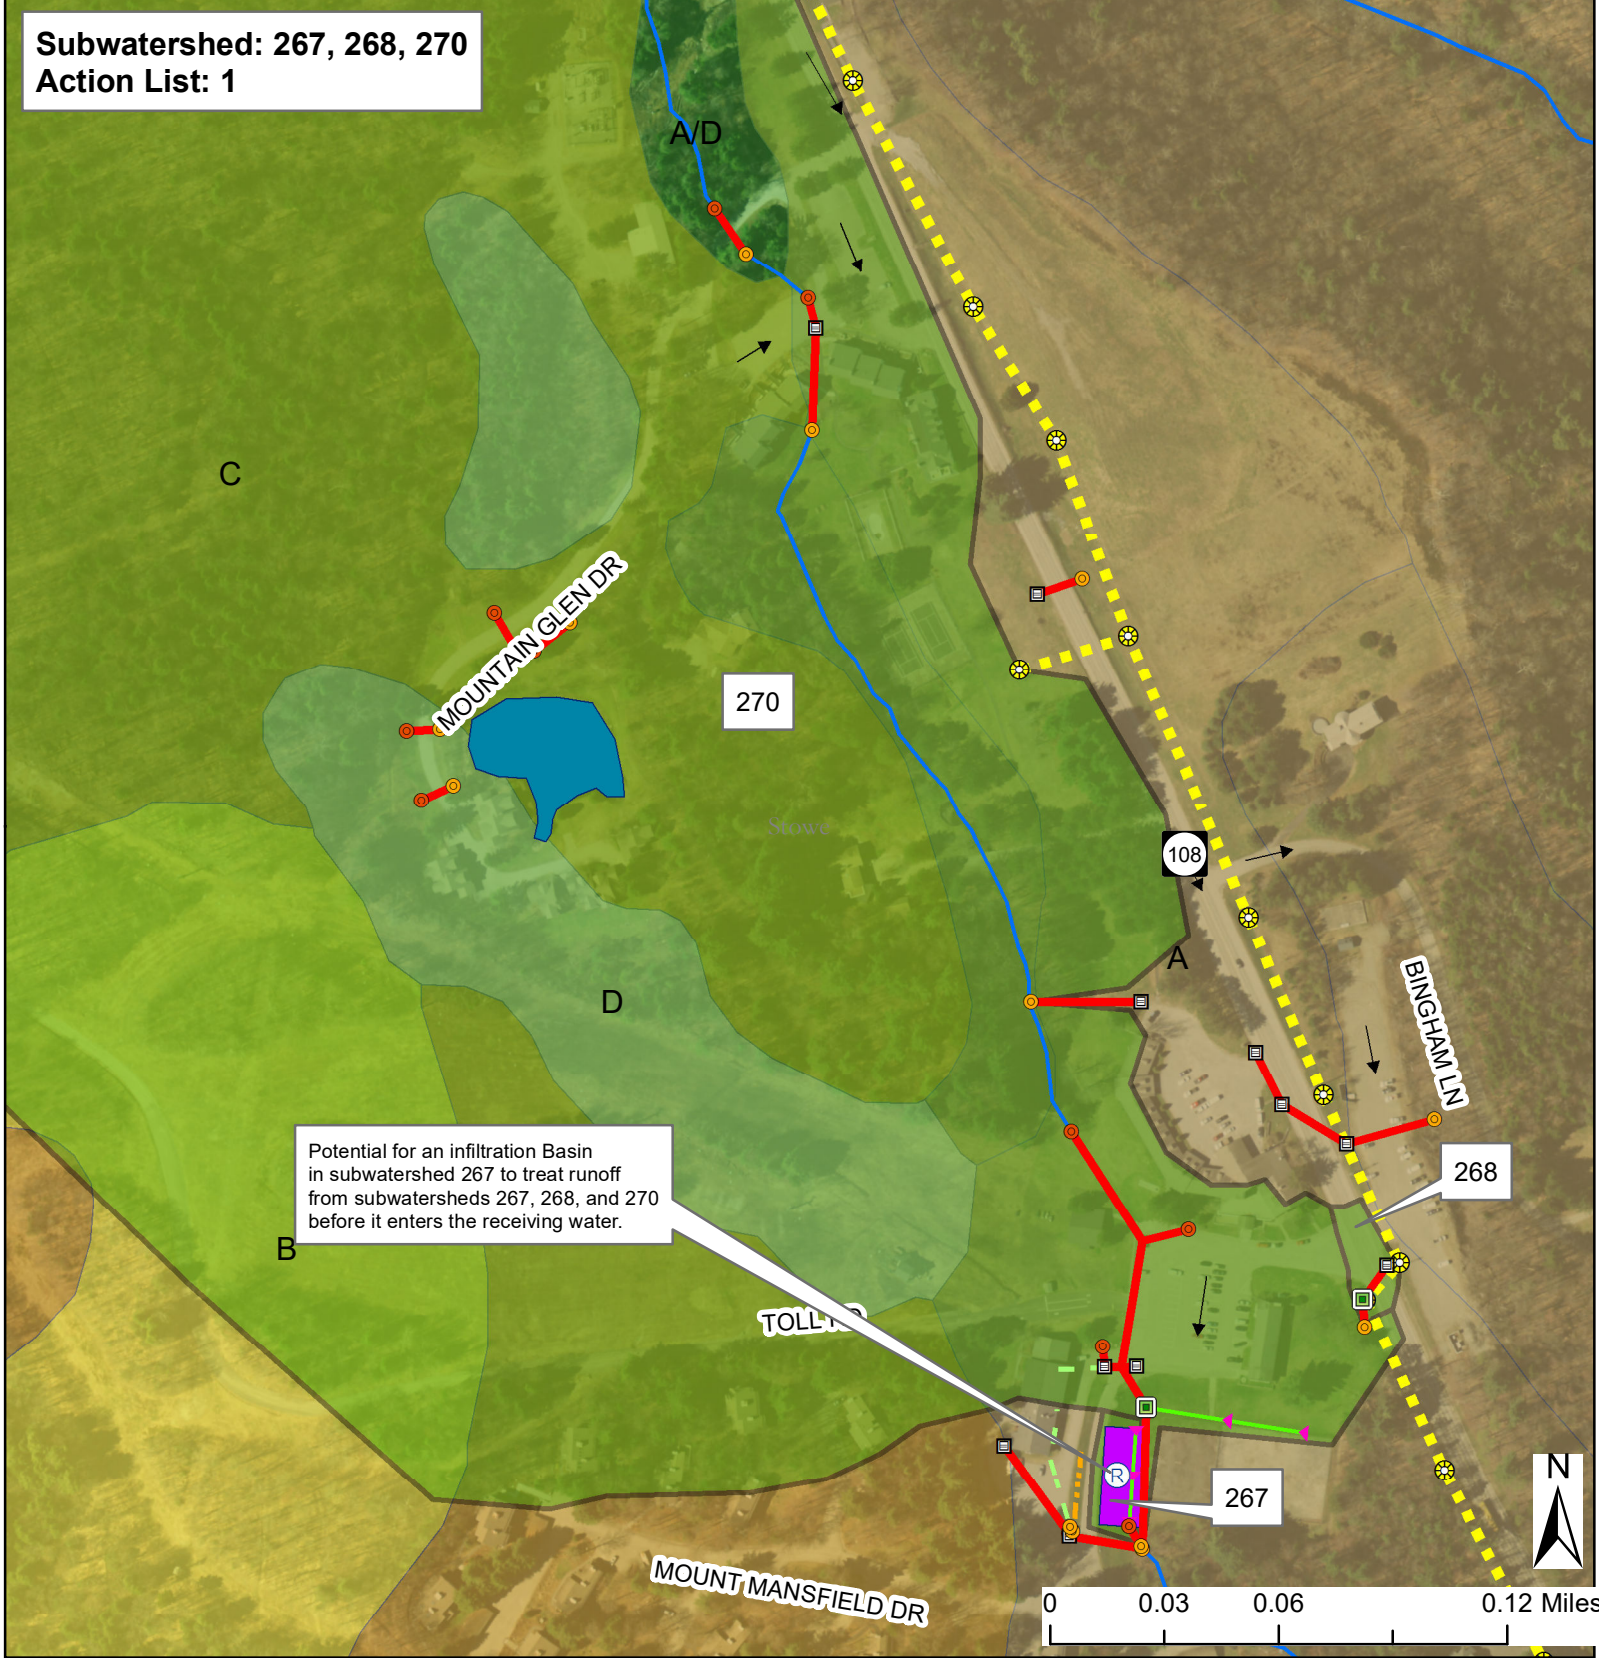
Subwatershed: 267, 268, 270
Action List: 1

Potential for an infiltration Basin in subwatershed 267 to treat runoff from subwatersheds 267, 268, and 270 before it enters the receiving water.
