# LEGGETTE, BRASHEARS & GRAHAM, INC.

June 30, 2010

**Re: Boehringer Investigation, Husky Injection Molding Systems, Ltd., Milton, VT  
VT SMS #2009-4003  
Revision 2.0**

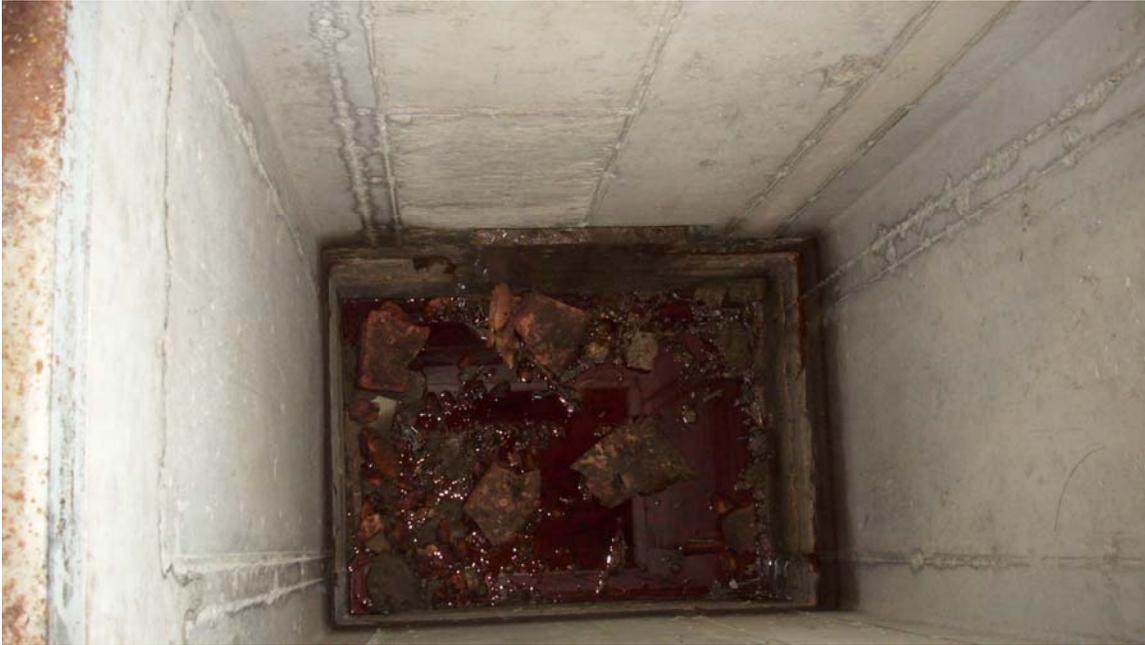
**Photo 1.** Sump of Boehringer No. 4 (BO-4) prior to Boehringer Investigation testing.

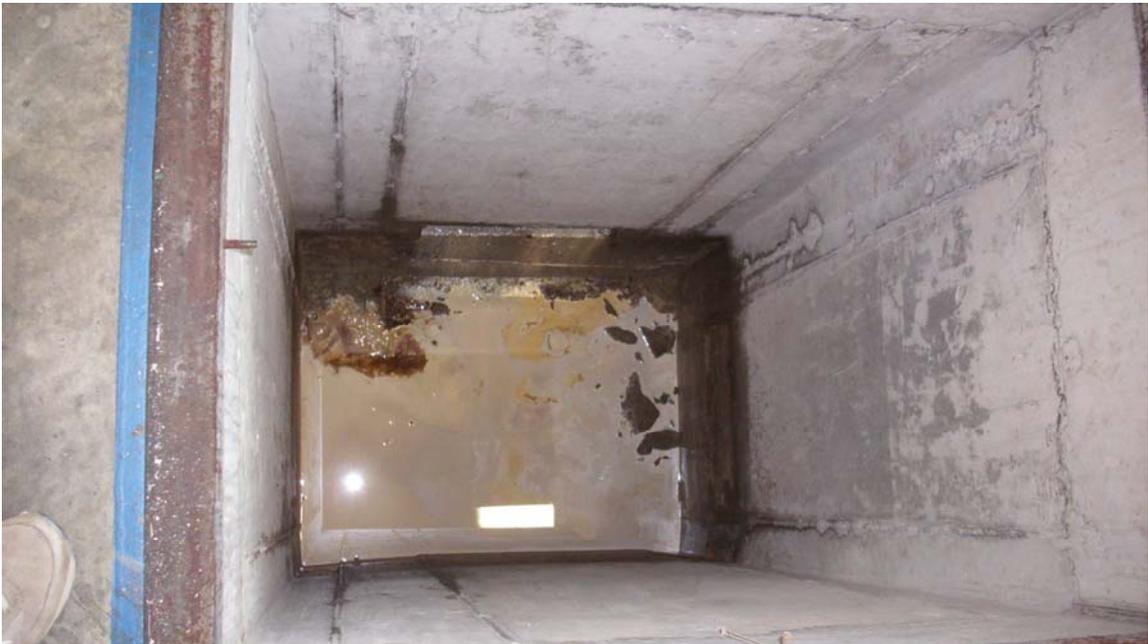
It appears that the surface of the sump wall below the raceway in BO-5 was parged with concrete. The parged material has broken off from the poured concrete wall of the sump as depicted in Photographs 4, 5 and 6. Further evidence of concrete corrosion was also noted below the raceway, where coolant frequently seeps into the sump. More detailed information about Henry Filter coolant chemistry should be obtained to assess

**Photo 4.** BO-5 sump with crumbling concrete from parged surface.

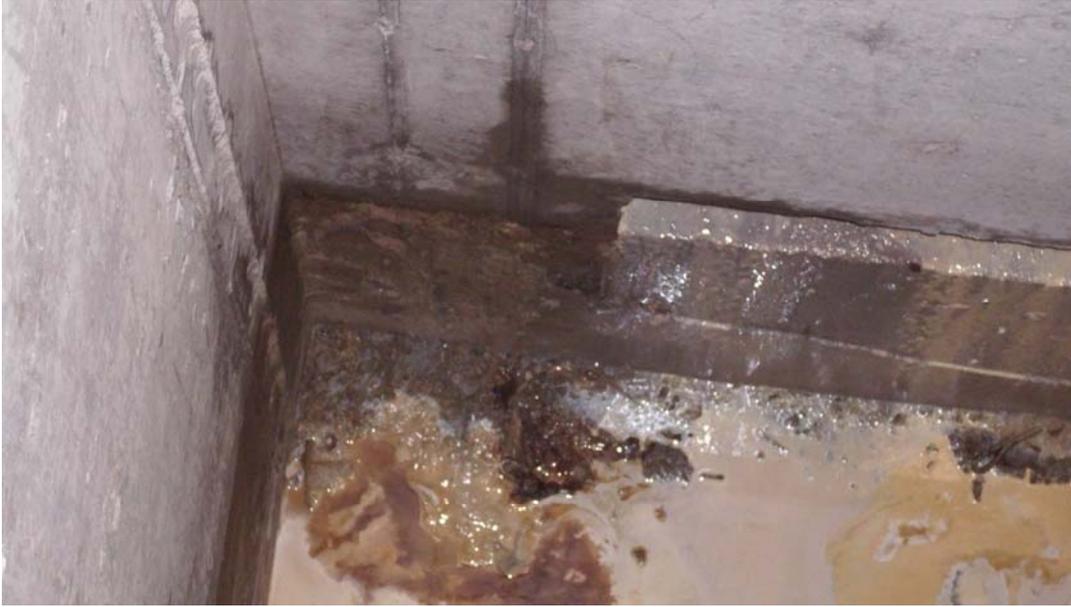
**Photo 5.** BO-5 sump with crumbling concrete from parged surface.

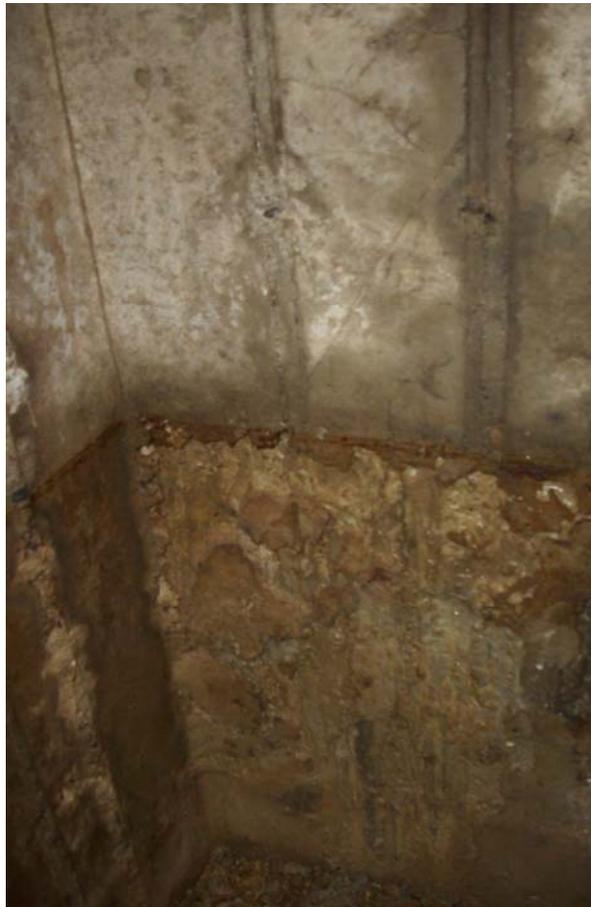
**Photo 6.** BO-5 sump with crumbling concrete from parged surface.

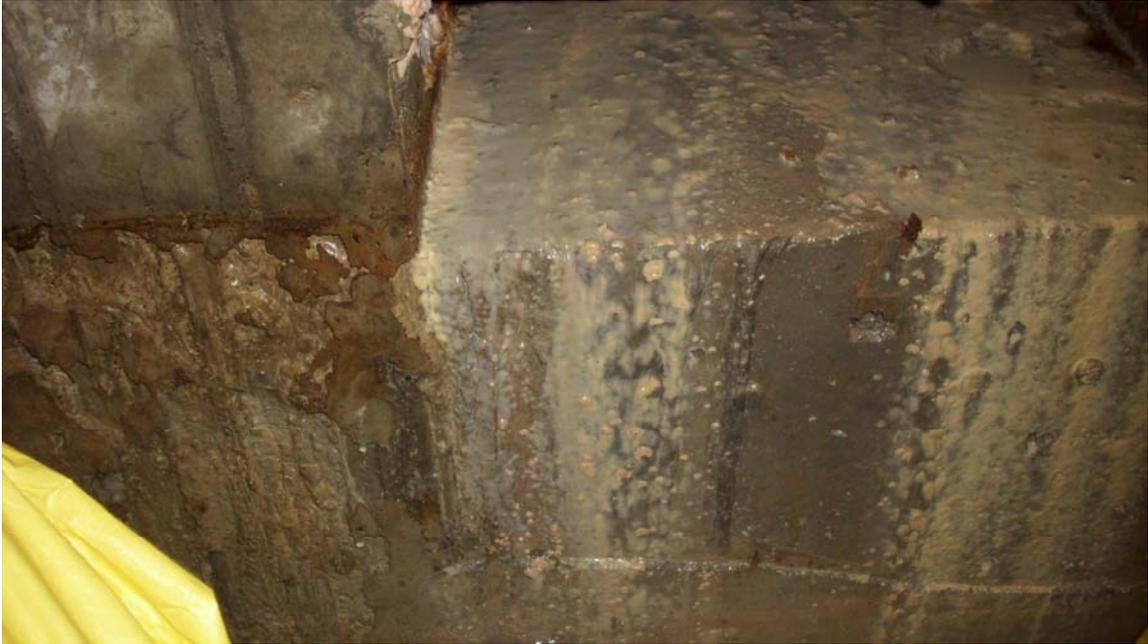
A hydrostatic test was performed to assess the integrity of the Bohringer machine sumps. The sumps were filled with water to the base of the raceway opening. The Bohringer machine No. 5 (BO-5) sump was filled to level that covered an apparent concrete seam to assess whether the seam was leaking (see below for a more detail). Refer to Photograph 7. Water level was recorded from the plateline floor immediately upon filling the sumps and again after approximately 24 and 48 hours.

**Photo 7.** BO-5 sump – apparent seam at raceway level.

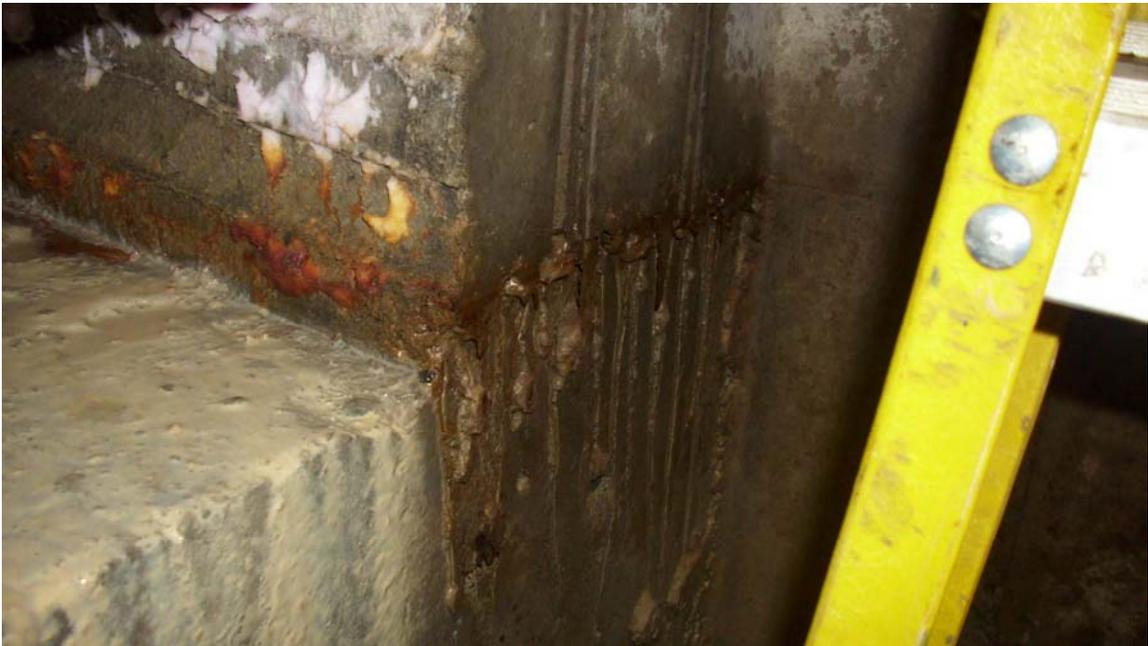
Visual inspection of the Bohringer sumps revealed that more than one concrete pour was used to construct the sump. The apparent seam(s) may also be coincidental with the concrete form lines. All three sumps showed a distinct ring of staining at or near the base of the raceway. This staining may indicate that coolant has accumulated in the sumps but not at levels above the raceway. The staining and corrosion of the concrete at the raceway elevation depicted in the attached photographs insinuates that coolant may have accumulated to this sump elevation for some period of time before the sumps were evacuated.

**Photo 8.** Staining and deterioration of concrete within BO-5.

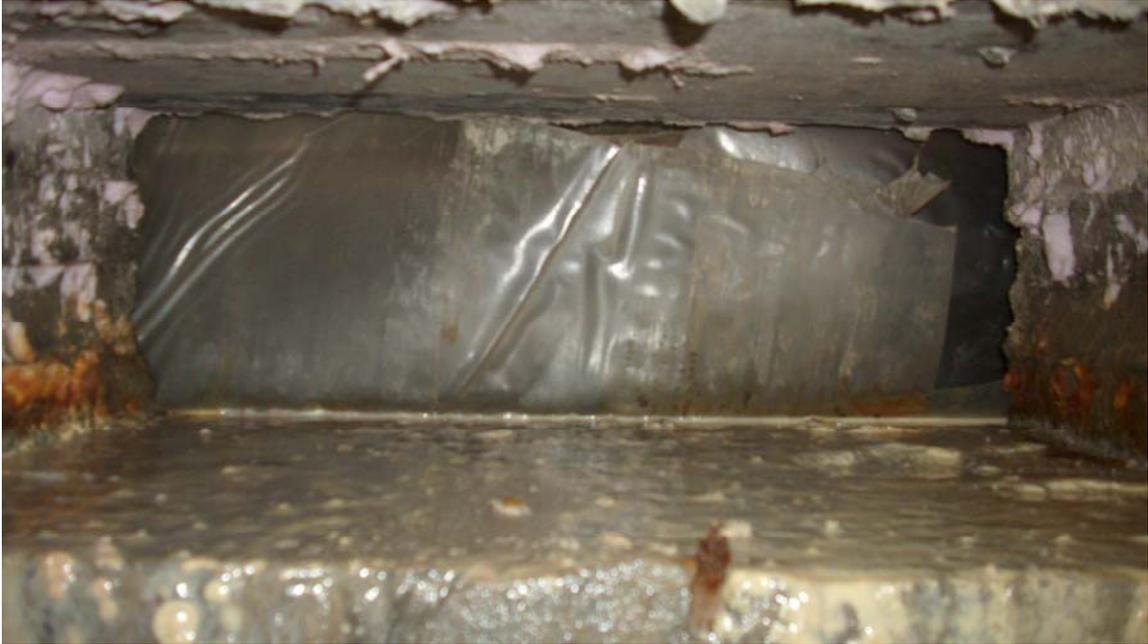
**Photo 9.** Polyethylene sheeting in BO-6 raceway at the entrance to the interstitial space.

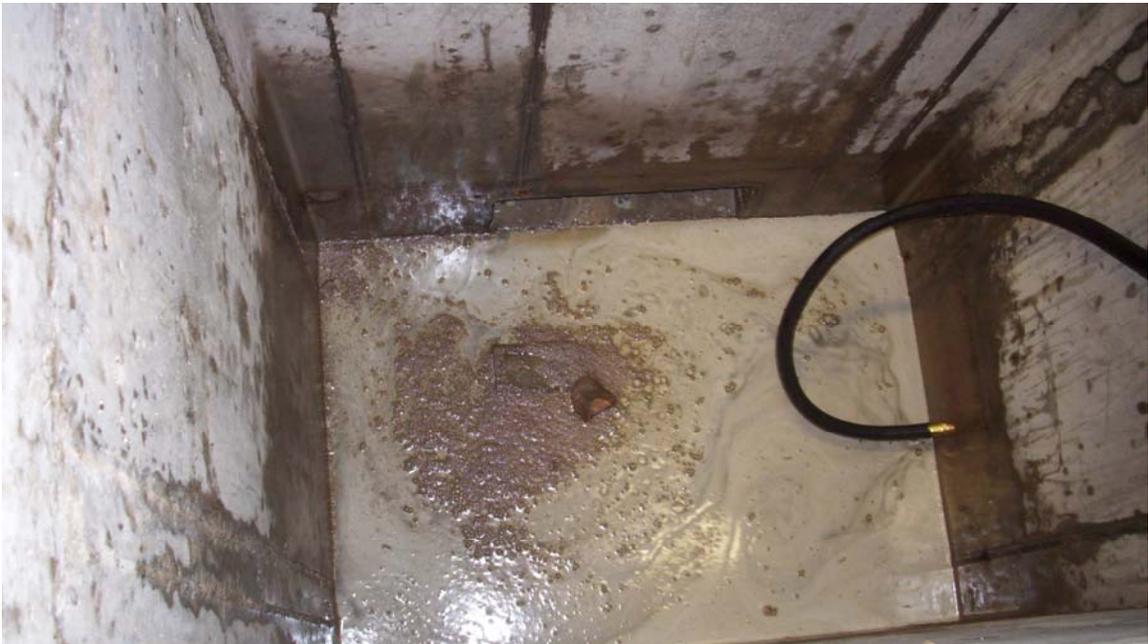
**Photo 10.** BO-6 sump as it was filled for commencement of the hydrostatic test (Following extraction of all coolant from the sump and Boehringer Investigation activity).

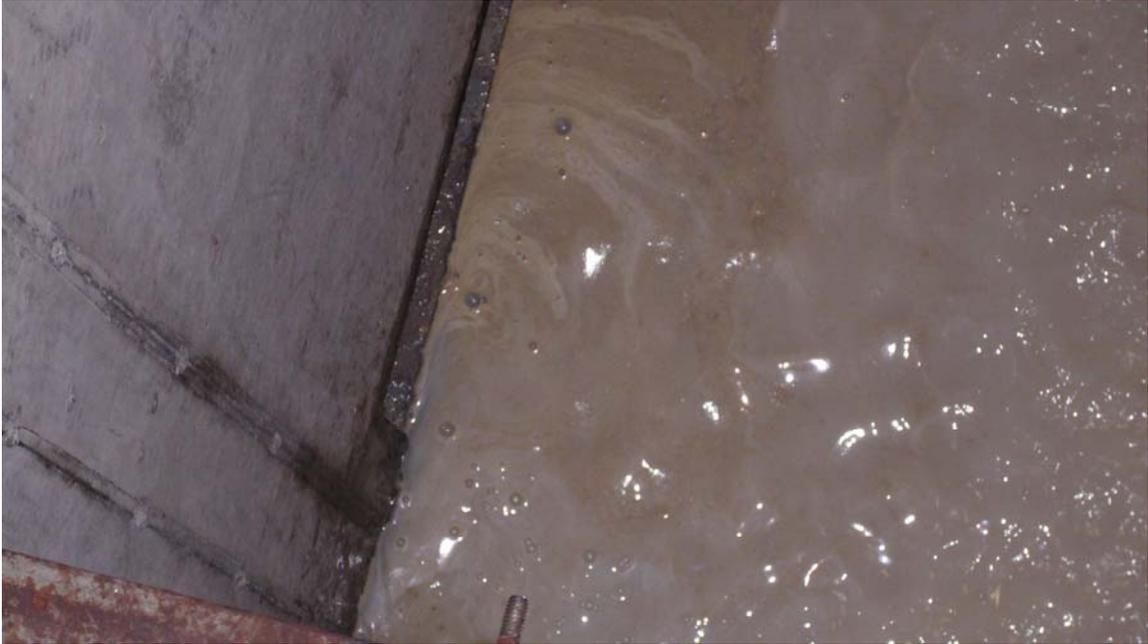
**Photo 11.** BO-6 sump after filling it with water to complete the hydrostatic test.

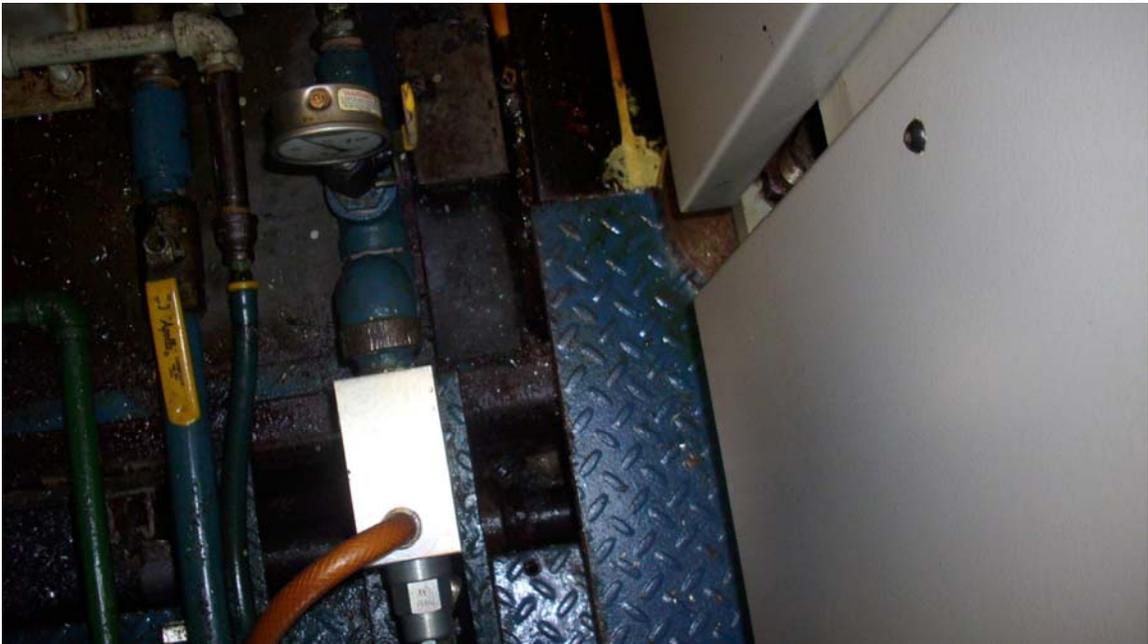
**Photo 12.** Rear of BO-4 where helium was introduced into the Boehringer foundation to assess the potential for cracks in the concrete. Coolant was observed on the floor in this area.

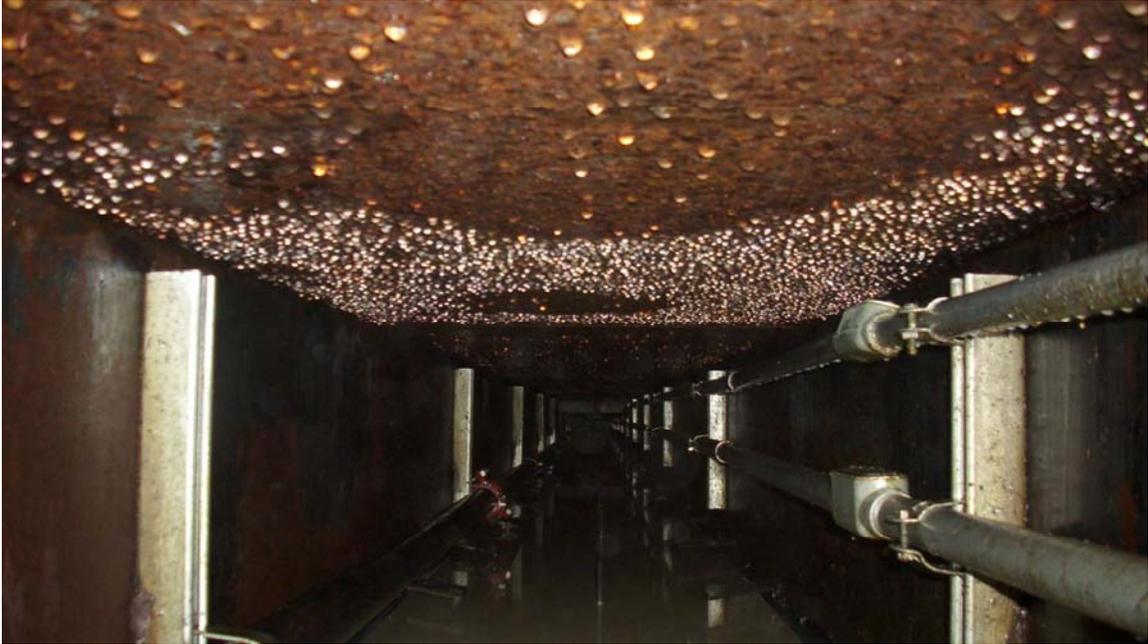
**Photo 13.** Condensate on diamond plate covers above the harpoon system.
