October 13, 2020

**RE: Monitoring Well Abandonment and Sump Restoration / Site Closure Request**  
Young Residence  
28 North Williams Street (SMS #2013-4436)  
Burlington, VT, 05401

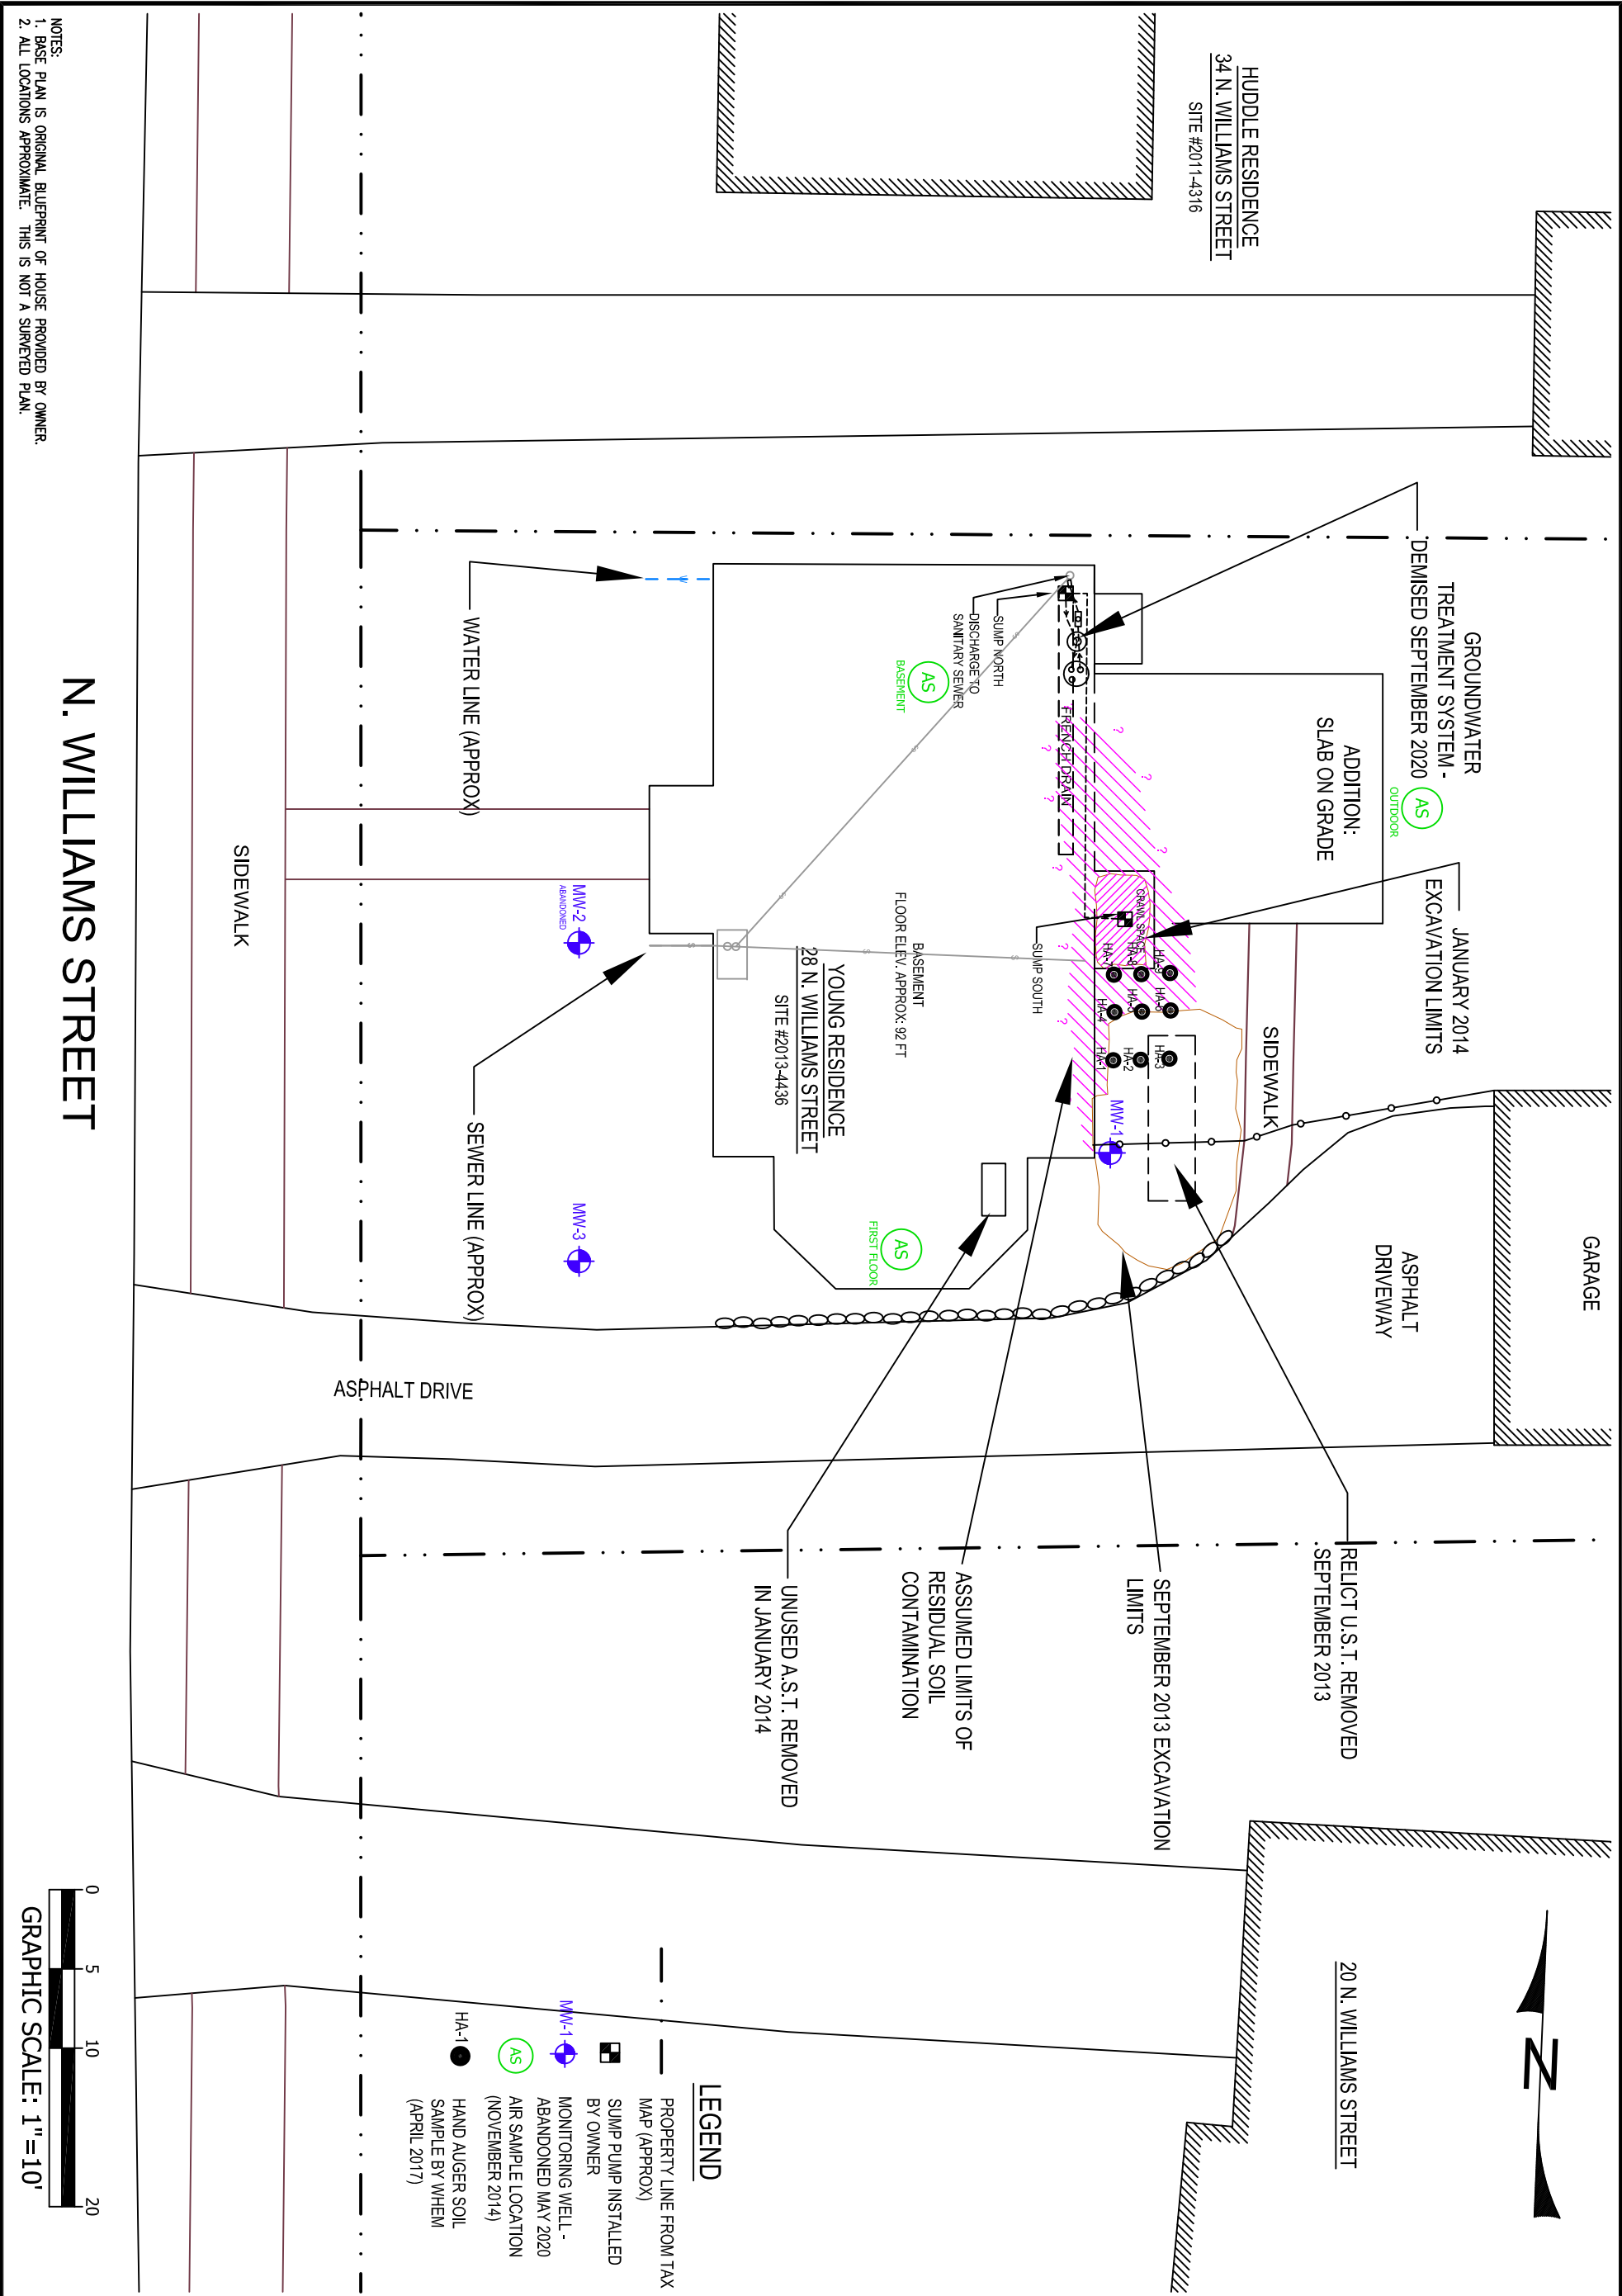
It is WHEM's opinion that this work concludes all sites management-related activities at the property, making it eligible for closure via SMAC designation. Because of persisting groundwater standards exceedances of Naphthalene beneath a portion of the property and the presence of residual soil contamination immediately north of the former UST grave, site closure may require a notice to the land records that meets the requirements of §35-902 of the IRULE (July 2019). Refer to the attached Site Plan for a depiction of the assumed limits of residual petroleum contamination to soil.

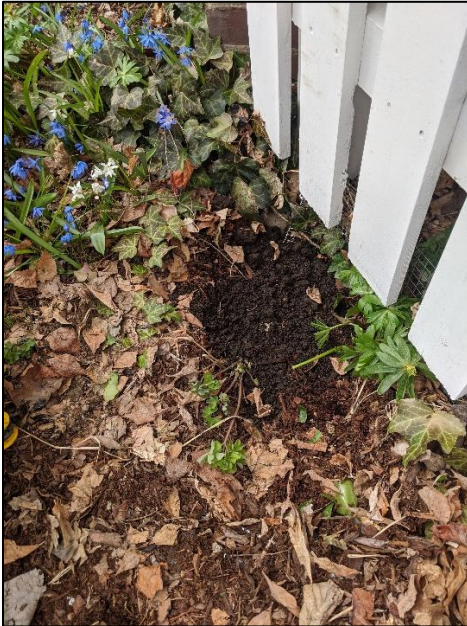
Photo #1: Finished MW-1 after formal abandonment.

4. Finishing with clean soil and sod. In the case of MW-3, sod was replaced over the well. In the case of MW-1, where no sod was present, the filled borehole was topped with mulch and clean soil.

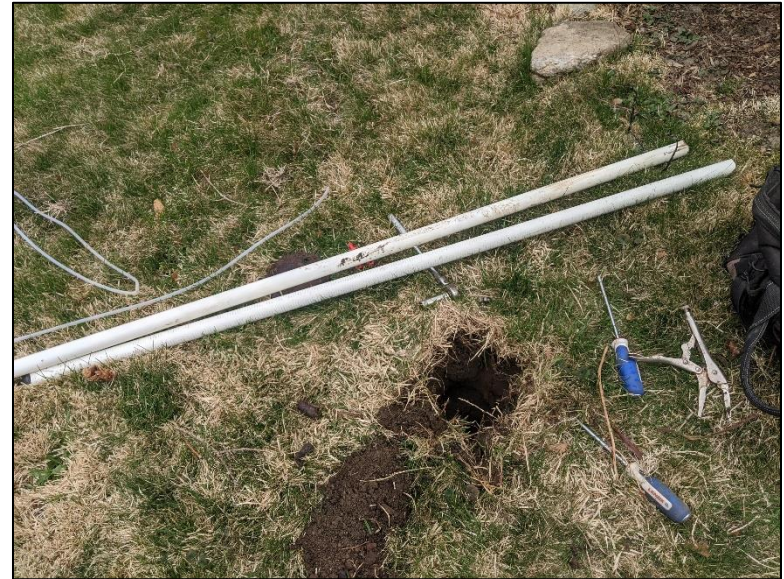
Photo #2: Well materials removed at MW-3, before backfilling.

1. Removal of well box via rock bar
  - a. Neither well box had a concrete grout collar, so both well boxes were easily removed with minimal footprint.
2. Removal of well casing and screen via rock bar/plyers.
  - a. Both monitoring wells were successfully removed in their entirety.
3. Backfilling of annular space with bentonite chips, sand, and clean topsoil.

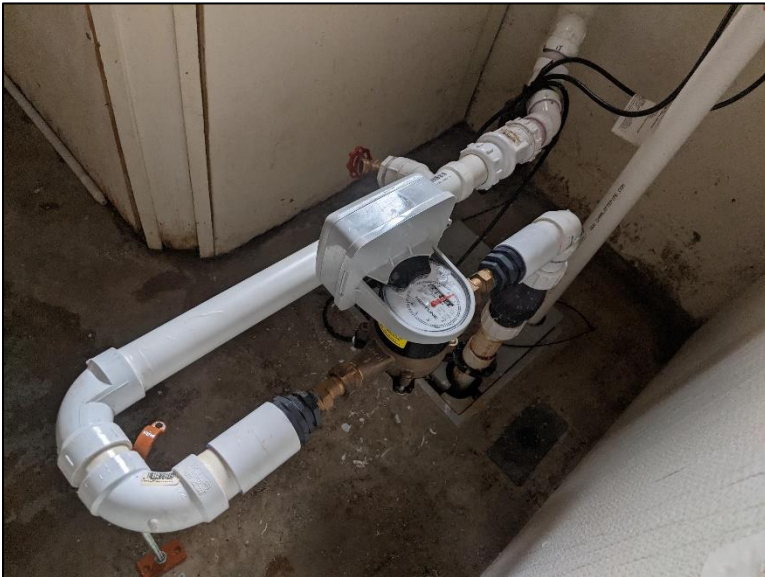
Photo #3: Totalizing flow-meter installed in-line with 1.5" PVC.

1. Existing 1.5" PVC line cut at sump outlet and laundry pump outlet, thereby disconnecting treatment loop.
2. Sump outlet re-plumbed via 1.5" PVC to totalizing flow meter and re-connected via 1.5" PVC to sanitary sewer (thus restoring original sump connection).
3. Treatment loop disassembled by Vermont Water, Inc.; PVC cut into manageable lengths, GAC filters drained and removed. Recycling of filters and disposal of PVC and other waste was managed by Vermont Water.

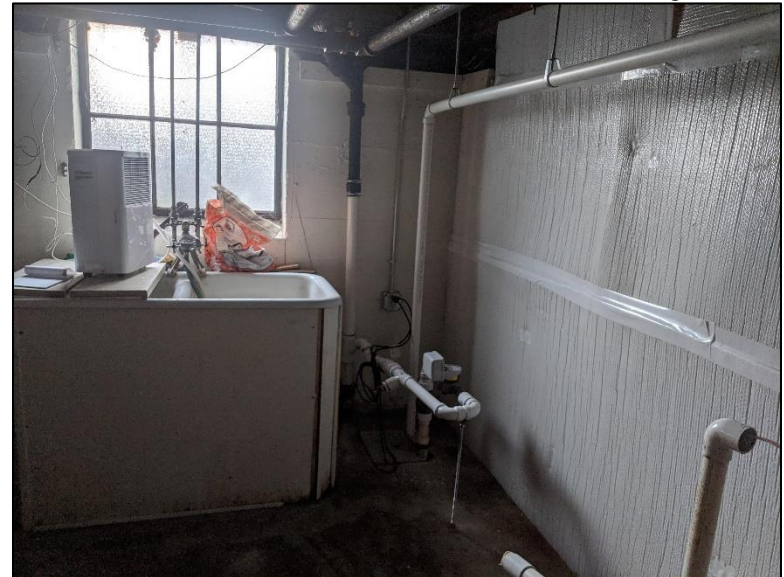
Photo #4: Full system restored, showing connection to sanitary sewer (black pipe)
