RE: AST Spill Response – WMD 478

**WMD 478
Leamy AST Release
2346 Vermont Route 101
North Troy, Vermont**

Leamy Residence Fuel Oil AST Release

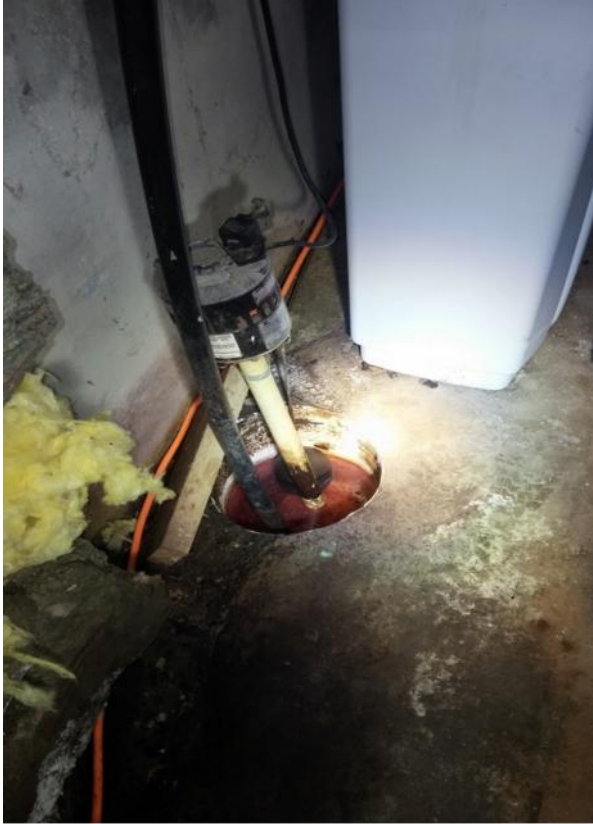
Visible free-phase fuel oil was observed within the sump basin; the sump pump was unplugged by Fred's Plumbing and Heating during their visit to reduce the amount of oil into the septic tank. Fuel was also observed along the floor from the replaced copper line to the sump. Free-phase fuel oil was removed and the impacted concrete floor was cleaned with a mild surfactant. Following cleaning the area was allowed to dry and a two-part epoxy sealant was applied to the affected area. Free-phase fuel oil was removed from the sump basin using a vacuum. Additional free-phase fuel oil was found to be entering the sump from the basement drainage pipes once the water level within the basin was depressed, so oil adsorbent booms were placed in the basin to passively collect residual fuel oil and the system is being periodically monitored.

Photograph #1-Site Overview – Fuel Oil in Sump.

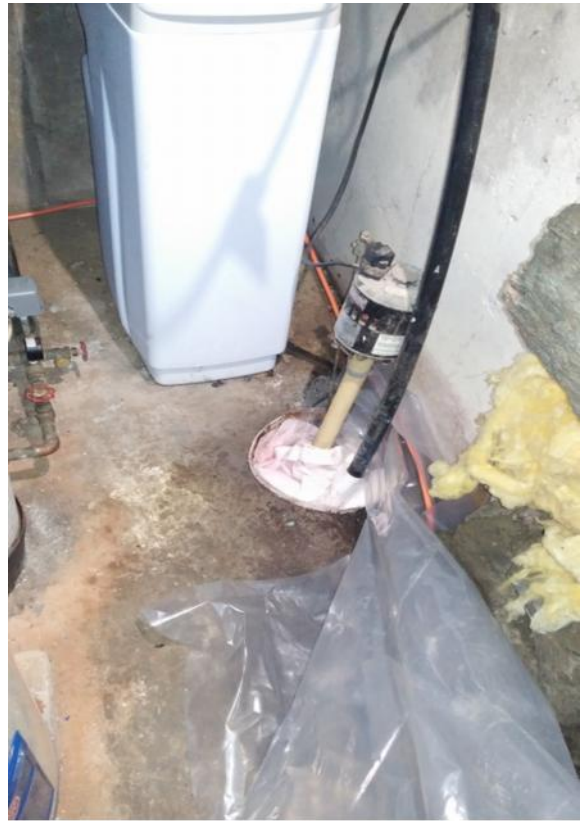
Photograph #2-Site Overview – Oil Adsorbent Pads Following Pump out (next day)

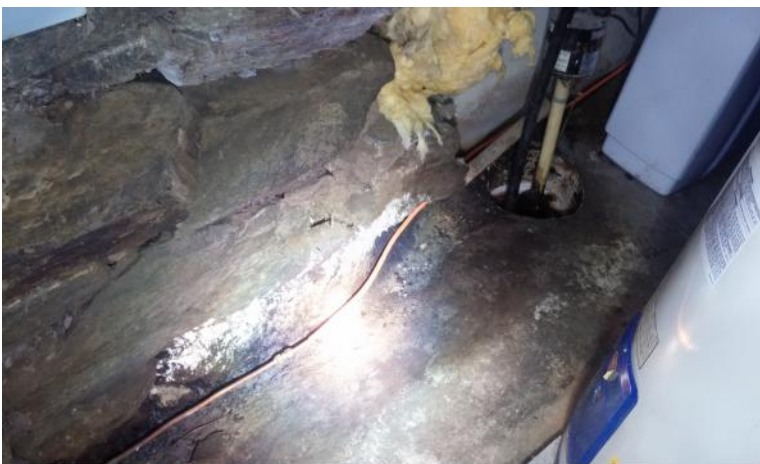
On 25 September 2014, ACCUWORX USA, Inc. (ACCUWORX) was notified by Mr. Dennis Percy of Fred's Plumbing and Heating to the presence of a fuel oil release at your residence located at 2346 Vermont Route 101 in North Troy, Vermont (**Figure 1**). The release is believed to have resulted from a slow leak within the uncoated copper supply line connected to your 275-gallon above ground storage tank (AST) that ran along the basement concrete floor.. The failed line had been replaced by a plastic coated copper line prior to ACCUWORXs arrival onsite.

Photograph #3-Site Overview – Spill Area from Soft Copper Line.

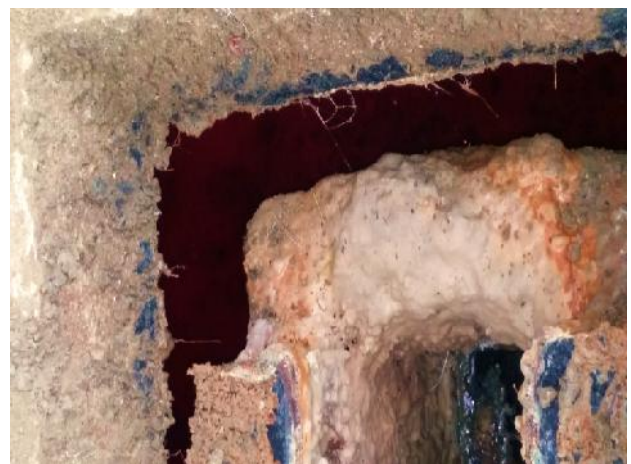
On 1 October 2014, the onsite septic tank was located and free-phase fuel oil was observed floating within the tank. The tank has not been pumped for quite some time, and found to be very full of solids. Fuel oil was also observed within the effluent pipe that leads to the mound style leach field, which is gravity fed to the downgradient of the septic tank. On 2 October 2014, ACCUWORX removed free-phase fuel oil from the septic tank using our vacuum truck. During the skimming of the fuel oil, it was found that the fuel oil was incorporated within the solids of the tank, so oil adsorbent booms were placed in the septic tank to recover oil that could not be skimmed. Upon speaking with local septic companies, they were unwilling to pump the solids within the tank as it will create an issue with their offloads at the Wastewater Treatment Facilities, and they recommend pumping the entire contents of the tank.

Photograph #4-Fuel Oil within Septic Tank.

1. The oil adsorbent booms within the septic tank and sump system should be periodically inspected.
2. The contents of the septic tank should be pumped and disposed of as hazardous waste, due to the unwillingness of the traditional wastewater treatment facility to accept the material.

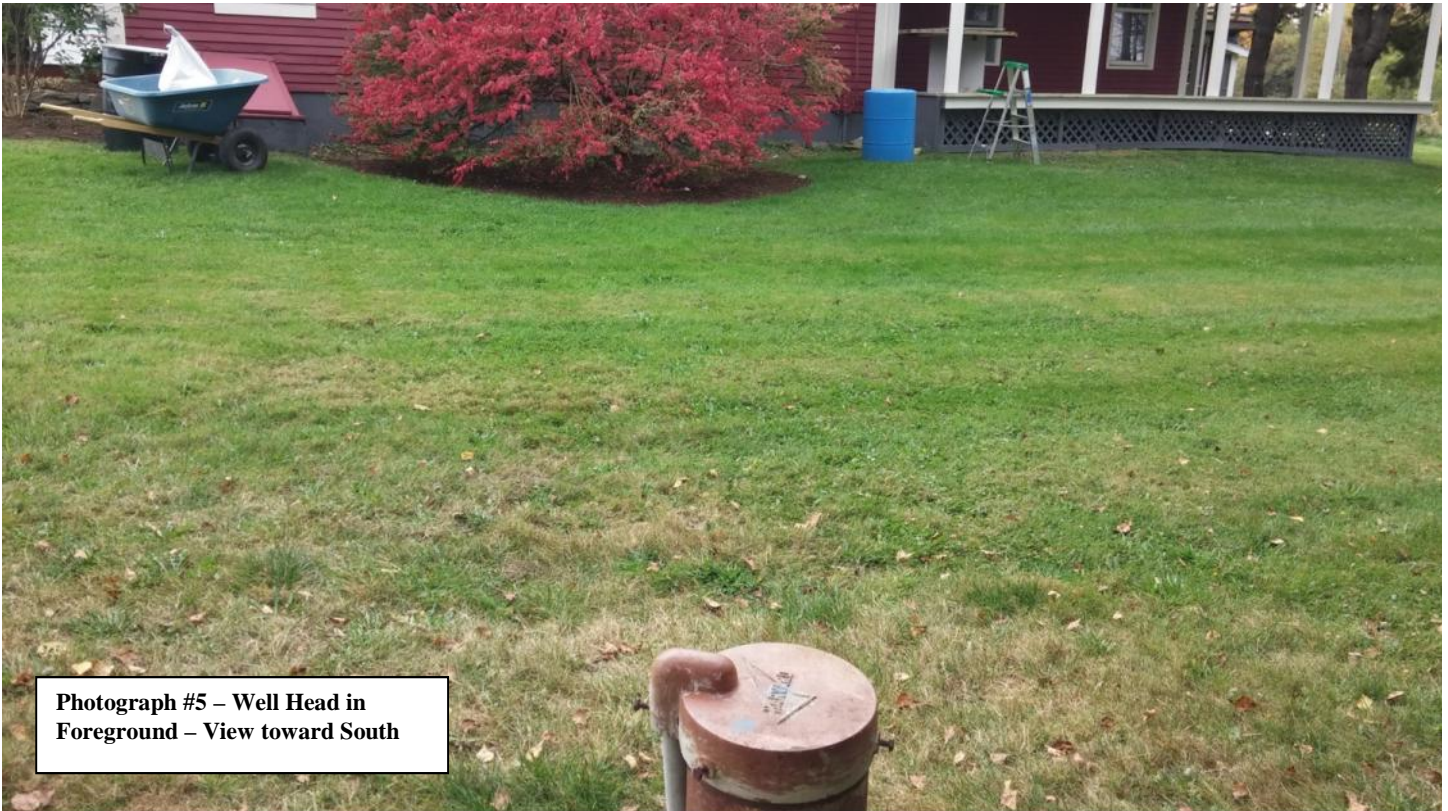
The site and surrounding properties are supplied by private drilled wells. The on-site supply well is located approximately 45 feet west of the release area. Upon inspection of the well casing, no well tag or information was obtained on the wells construction or depth, but it is believed to be a drilled bedrock well based upon the casing. The onsite septic tank, where the sump pump discharges to, and associated mound leach field are located approximately 40 feet and 100 feet west from the release area, respectively.

Photograph #5 - Well Head in Foreground - View toward South

3. The mound system should be evaluated for fuel oil contamination through the use of borings.
4. A water supply sample should be collected from the on-site drilled well for the possible presence of volatile organic compounds in accordance with EPA Method 524.2.

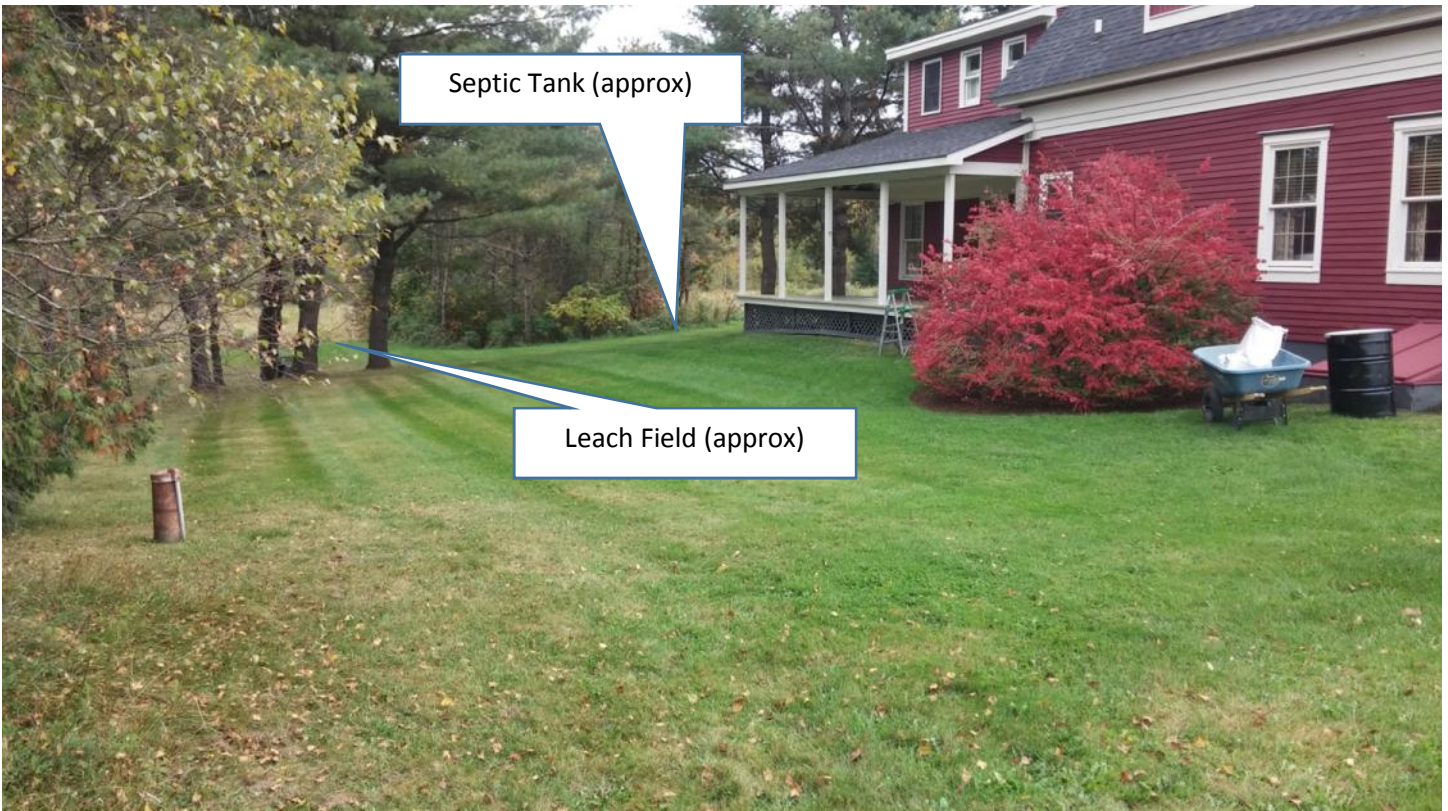
Photograph #6 - Site Overview - View toward West
