**LEDDY PARK SOIL STOCKPILE  
BURLINGTON, VERMONT  
WEEKLY INSPECTION REPORT**

**PHOTO DOCUMENTATION**  
*(Before and After Corrective Action)*

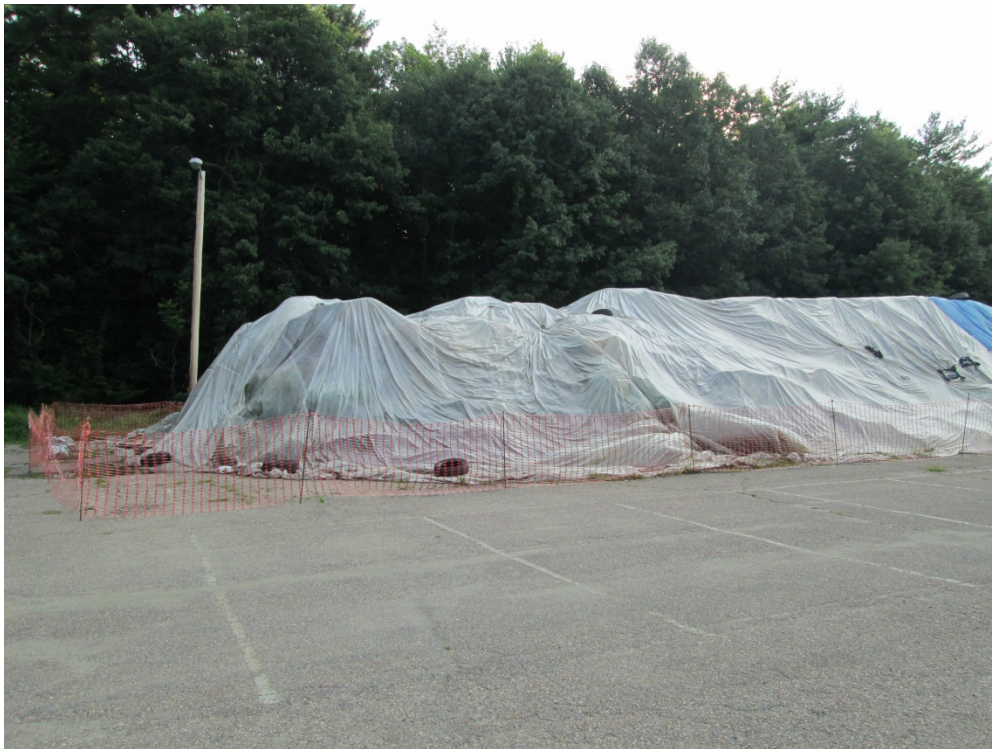
Photo 1: Soil stockpile condition before corrective action on 7/29/15. Photo taken looking east.

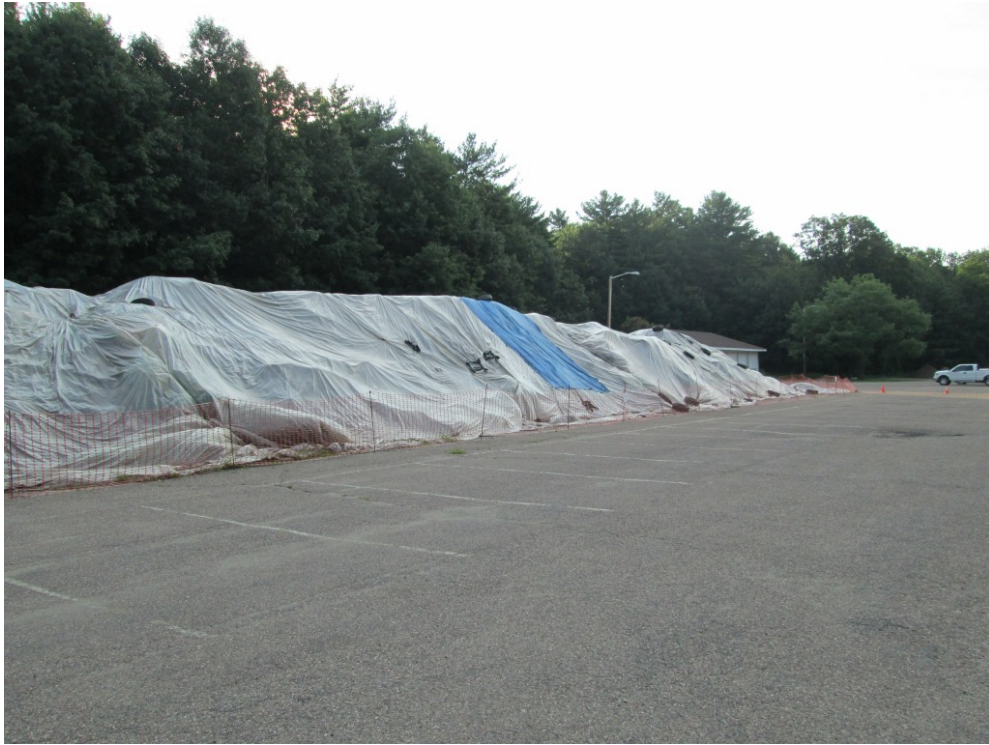
Photo 2: Soil stockpile before corrective action on 7/29/15. Photo taken looking southeast.

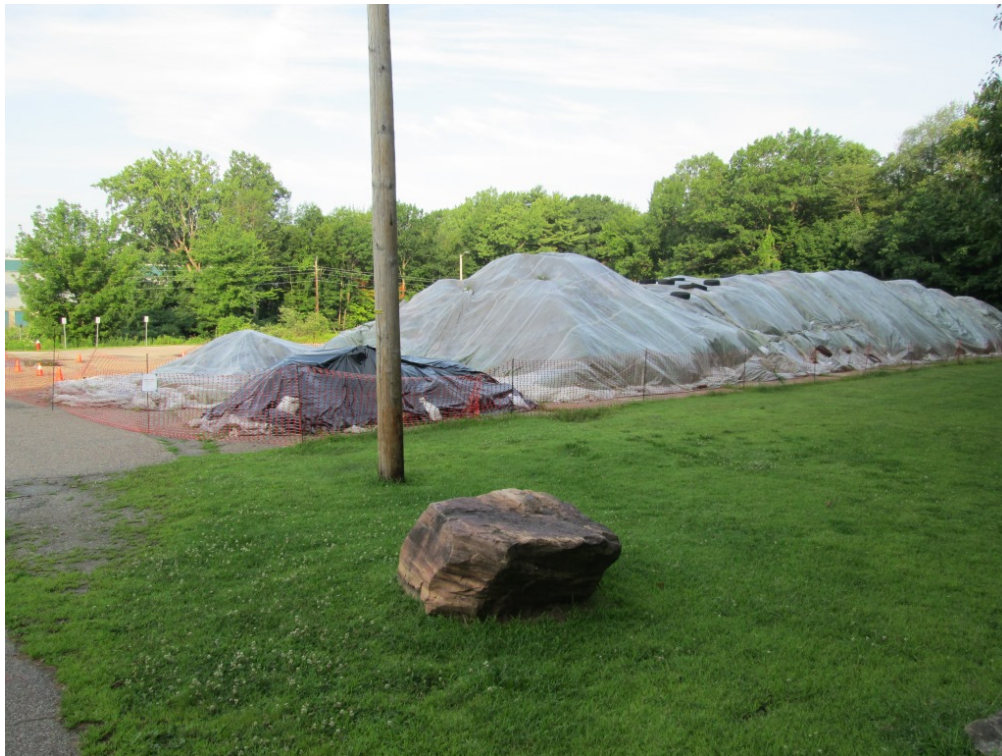
Photo 3: Soil stockpile before corrective action on 7/29/15. Photo taken looking west.

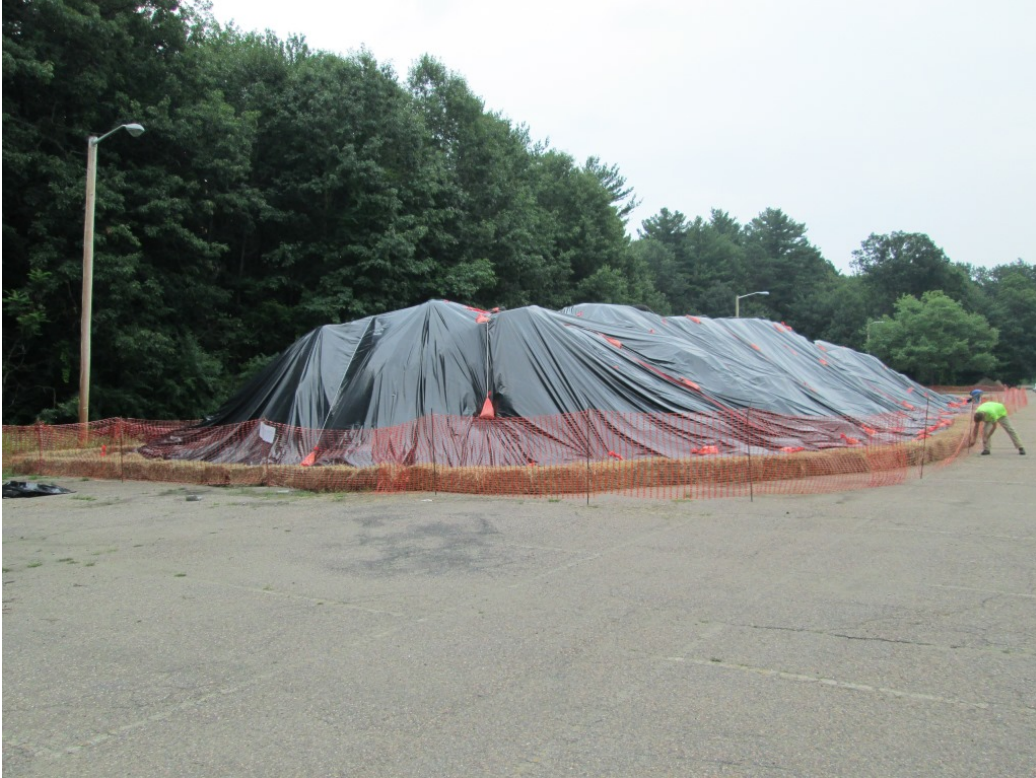
Photo 4: Soil pile after corrective action on 7/30/15. Photo taken looking southeast.

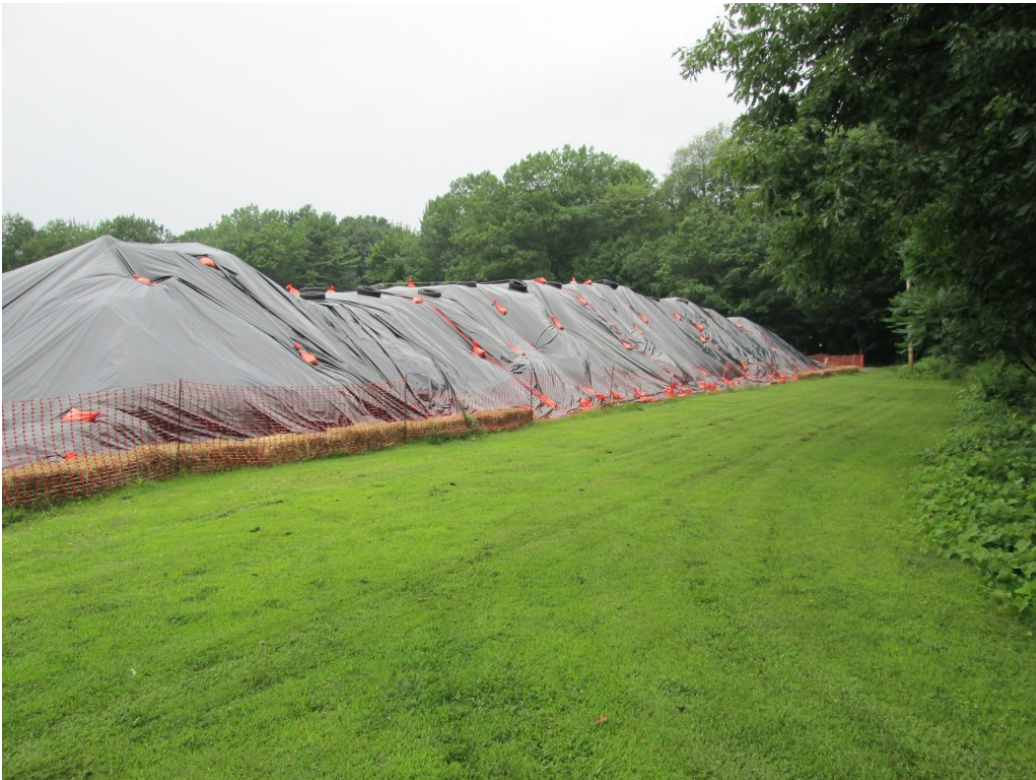
Photo 5: Soil stockpile after corrective action on 7/30/15. Photo taken looking northwest.

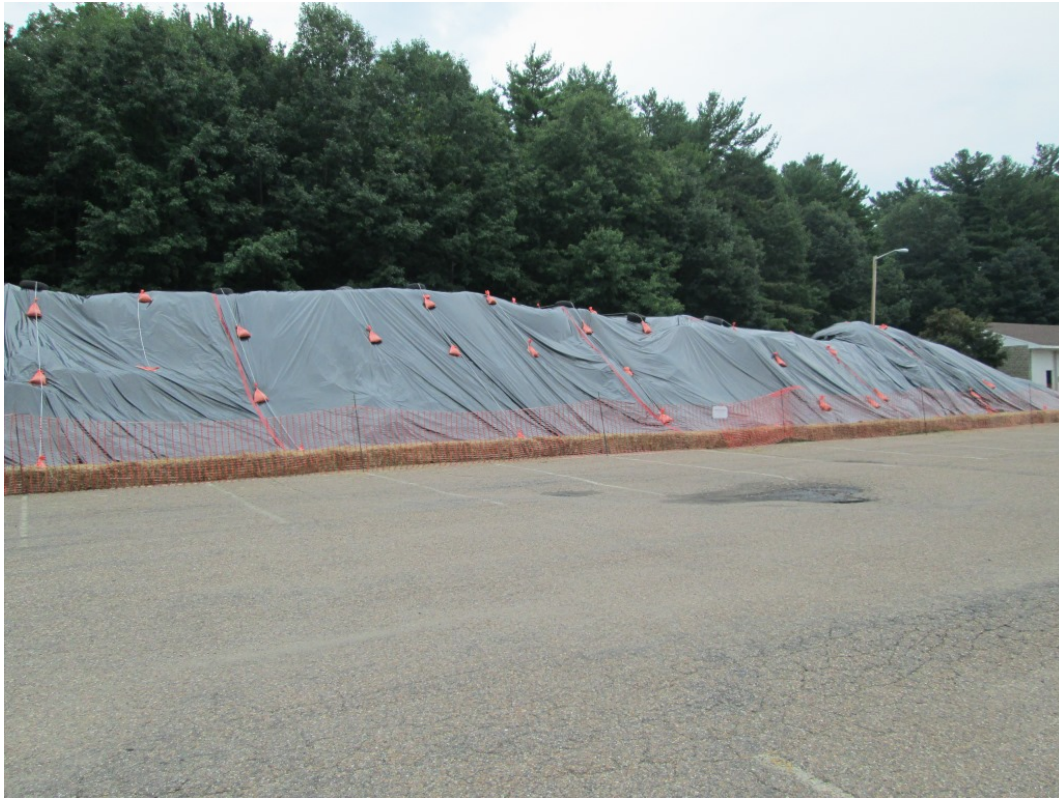
Photo 6: Soil stockpile after corrective action on 7/30/15. Photo taken looking east.

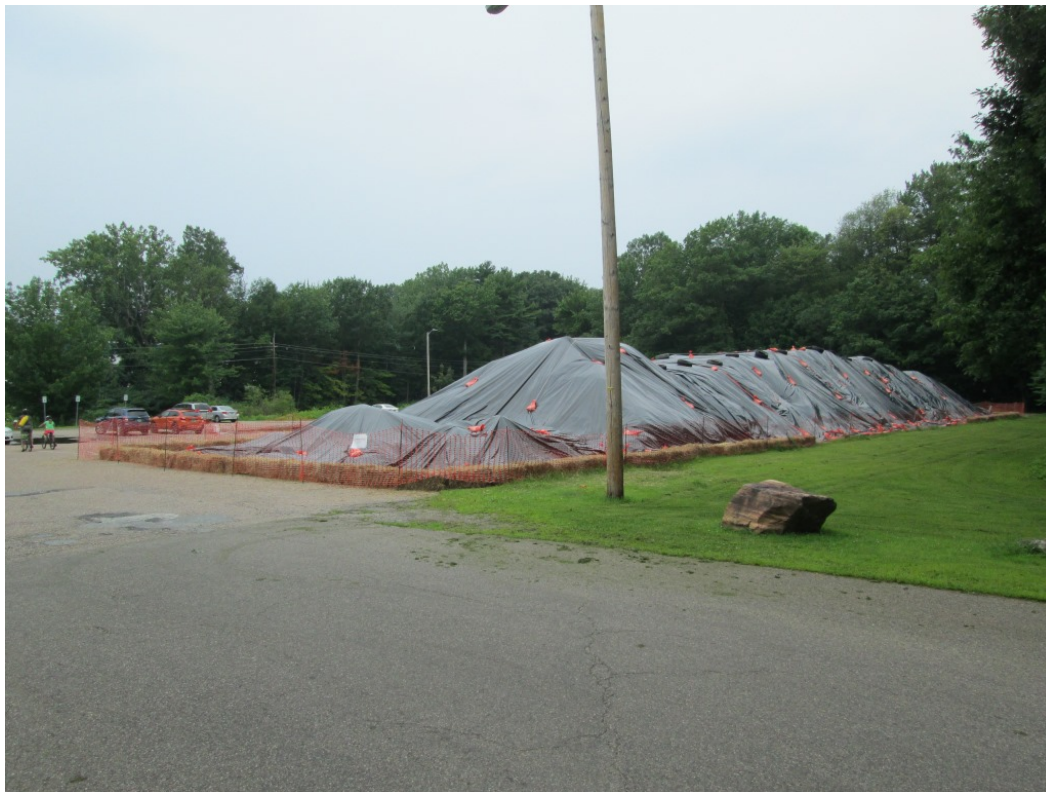
Photo 7: Soil stockpile after corrective action on 7/30/15. Photo taken looking northeast from parking lot entrance.

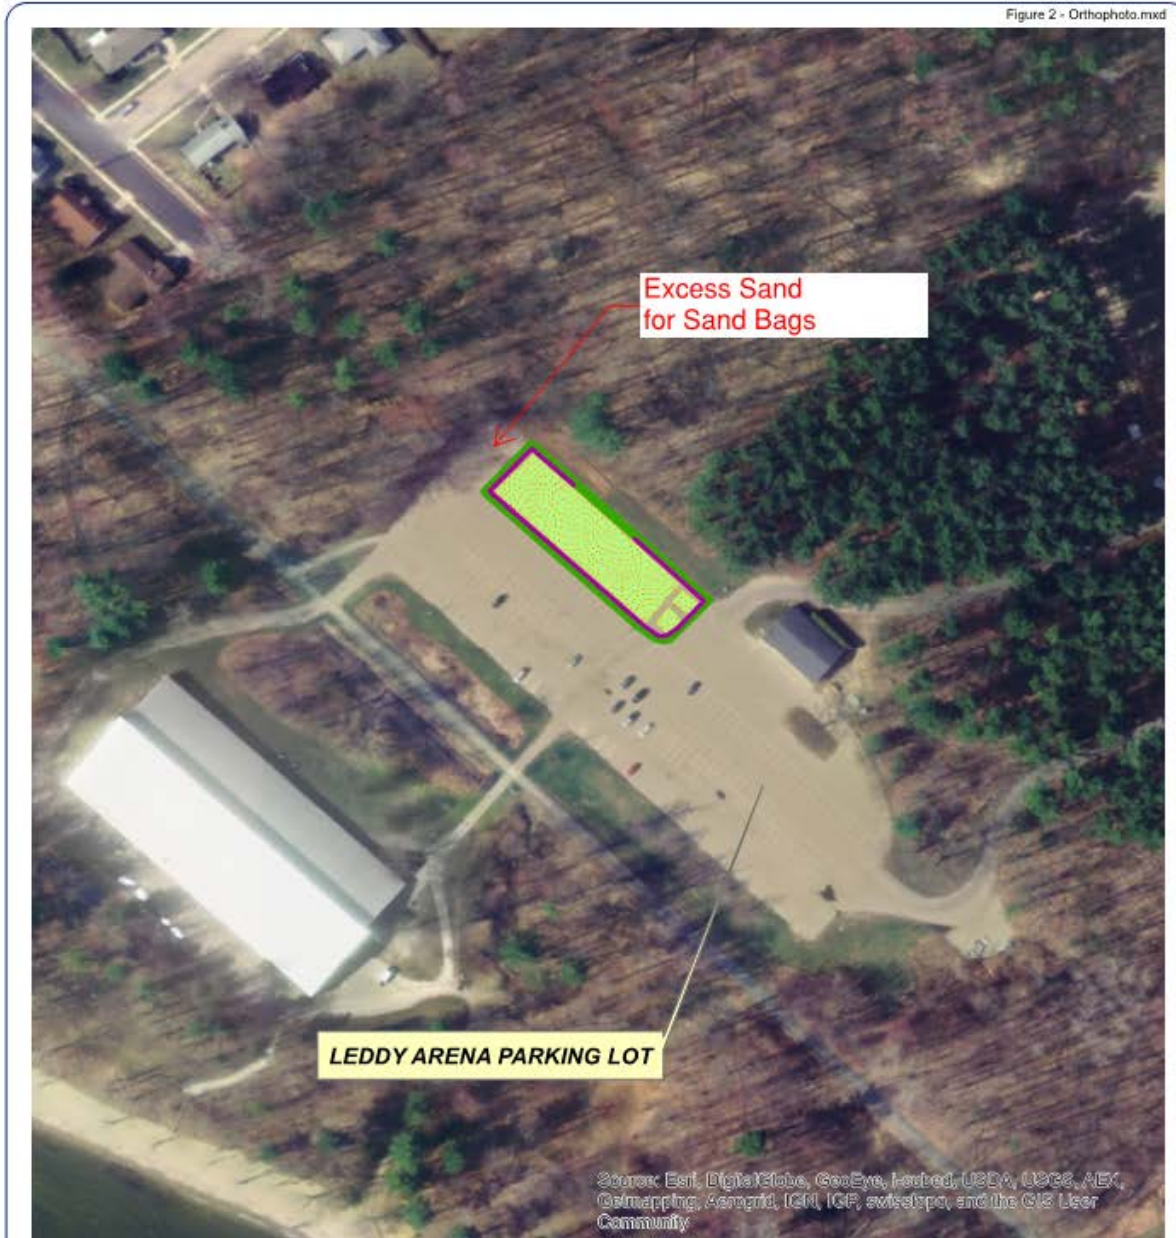
**FIGURE 1: ORTHOPHOTO & SITE SKETCH**  
**LEDDY PARK**  
**BURLINGTON, VERMONT**

**Figure 1 – Orthophoto & Site Sketch**  
*(Areas of Corrective Action)*
