## **SUMMARY REPORT – PFAS BUILDING CLEANING INSPECTIONS FORMER CHEMFAB FACILITY – SAINT GOBAIN PERFORMANCE PLASTICS**

PROJECT NO. 280EM01070 (SMS SITE #2006-4630)

1030 Water Street, North Bennington, VT 05257

April 24, 2024

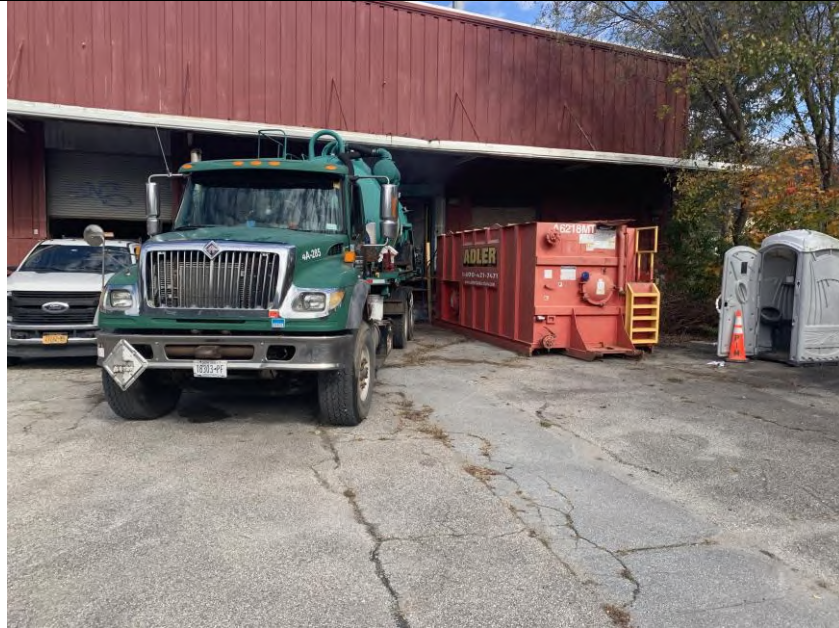
**Description:**  
*Vactor truck and  
clean water  
fractionation tank in  
front of building.*

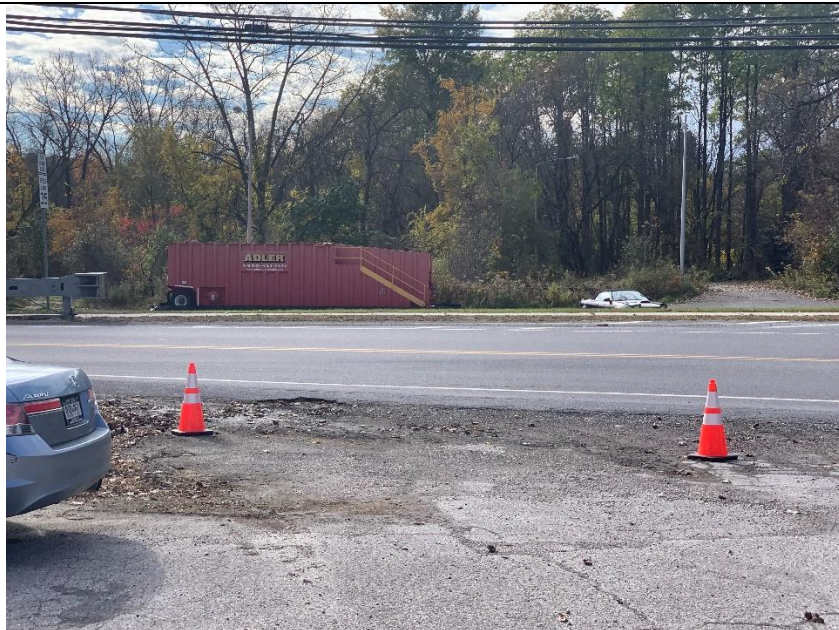
**Photograph #2**

**Description:**  
*20k Wastewater  
fractionation tank set  
up across the road*

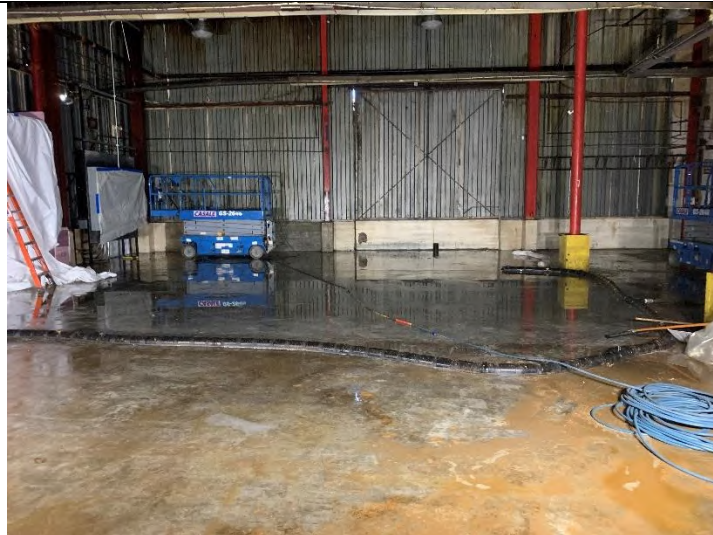
**Photograph #4**

**Description:**  
*Containment setup  
with vacuum boom.*

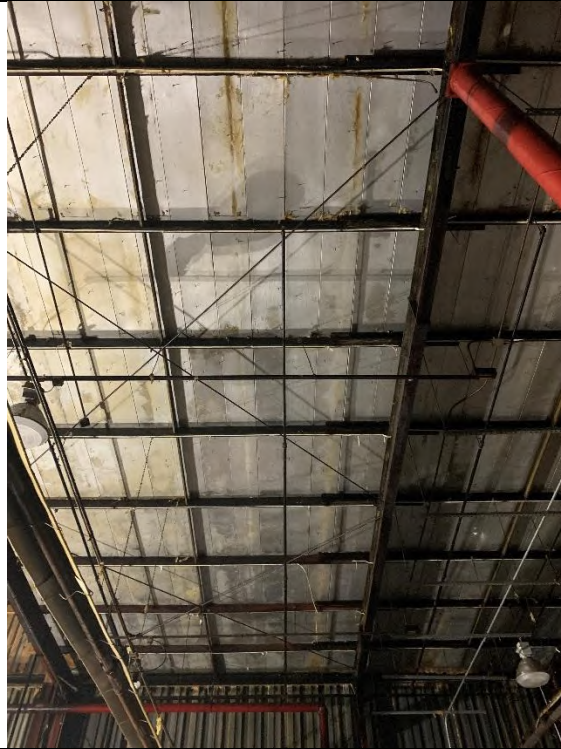
*Test section of the  
metal roof in  
northwestern portion  
of the warehouse.  
Light residue still  
visible in sections.*

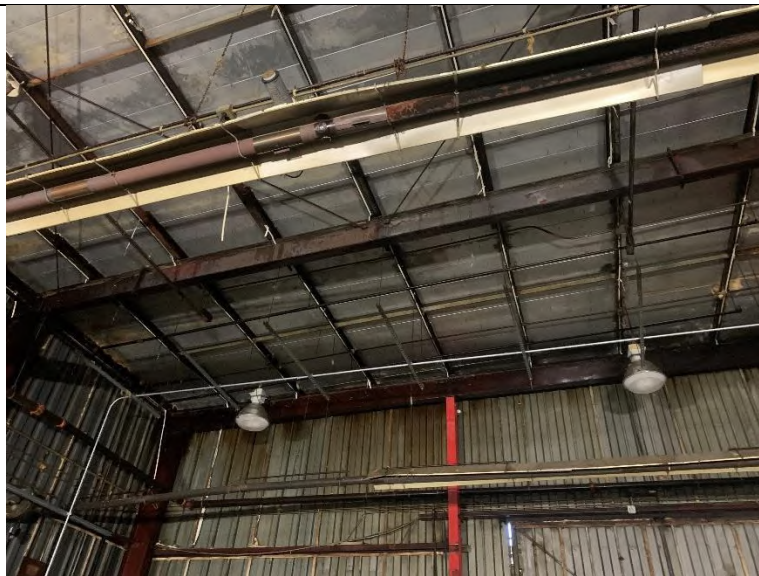
**Photograph #6**

*Test section of steel  
beam. Three  
sections washed  
show visible  
improvement in  
residue removal.*

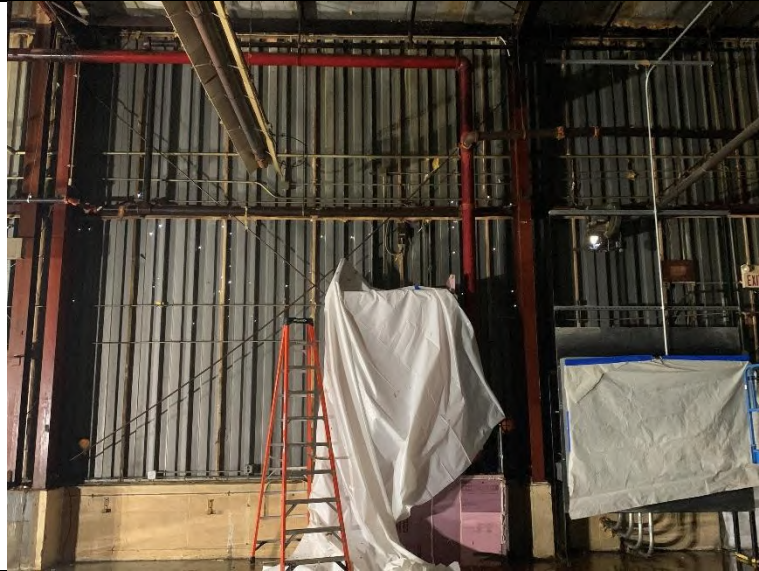
**Description:**  
*Western wall of  
warehouse with  
numerous open  
screw holes in the  
sheet metal.*

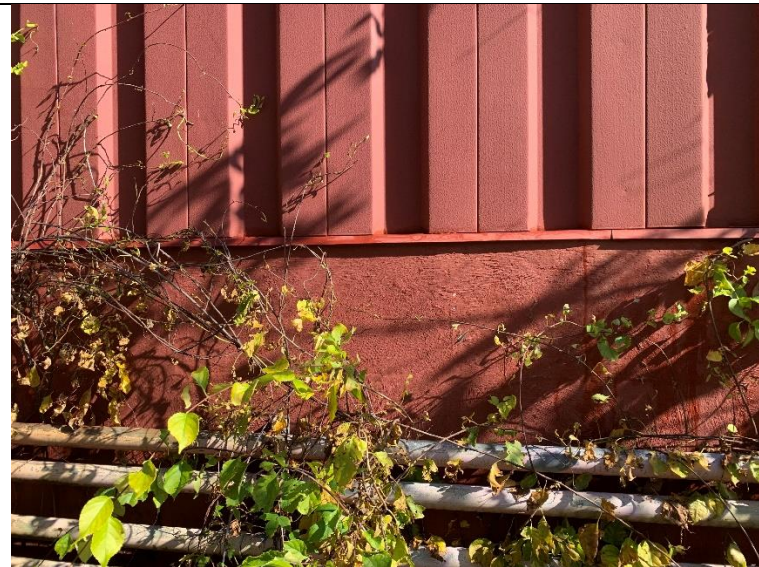
**Photograph #8**

**Description:**  
*Spray water seeping  
out of junction  
between sheet metal  
wall and concrete  
foundation.*

1530 C.T. Male & Barr walked outside to show  
me the unsealed seam between concrete foundation  
& sheet metal. Precision Group is planning to  
seal w/ insulating foam on the outside. Caulk  
would not set, so foam will be used.

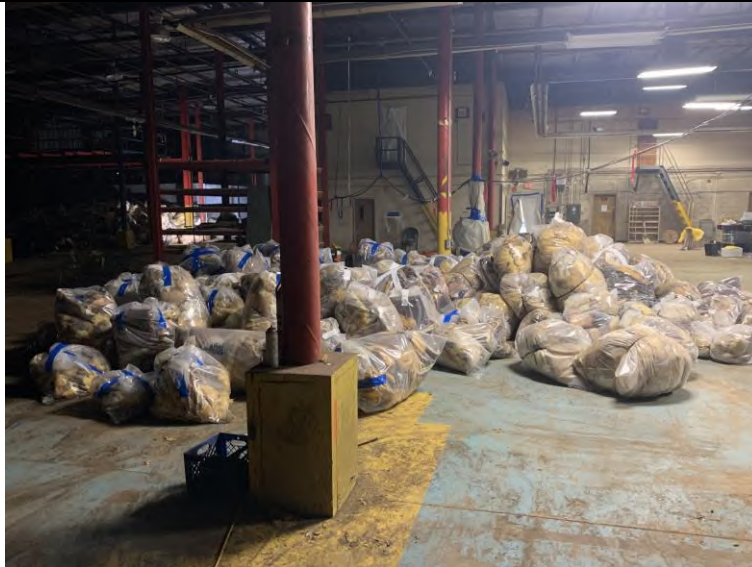
**Description:**  
*Insulation bagged  
and ready for  
removal.*

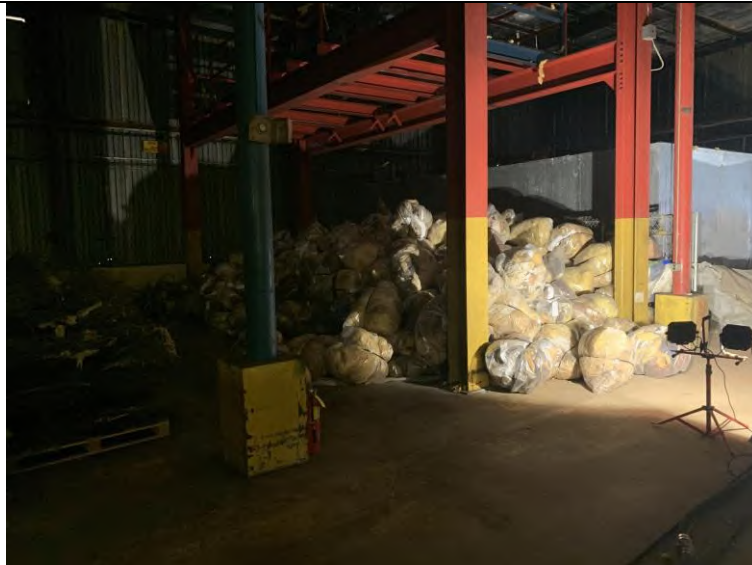
**Photograph #10**

**Description:**  
*Insulation bagged  
and ready for  
removal.*

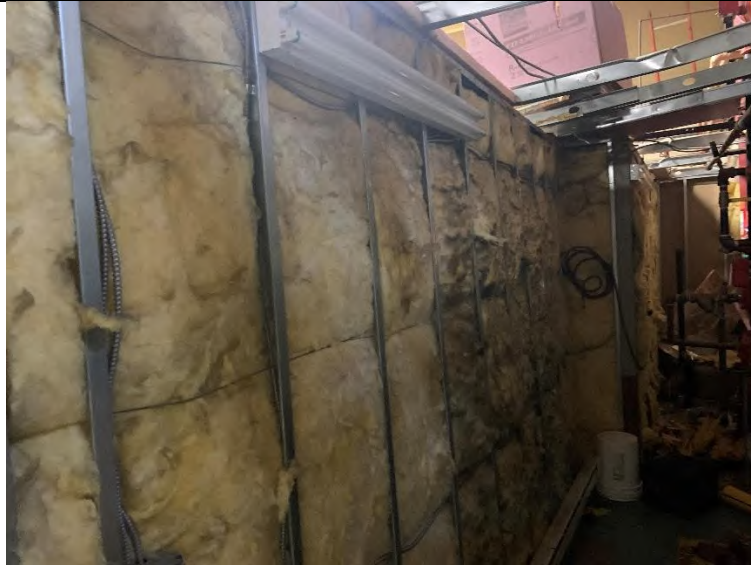
**Description:**  
*Utility closet in  
warehouse still in  
need of insulation  
removal.*

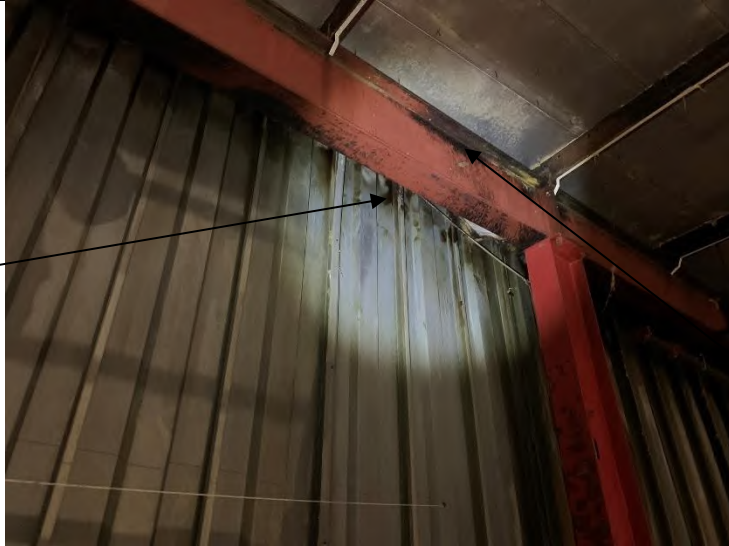
Corrosion  
where water  
is seeping into  
building.

Dark coloration is  
raw metal where  
paint has been  
removed.

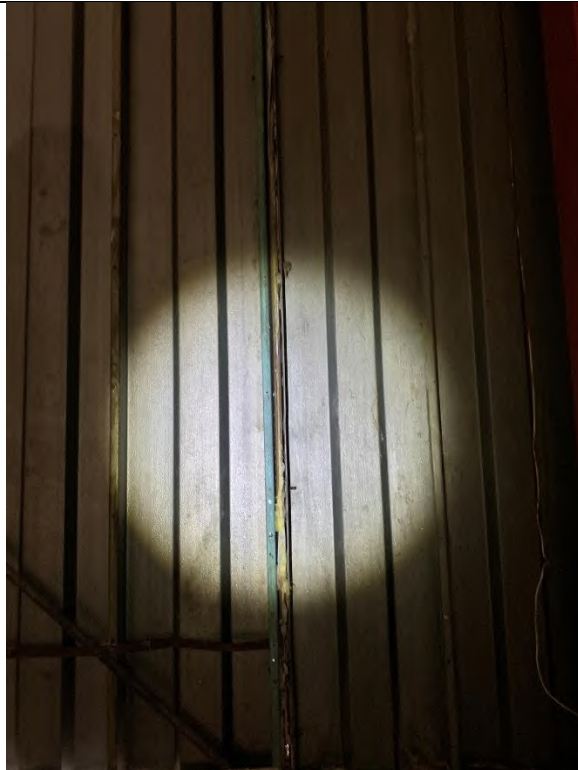
### Photograph #2

**Description:**  
*Sheet metal along  
northern wall.  
Representative  
photo of finished  
sheet metal surface  
in this area. Leftover  
insulation removed  
by The Precision  
Group after this  
photo.*

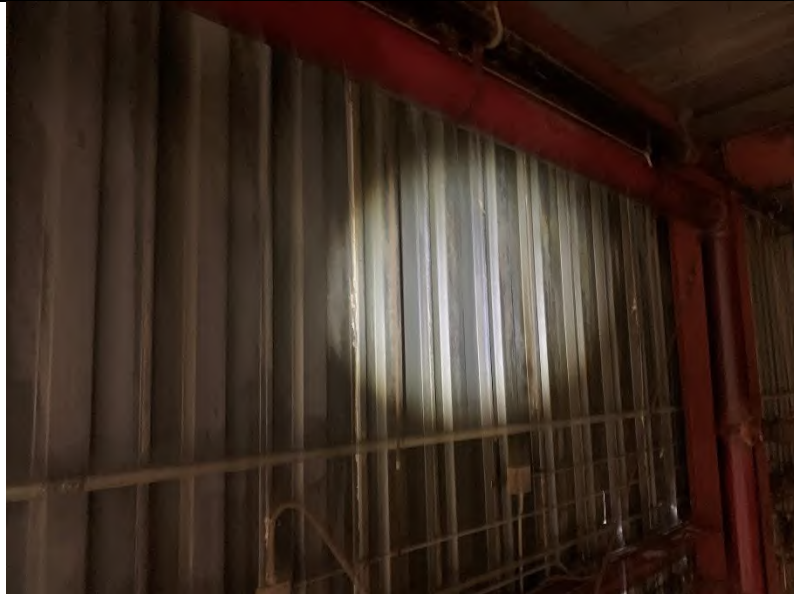
**Description:**  
*Upper portion of the  
west wall (Section A),  
near corner of north  
wall.*

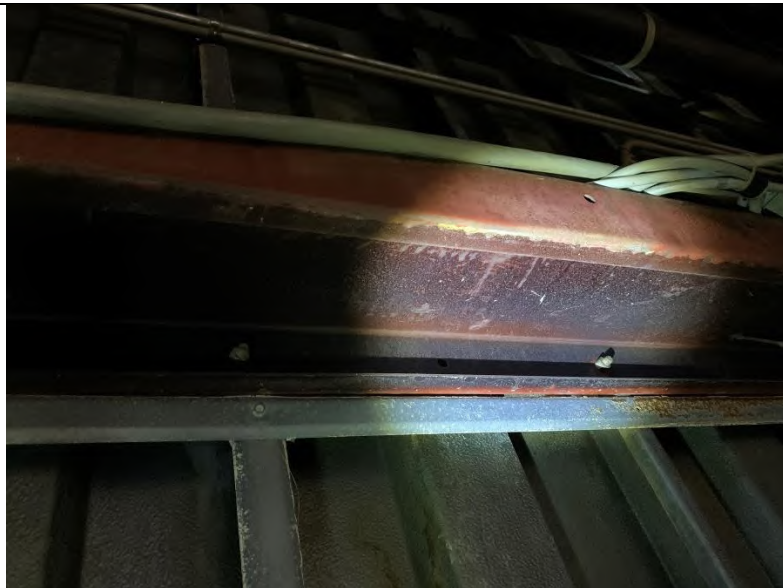
**Photograph #4**

**Description:**  
*Close up of purlin  
along the western  
wall (Section A).  
Purlins showed no  
signs of PFAS  
residue.*

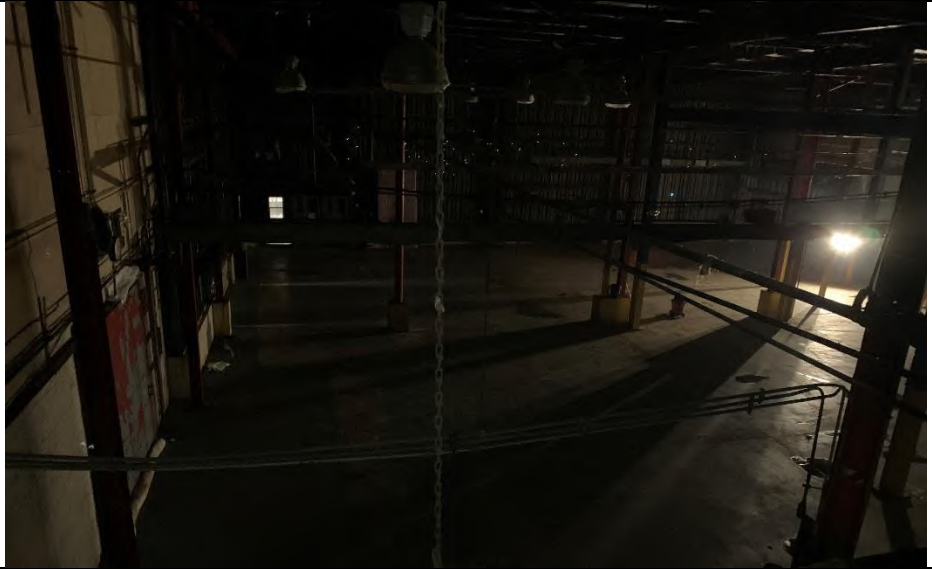
**Description:**  
*Overview of cleaned  
portion of floor in the  
north end of the  
warehouse (Section  
E).*

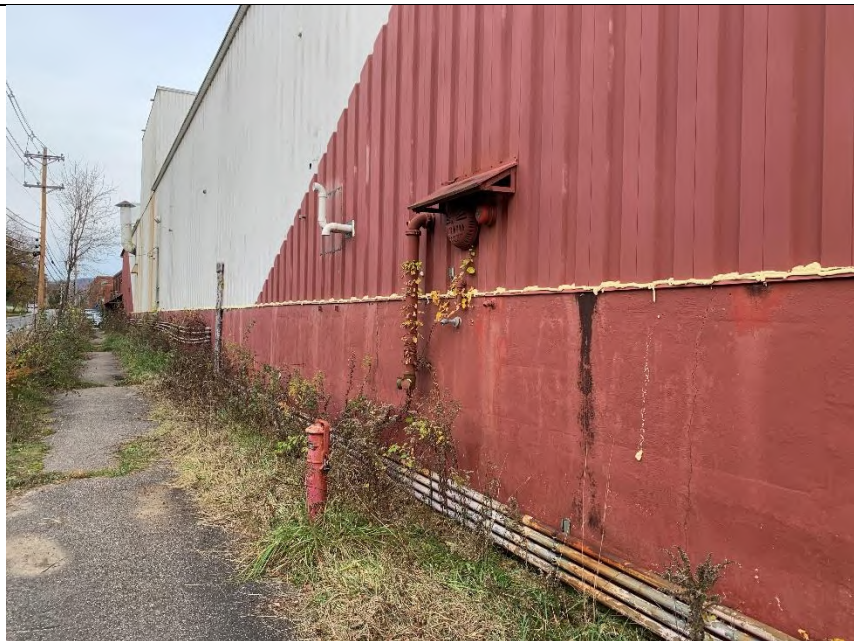
**Photograph #6**

**Description:**  
*Outside of western  
wall where contractor  
used foam to seal  
gap between sheet  
metal and concrete.*

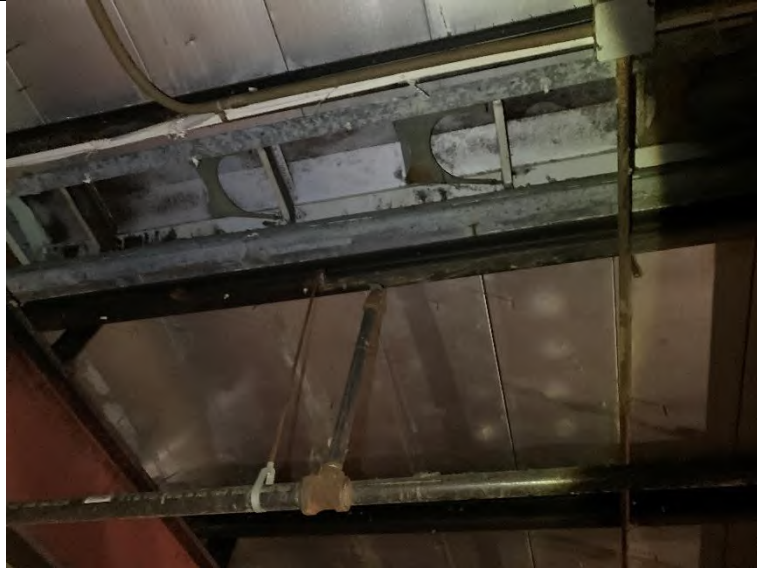
**Description:**  
Upper shaft running  
down the center of  
the north end ceiling.  
This section is to be  
re-cleaned due to  
visible residue.

11:45 Asked TPG to reclean failed column beams <sup>3</sup> to do a second clean of the ceiling shaft that runs the middle of the northern ceiling. This is an approx. 8-10 ft length by 2 ft area.

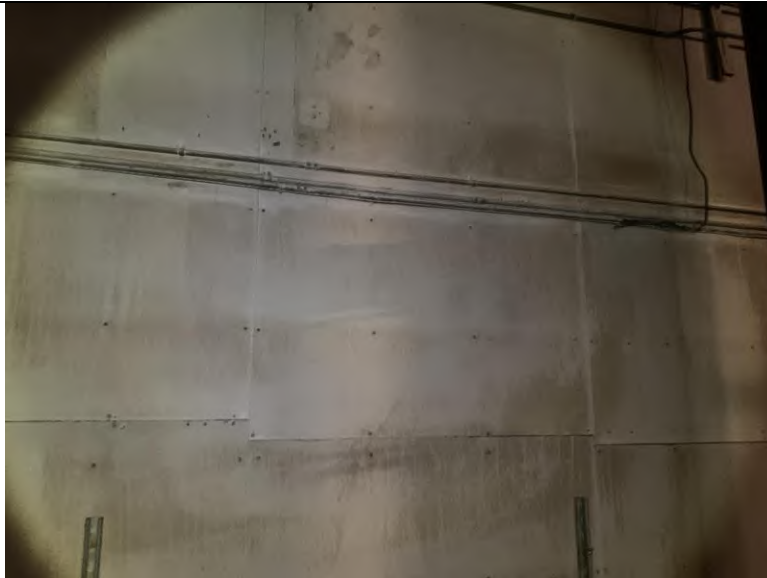
**Photograph #2**

**Description:**  
*Section of drywall  
along upper portion  
of the northern wall  
(Section B). Brown  
discoloration looks to  
be from seeping from  
roofline.*

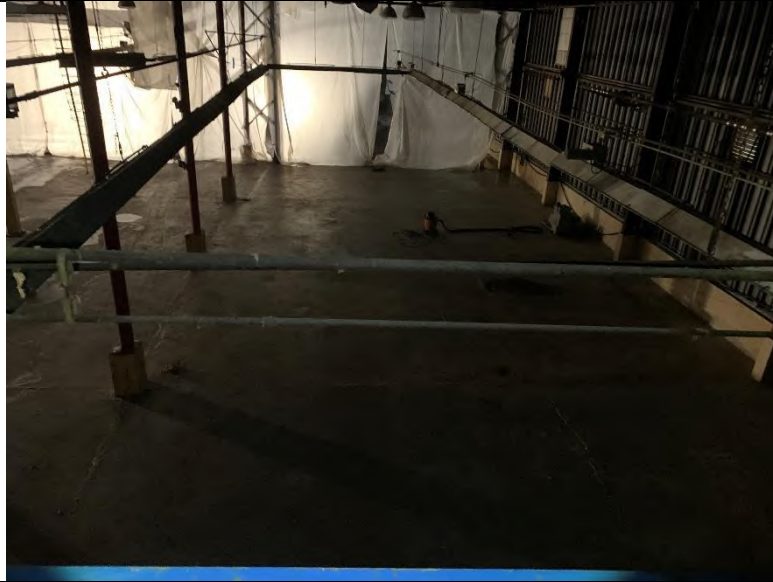
**Description:**  
*Overview of cleaned  
and inspected floor in  
northern end of  
warehouse (Section  
E).*

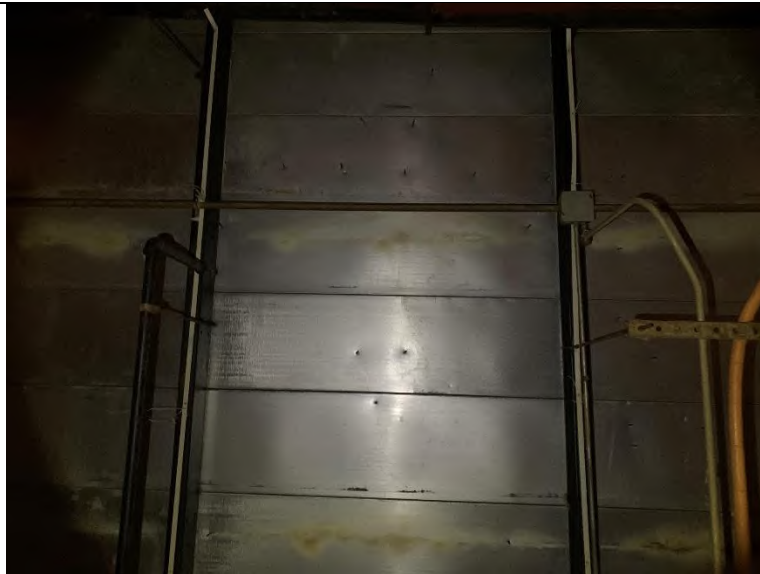
**Photograph #4**

**Description:**  
Representative  
section of clean  
ceiling panels in  
northern end of  
warehouse. Yellow  
stains are from  
adhesive strips used  
for insulation.

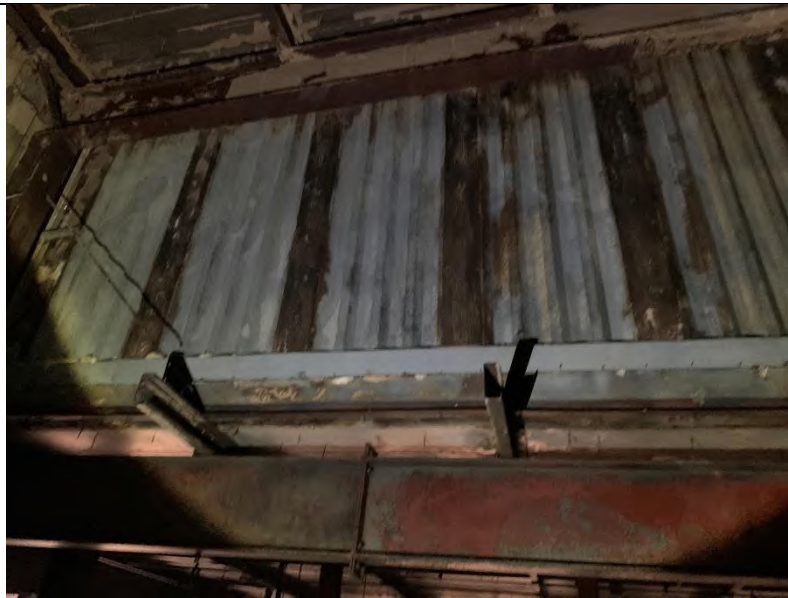
**Photograph #6**

**Description:**  
Side wall of  
northwestern cupola  
(Section K) and steel  
support beam.

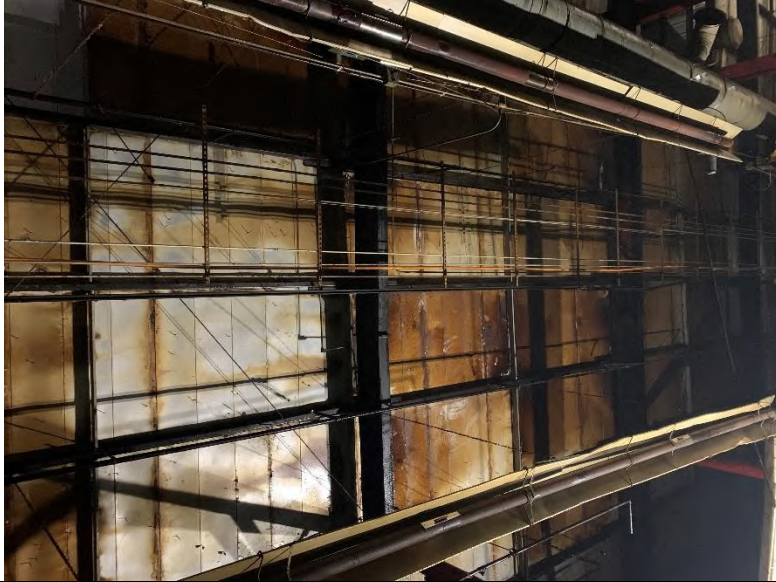
11:30 Walked through area currently being cleaned (mid-section of warehouse). TPG having trouble removing brown residue from some ceiling tiles. They believe these areas may be a result of a historical fire. This area has not yet been inspected by Atlas or Barr. Further discussion/investigation may be needed to identify cause/solution to these problem areas.

*Current area that is  
being cleaned  
(middle portion of  
warehouse).  
Cleaners noted  
brown residue is not  
coming off.  
Potentially discolored  
from a historical fire  
in building where  
insulation was not  
present. Area has not  
been inspected yet.*

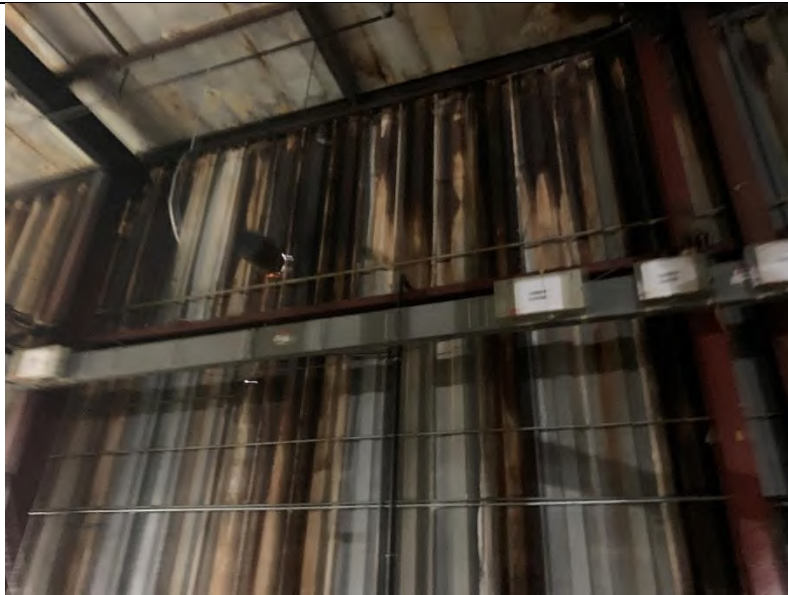
**Photograph #8**

*Brown residue from  
Photo #6 also noted  
along western wall in  
current cleaning  
area. Area has not  
been inspected and  
discoloration is not  
coming off.*

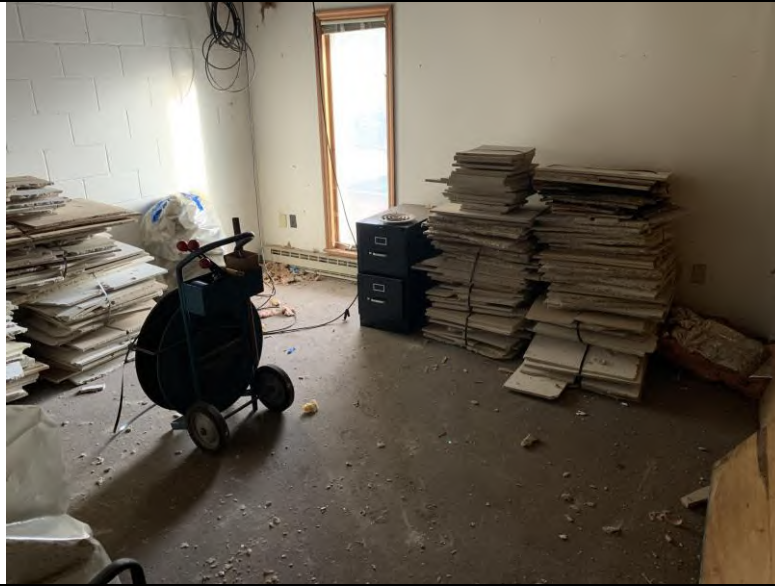
**Description:**  
Ceiling tile in office  
spaces has started to  
be removed. Wall  
have not been  
cleaned.

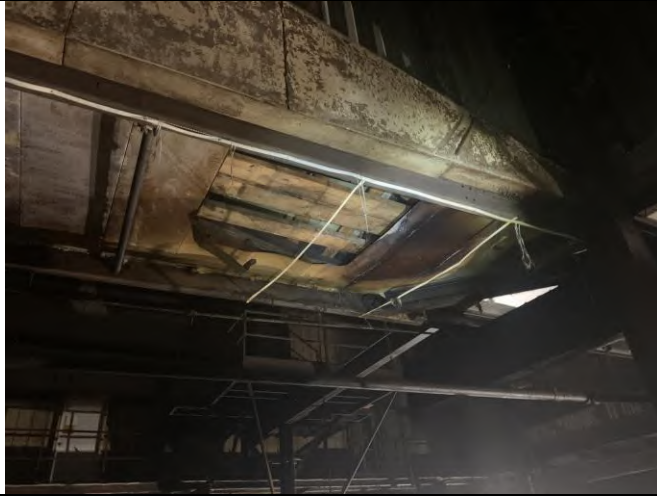
**Description:**  
Stained panels at the  
base of Cupola III

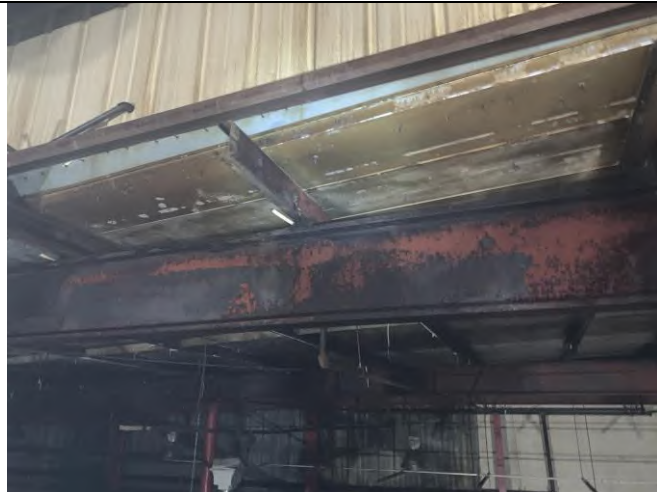
**Photograph #2**

**Description:**  
Stained panels and  
clean steel beam at  
the base of cupola III.

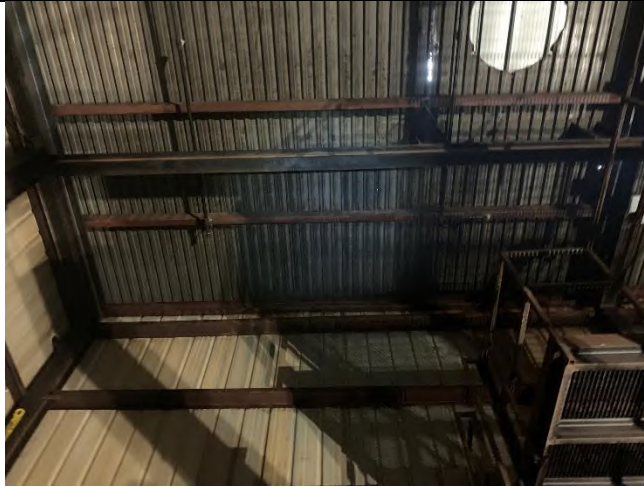
**Description:**  
Cupola III ceiling with  
some dark staining  
along western  
portion above the  
catwalk.

1330 Passed previously "pending" areas where brown residue (staining from insulation) was present. Also passed ceiling in cupola 3 where dark area was present. After using higher scissor lift it was determined that the dark area was heavy metal corrosion. →

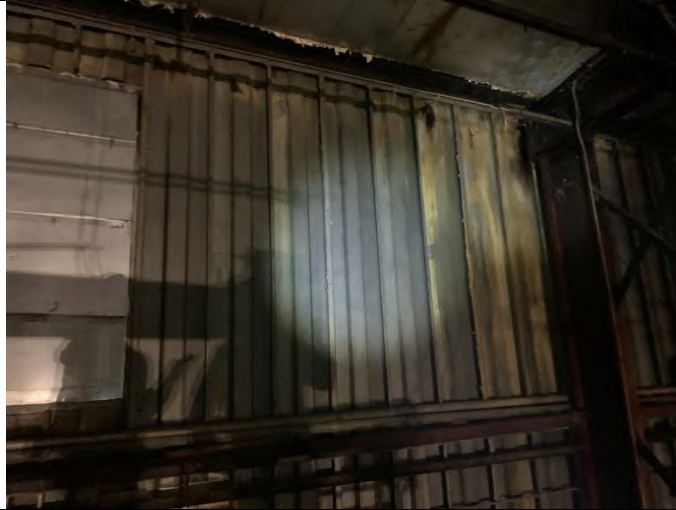
**Description:**  
Passing sheet metal  
along western wall of  
warehouse.

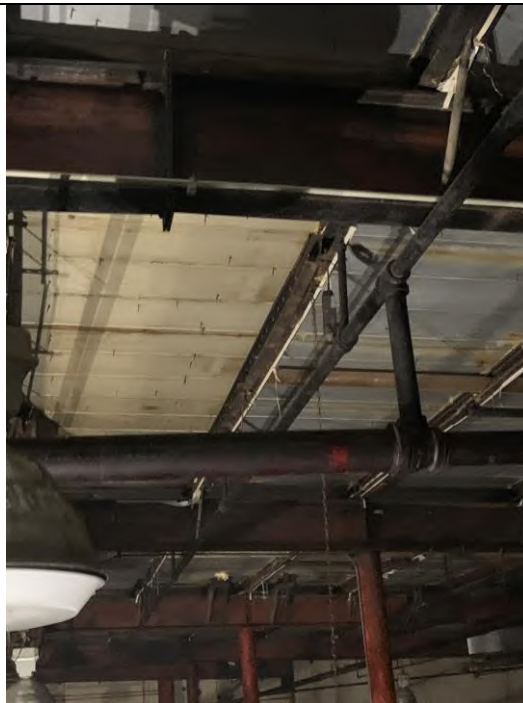
**Photograph #8**

**Description:**  
Passing ceiling tile  
shown on the right  
versus pending tile  
stained brown on the  
left.

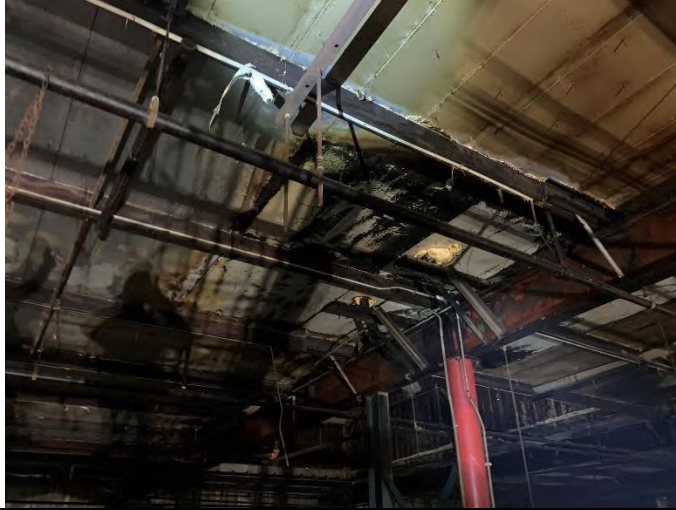
Brown staining on ceiling around outside of cupola III. Black staining also noticed in some areas here.

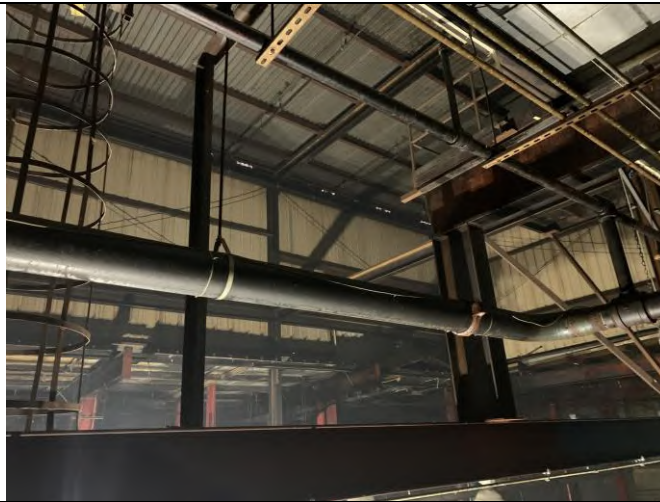
**Photograph #10**

Cupola III walls and ceiling from the southern side.

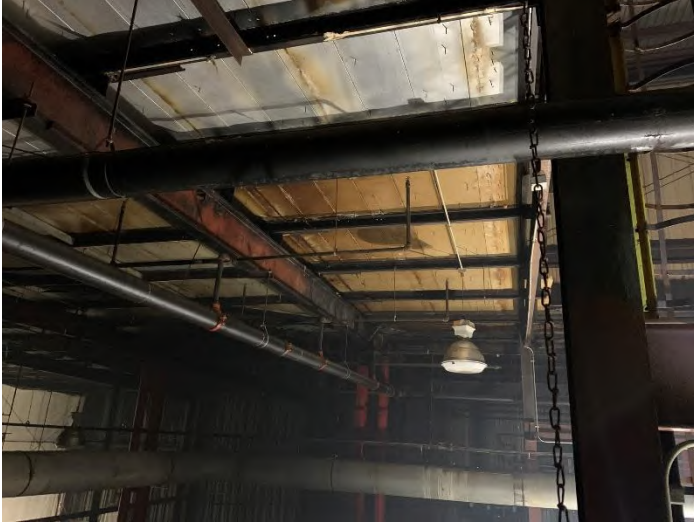
**Description:**  
Stained ceiling tile  
along southern edge  
of cupola III.

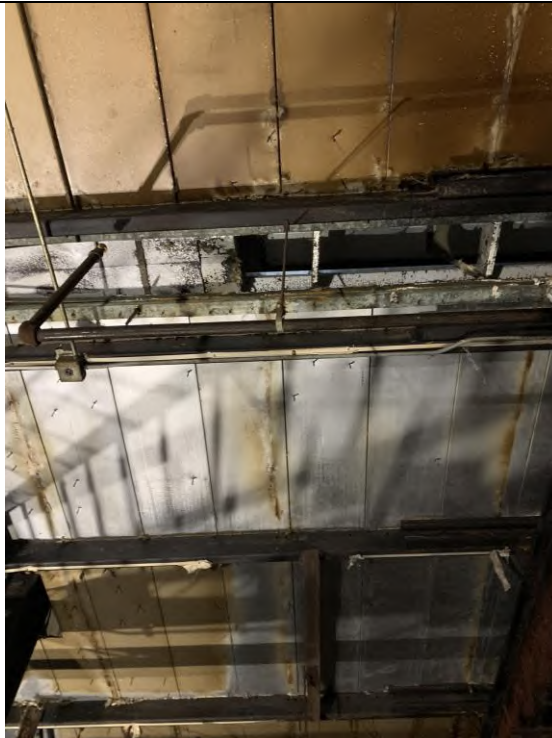
**Photograph #12**

**Description:**  
Stained ceiling tile  
and center shaft area  
with noticeable black  
residue left over.  
Asked The Precision  
Group to hand wipe.

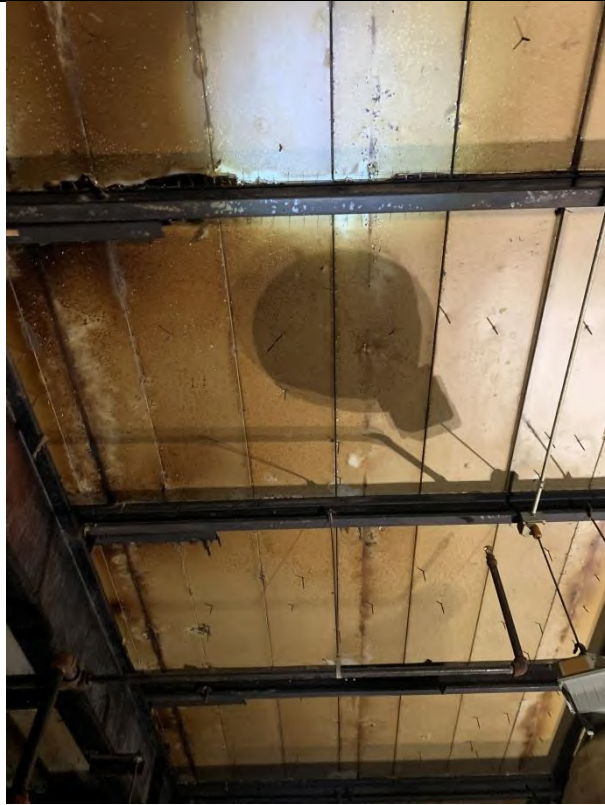
**Description:**  
Stained ceiling tile  
around cupola III.

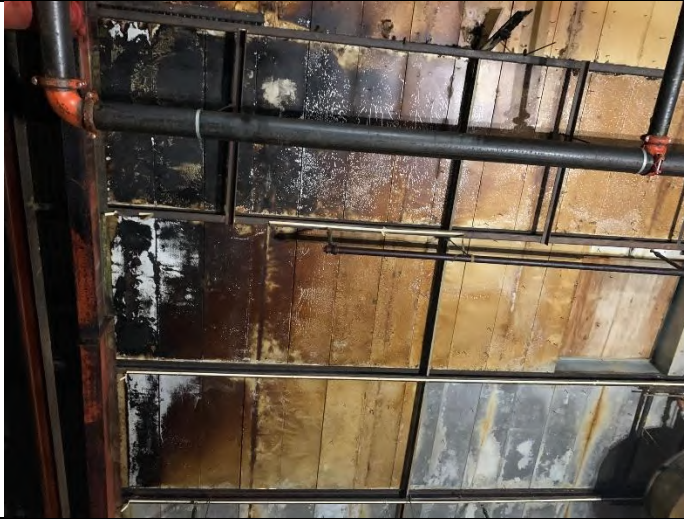
More stained ceiling  
tile with both black  
stains and more  
common brown  
staining.

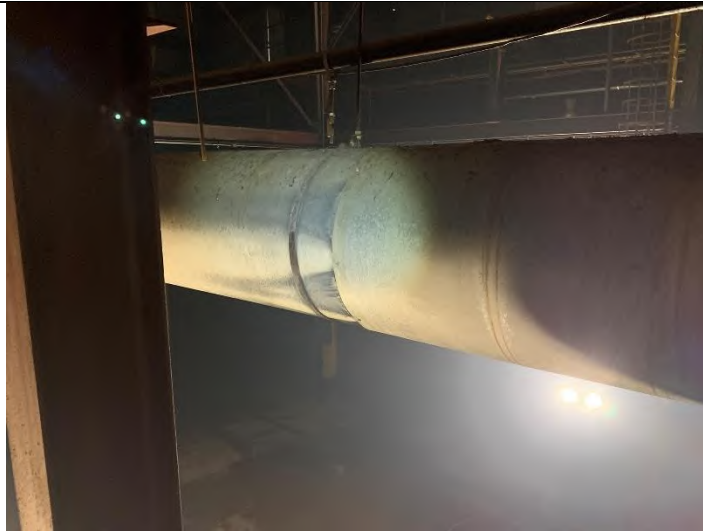
**Photograph #16**

HVAC piping with  
noticeable black  
residue streaming  
around seams in the  
pipe. TPG to hand  
wipe.

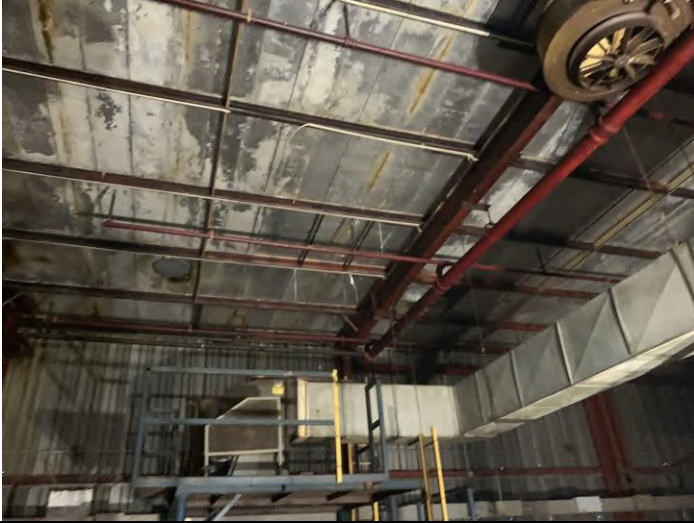
**Description:**  
Passing ceiling tile  
above HVAC system  
along eastern wall.

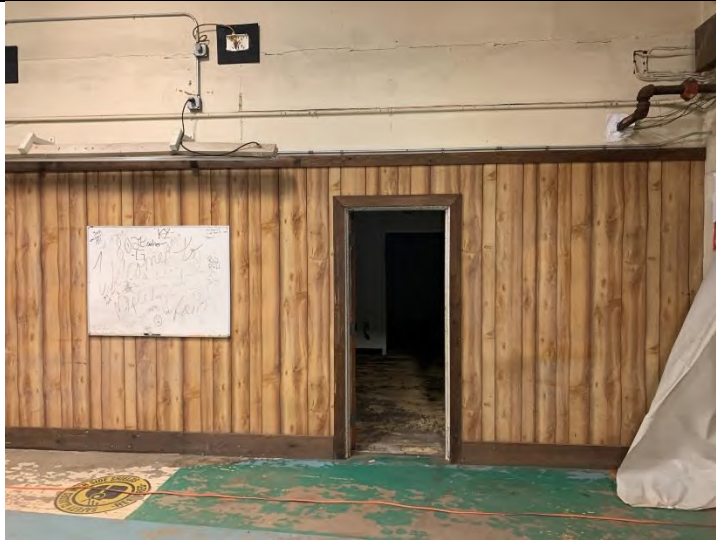
**Description:**  
Wood paneling along  
east wall when  
entering warehouse.

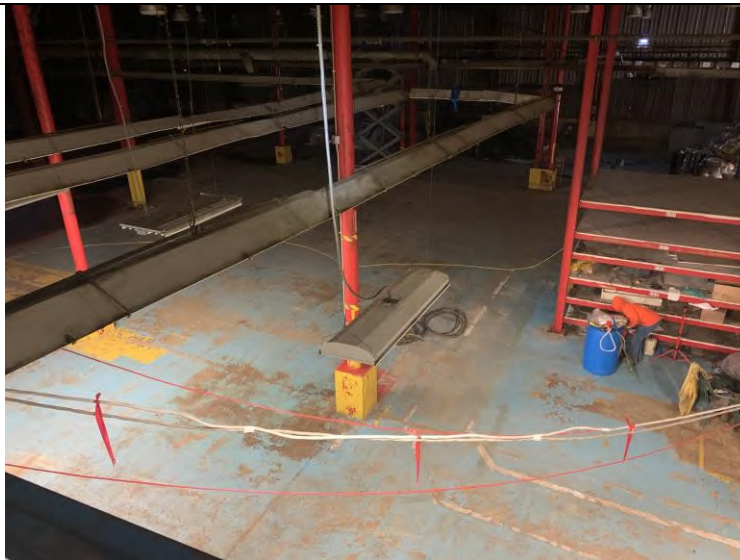
**Photograph #2**

**Description:**  
Floor of the central  
southern area of the  
warehouse.

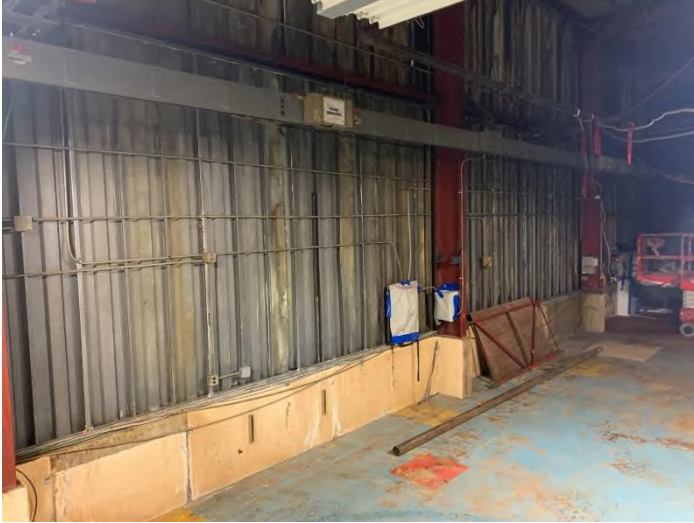
**Description:**  
"A" wall (west) lower  
paneling in southern  
portion of the  
warehouse.

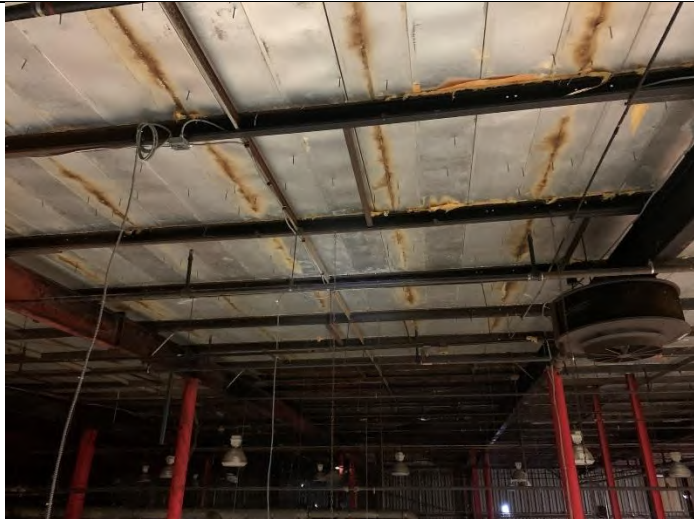
**Photograph #4**

**Description:**  
Clean ceiling tile in  
center of the  
southern area of the  
warehouse.

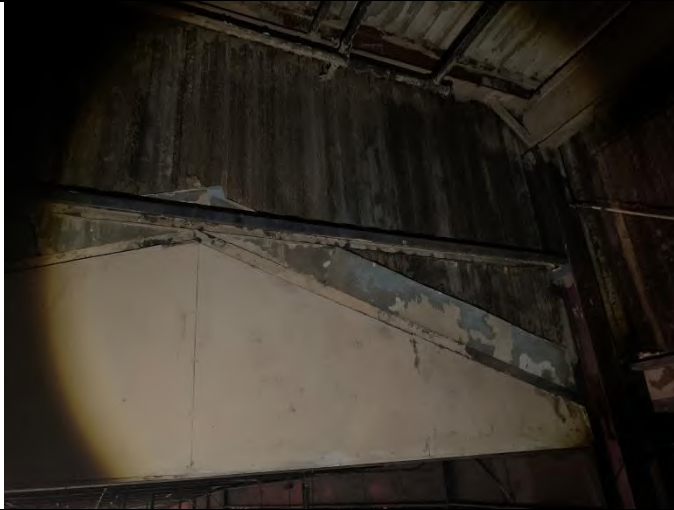
**Description:**  
Representative side  
wall of Cupola 1.

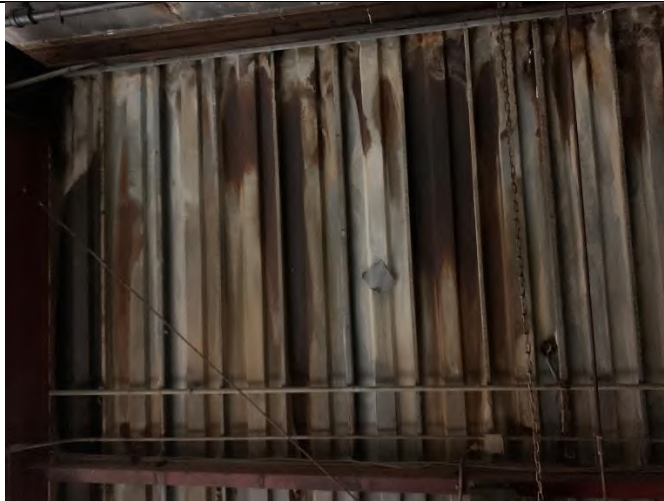
**Photograph #6**

**Description:**  
Some brown staining  
on upper portion of  
the "A" wall in the  
southern section of  
the warehouse. Not  
believed to be PFOA-  
related.

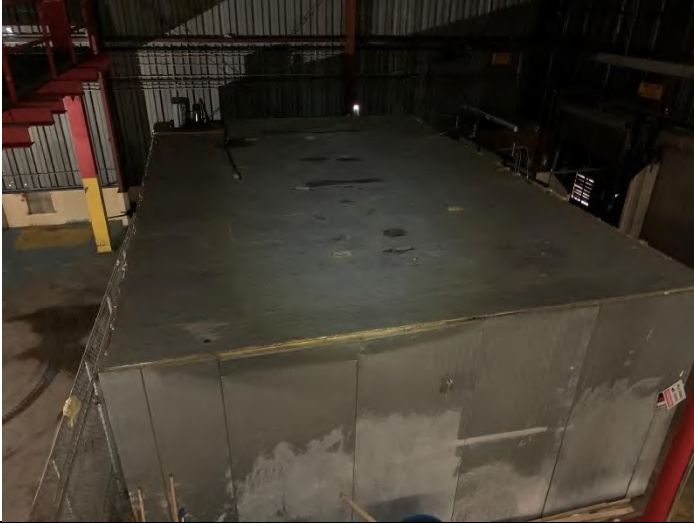
**Description:**  
Top of the  
refrigeration area in  
the southeast corner  
of the warehouse.

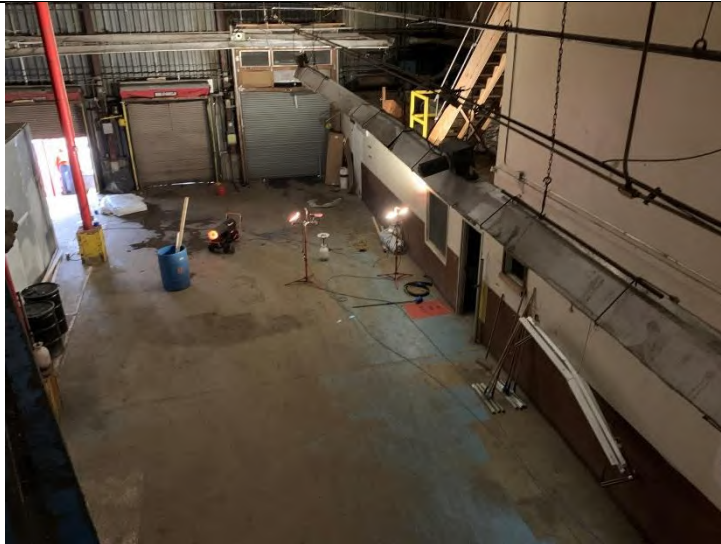
**Photograph #10**

**Description:**  
Representative floor  
area in the southeast  
corner of the  
warehouse.

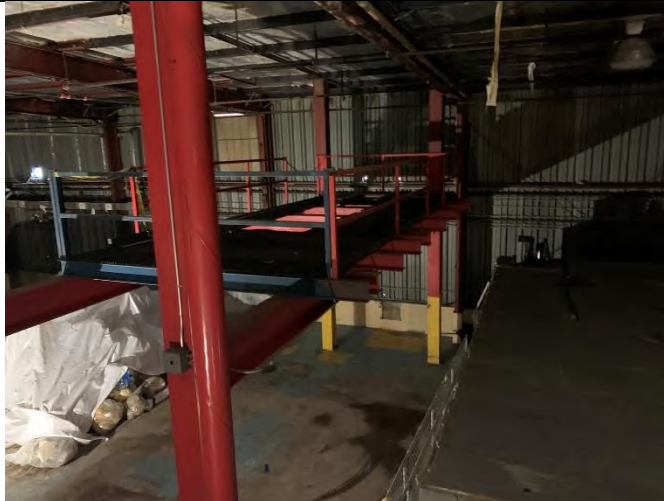
**Description:**  
Catwalk above  
refrigeration area.

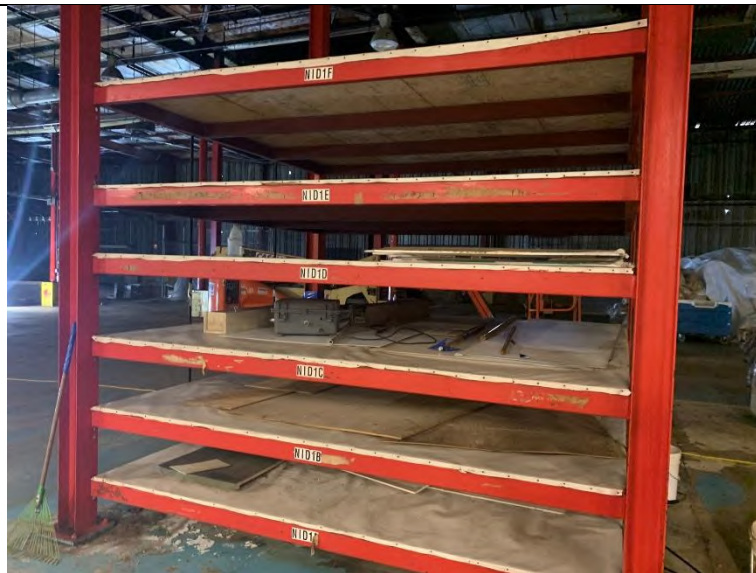
**Photograph #12**

**Description:**  
Shelving unit in the  
middle of the  
southern portion of  
the warehouse.

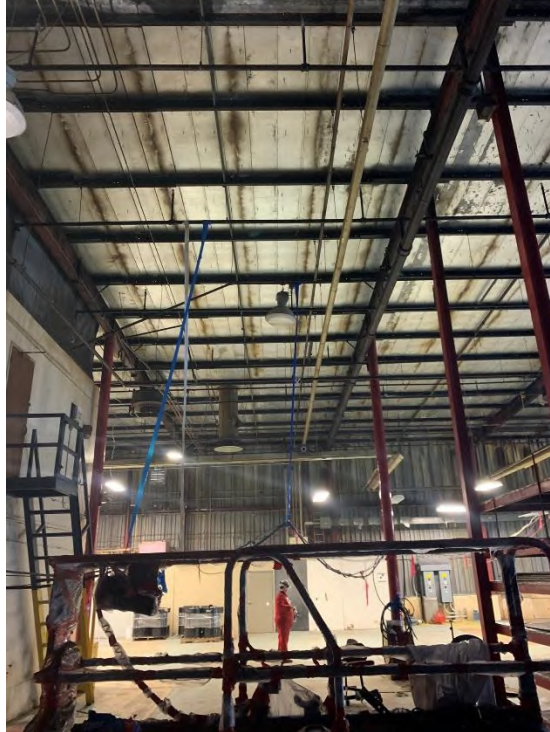
**Description:**  
Ceiling tile in the  
southern section of  
the warehouse.

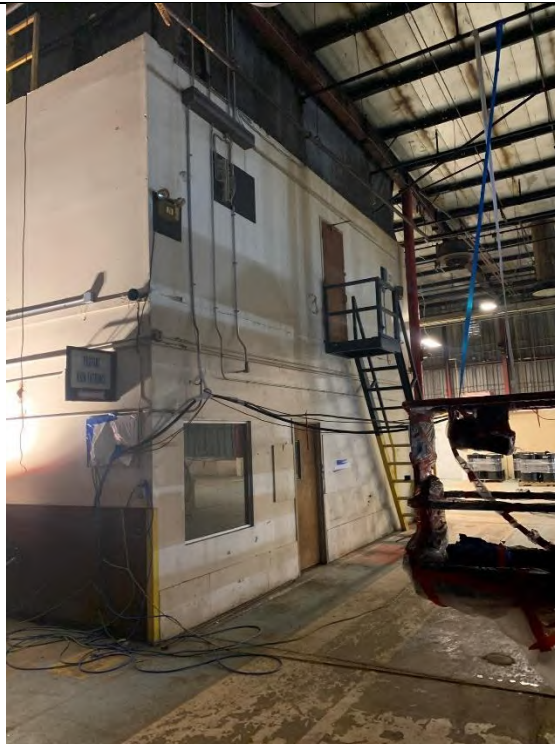
**Photograph #14**

**Description:**  
North wall of cutout  
area in southern  
section of  
warehouse.

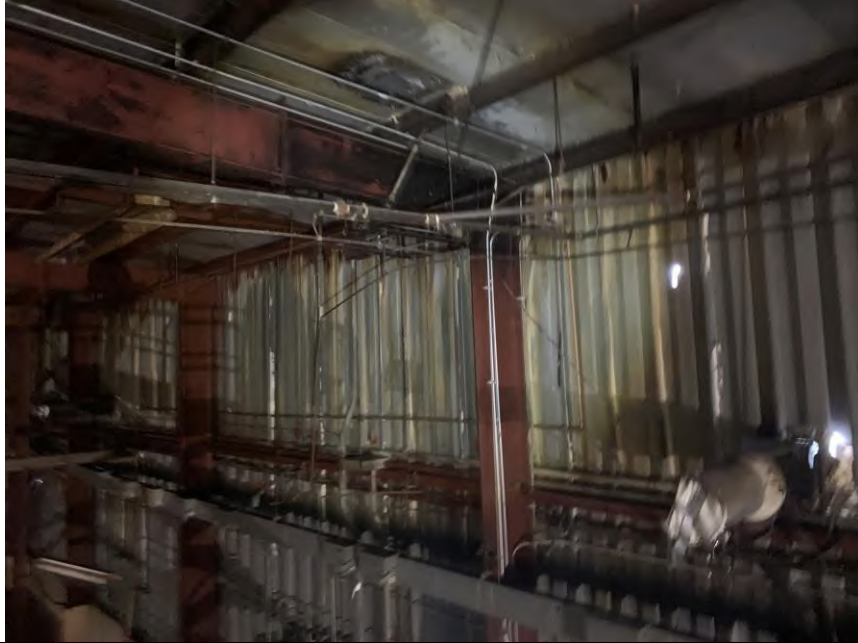
**Description:**  
Upper sheet metal  
along "C" wall (east)  
located south of  
cupola I.

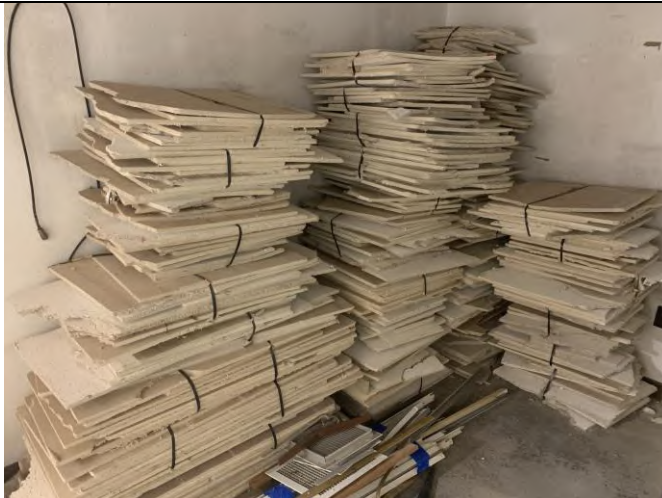
**Photograph #16**

**Description:**  
Stacked ceiling tile  
awaiting removal.
