## **SUMMARY REPORT – PFAS BUILDING CLEANING INSPECTIONS FORMER CHEMFAB FACILITY – SAINT GOBAIN PERFORMANCE PLASTICS**

PROJECT NO. 280EM01070 (SMS SITE #2006-4630)

1030 Water Street, North Bennington, VT 05257

April 24, 2024

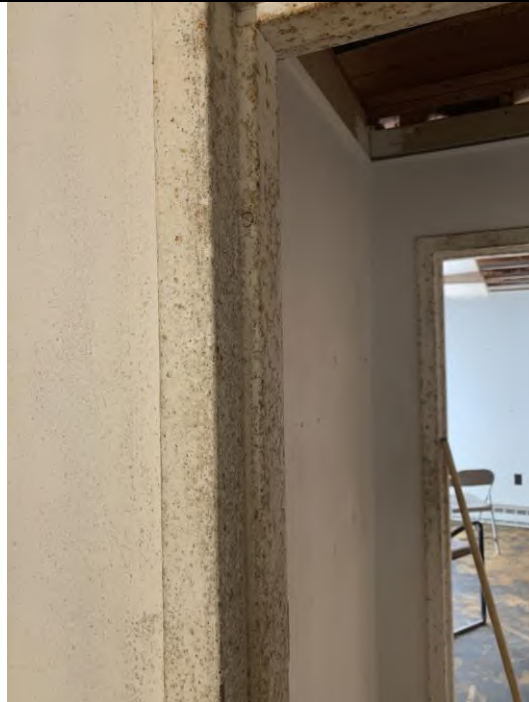
1200 Noted black spotting on door jams around office/warehouse doors. Would not come off w/ hand wiping/paint scraper. Most likely mold related.

Black residue on door jams of downstairs office area. Most likely mold. Did not come off with scraper/wipes.

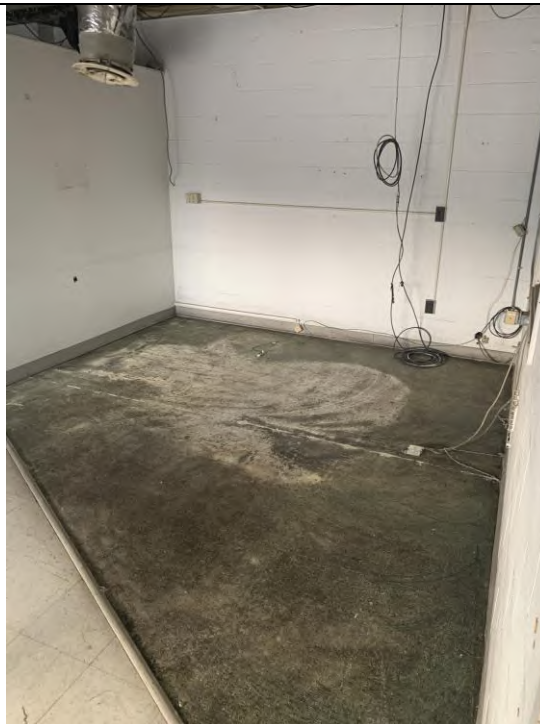
**Photograph #18**

Floor beneath asbestos-containing tile post-removal in downstairs east office area.

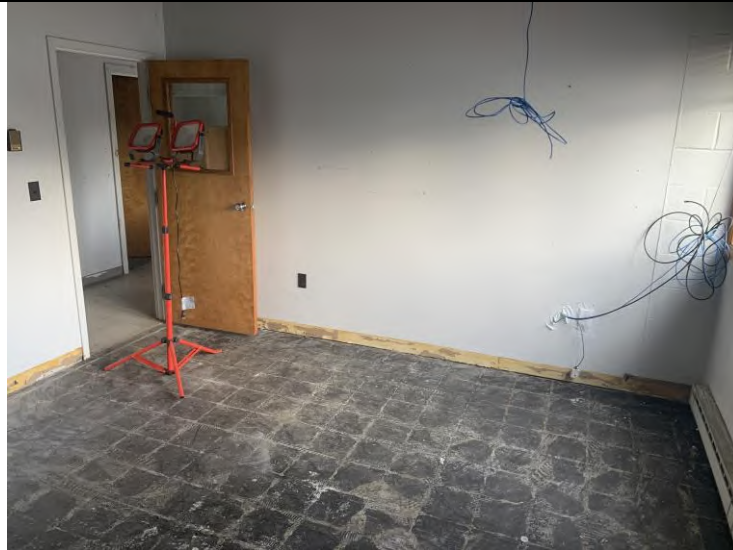
**Description:**  
Floor beneath  
asbestos-containing  
tile post-removal in  
downstairs east  
office area.

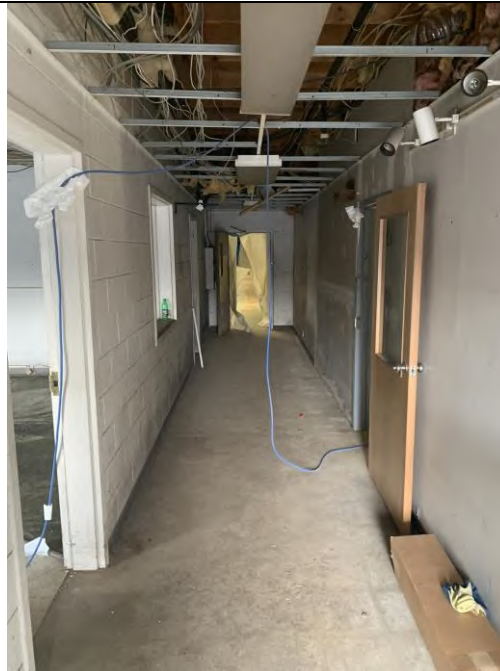
**Photograph #20**

**Description:**  
Entrance hall post-  
cleaning and removal  
of ceiling tile.

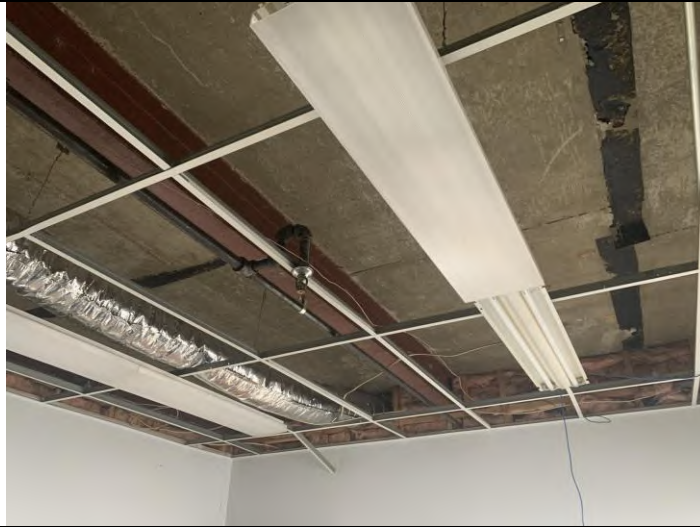
**Description:**  
Representative  
downstairs office  
ceiling post-removal  
of ceiling tile.

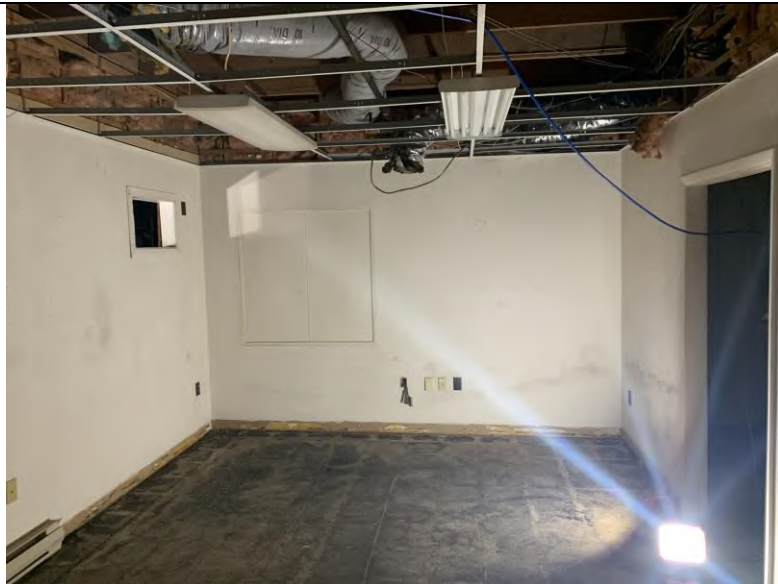
**Photograph #22**

**Description:**  
Representative  
downstairs wall in  
office area post-  
cleaning/ceiling tile  
removal.

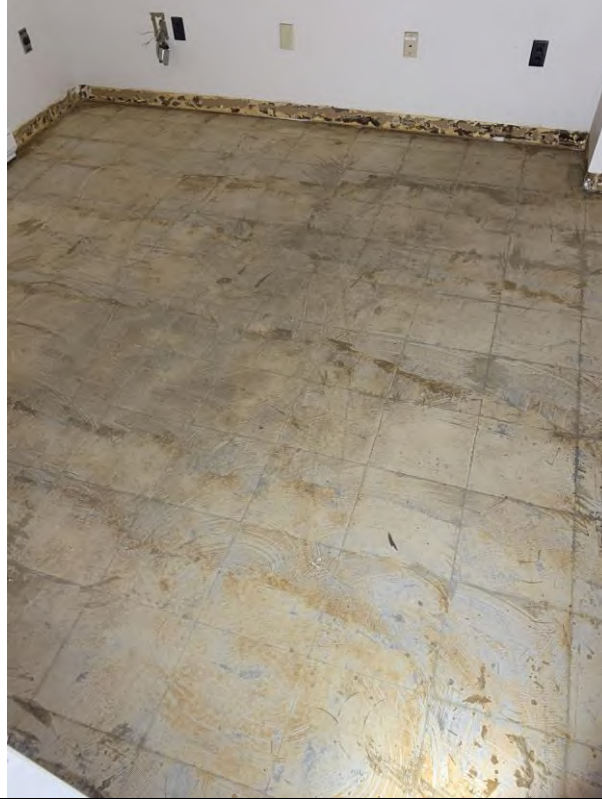
**Description:**  
Representative floor  
in upstairs area post  
rug removal.

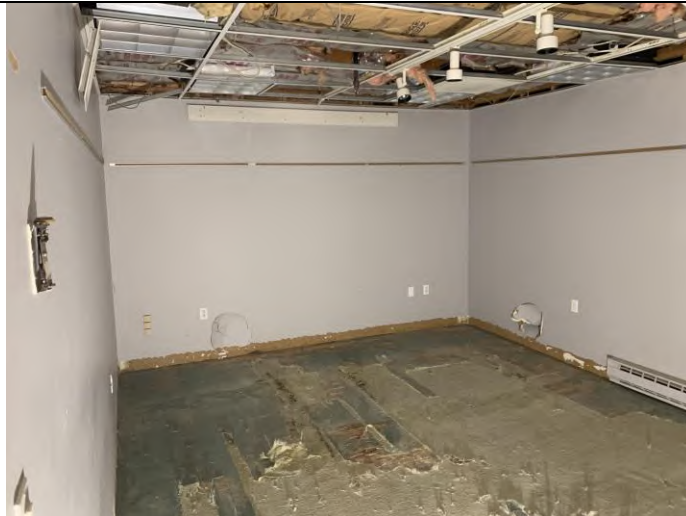
**Photograph #24**

**Description:**  
Representative  
upstairs office wall  
post rug/ceiling tile  
removal and  
cleaning.

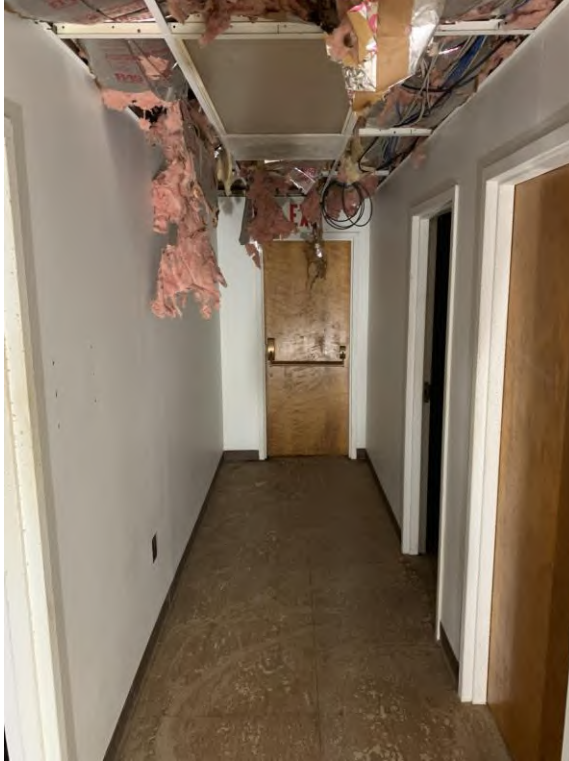
**Description:**  
Upstairs hallway post  
cleaning and ceiling  
tile removal.

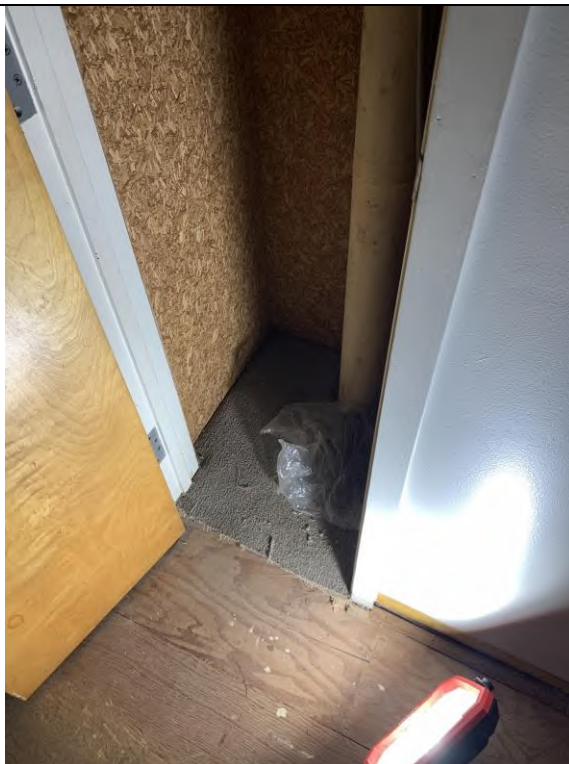
**Photograph #26**

**Description:**  
Small piece of rug  
leftover around  
asbestos containing  
pipe in upstairs  
closet.

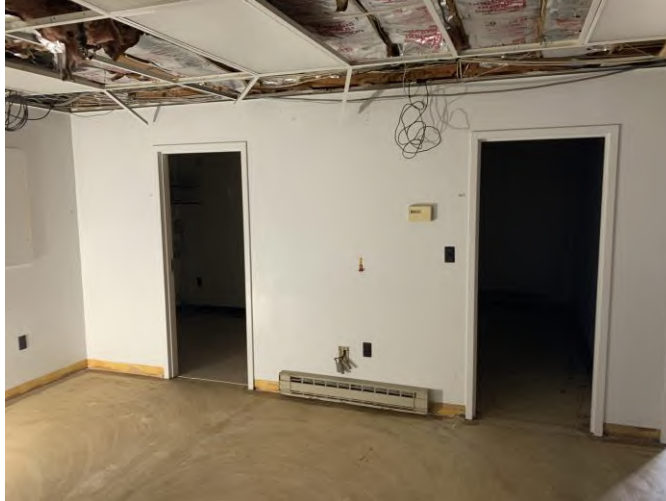
**Description:**  
Upstairs office walls  
and floor post  
cleaning (lobby  
area).

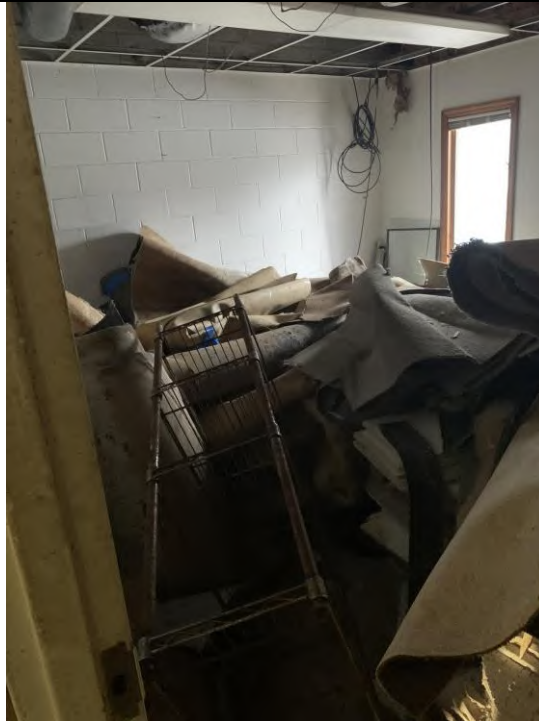
**Photograph #28**

**Description:**  
Downstairs room  
with rugs and ceiling  
tile awaiting removal.
