Evaluation of Corrective Action Alternatives:

Former Bennington High School, 650 Main Street, Bennington, Vermont, SMS# 2023-5275

January 2, 2024

STONE
ENVIRONMENTAL

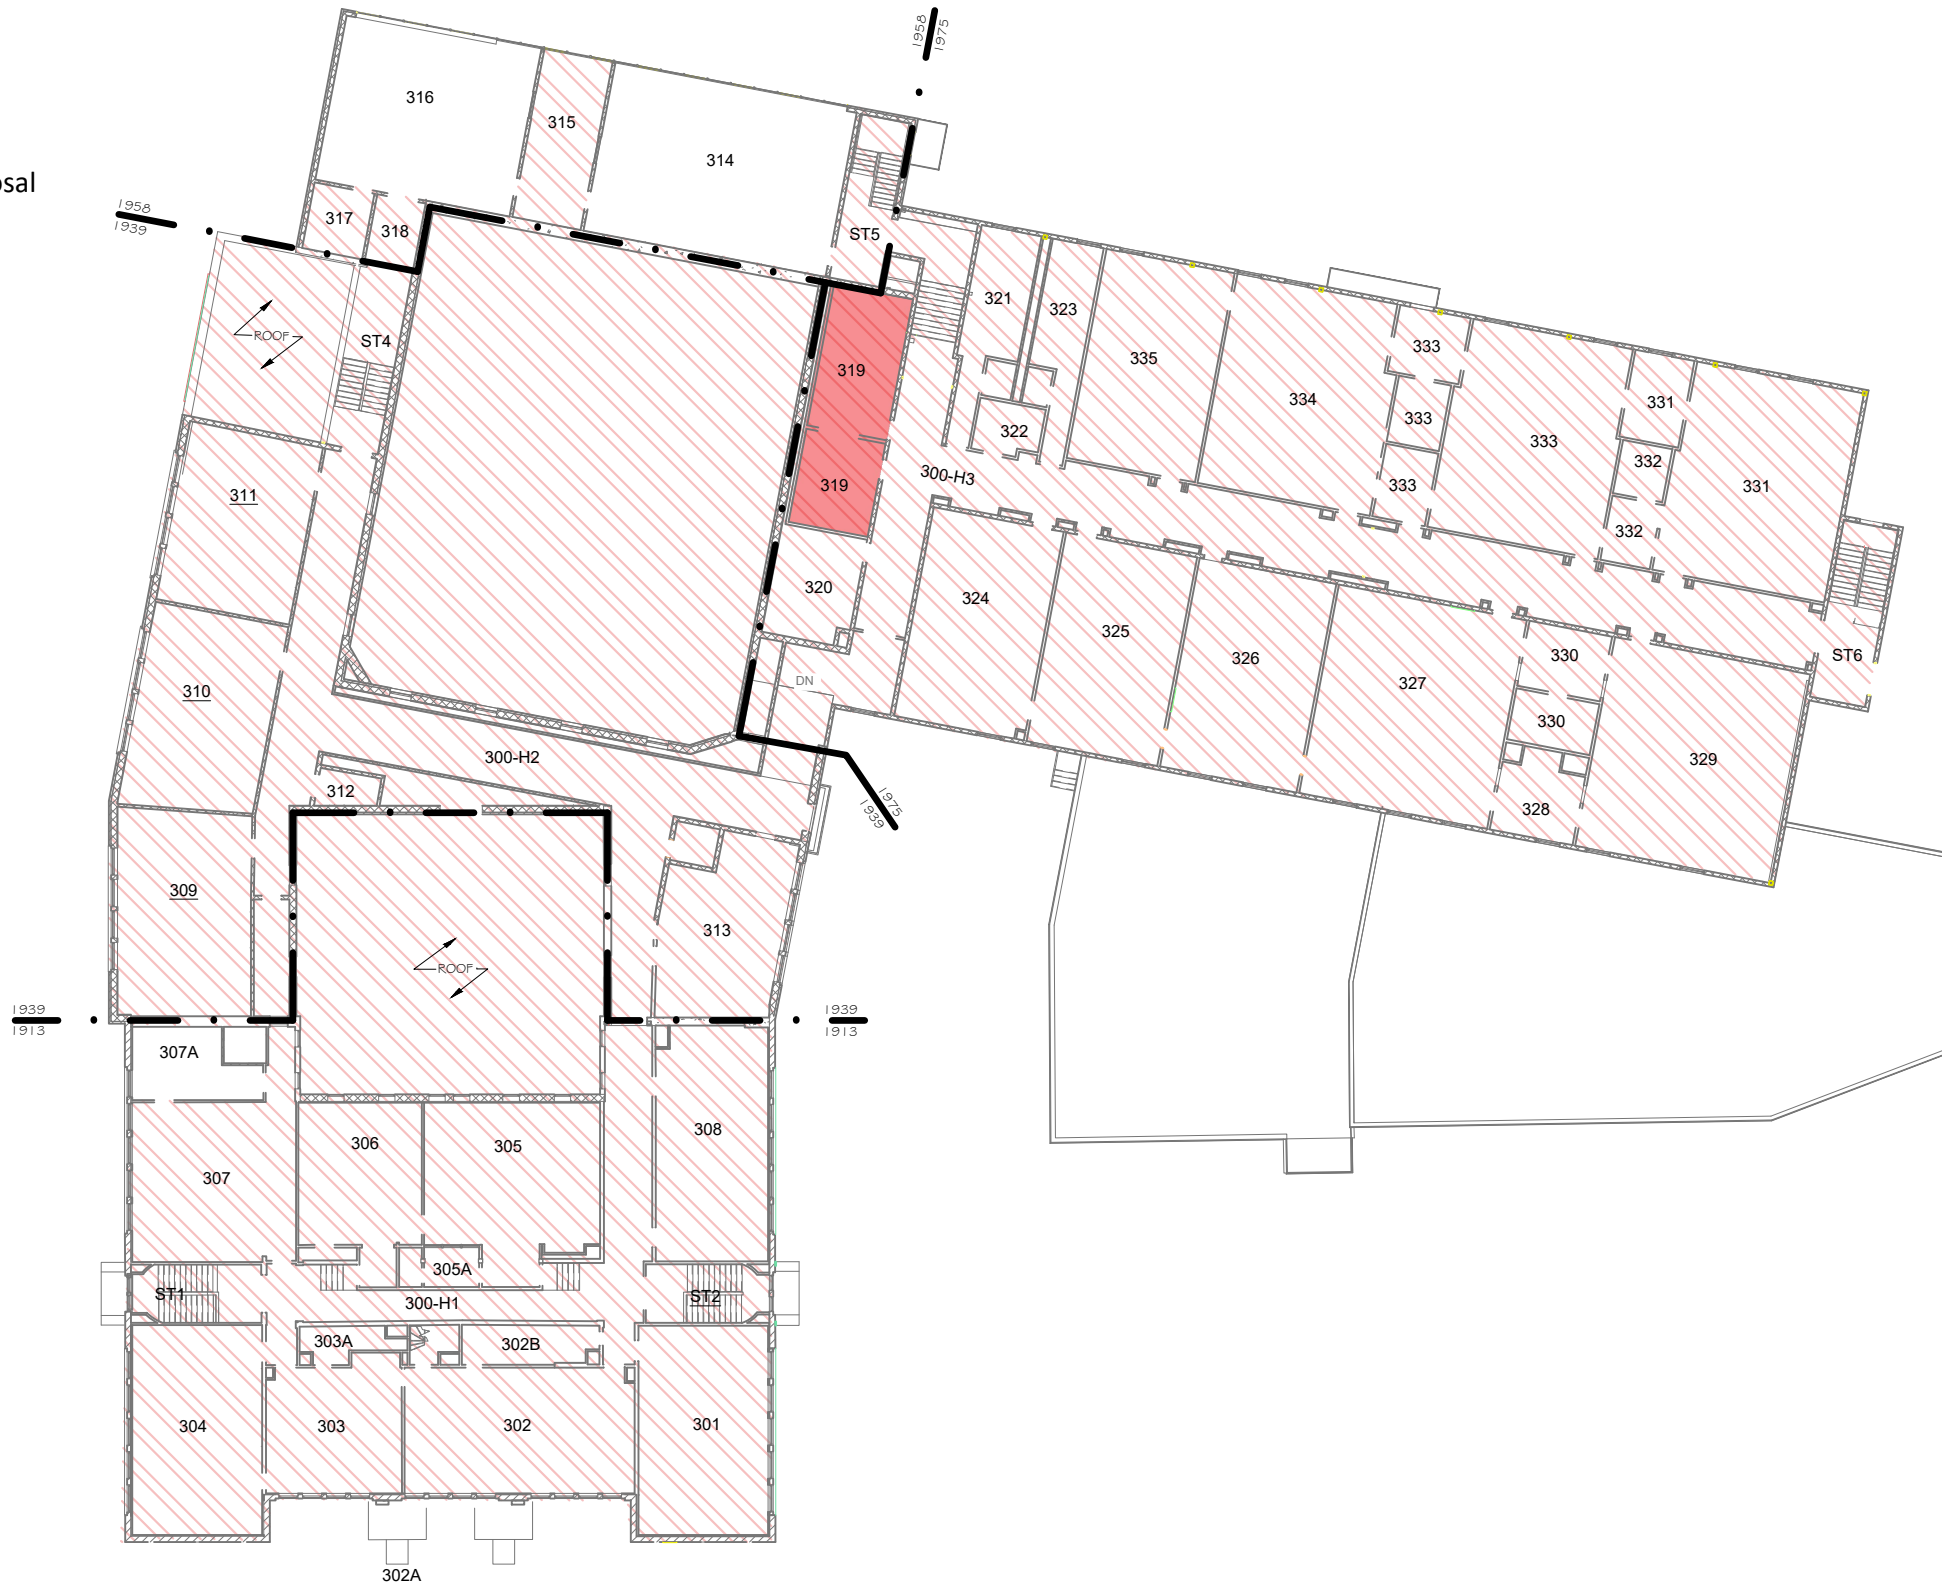
Figure 8C: PCB Mitigation Plan – Upper Level

- i. Low levels of PCBs in bulk products have been detected in all Site areas in various construction materials. The product with the highest concentrations, which exceed the Toxic Substances Control Act (TSCA) bulk product threshold, is paint found within room 319. Other detections are considered excluded bulk product under TSCA.

- 319 - Pale Green Paint - 150 ppm
- 319 - Light Blue Paint - 190 ppm
- 319 - Wood Panel Adhesive - 29 ppm
