Subject: Final Site Inspection Report
Mardon Industries
Lyndon, VT
CERCLIS No. VTD990800641
TDD No. 99-05-0053

FINAL SITE INSPECTION PRIORITIZATION REPORT
FOR
MARDON INDUSTRIES
LYNDON, VERMONT

CERCLIS No. VTD990800641
TDD No. 99-05-0053
PCS NO. 7127
DC NO. A-4136

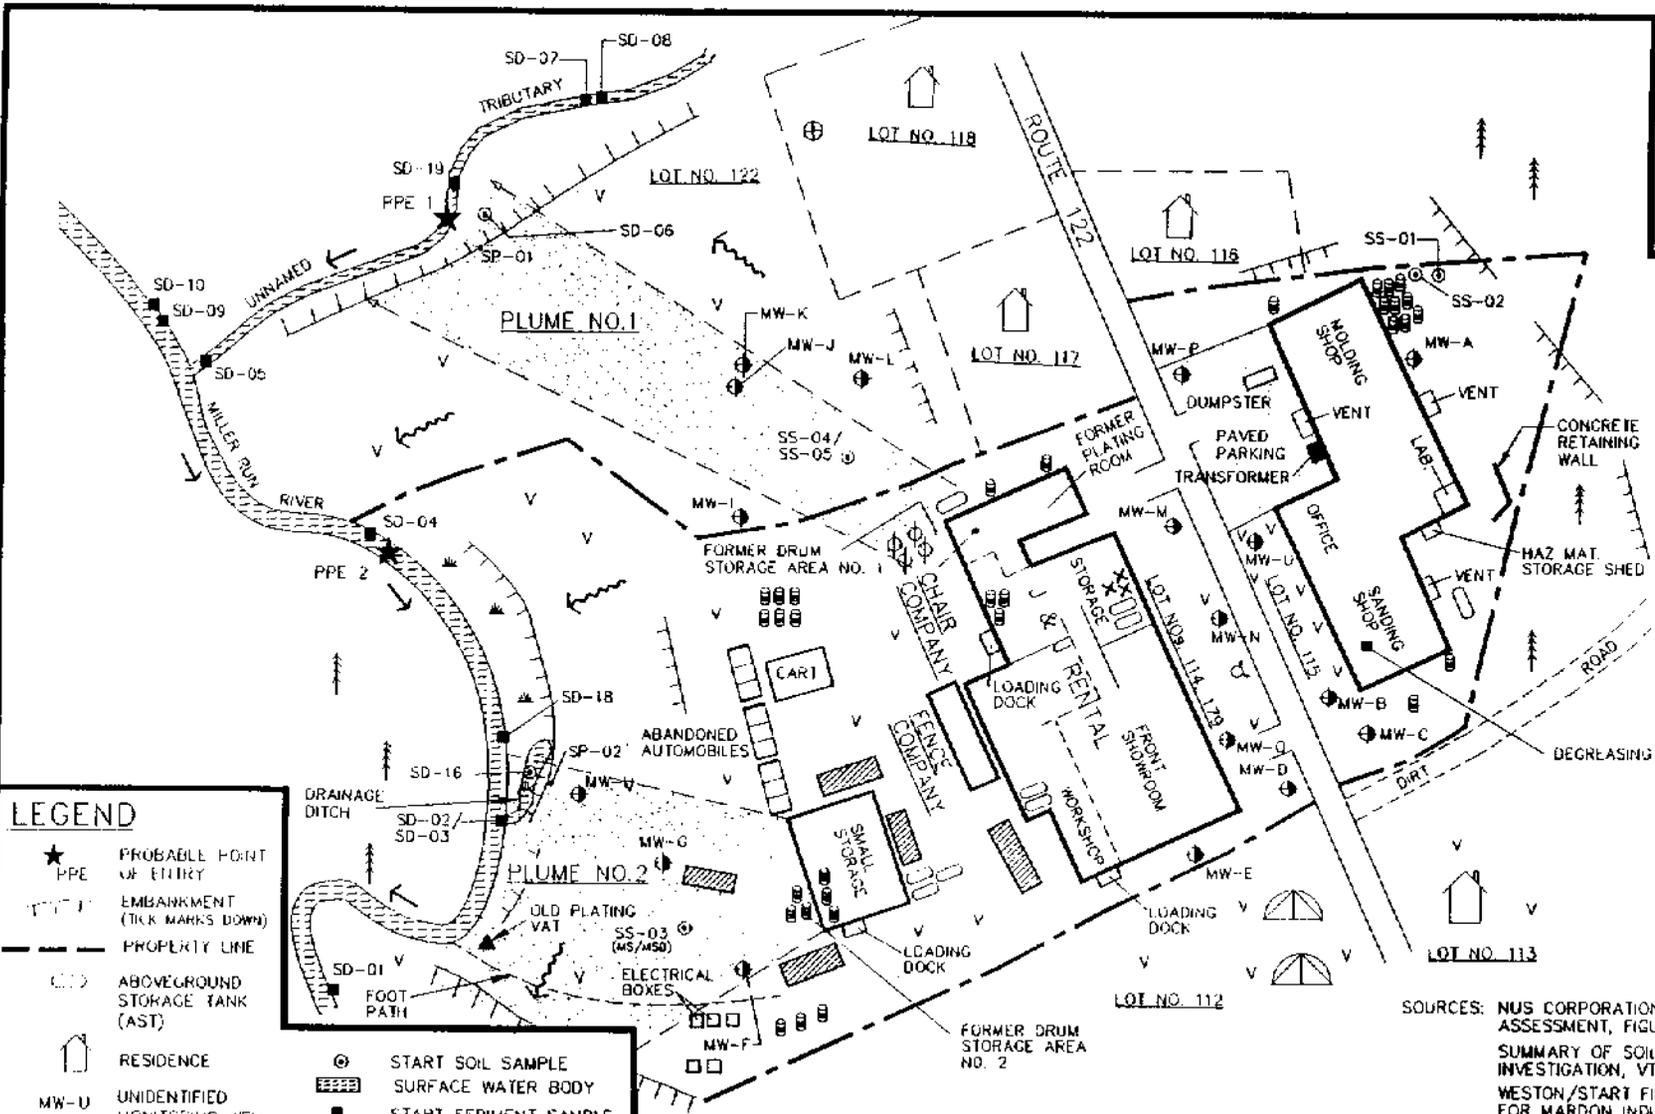
TDD # 98-05-0028	DRAWN BY: W. SHAW	DATE 8/24/98
FILE NAME: S:\97020033\FIG2S		FIGURE 2

The topography of the Mardon property slopes to the southwest and northwest towards the Miller Run River and an unnamed tributary to the Miller Run River, respectively (Figure 2). The property is located within the 100-year floodplain of the Miller Run River [6, p. 3; 57]. Surface water drainage from the property apparently flows to the Miller Run River, which is located approximately 350 feet west of the small storage shed located on Lot Nos. 114 and 179; and in a northwesterly direction toward the unnamed tributary, located on Lot 122 approximately 400 feet northwest of the main building [7, pp. 18, 19]. The property is served by the Lyndon municipal water and sewer system [25]. The property is not enclosed by a fence. The nearest residences to the Mardon property are less than 200 feet north of the western portion of the property on Lot No. 117, and less than 200 feet south of the eastern portion of the property on Lot No. 113 [7, pp. 7, 9, 12, 13, 16, 17].

START personnel observed a decrepit plating vat located approximately 160 feet west of the small storage building [7, pp. 14, 19]. A steep embankment was observed paralleling the unnamed tributary northwest of the property in Lot No. 122. Steep embankments were also noted paralleling the Miller Run River along the western and southwestern portions of the property in Lot Nos. 114 and 179. A drainage ditch was observed along the embankment along the Miller Run River (Figure 2).
