June 29, 1989

Final Expanded Site Inspection Report
Lemieux Truck Dump/Mountain View Auto Restoration
Lyndonville, Vermont

TDD No. F1-8702-02
Reference No. \$375VT10E1
CERCLIS No. VTD108866278/
VTD981204159

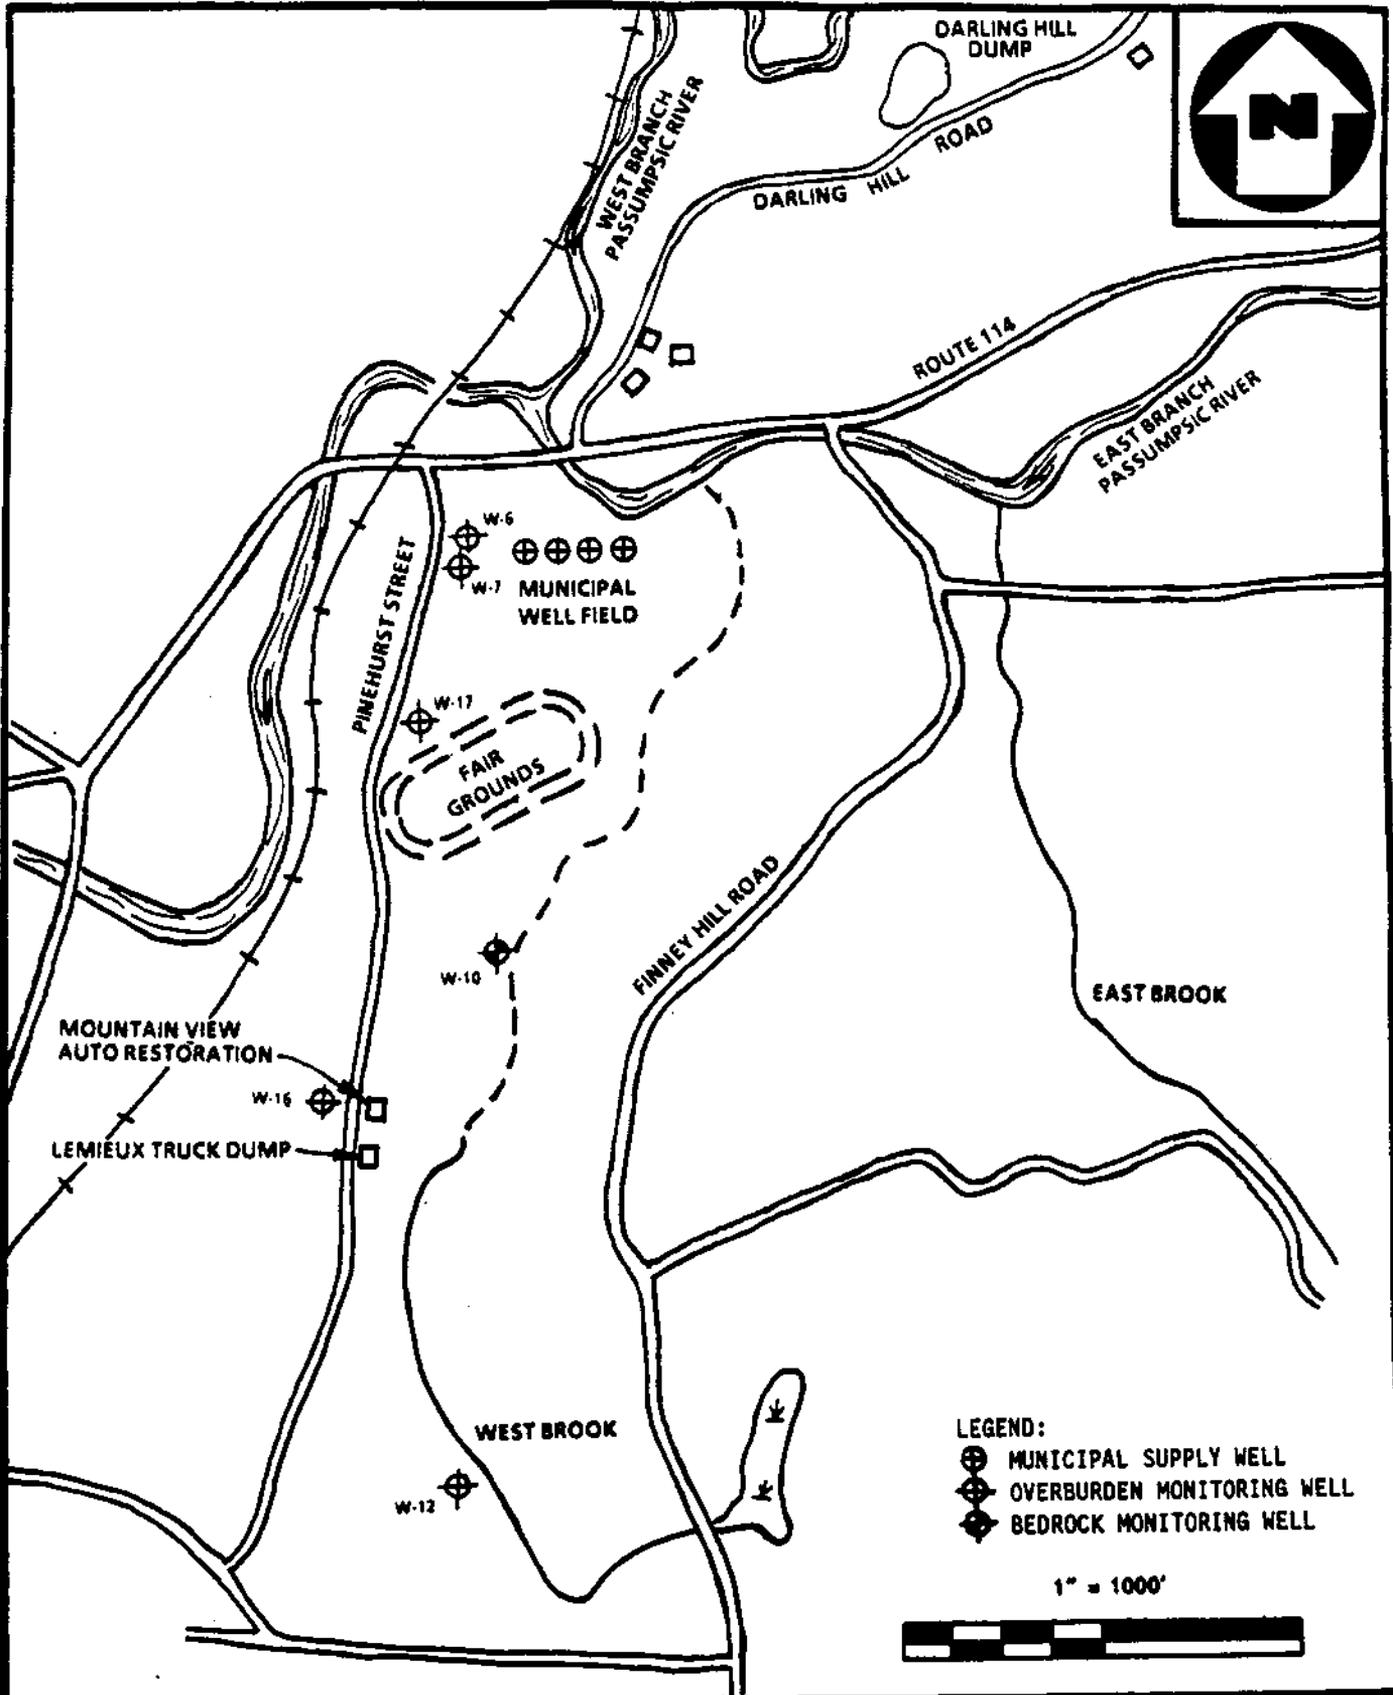
FIGURE 2

A total of 17 groundwater monitoring wells were installed by NUS/FIT during two phases of drilling. Thirteen wells were installed near Darling Hill Dump and four wells were installed near Lemieux Truck Dump/Mountain View Auto Restoration (Figure 2).

All drilling and monitoring well installation for Lemieux Truck Dump/Mountain View Auto Restoration was completed during NUS/FIT Phase 2 drilling (Attachment 2), from March 3 to May 21, 1987. The four wells installed for Lemieux Truck Dump/Mountain View Auto Restoration provided information on soil and groundwater conditions, groundwater potentiometric surface (to determine groundwater flow direction and gradient), depth to and integrity of bedrock, and stratigraphy of the overburden deposits. The well locations are summarized in more detail below and are shown in Figure 2.

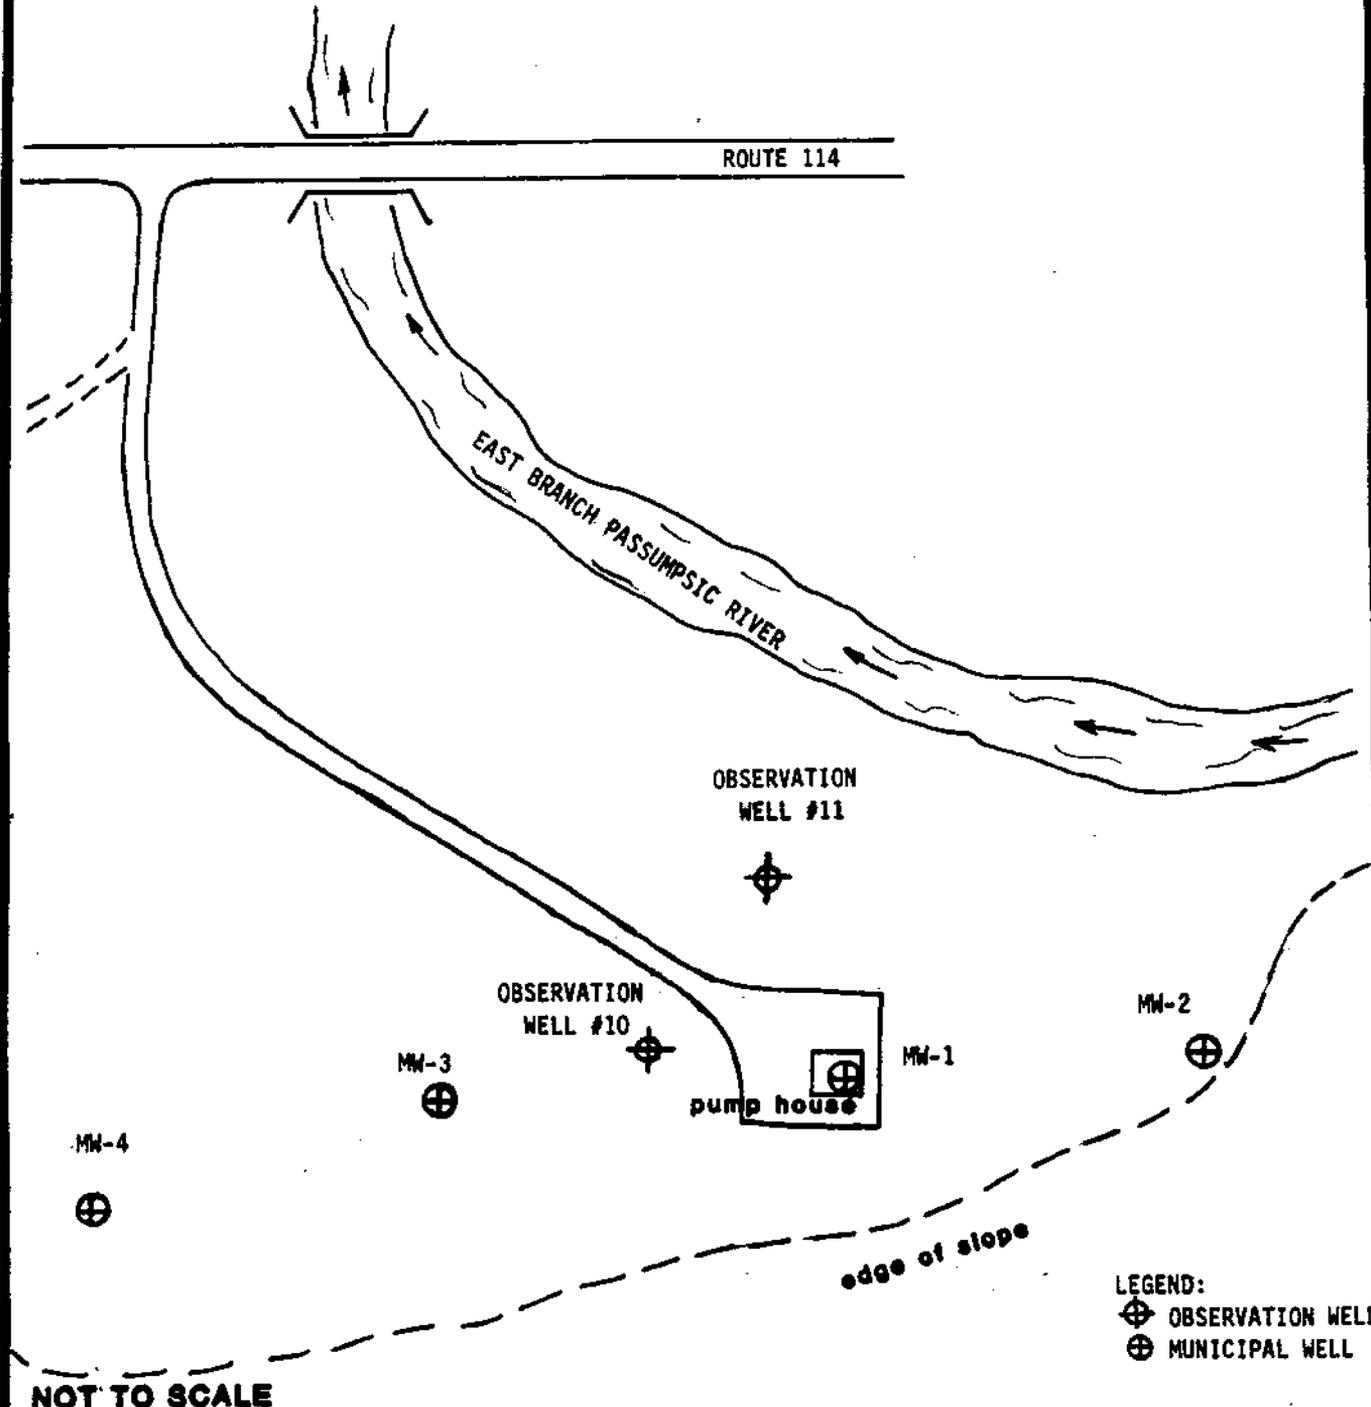
FIGURE 3'

VT DOH also conducted pumping tests of MW-1 and MW-3 in February, 1985 (Figure 3). VT DOH concluded from the tests that pumping from these wells could influence the water level 280 to 470 feet in the western direction and 250 to 300 feet in the eastern direction. The VT DOH included a summary of pumping test results in their 1985 report. The report concluded that buried eskers (elongate stratified glacial drift deposits) might strongly influence groundwater flow in the immediate vicinity of the municipal wells, and that regional groundwater flow was in a southern direction (VT DOH, 1985).

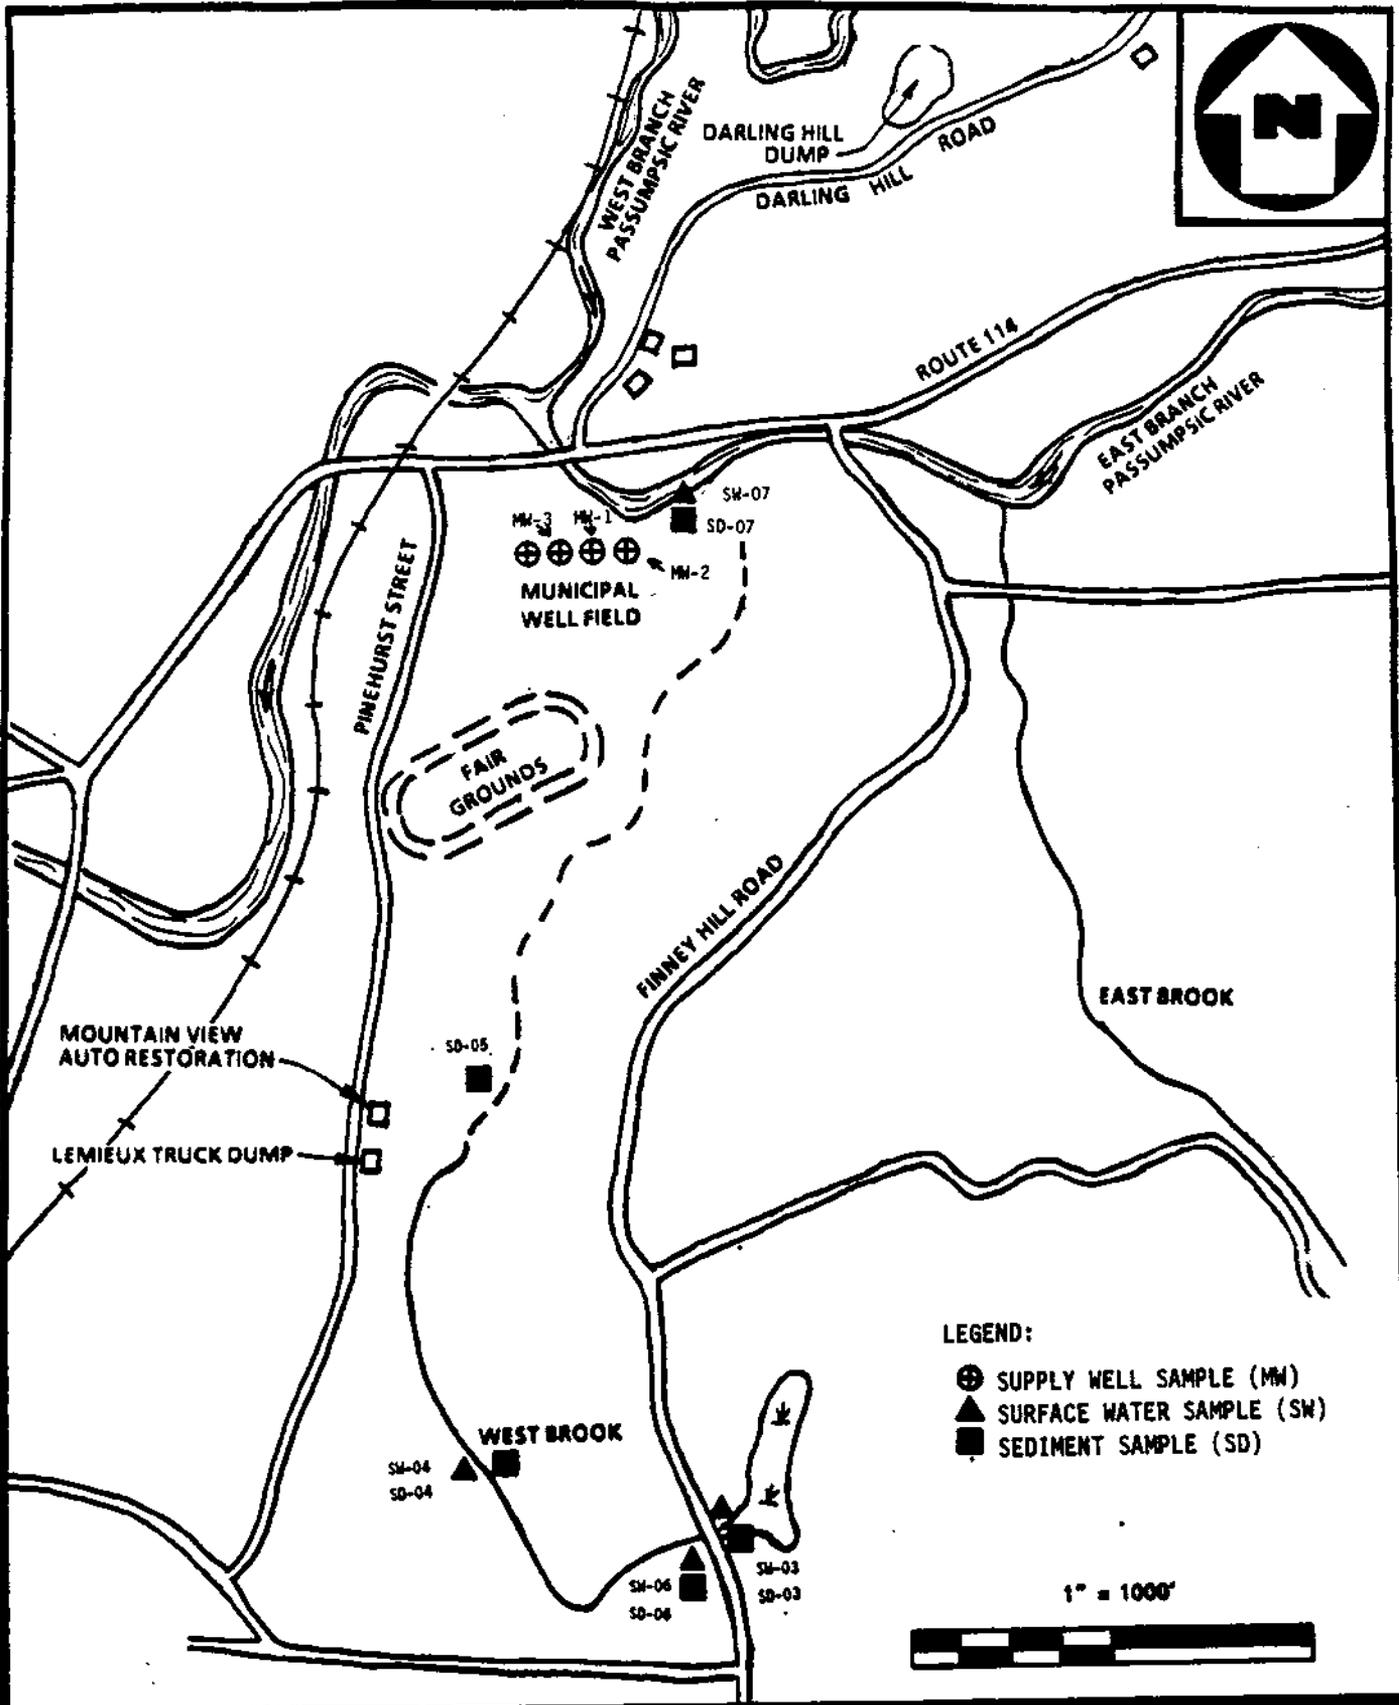
FIGURE 4

collected from West Brook immediately downslope and downstream of the facilities. The sample from location SD-07 was collected from the East Branch Passumpsic River, immediately downstream of where West Brook joins it (Figure 4).

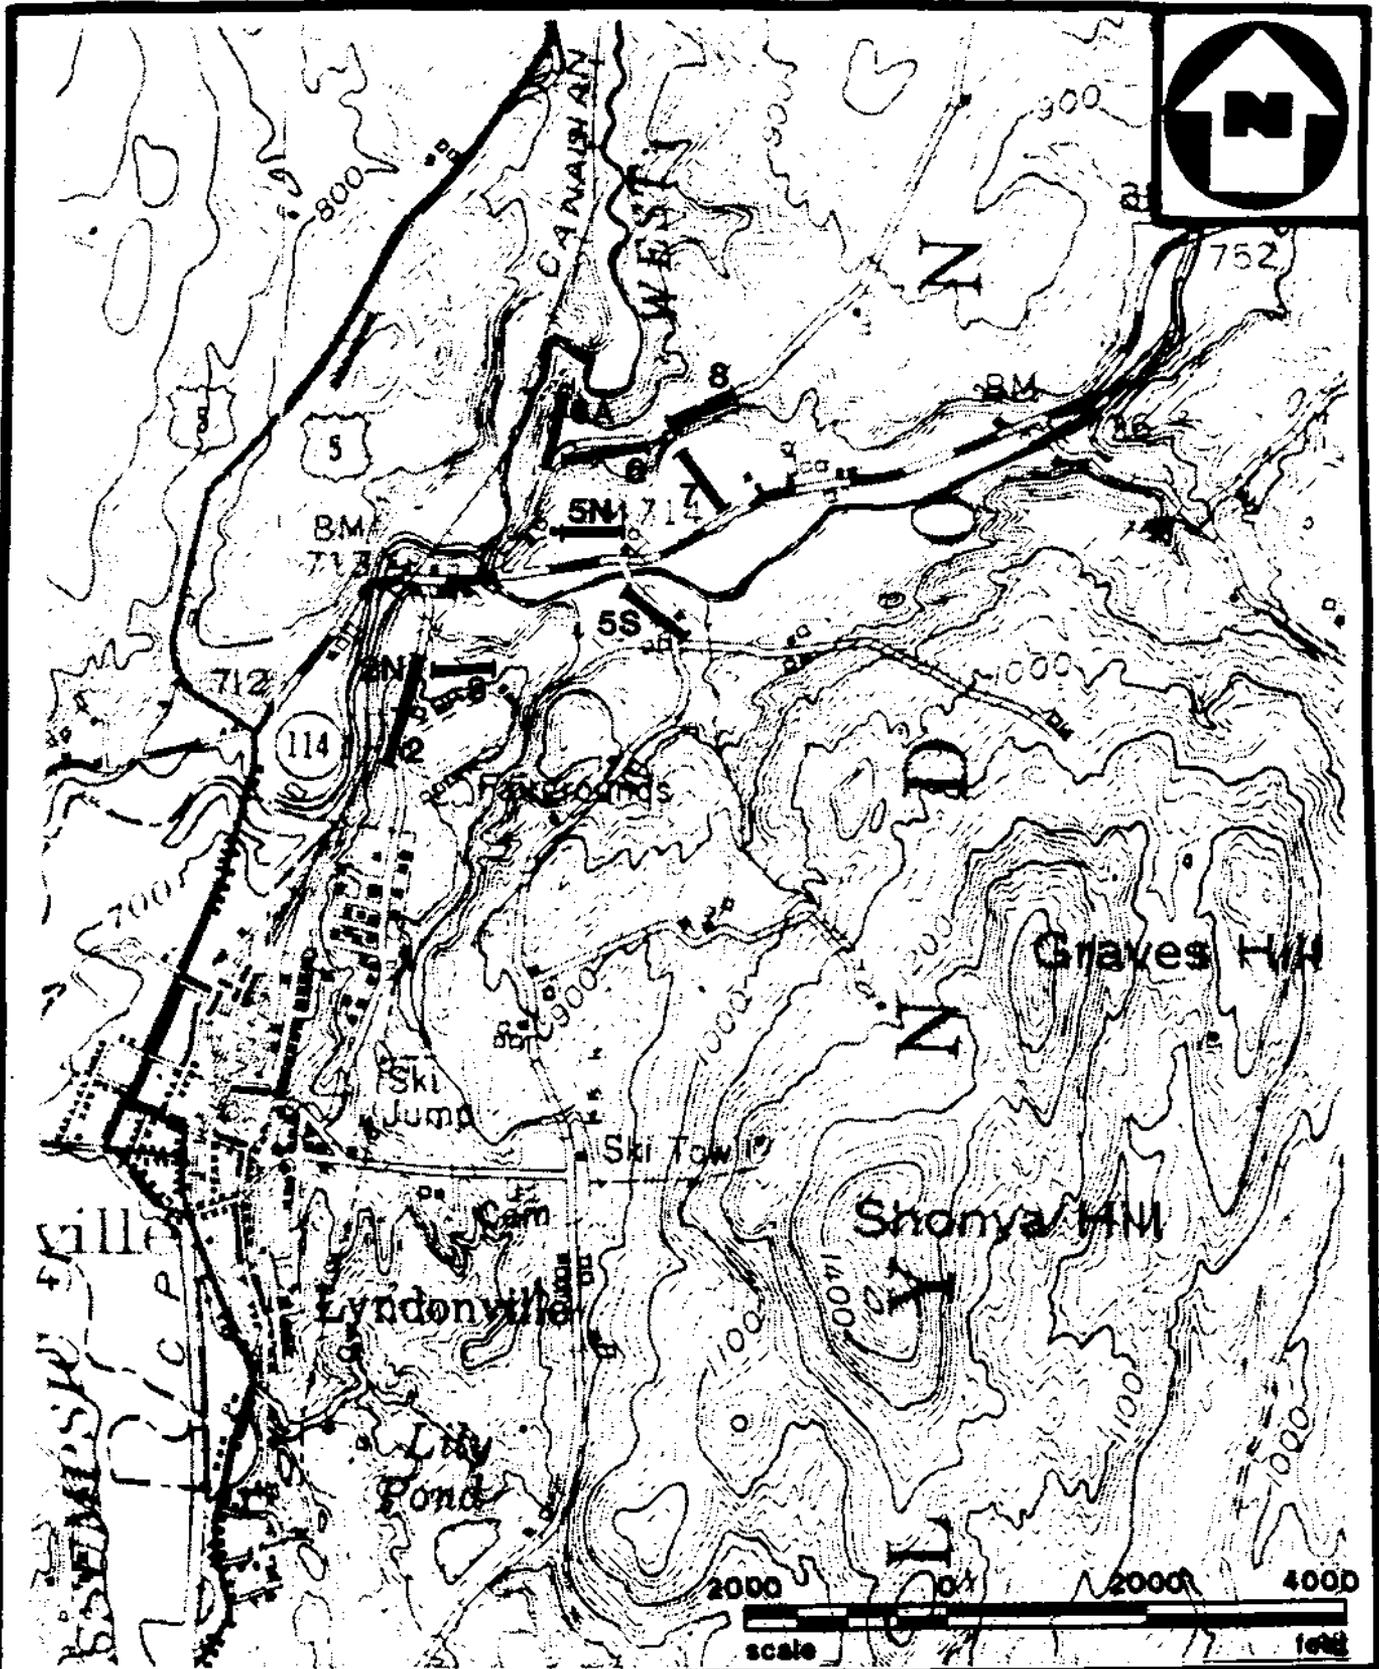
FIGURE 6

Data from seismic lines 2, 2N, and 3 (Figure 6) indicated that the overburden thickness could approach or exceed 200 feet and that significant glacial till, boulder pavement, or clay beds were not present in the vicinity of the facilities.

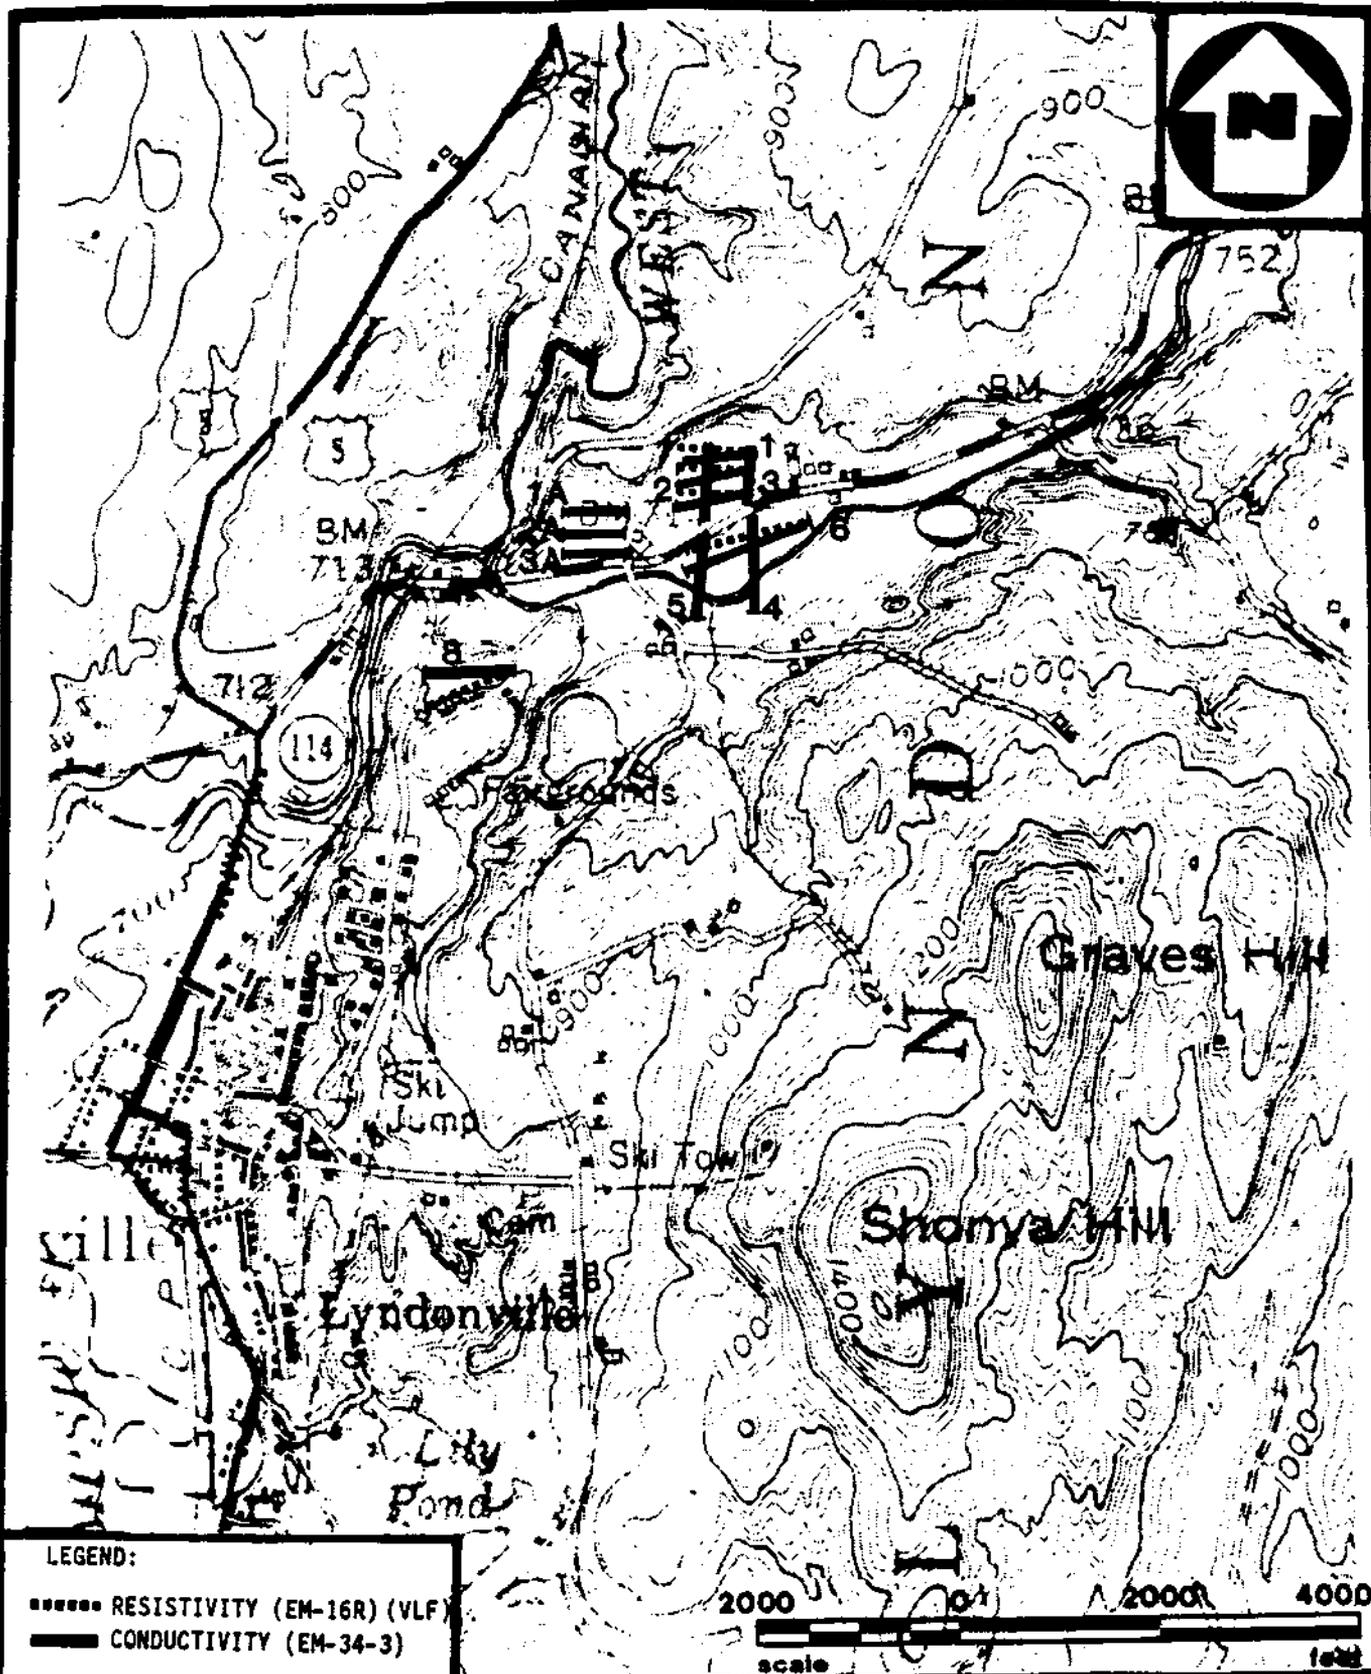
FIGURE 7

An EM resistivity and conductivity survey line (line number 8) was set up about 2,000 feet north of the study area along the northern edge of the fairgrounds (Figure 7). Data collected along this line did not indicate any anomalies which might be attributable to groundwater contamination. Details of the geophysical surveys are discussed further in the Geophysical Task Report (Attachment 1).

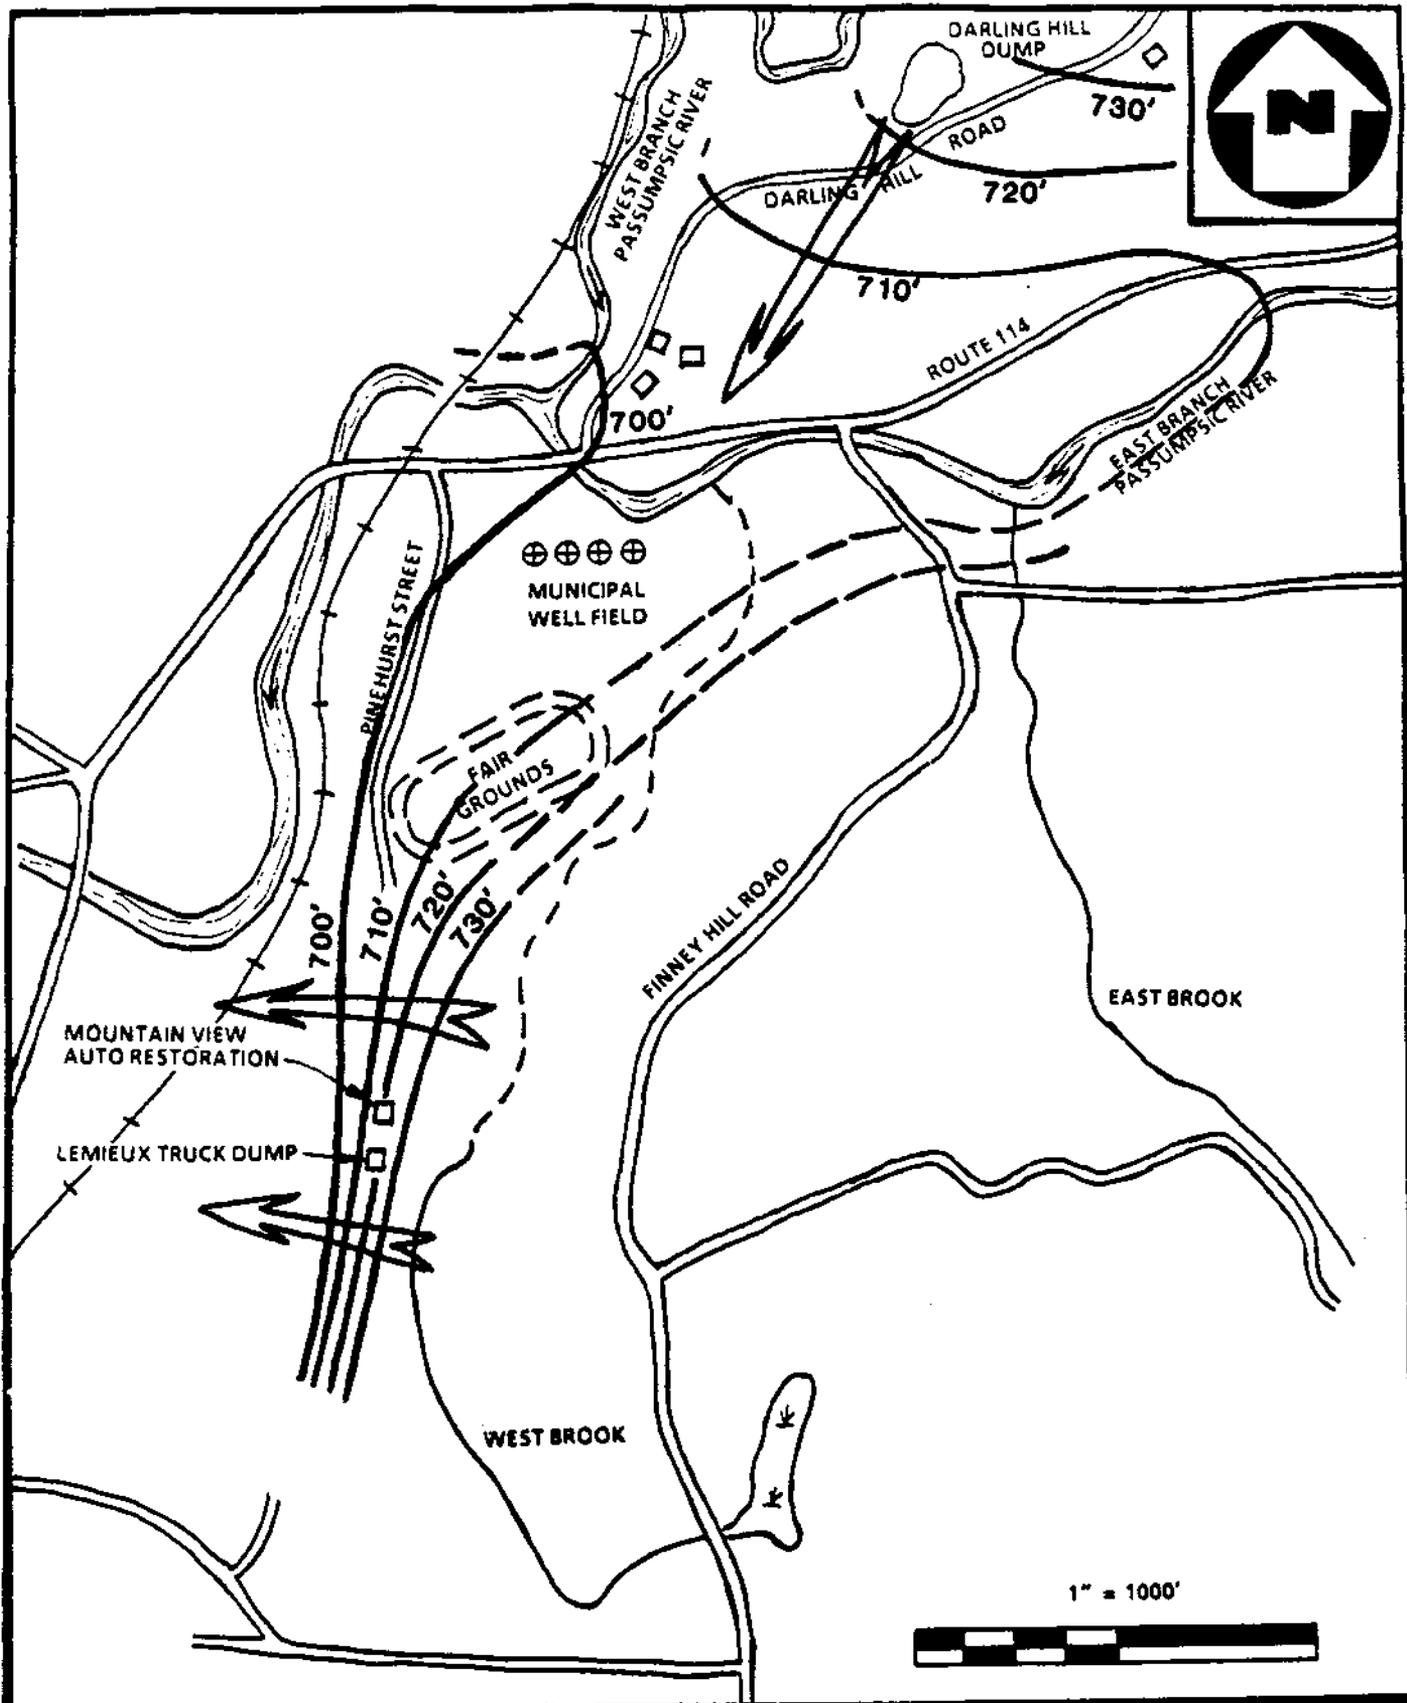
FIGURE 8

Water level measurements (Table 2) taken in September 1987 were used to construct a water table elevation contour map (Figure 8). The dashed lines indicate where contours were projected beyond available data points. Arrows indicate the presumed horizontal direction of groundwater flow. Because water level measurements were not taken from the municipal wells, the shape of the cone of depression in their immediate vicinity was not determined.
