REPORT ON THE INVESTIGATION
OF SUBSURFACE PETROLEUM CONTAMINATION
MIDDLESEX COUNTRY STORE
MIDDLESEX, VERMONT

November 7, 1990

Griffin International, Inc.
Williston, Vermont

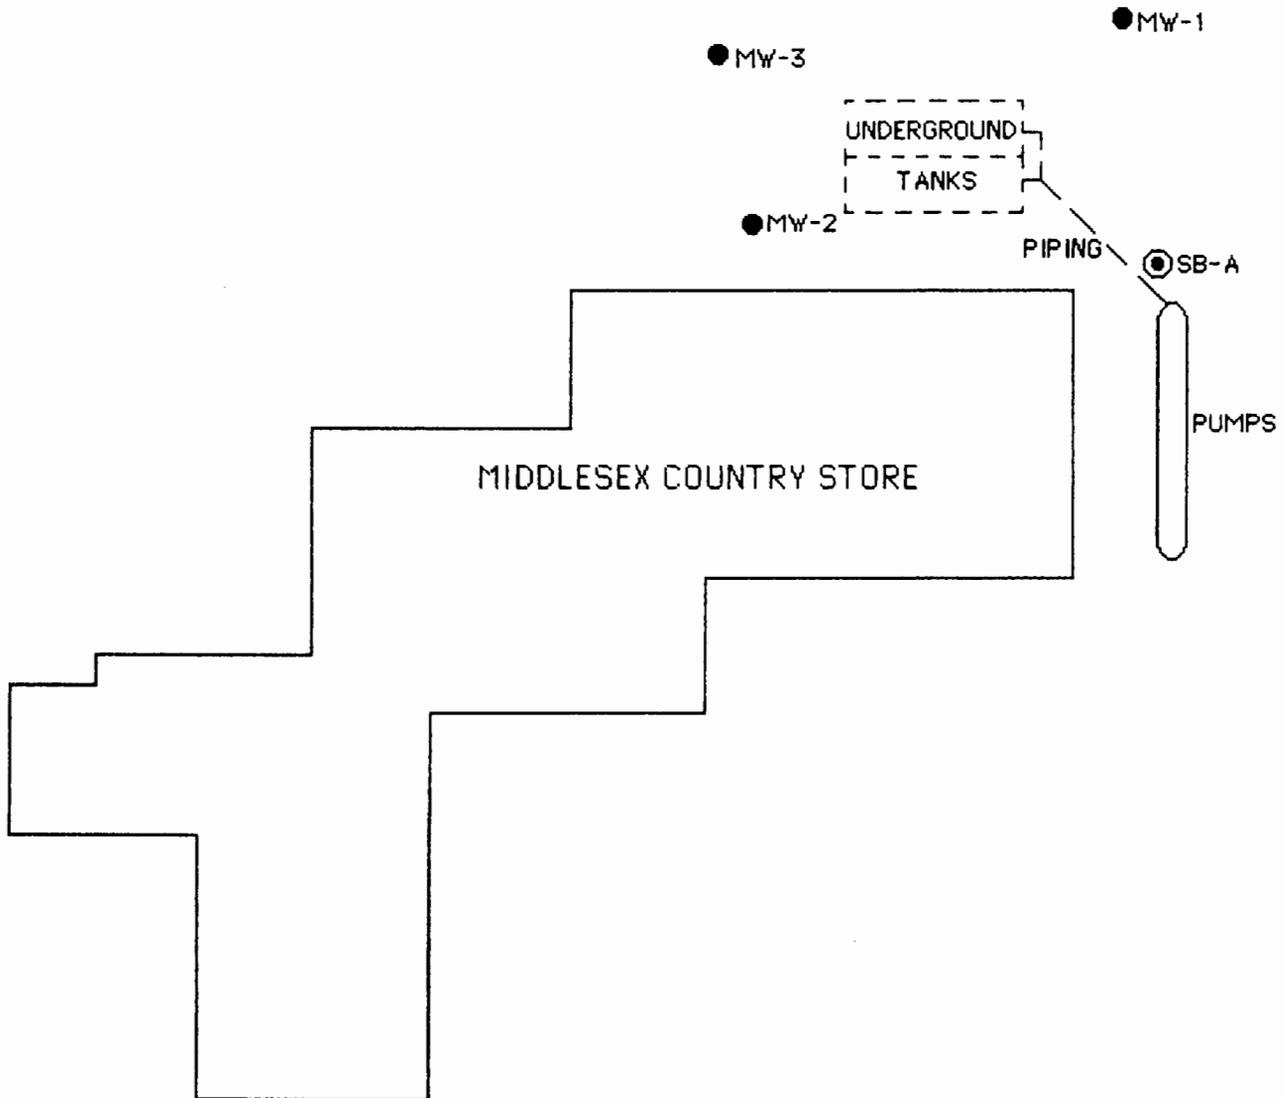
SITE MAP

Drilling for the first borehole, SB-A, was begun on October 10th, 1990 (see Site Map for borehole locations). This hole was drilled to determine if any petroleum contamination exists in the vicinity of the underground piping, between the tanks and the pumps. The borehole was extended to a depth of 23.5 feet, at which point, the augers and split spoon encountered what appeared to be bedrock refusal. Soils collected from the augers and spoons consisted of mostly sand and silt and gravel. The soils contained high concentrations of petroleum hydrocarbon vapors, ranging from 85 ppm to 280 ppm. Since the water table was not reached before encountering refusal, no monitoring well was installed in this borehole.

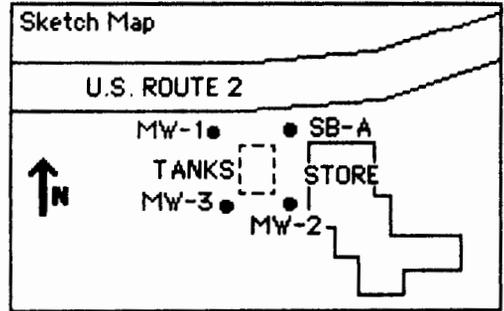
WELL NUMBER SB-A

7. The underground piping, between the tanks and the pump island, may have been leaking. This conclusion is based on the fact that the borehole nearest to the piping contained significant petroleum vapors. Additionally, the piping has never been tested for tightness, as have the tanks.

DEPTH IN FEET	WELL CONSTRUCTION	NOTES	BLOWS PER 6" OF SPOON	DESCRIPTION / SOIL CLASSIFICATION (COLOR, TEXTURE, STRUCTURES)
0	CONCRETE			
1	BENTONITE			
2				HEAVY PETROLEUM ODOR AT 2' - 220 PPM Fine, dry SAND, some silt and gravel
3				
4				
5			10,15,7,6	
6				HEAVY PETROLEUM ODOR - 210 PPM Dry, light brown, fine SAND and SILT, some gravel
7	NATIVE BACKFILL			
8				
9				
10			18,21,14,10	
11				HEAVY PETROLEUM ODOR - 145 PPM Dry, fine to coarse SAND and fine to coarse, well rounded GRAVEL
12				
13				
14				
15			19,22,14,15	
16				HEAVY PETROLEUM ODOR - 280 PPM Coarse, subrounded GRAVEL, some coarse sand
17				
18				
19				
20			25,33,72 -	
21				PETROLEUM ODOR - 85 PPM Dry, red, coarse SAND and coarse GRAVEL
22				
23				BASE OF EXPLORATION AT 23.5'
24				
25				BEDROCK
26

1. To fully define the extent of the contamination in the vicinity of the piping and pump island, we recommend that several additional soil borings/monitoring wells be installed in their vicinity.

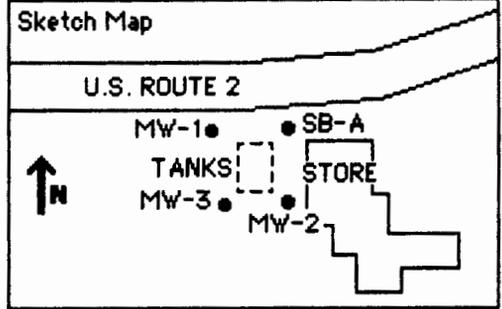
WELL NUMBER MW-1

on a line between the tanks and the affected supply wells across the street. This well was installed to determine if possible contamination, originating from the tanks, was flowing to the wells, via the overburden. The borehole was extended to a depth of 27 feet. Soils retrieved from this borehole consisted of sand, silt and gravel. Very fine, wet sand was encountered at approximately 22 feet. A slight petroleum odor, measured at 13 ppm with the PID, was detected in the soils near the water table. A well was installed in this borehole. The well is constructed of ten feet of screen and fourteen feet of casing. Attempts to install the bottom of the screen at 27 feet were prevented by running sands. The bottom of the screen is currently two feet below the water table.

DEPTH IN FEET	WELL CONSTRUCTION	NOTES	BLOWS PER 6" OF SPOON	DESCRIPTION / SOIL CLASSIFICATION (COLOR, TEXTURE, STRUCTURES)
0		ROAD BOX CONCRETE CAP		
1		BENTONITE		Light brown, fine SAND, some silt NO PETROLEUM ODOR - 0.1 PPM
2		WELL CASING		
3				
4			4,4,4,4	
5				Dry, very fine SAND and SILT NO PETROLEUM ODOR - 0.2 PPM
6				
7				
8		NATIVE BACKFILL		
9				
10			1,8,11,17	
11				Medium to coarse SAND, some gravel, little silt NO PETROLEUM ODOR - 0.1 PPM
12				
13				
14			96,26,17,15	
15				Medium to coarse SAND, GRAVEL and COBBLES, little silt VERY SLIGHT PETROLEUM ODOR - 1 PPM
16				
17		WELL SCREEN		
18				
19		GRAVEL PACK		Fine, moist SAND, little silt SLIGHT PETROLEUM ODOR - 13 PPM
20			8,10,10,12	
21				
22				
23				WATER TABLE
24				Wet, very fine SAND, some silt NO PETROLEUM ODOR
25		BOTTOM PLUG		
26		NATIVE BACKFILL	2,6,8,11	
				BASE OF EXPLORATION AT 27'

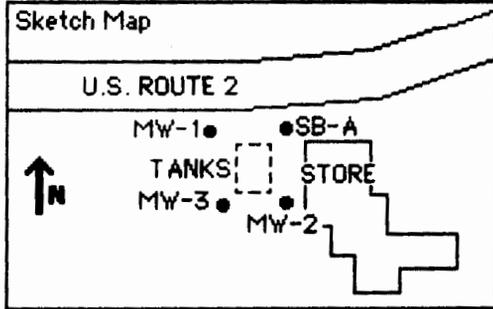
WELL NUMBER MW-2

MW-2 was installed on October 12th, in a location which was assumed to be immediately downgradient of the two, underground storage tanks. The borehole for this well was drilled to a depth of 24.5'. Soils encountered in this borehole consisted of sand, silt and gravel. No petroleum vapors were detected in these soils. The well was constructed of 10 feet of screen and 14 feet of casing. The bottom of the screen is currently 5 feet below the water table.

DEPTH IN FEET	WELL CONSTRUCTION	NOTES	BLOWS PER 6" OF SPOON	DESCRIPTION / SOIL CLASSIFICATION (COLOR, TEXTURE, STRUCTURES)
0	ROAD BOX CONCRETE CAP			
1	BENTONITE			Wet, brown, fine SAND and SILT, little clay
2	WELL CASING			NO PETROLEUM ODORS
3				
4			5,4,4,5	
5				
6				
7	NATIVE BACKFILL			
8				Moist, fine SAND and SILT NO PETROLEUM ODORS
9				
10			18,10,6,11	Moist, fine SAND and SILT, some gravel
11				
12				Moist, medium to coarse SAND, some well rounded gravel NO PETROLEUM ODOR
13				
14				
15			34,26,30,15	Moist, medium to coarse SAND and GRAVEL
16	WELL SCREEN			
17				
18	GRAVEL PACK			Moist, light brown, fine SAND, some silt NO PETROLEUM ODORS
19				
20			6,7,10,7	WATER TABLE ▼
21				Wet, fine SAND, little silt NO PETROLEUM ODORS
22				
23				
24				
25	BOTTOM PLUG			BASE OF EXPLORATION AT 24.5'
26

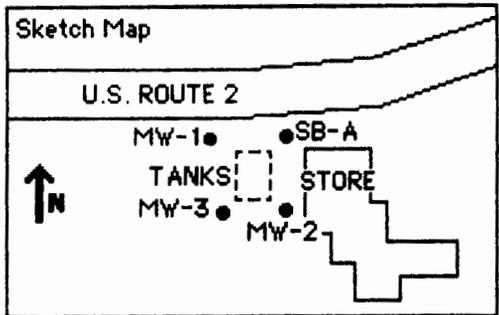
WELL NUMBER MW-3

MW-3 was also drilled in a location which was assumed to be downgradient of the tanks. The borehole for this well was advanced to a depth of 25.5 feet. Soils encountered in this hole consisted of sand and silt. No petroleum vapors were detected in these soils. The well is constructed of 10 feet of screen and 15 feet of casing. The bottom of the screen is currently 7.5 feet below the water table.

DEPTH IN FEET	WELL CONSTRUCTION	NOTES	BLOWS PER 6" OF SPOON	DESCRIPTION / SOIL CLASSIFICATION (COLOR, TEXTURE, STRUCTURES)
0		ROAD BOX CONCRETE CAP		
1		BENTONITE		Dark brown TOPSOIL; wet, fine SAND and SILT, little clay
2		WELL CASING		
3				
4		NATIVE BACKFILL		
5				
6				Dry, light brown SAND and SILT
7				NO PETROLEUM ODORS
8				
9				
10			10,18,23,19	Dry, medium to coarse SAND and GRAVEL
11				NO PETROLEUM ODORS
12				
13				
14				
15			14,14,10,10	Moist, fine SAND, some silt
16				
17				
18		WELL SCREEN		WATER TABLE ▼
19		GRAVEL PACK		NO PETROLEUM ODORS
20			3,2,4,6	Wet, fine SAND, some silt
21				NO PETROLEUM ODORS
22				
23				
24				
25		BOTTOM PLUG		BASE OF EXPLORATION AT 25.5'
26
