Re: Bank of Vermont/Gleason Site, Route 103, Rockingham, Vermont

GLEASON SITE INVESTIGATION

PHASE II HYDROGEOLOGIC INVESTIGATION

GLEASON SITE; ROCKINGHAM-VT

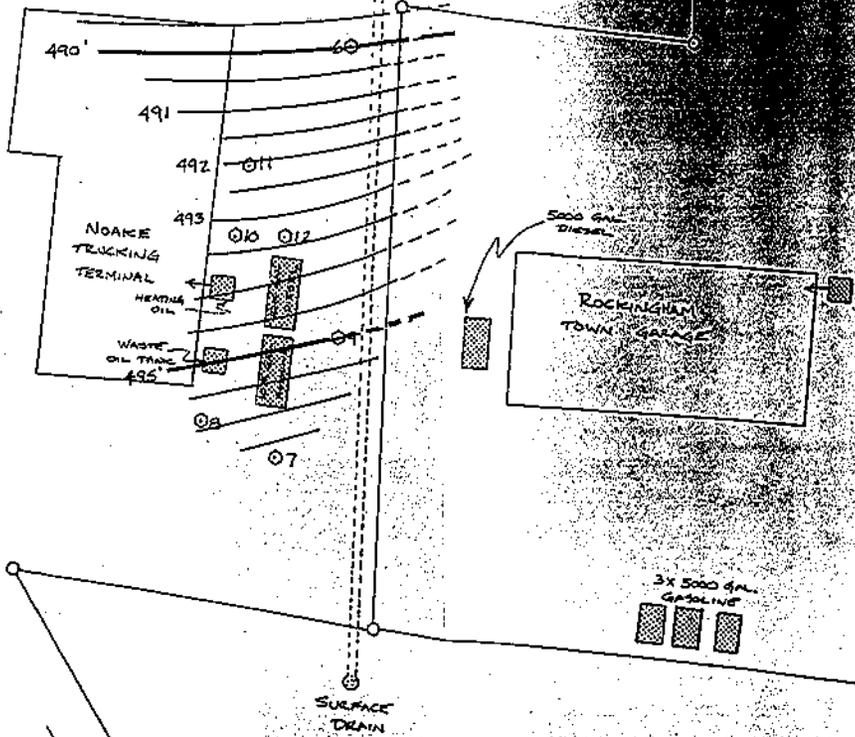
MONITOR WELL LOCATIONS
 WATER TABLE MAP

7. The detailed water table map developed from Phase II monitor well data indicates groundwater flow to be in a north-northwesterly direction. Given such flow conditions, monitor wells 10, 11, and 12 are located directly downgradient from all possible on-site contaminant sources. These wells show no sign of groundwater contamination. Monitor well 6 is located out of the primary flow path from the on-site petroleum storage facilities. However, it is directly downgradient of the underground diesel and gasoline storage tanks on the adjoining property.

Given the flow direction and generally acceptable quality of groundwater in and around the re-fueling area, it appears that the contaminants noted in monitor well 6 are derived from an off-site source. Only through pressurized tank testing and subsurface evaluation of the neighboring Town owned property will the exact source(s) and extent of this contamination be known.
