HOFFER & ASSOCIATES CONSULTING HYDROGEOLOGISTS

August 18, 1997

Re: Site Investigation Report, Walden Town Garage, Walden, Vermont
SMS Site #88-0168

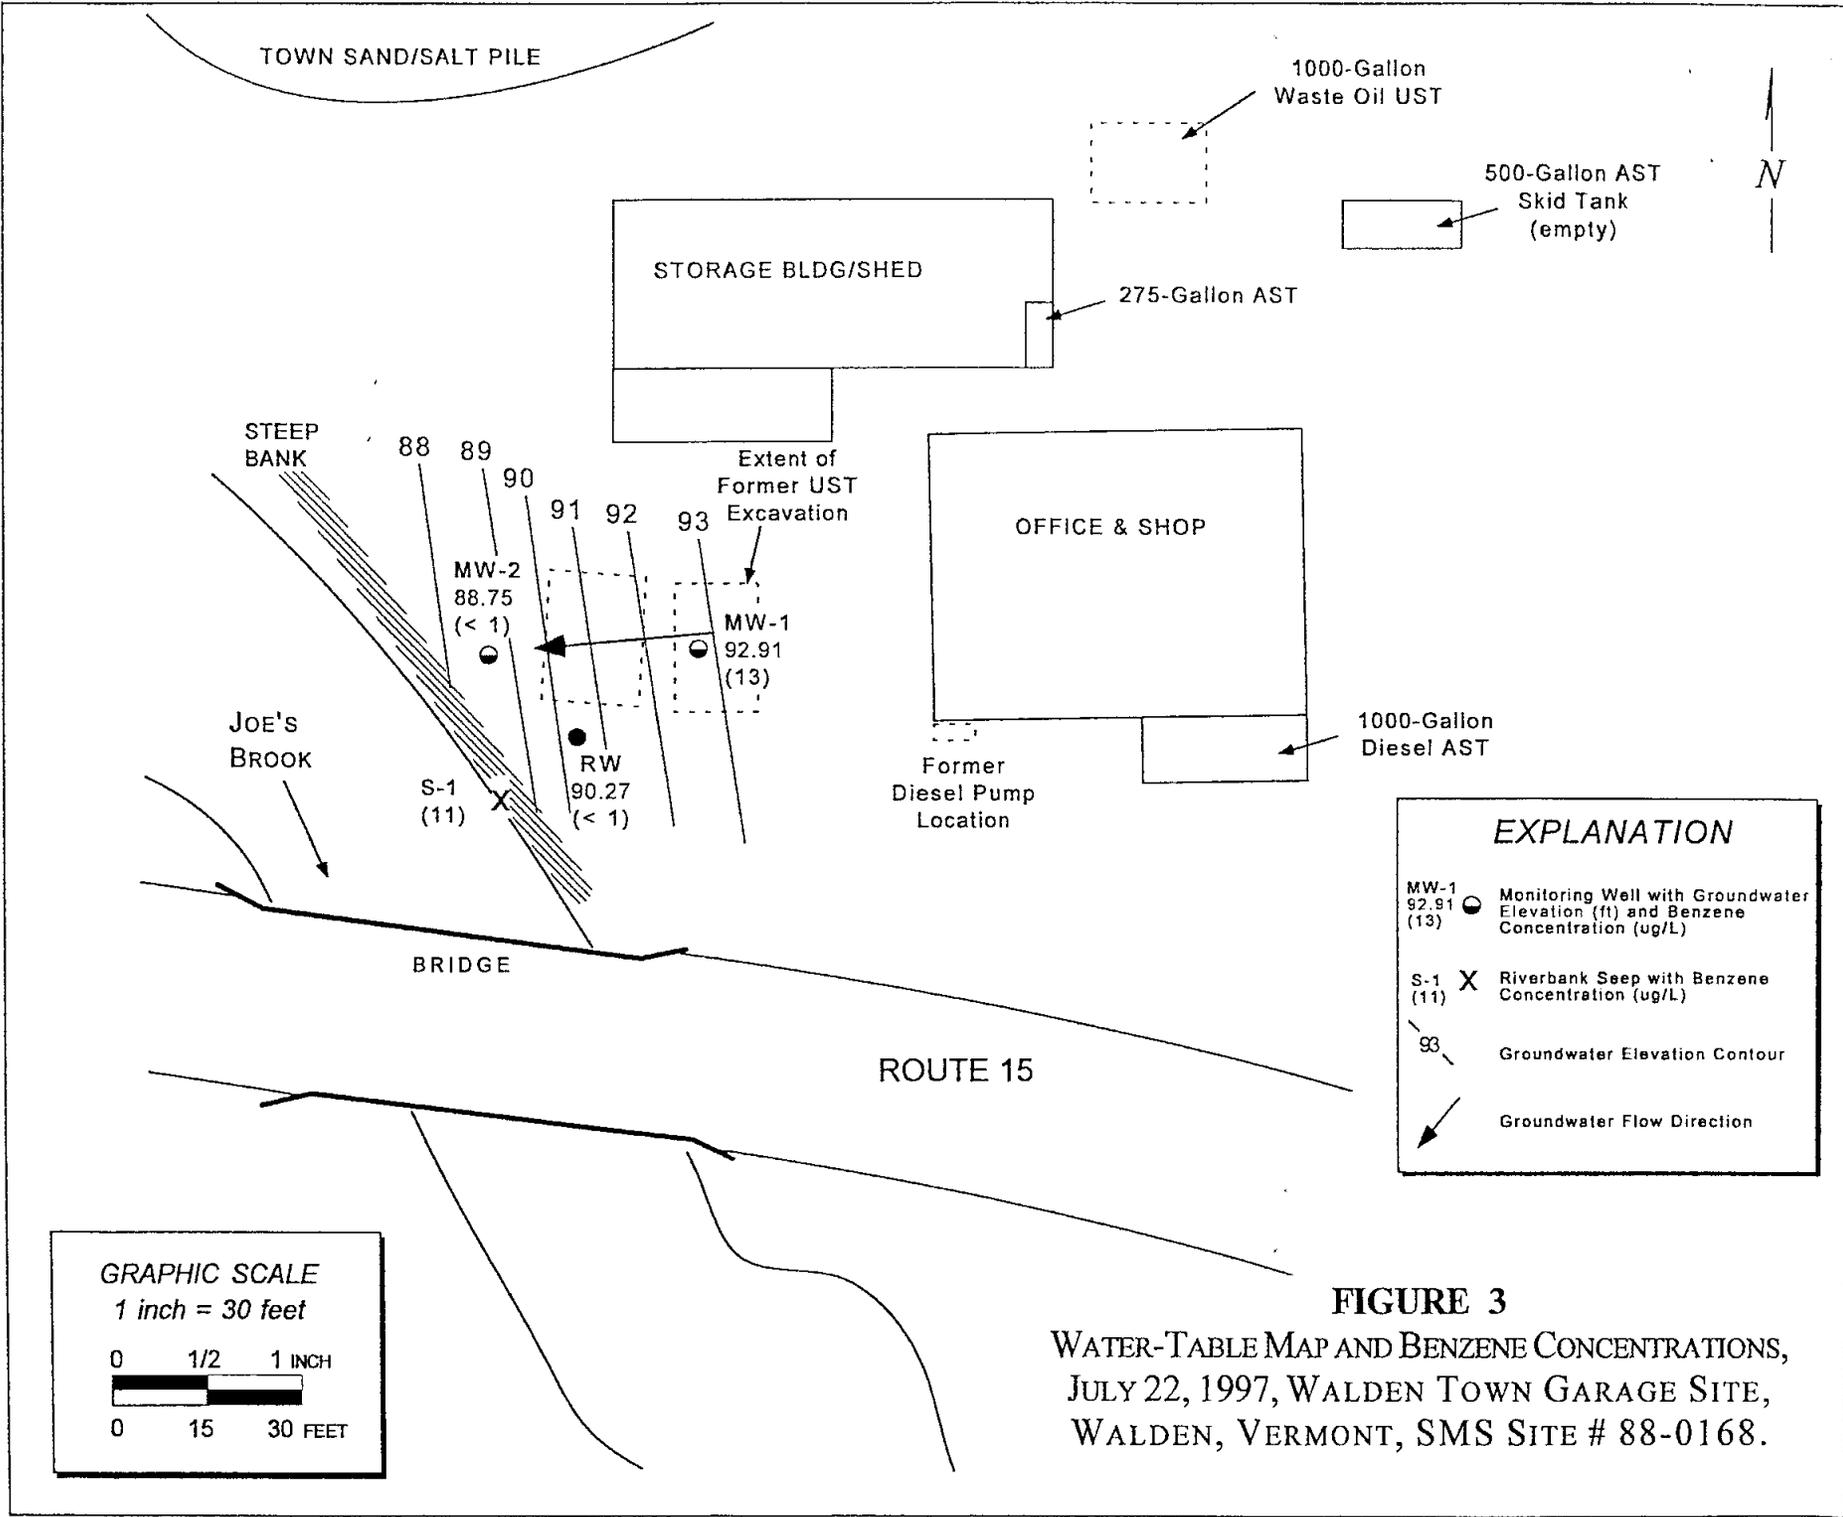
FIGURE 2
 SITE BASEMAP,
 WALDEN TOWN GARAGE SITE,
 WALDEN, VERMONT, SMS SITE # 88-0168.

Water levels in the wells were recorded using an interface probe to detect the presence of floating free-phase product. No product was encountered. Water levels ranged from 7.0 to 9.5 feet below the ground surface within these three wells, which are positioned fairly close together. A level survey of the well casing lips was performed in order to construct a water table contour map (see Table 1). Figure 3 presents this map showing westerly flow from the UST area into Joe's Brook. This flow direction is not surprising given the close proximity of this brook, and the history of free product discharging into it. A moderately steep hydraulic gradient of 0.13 ft/ft has been measured. The westerly flow path is consistent with previous information.

A reconnaissance was performed on July 22, 1997 along the streambed and bank of Joe's Brook where free product had been observed seeping from the riverbank during the UST closure in 1996. This area is directly downgradient from the former USTs and wells. The bank drops steeply approximately 14 feet to the brook (see Figure 2). Although no sheens were present, stained soils were observed and, when disturbed, sheens appeared in the water and moderately strong petroleum odors were detected. The area of staining extended for approximately 10 feet along the waters edge. As such, a sample of the riverbank sediment pore water was obtained.
