ATLANTIC TESTING LABORATORIES, LIMITED

November 10, 1989

Re: Supplementary Subsurface Investigation
Boutin Beverage
Fairfax, Vermont
ATL Project No. VTCD1021-1-11-89

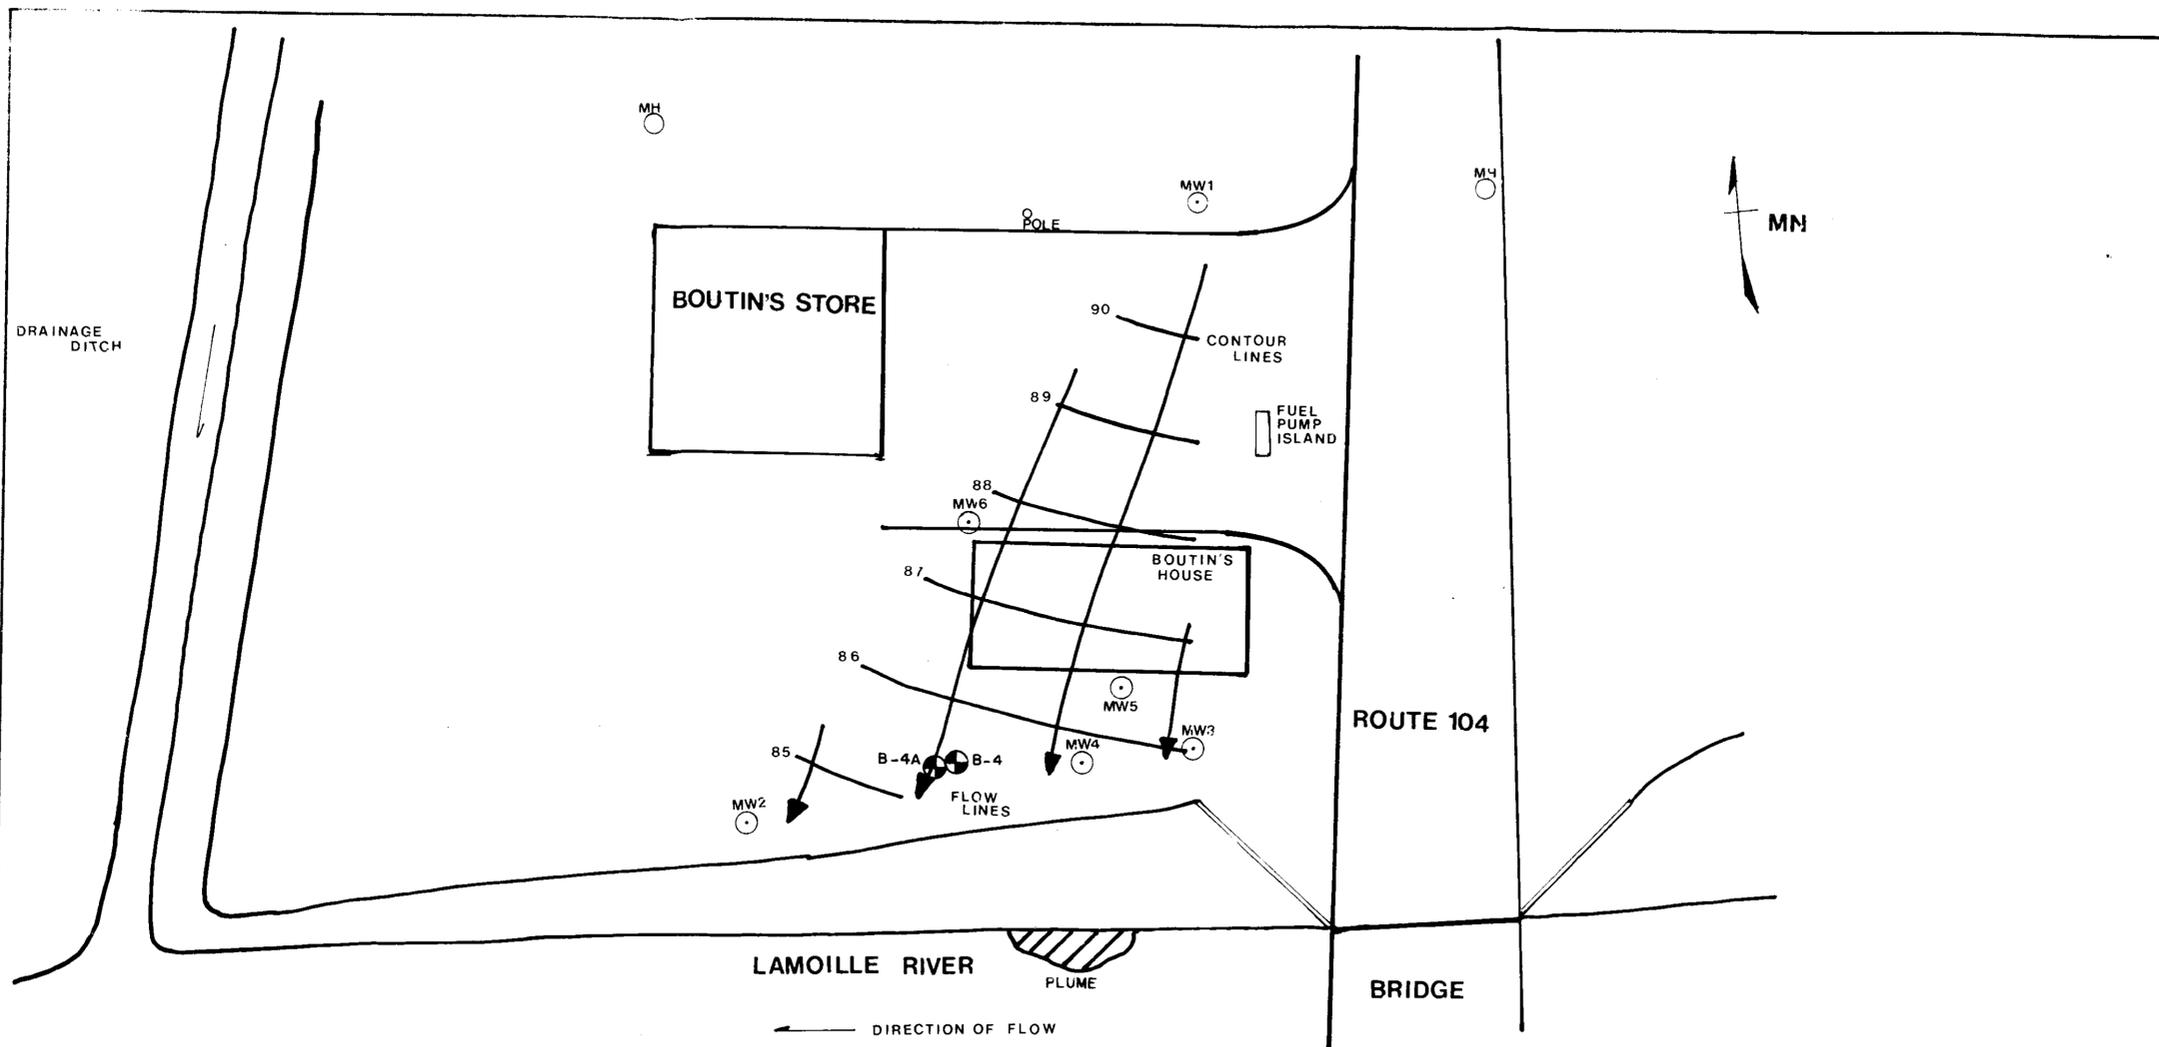
REV.	DESCRIPTION	DATE	PROJECT NUMBER	DRF/TAC	GROUND WATER FLOW MAP BOUTIN'S - FAIRFAX, VERMONT PREPARED FOR VERMONT D.E.C.
				1"=20'	BY ATLANTIC TESTING LABORATORIES, LIMITED P.O. BOX 903 WILLISTON, VERMONT 05495 TEL. 802-860-1298
				9/22/89	
			VTCD1021-1-8-89

An oil interface tape was used to determine if measurable quantities of free product were present in the wells and to obtain groundwater measurements. The tape did not indicate the presence of any measurable free-product in any of the wells even though odors were present in MW-6. Consolidation of the groundwater measurements indicate groundwater elevations at respective well locations have not changed to any significant degree since the preparation of the flow map dated September 22, 1989. The flow direction based on these measurements is also consistent.

- 1). Groundwater contours shown above are interpolations between groundwater elevation data obtained from the six (6) monitoring wells on September 7, 1989 at the direction of the State of Vermont Department of Environmental Conservation.

- 2). The full basement in the Boutin House is above the groundwater table and is expected to have a negligible effect on groundwater flow.
- 3). The underground storage tanks associated with the Fuel Pump Island shown above are outside the area encompassed by the 6 monitoring wells and is expected to have a negligible effect on groundwater flow.
