REPORT ON THE INVESTIGATION  
OF SUBSURFACE PETROLEUM CONTAMINATION  
TAYLOR AUTOMOTIVE  
BARTON, VERMONT

August, 1990

Griffin International  
2B Dorset Ln.  
Williston, Vermont

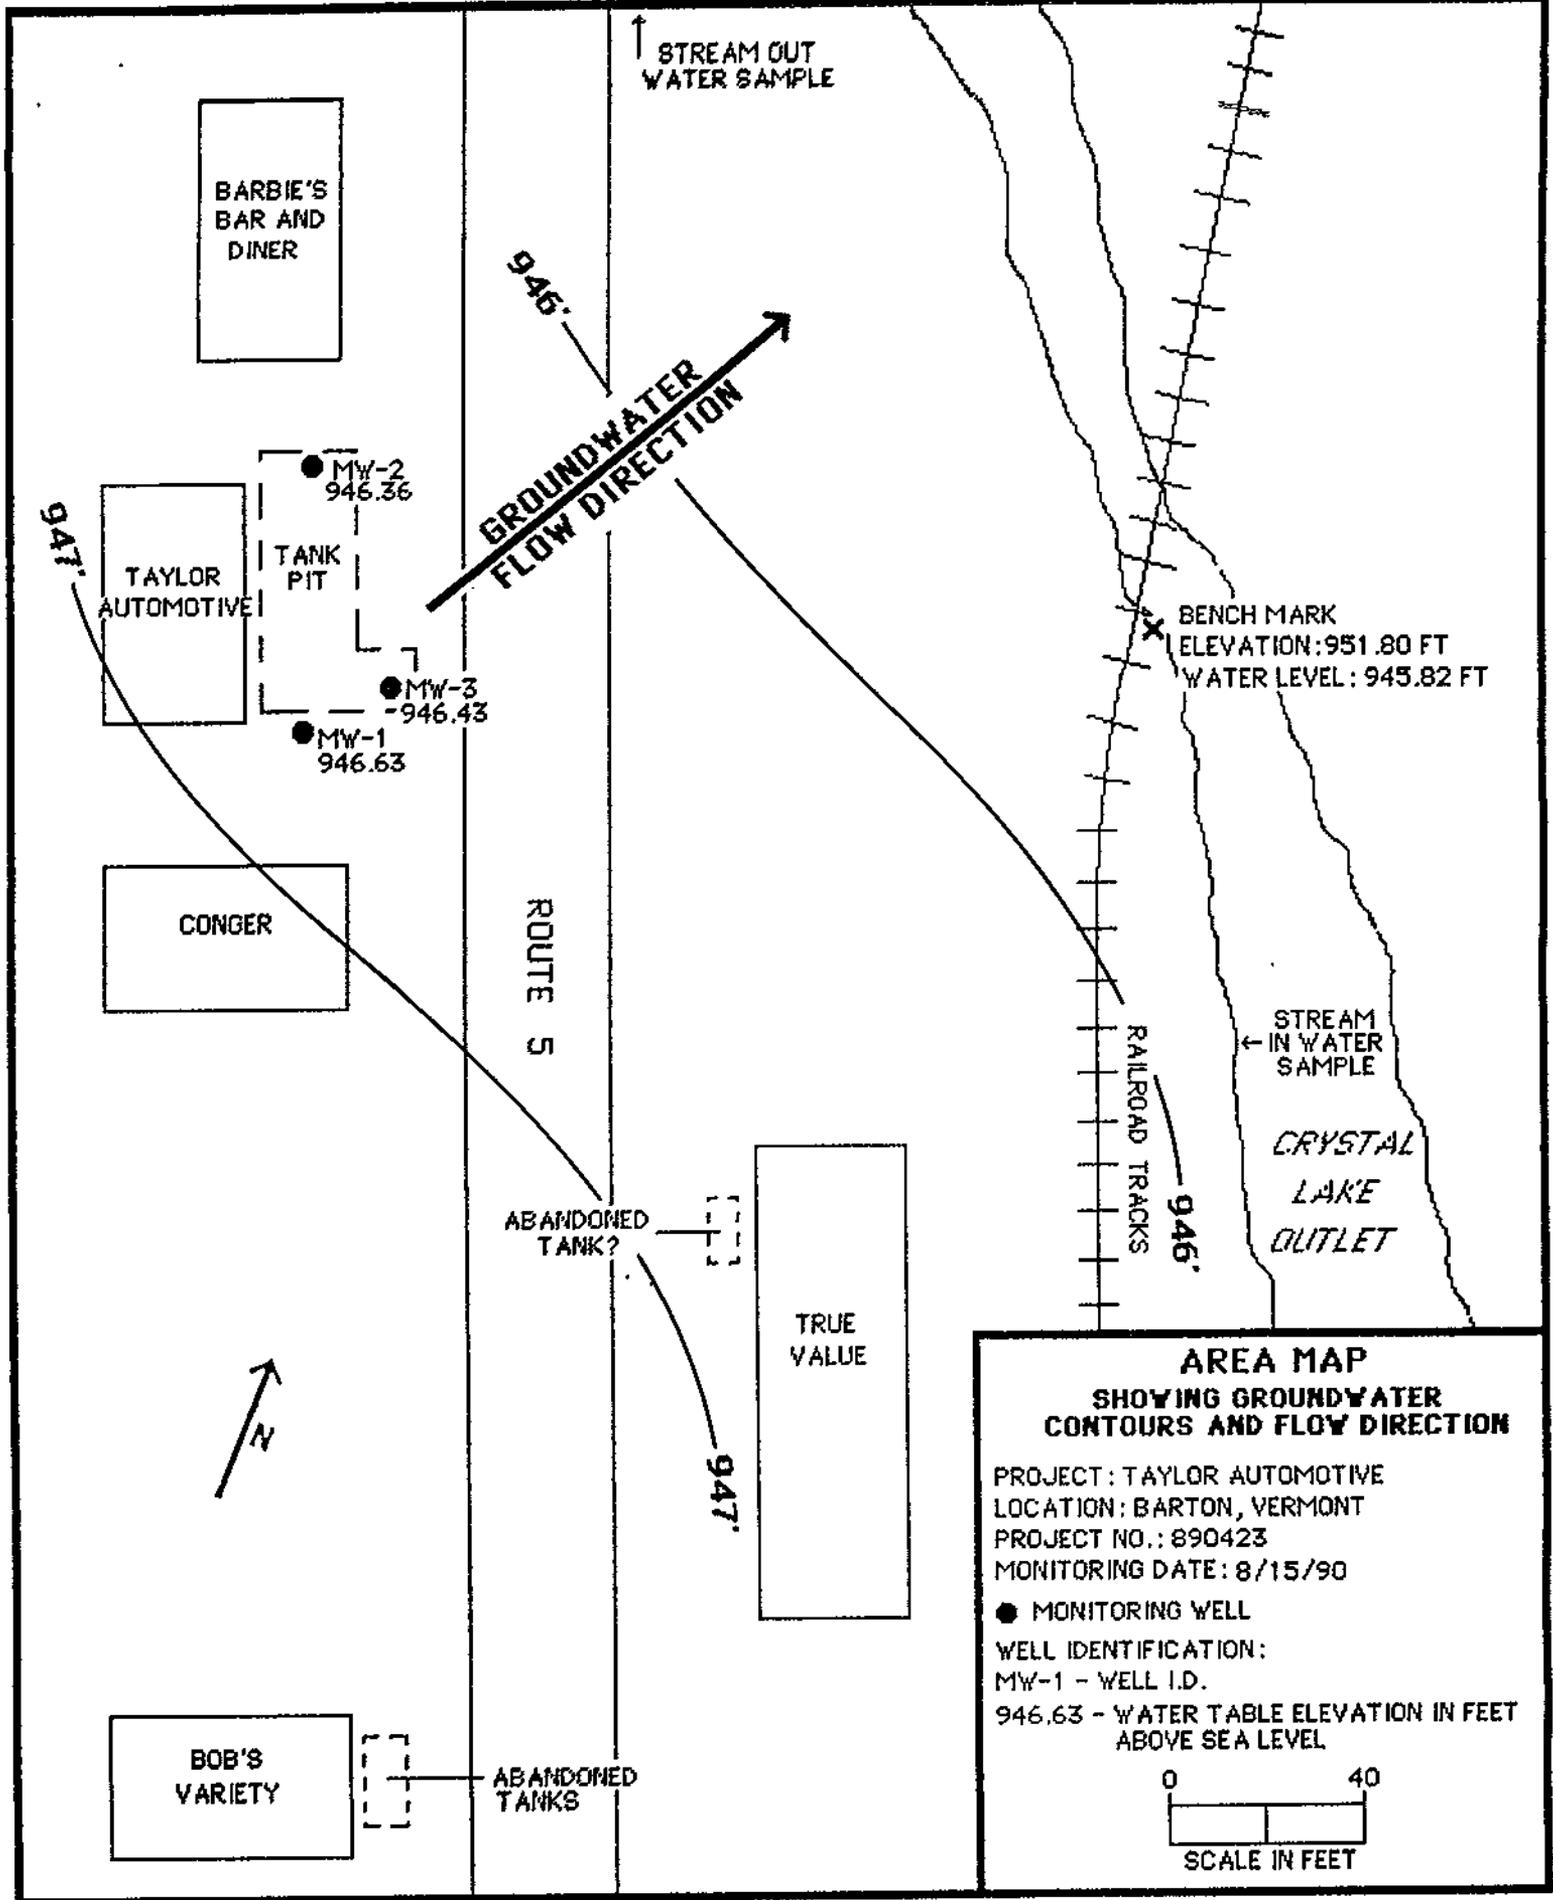
Area Map

In addition to Taylor Automotive, there are at least two other establishments in the immediate area that are believed to have underground storage tanks on the premises. These establishments are Bob's Variety and True Value. The locations of these establishments are illustrated on the Area Map, in Appendix A. All of these tanks have been abandoned for several years and are not believed to be contributing to the subsurface contamination

Three groundwater monitoring wells were installed in the tank pit by Wyman's on August 9th. The PVC wells were placed in the bottom of the tank pit, which was then backfilled. The wells extend to a depth of fifteen feet below grade and are screened to a depth of two feet below grade. The wells were completed with eight inch diameter road boxes which were grouted in place for security and to provide an adequate seal to prevent downhole migration of surface contamination. The locations of the wells are illustrated on the Site Map, in Appendix A.

On August 15th, water table elevations, as well as the water level in the Crystal Lake outlet, were measured relative to mean sea level for the purpose of determining groundwater flow direction across the site. The Area Map, in Appendix A illustrates groundwater contours and flow direction which is to the north east. The groundwater gradient in the vicinity of Taylor Automotive is approximately 0.9%.
