**MANCHESTER MOTORS**  
**Manchester, Vermont**

**EXPANDED PHASE II ENVIRONMENTAL SITE ASSESSMENT**  
**AUGUST 1992**

**August 25, 1992**

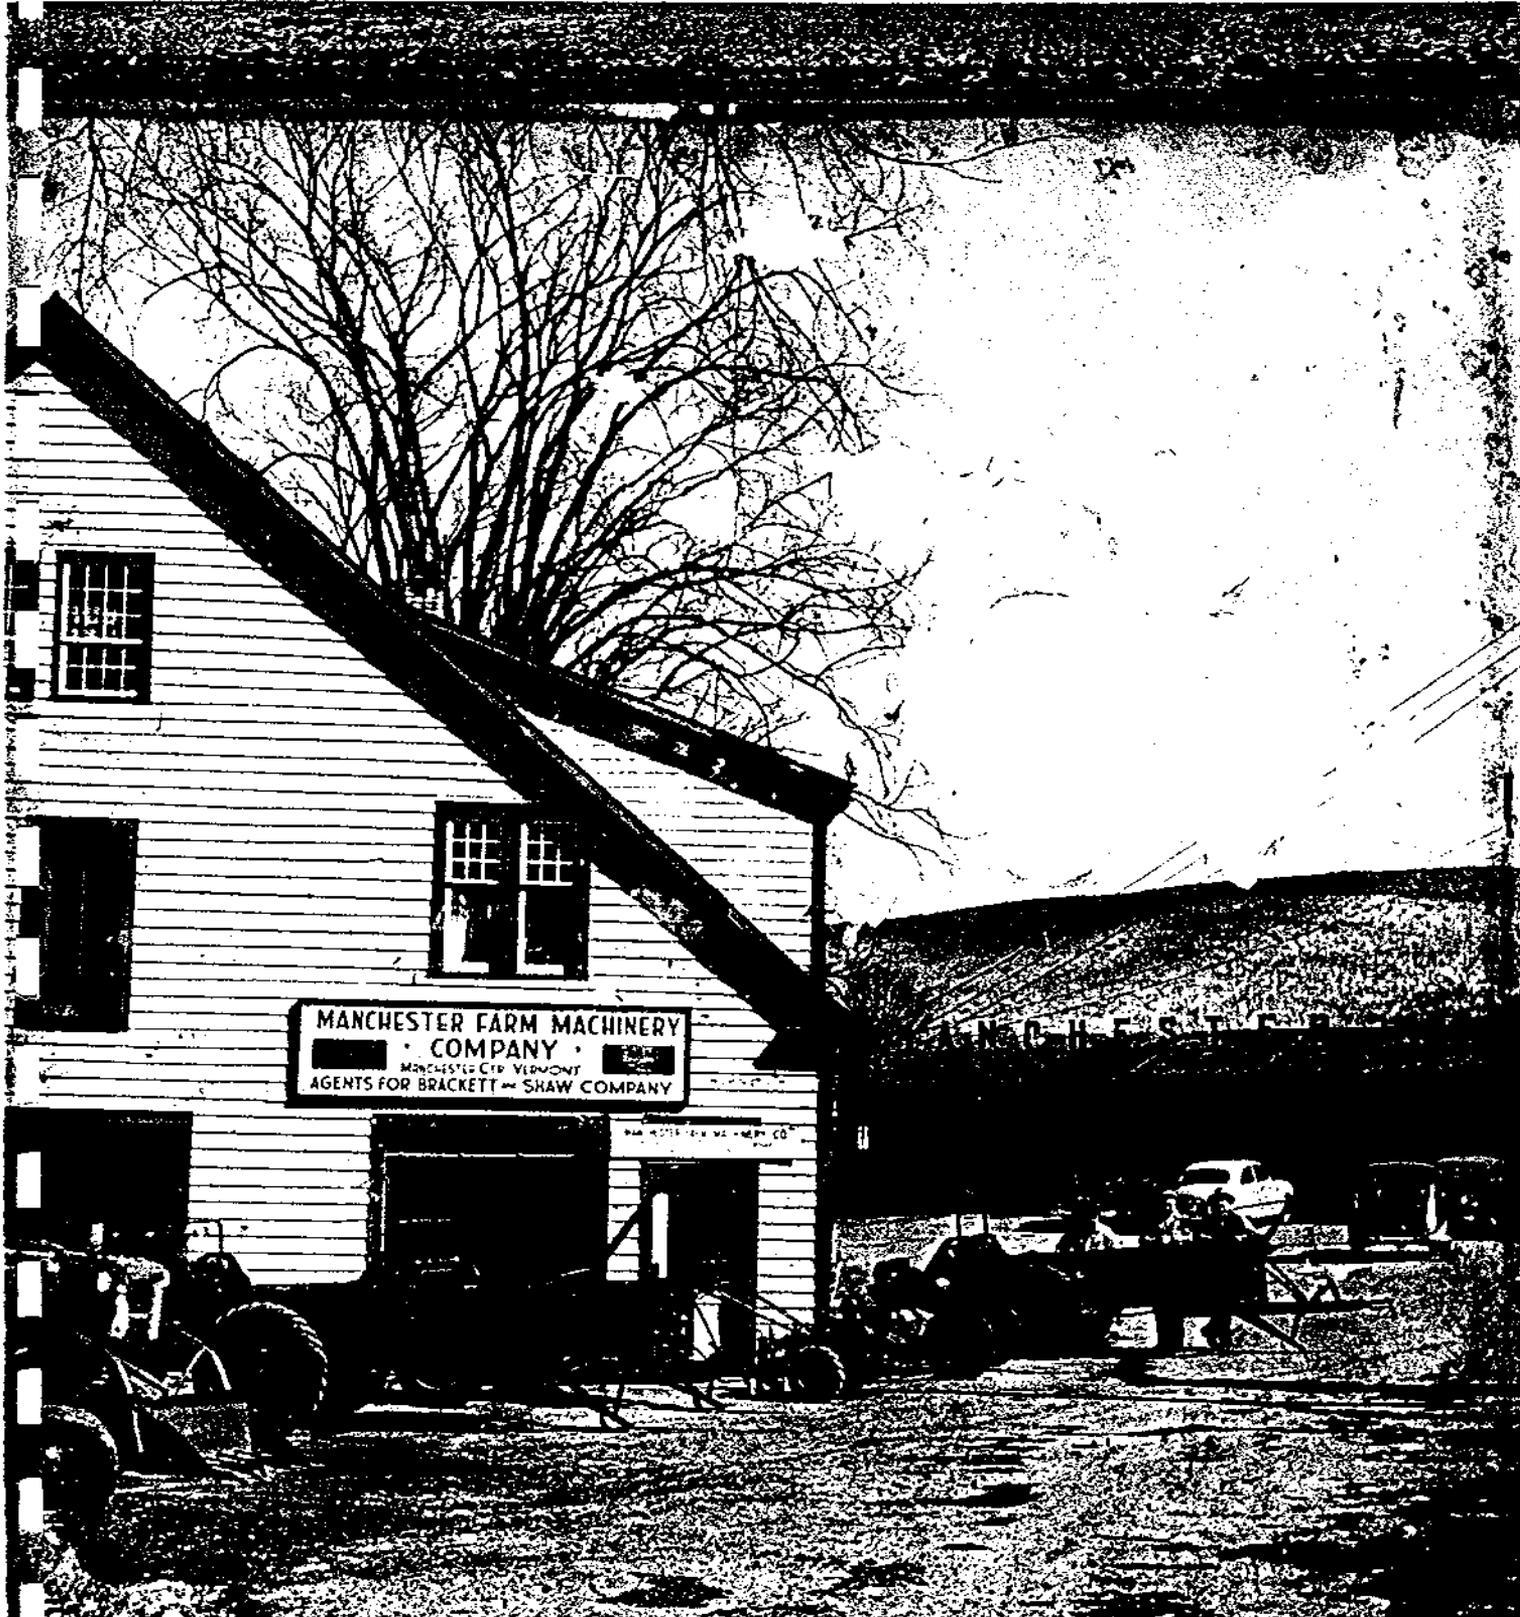
Historical Photograph of Site  
Approximate Date: 1950

1. The oldest photograph, from approximately 1950, shows a view of the original Manchester Motors sales and body shop building in the background (with the curved roof line), and a wood frame building housing the Manchester Farm Machinery Company in the foreground. This building is likely the "third" building observed in the 1942 and 1948 air photographs of the site, located near the northwest corner of the property. From the photographs, it is evident that farm implements were sold at the site. It's possible that the repair of farm implements was also performed upon the property, although there is no direct evidence of this service.

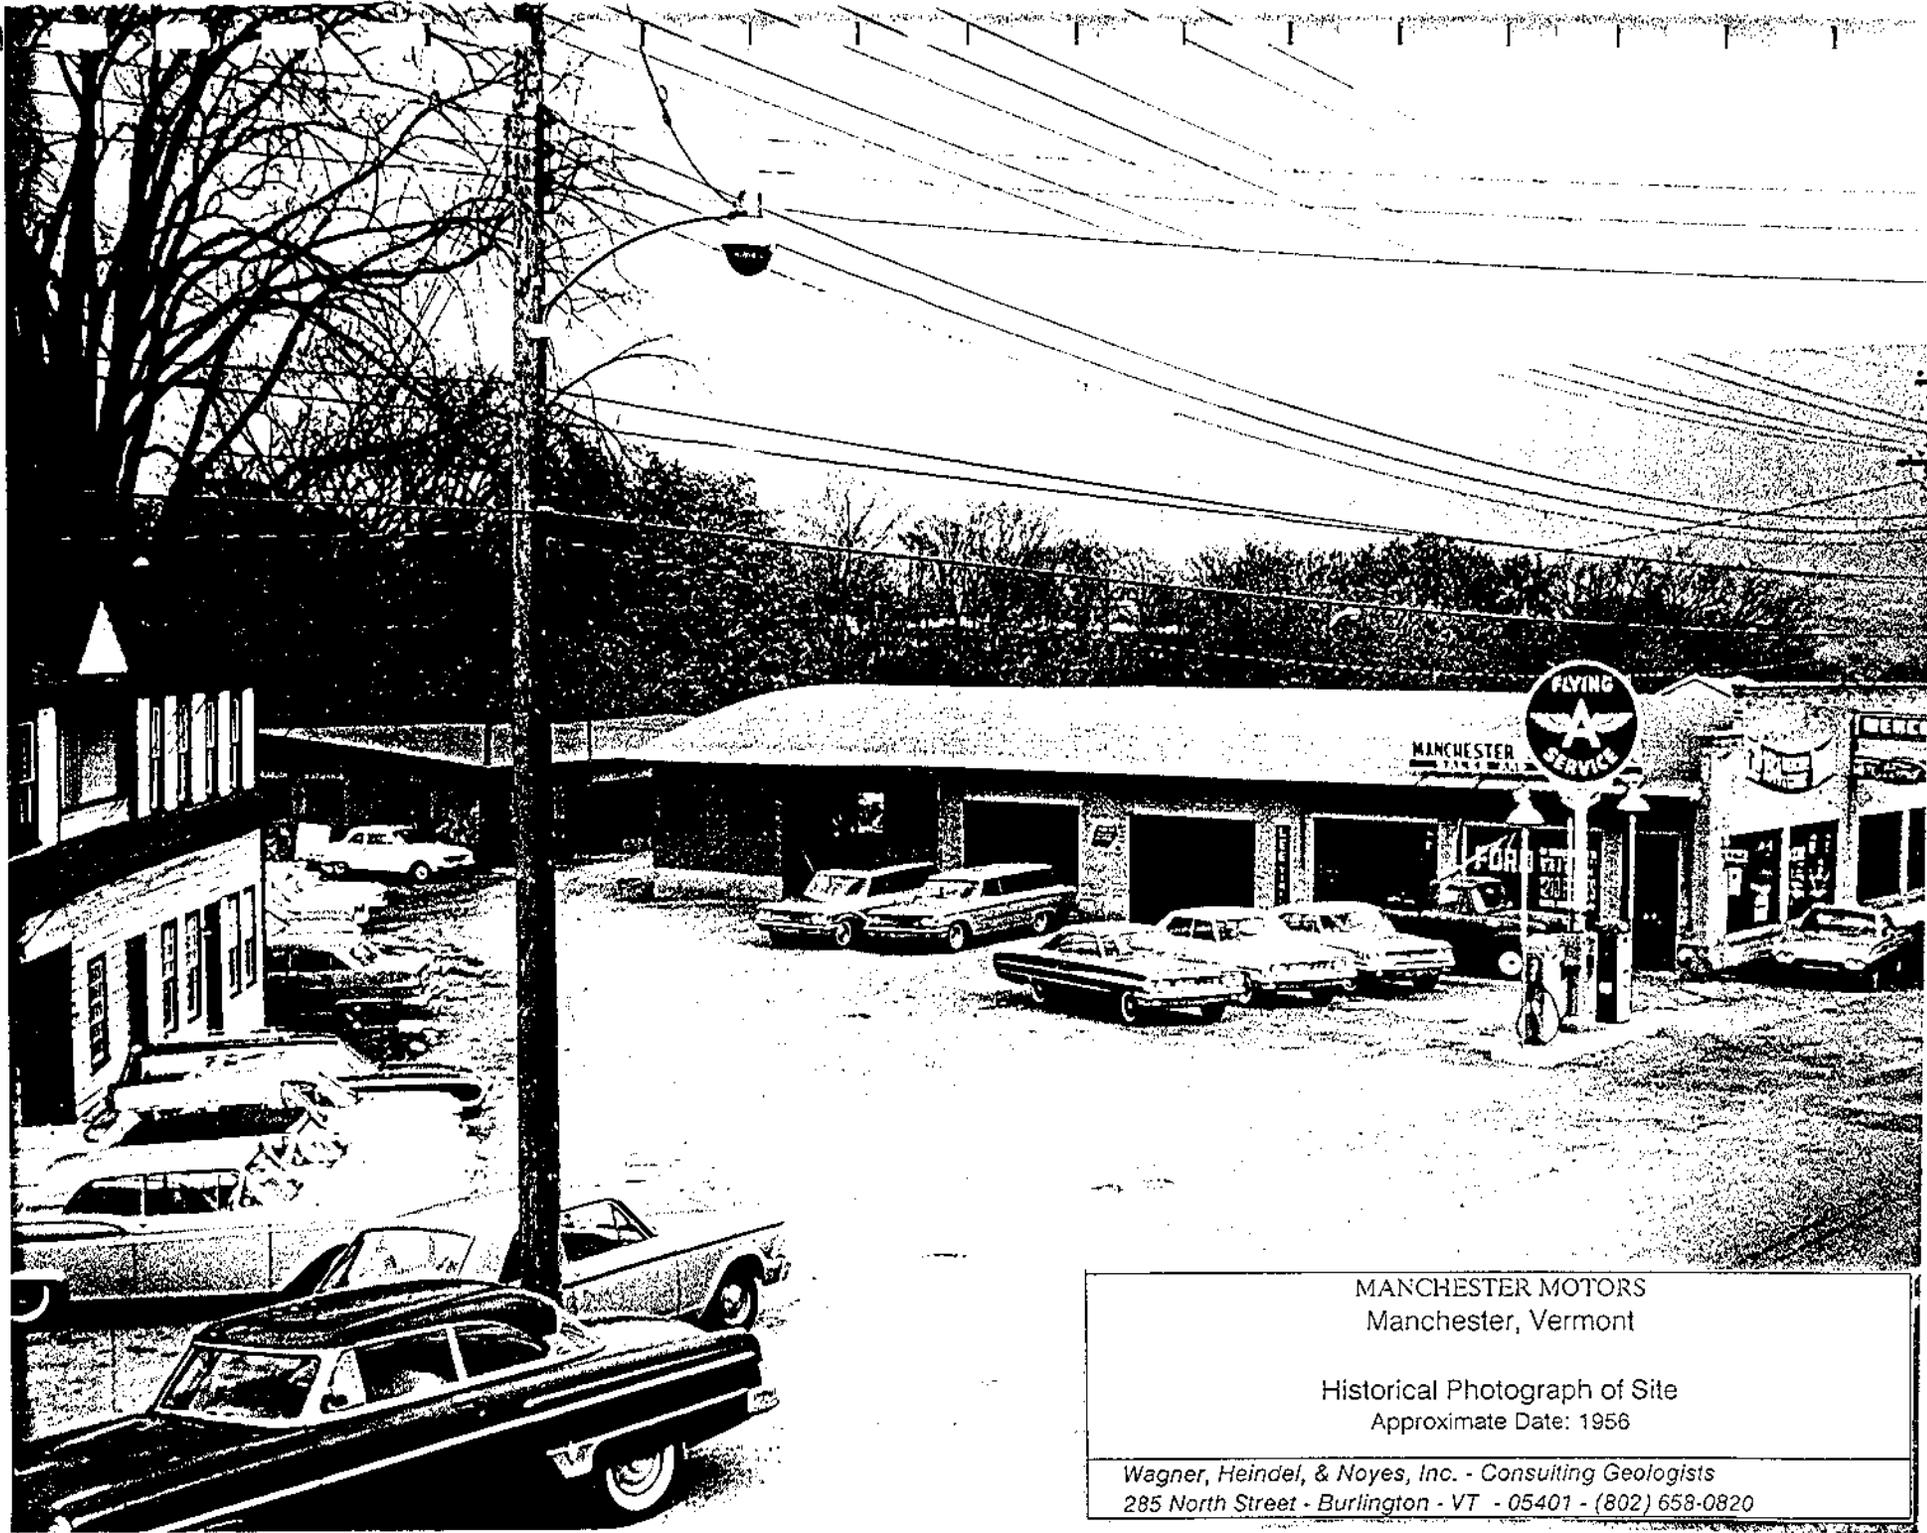
Historical Photograph of Site  
Approximate Date: 1956

There is a notable downward slope of the ground surface from the back of the sales and service building to the north building. Later photographs, and the current conditions at the site, show no appreciable slope between the sales building and the new service building, so it is likely that 1 to 2 feet of additional fill were brought to the site when the north building was later replaced with the large metal service garage that now rests on the property.
