**REPORT ON INVESTIGATIONS IN NOYESVILLE
WALDEN, VERMONT:**

**The Hooker Residence (Site #93-1314);
The Walden General Store (Site #88-0271); and
The Walden Town Garage (Site #88-0168)**

December 1993

THE JOHNSON COMPANY, INC.

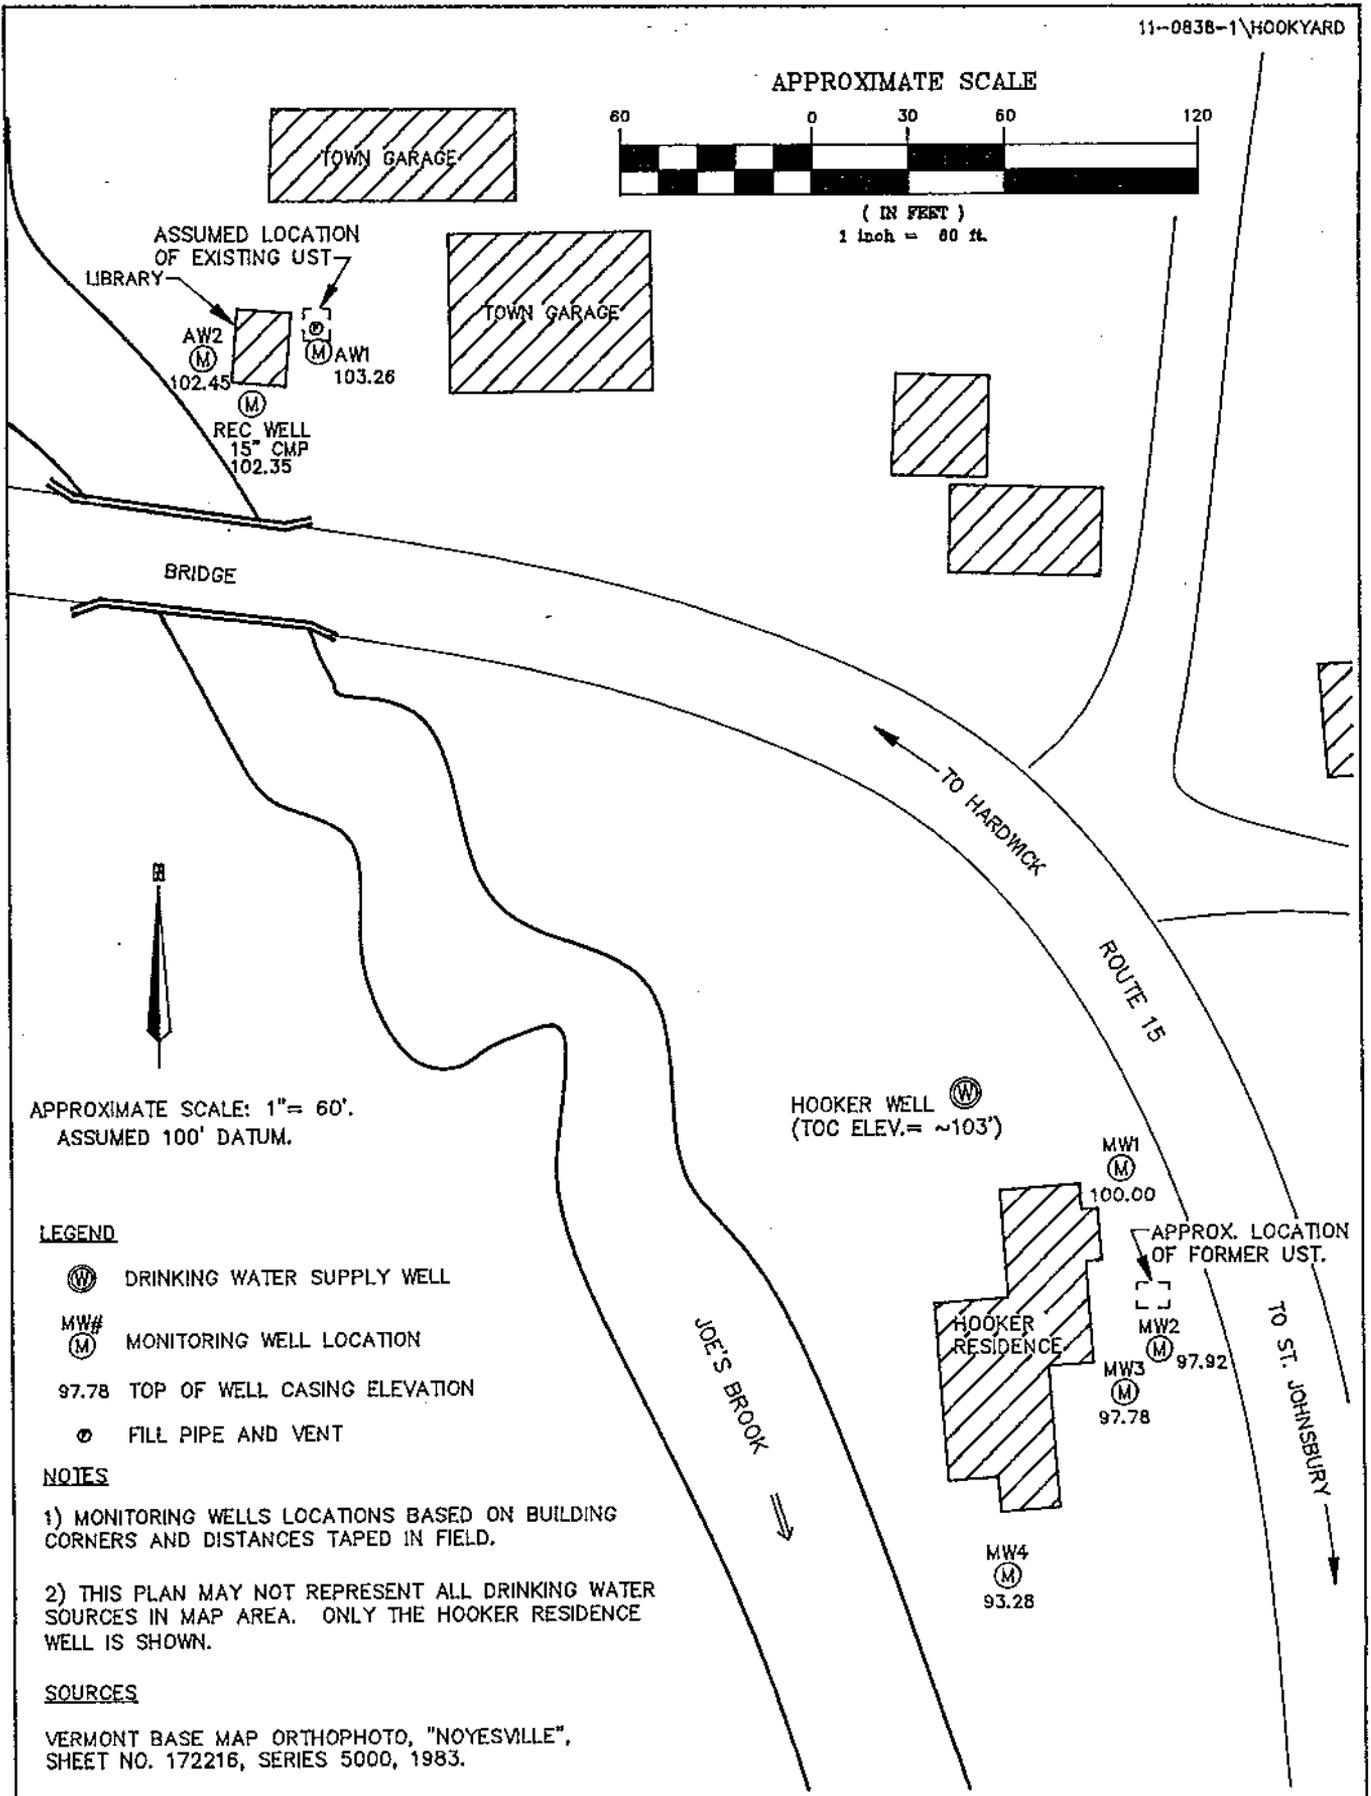
FIGURE 3 -- MONITORING WELL LOCATIONS
 HOOKER RESIDENCE
 NOYESVILLE, VERMONT

PID readings from soils obtained at MW-2 and MW-3 averaged over 120 parts per million (ppm) from a total of five soil samples assayed from these two locations. MW-4, the down gradient well, had a high of 7.6 ppm from a sample obtained from an interval corresponding to the surface of the water table. All significant PID readings are reported on the drilling logs included in Attachment 3.

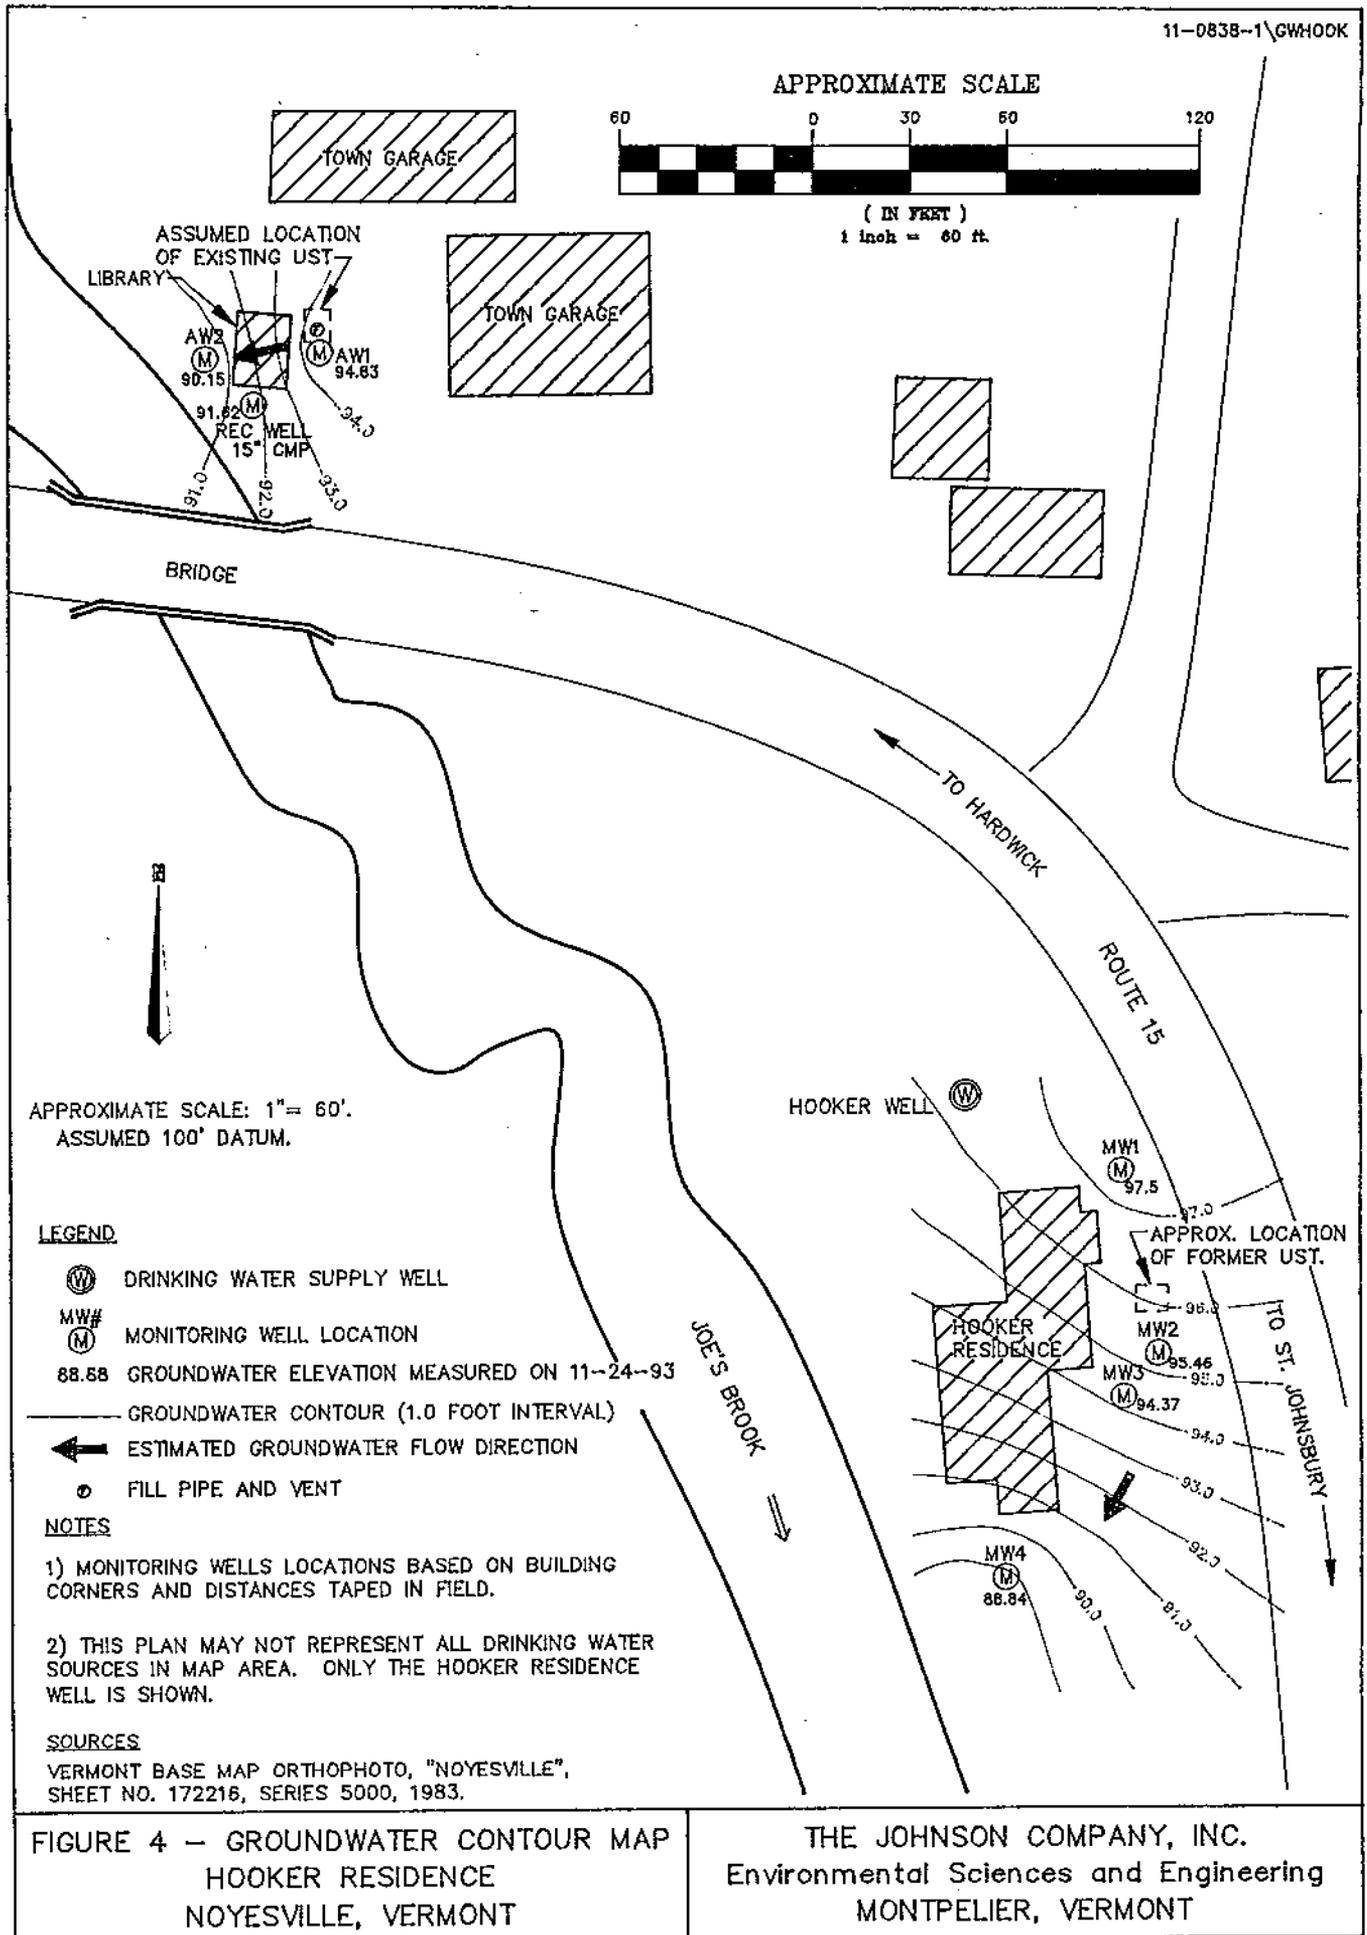
FIGURE 4 - GROUNDWATER CONTOUR MAP
 HOOKER RESIDENCE
 NOYESVILLE, VERMONT

Groundwater flow directions were determined on the Hooker property and at the Town Garage. The predominant groundwater flow direction at both sites is towards Joe's Brook. No other sensitive receptors appear to be at risk from the contamination present at the Hooker's or the Town Garage.

Groundwater flow directions on the Town Garage site and on the Hooker property do not indicate a connection between the two sites, nor a threat to any sensitive receptor other than Joe's Brook.

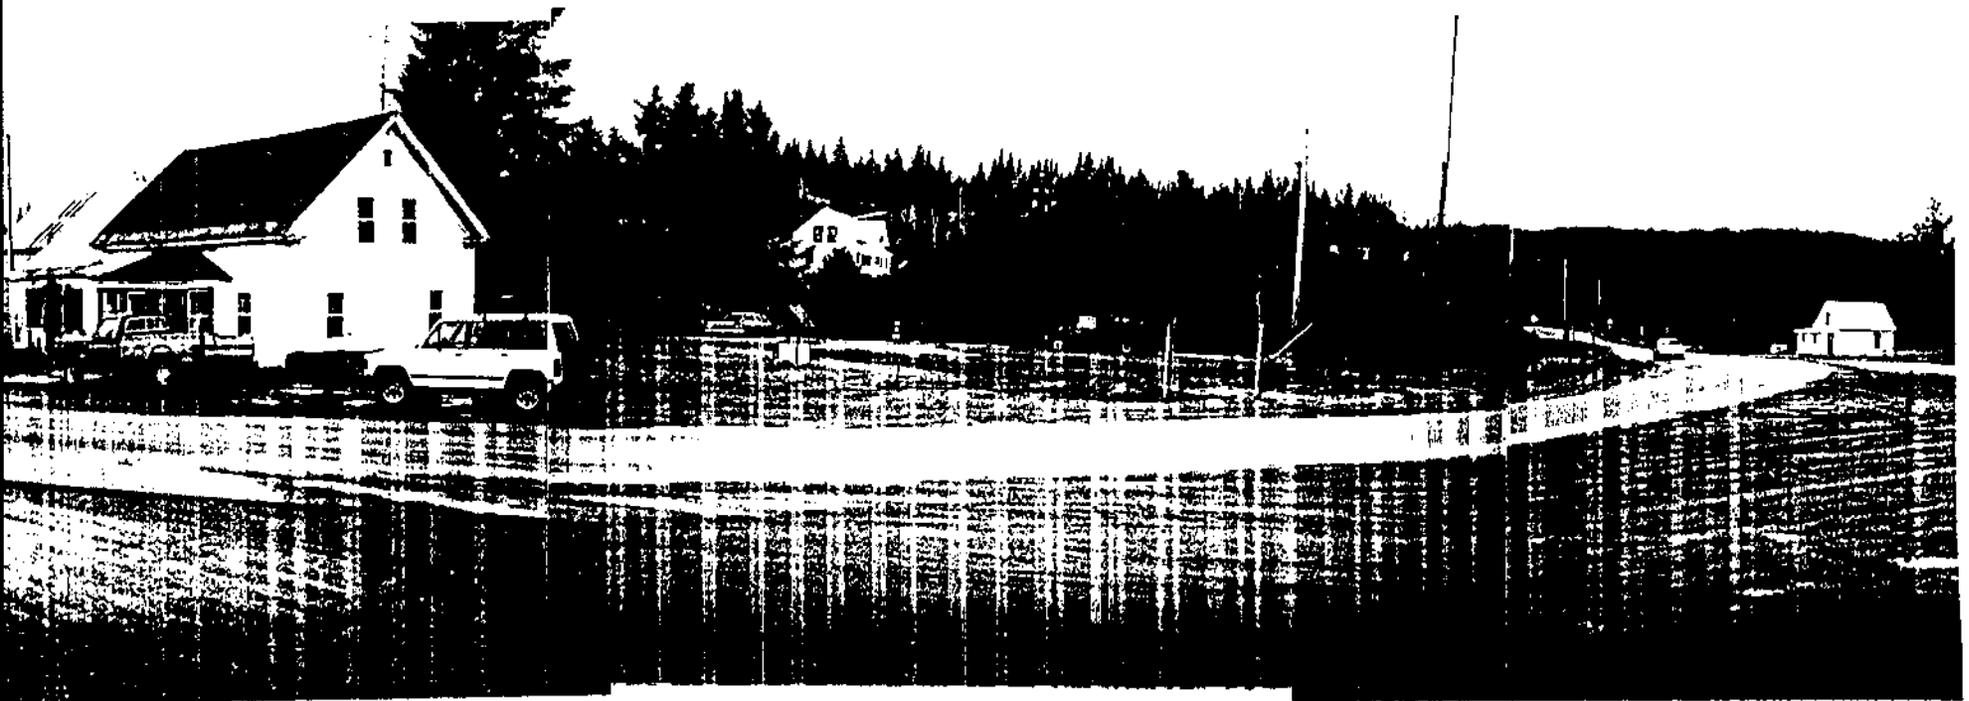
PLATE 2B: The Hooker's residence is evident in the left-hand photograph, the Hooker's well is located in the center photograph and the Town of Walden Public Library is in the center of the right-hand photograph with the roof of the Town Garage just visible to the right of the library through the trees. Note the bridge over Joe's Brook immediately to the left of the Public Library.

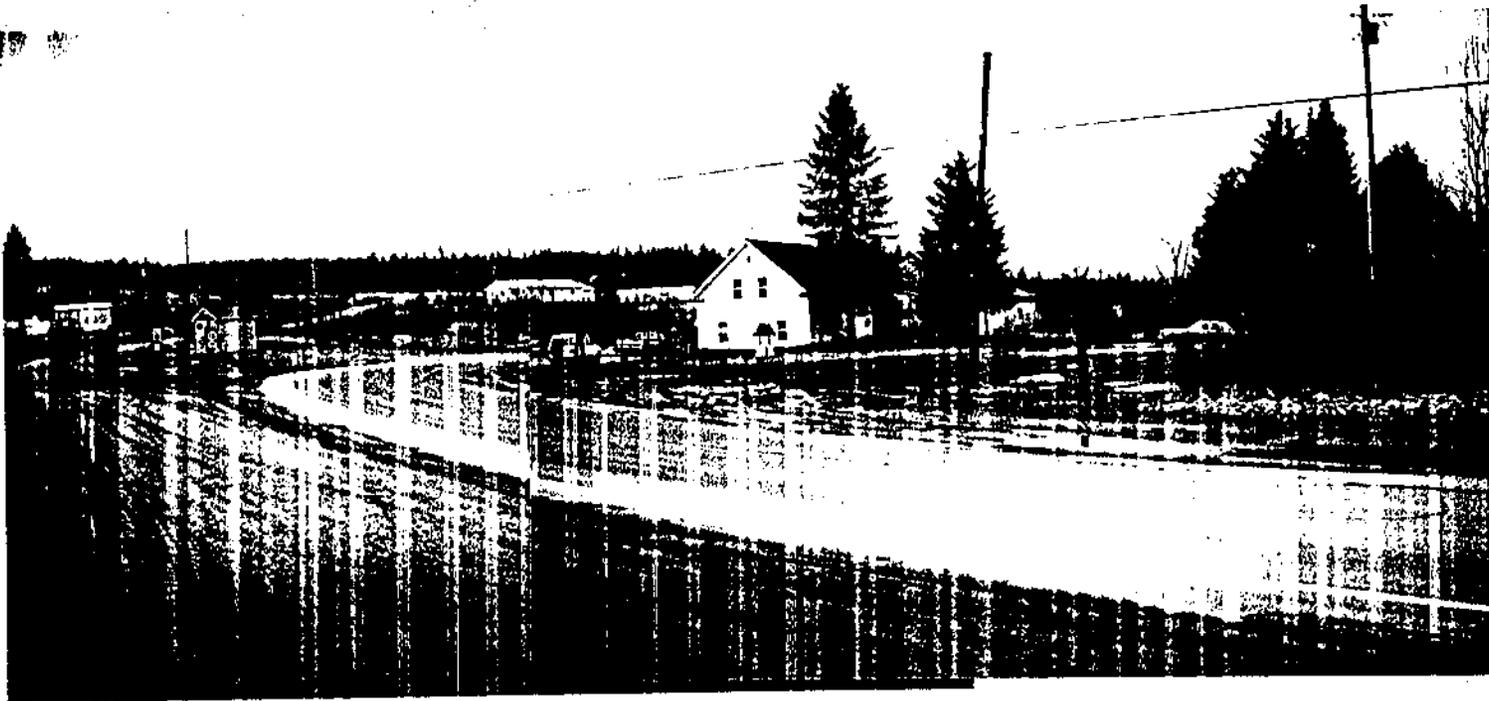
PLATE 3 This photograph was taken from the north side of Route 15 just before the road turns 90° to the south. This photograph shows that there are no residences immediately across the street to the east of the Hooker's which would be potentially located cross gradient from the former UST location on the Hooker's property.

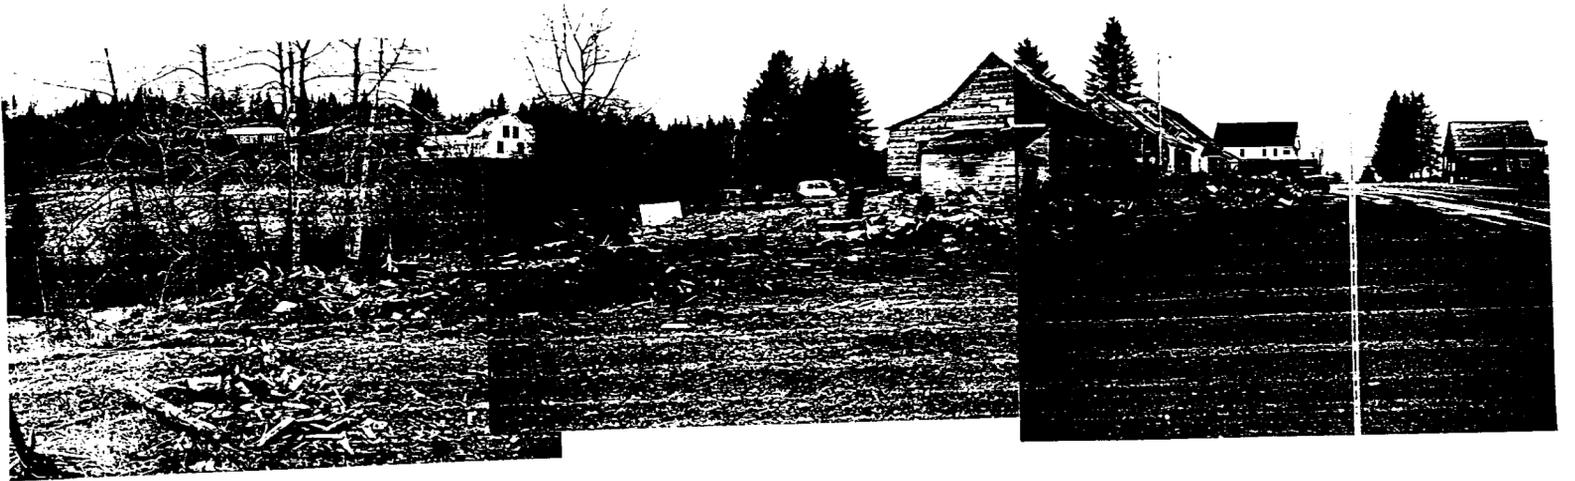
PLATE 4 The left-hand photograph in this plate is looking almost due west, and Joe's Brook is evident in the center of this photograph. The right-hand photograph in this plate looks almost due north. Note the "general store-type" structure on the opposite side of Route 15 from the Hooker's. This building is both east and north of the Hooker residence.

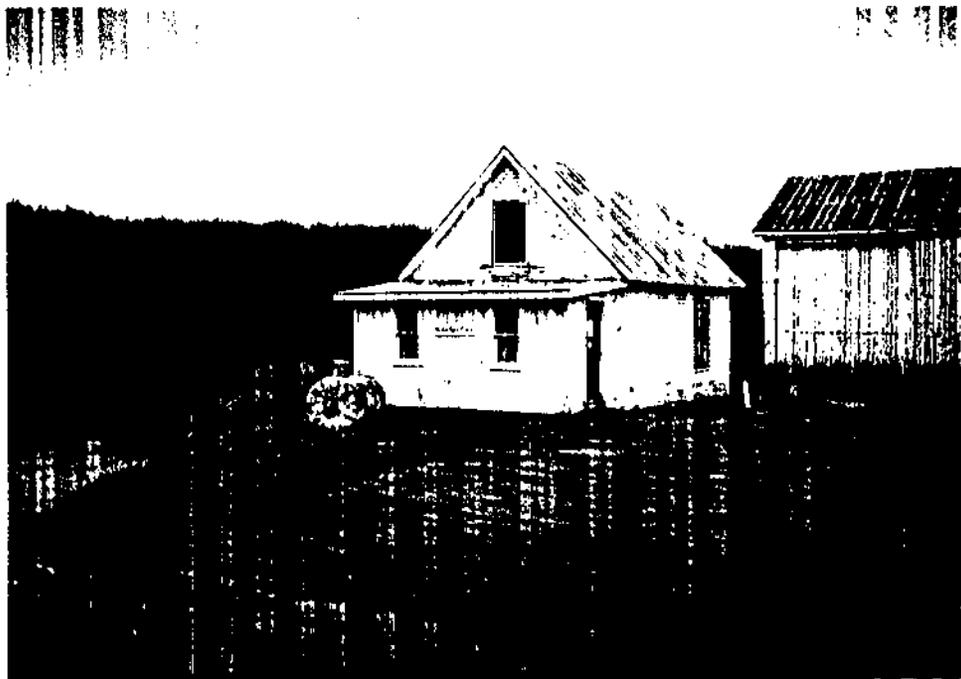
PLATE 5 This photograph was taken facing north on the north side of Route 15 immediately across the street from the Hooker property. The Town of Walden Public Library is evident in the center of the photograph, and Joe's Brook is evident on the lefthand side. The Town Garage is located on the righthand side of this photograph. Please note the white pipe, the metal drum, and the vent pipe (silhouetted in front of the Town Garage) just to the right of the Public Library.
