**REPORT ON THE
INVESTIGATION OF SUBSURFACE
PETROLEUM CONTAMINATION**

**PLAINFIELD AUTO PARTS
PLAINFIELD, VT 05667
VT DEC SITE #90-552**

SEPTEMBER 30, 1993

**Griffin International Inc.
2B Dorset Lane
Williston, VT 05495
(802) 879-7708**

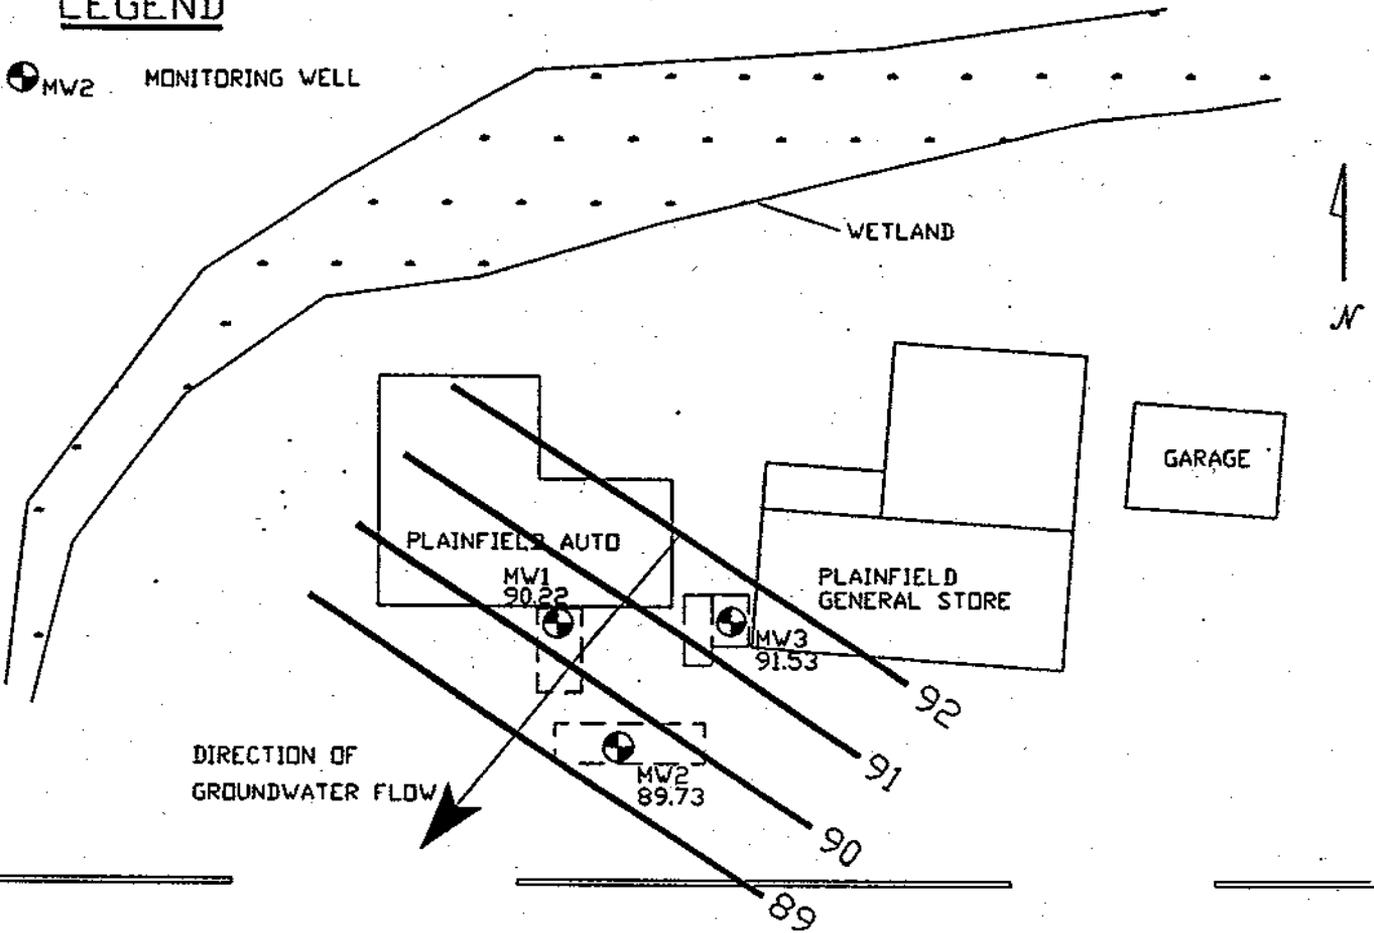
GROUNDWATER CONTOUR MAP

top of the MW-3 well casing. Elevations are plotted on the Groundwater Contour Map in Appendix A. The map indicates that groundwater is flowing southwest. The average hydraulic gradient in the vicinity of the monitoring wells is calculated to be 5.3 percent.

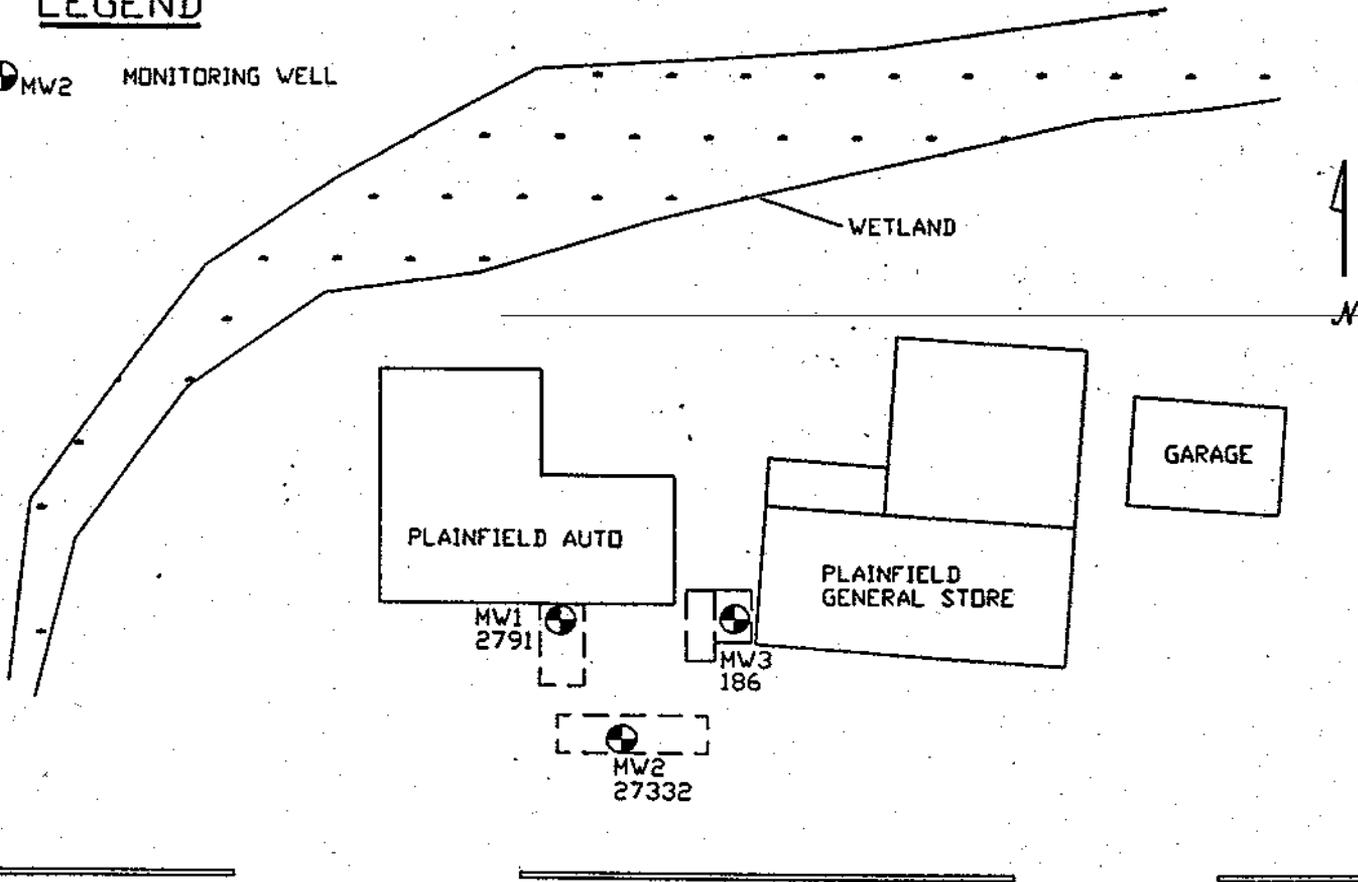
BTEX AND MTBE CONTAMINANT
CONCENTRATION MAP (PPb)

Significant contaminant levels were found in MW-2, which is the well in the former pump island excavation. MW-2 contained total contaminant levels of 27,332 parts per billion (ppb). Benzene, ethylbenzene, toluene, xylenes, and MTBE were all above Vermont Drinking Water Standards. Well MW-1 contained 2791 ppb total contaminants with only xylenes above the Vermont Drinking Water Standards. Well MW-3 contained 186 ppb total contaminants with no contaminant above Vermont Drinking Water Standards. Total BTEX + MTBE contaminant levels are shown for each well in the Contaminant Distribution Map in Appendix A.

1) Because of the presence of dissolved hydrocarbon compounds which exceed Vermont drinking water standards in two of the monitoring wells at the site, all of the wells at the site should be sampled again in November 1993.

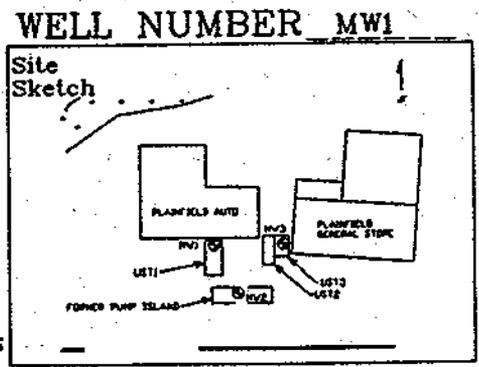
DEPTH IN FEET	WELL CONSTRUCTION	NOTES	BLOWS PER 6" OF SPOON & PID READINGS	DESCRIPTION/SOIL CLASSIFICATION (COLOR, TEXTURE, STRUCTURES)	DEPTH IN FEET
0		TOP CAP			0
1			0'-9' 30-220 ppm	0' - 9' sand and gravel	1
2		BACKFILL			2
3		WELL RISER			3
4		WELL SCREEN			4
5					5
6					6
7				7.54' WATER TABLE	7
8		BOTTOM CAP			8
9				BASE OF WELL AT 8.5'	9
10		UNDISTURBED NATIVE SOIL		END OF EXPLORATION AT 9'	10
11					11
12					12
13					13
14					14
15					15
16					16
17					17
18					18
19					19
20					20
21					21
22					22
23					23
24					24
25					25

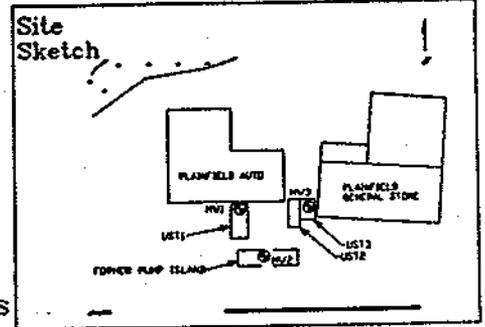
WELL NUMBER MW2

DEPTH IN FEET	WELL CONSTRUCTION	NOTES	BLOWS PER 6" OF SPOON & PID READINGS	DESCRIPTION/SOIL CLASSIFICATION (COLOR, TEXTURE, STRUCTURES)	DEPTH IN FEET
0		TOP CAP			0
1		WELL RISER	0'-9' 200-250 ppm	0' - 9' sand and gravel	1
2		BACKFILL			2
3					3
4					4
5		WELL SCREEN			5
6					6
7		BOTTOM CAP			7
8				8.69' WATER TABLE	8
9		UNDISTURBED NATIVE SOIL			9
10				BASE OF WELL AT 7.5'	10
11				END OF EXPLORATION AT 9'	11
12				9' - silty clay	12
13					13
14					14
15					15
16					16
17					17
18					18
19					19
20					20
21					21
22					22
23					23
24					24
25					25

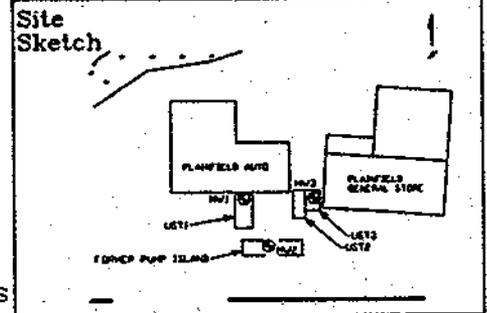
WELL NUMBER MW3

DEPTH IN FEET	WELL CONSTRUCTION	NOTES	BLOWS PER 6" OF SPOON & PID READINGS	DESCRIPTION/SOIL CLASSIFICATION (COLOR, TEXTURE, STRUCTURES)	DEPTH IN FEET
0		TOP CAP			0
1		WELL RISER	0'-6' 50 ppm	0'-6' sand and gravel	1
2		BACKFILL			2
3		WELL SCREEN	6'-9' 100 ppm		3
4					4
5			9'-12' 150 ppm		5
6		BOTTOM CAP			6
7			12'-13' 0 ppm	6'-9' sand and gravel	7
8				8.47' WATER TABLE	8
9					9
10				9'-12' gray, very silty clay	10
11					11
12					12
13		UNDISTURBED NATIVE SOIL		BASE OF WELL AT 7.5' END OF EXPLORATION AT 13'	13
14					14
15					15
16					16
17					17
18					18
19					19
20					20
21					21
22					22
23					23
24					24
25					25
