December 22, 1993

RE: Screening of Petroleum Vapors in the Basements of Ms. Persis Worrall and Mrs. Claire Mullen, Maple Street, Burlington, Vermont (VT DEC Site #93-1482)

BASEMENT SCREENING

CLAIRE MULLEN
NEXT DOOR TO WEST OF
PERSIS WORRALL
388 MAPLE, BURLINGTON

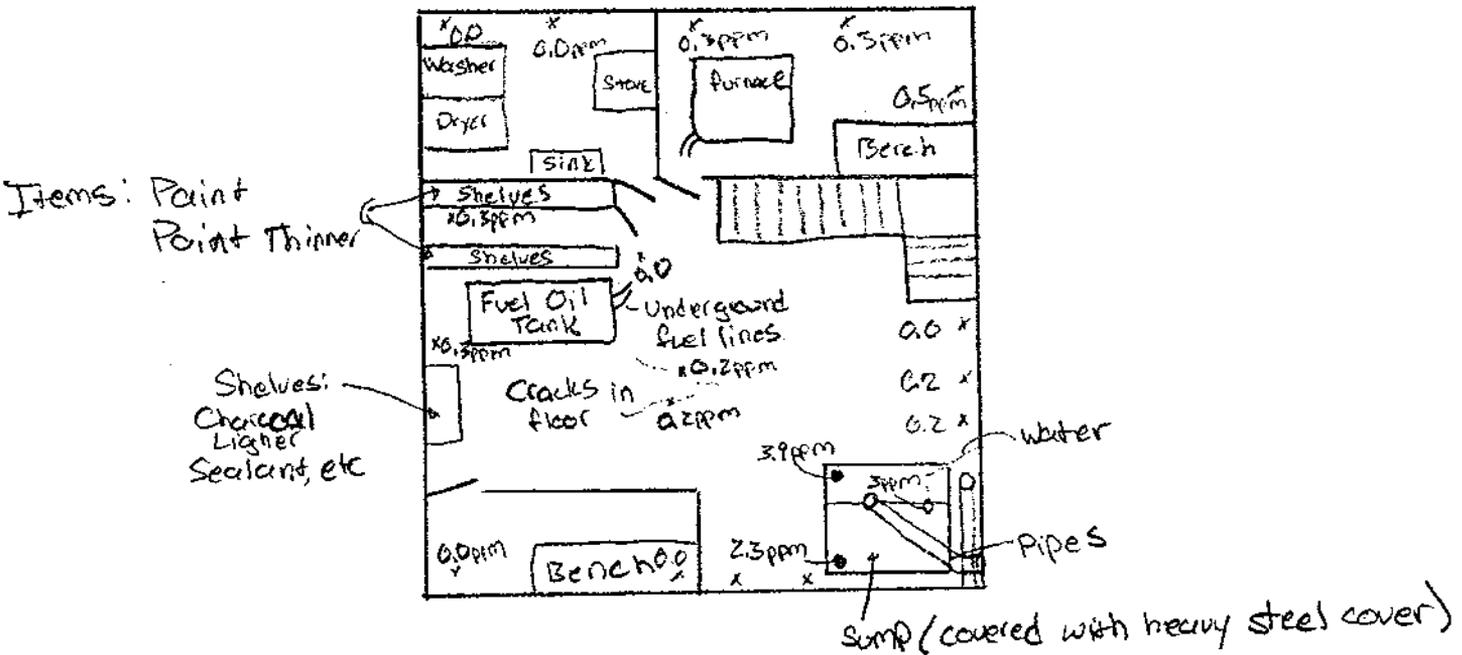
The Mullen residence may contain a minor source of residual contamination in the sump. It appears that the majority of the flooding that occurred in the basement during the release incident of February, 1993 drained into this area. Therefore, any contamination that may still be present in the water would most likely be left in the sump area in the basement. The levels of hydrocarbon vapors detected in the sump by the PID during the December, 1993 visit were very low and not likely a cause for concern. Cracks observed in the floor of the basement are not likely a source of contaminant infiltration based on PID screening.

Basement appeared and smelled recently painted (Completed after the cleanup, Spring '93?)

PID readings through holes in sump cover were 2.3-3.9 ppm
All other sample locations ranged 0-0.5 ppm (some sample loc. on map)

No apparent cracks in foundation wall.

- 1) The crack located on the south wall of the Worrall residence should be patched with an impermeable substance to reduce the possible infiltration of hydrocarbon vapors into the building.
- 2) No further action relative to the fuel oil spill is recommended for the Mullen residence.
