**REPORT ON THE INVESTIGATION OF SUSPECTED
SUBSURFACE PETROLEUM CONTAMINATION**

**BUDGET RENT-A-CAR
700 AIRPORT PARKWAY
SOUTH BURLINGTON, VERMONT 05403
(VT DEC SITE #93-1526)**

APRIL 7, 1994

GRIFFIN INTERNATIONAL
2B Dorset Lane
Williston, Vermont 05495
(802) 879-7708

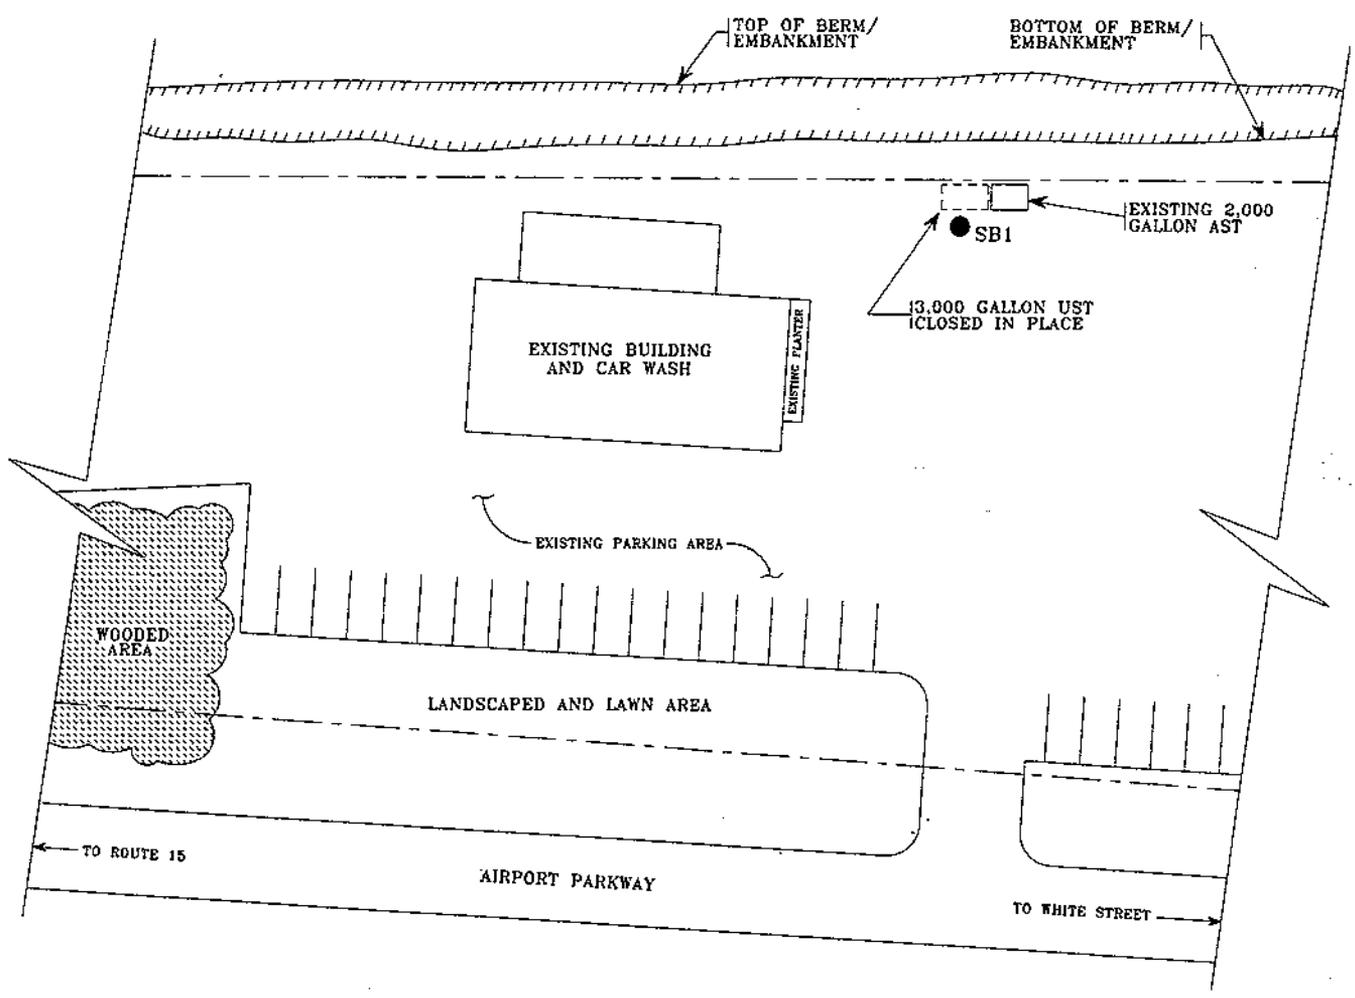
SITE MAP

On March 29, 1993, one soil boring was drilled at the site in order to determine the extent and degree of subsurface contamination. The location of this boring (SB-1) is displayed on the site map included in Appendix B. Groundwater monitoring wells were not installed as a part of this site investigation.

SB-1 was drilled to a depth of 42 feet at the edge of the asphalt parking lot immediately to the southwest of the closed UST. The soils in this location consisted primarily of well graded, medium dense, brown, damp, coarse to very fine sand with trace silt. Groundwater was encountered at approximately 40 feet below grade.

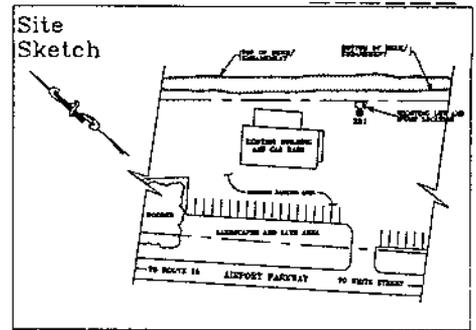
WELL NUMBER SB1

DEPTH IN FEET	WELL CONSTRUCTION	NOTES	BLOWS PER 6" OF SPOON & PID READINGS	DESCRIPTION/SOIL CLASSIFICATION (COLOR, TEXTURE, STRUCTURES)	DEPTH IN FEET
0					0
2			0'-5' 1.5 ppm	Brown fine to medium SAND, damp	2
4					4
6			5'-7'- 9,15,12,20 56 ppm	Damp SILT and very fine SAND to damp very fine SAND, brown	6
8					8
10			10'-12'- 3,11,22,23 32 ppm 13" of recovery	Brown very fine damp SAND with trace amounts of silt to dry light brown very fine sand	10
12					12
14			15'-17'-10,22,24,27 2.2 ppm 18" of recovery	Dry silty fine SAND, light brown slight odor	14
16					16
18			20'-22'-6,11,15,17 1.1 ppm 22" of recovery	Light brown fine to medium SAND, dry, petroleum odor	18
20		NATIVE SOIL			20
22					22
24			25'-27'-6,10,15,20 0.8 ppm 16" of recovery	Light brown fine to medium SAND, damp to dry, no petroleum odor	24
26					26
28			30'-32'-18,42,52,69 1.3 ppm 18" of recovery	Fine to very fine SAND, light gray, damp, with varves of dark brown, no pet. odor	28

30					30
32			35'-37'-11,18,17,17 1.3 ppm 21" of recovery	Fine brown moist SAND to dark brown moist fine SAND with silt and some gravel, no petroleum odor	32
34					34
36					36
38					38
40			40'-42'-3,6,8,15 0.7 ppm	40.0' WATER TABLE	40
42		UNDISTURBED NATIVE SOIL		Wet fine to very fine SAND with silt brown, no petroleum odor or sheen	42
44				BASE OF HOLE AT 42.0' END OF EXPLORATION AT 42.0'	44
46					46
48					48
50					50
