**REPORT ON THE
INVESTIGATION OF SUSPECTED SUBSURFACE
PETROLEUM CONTAMINATION**

**Fairdale Farms
Bennington, Vermont**

**VTDEC SITE #93-1544
GRIFFIN PROJECT #1944481**

SEPTEMBER 1994

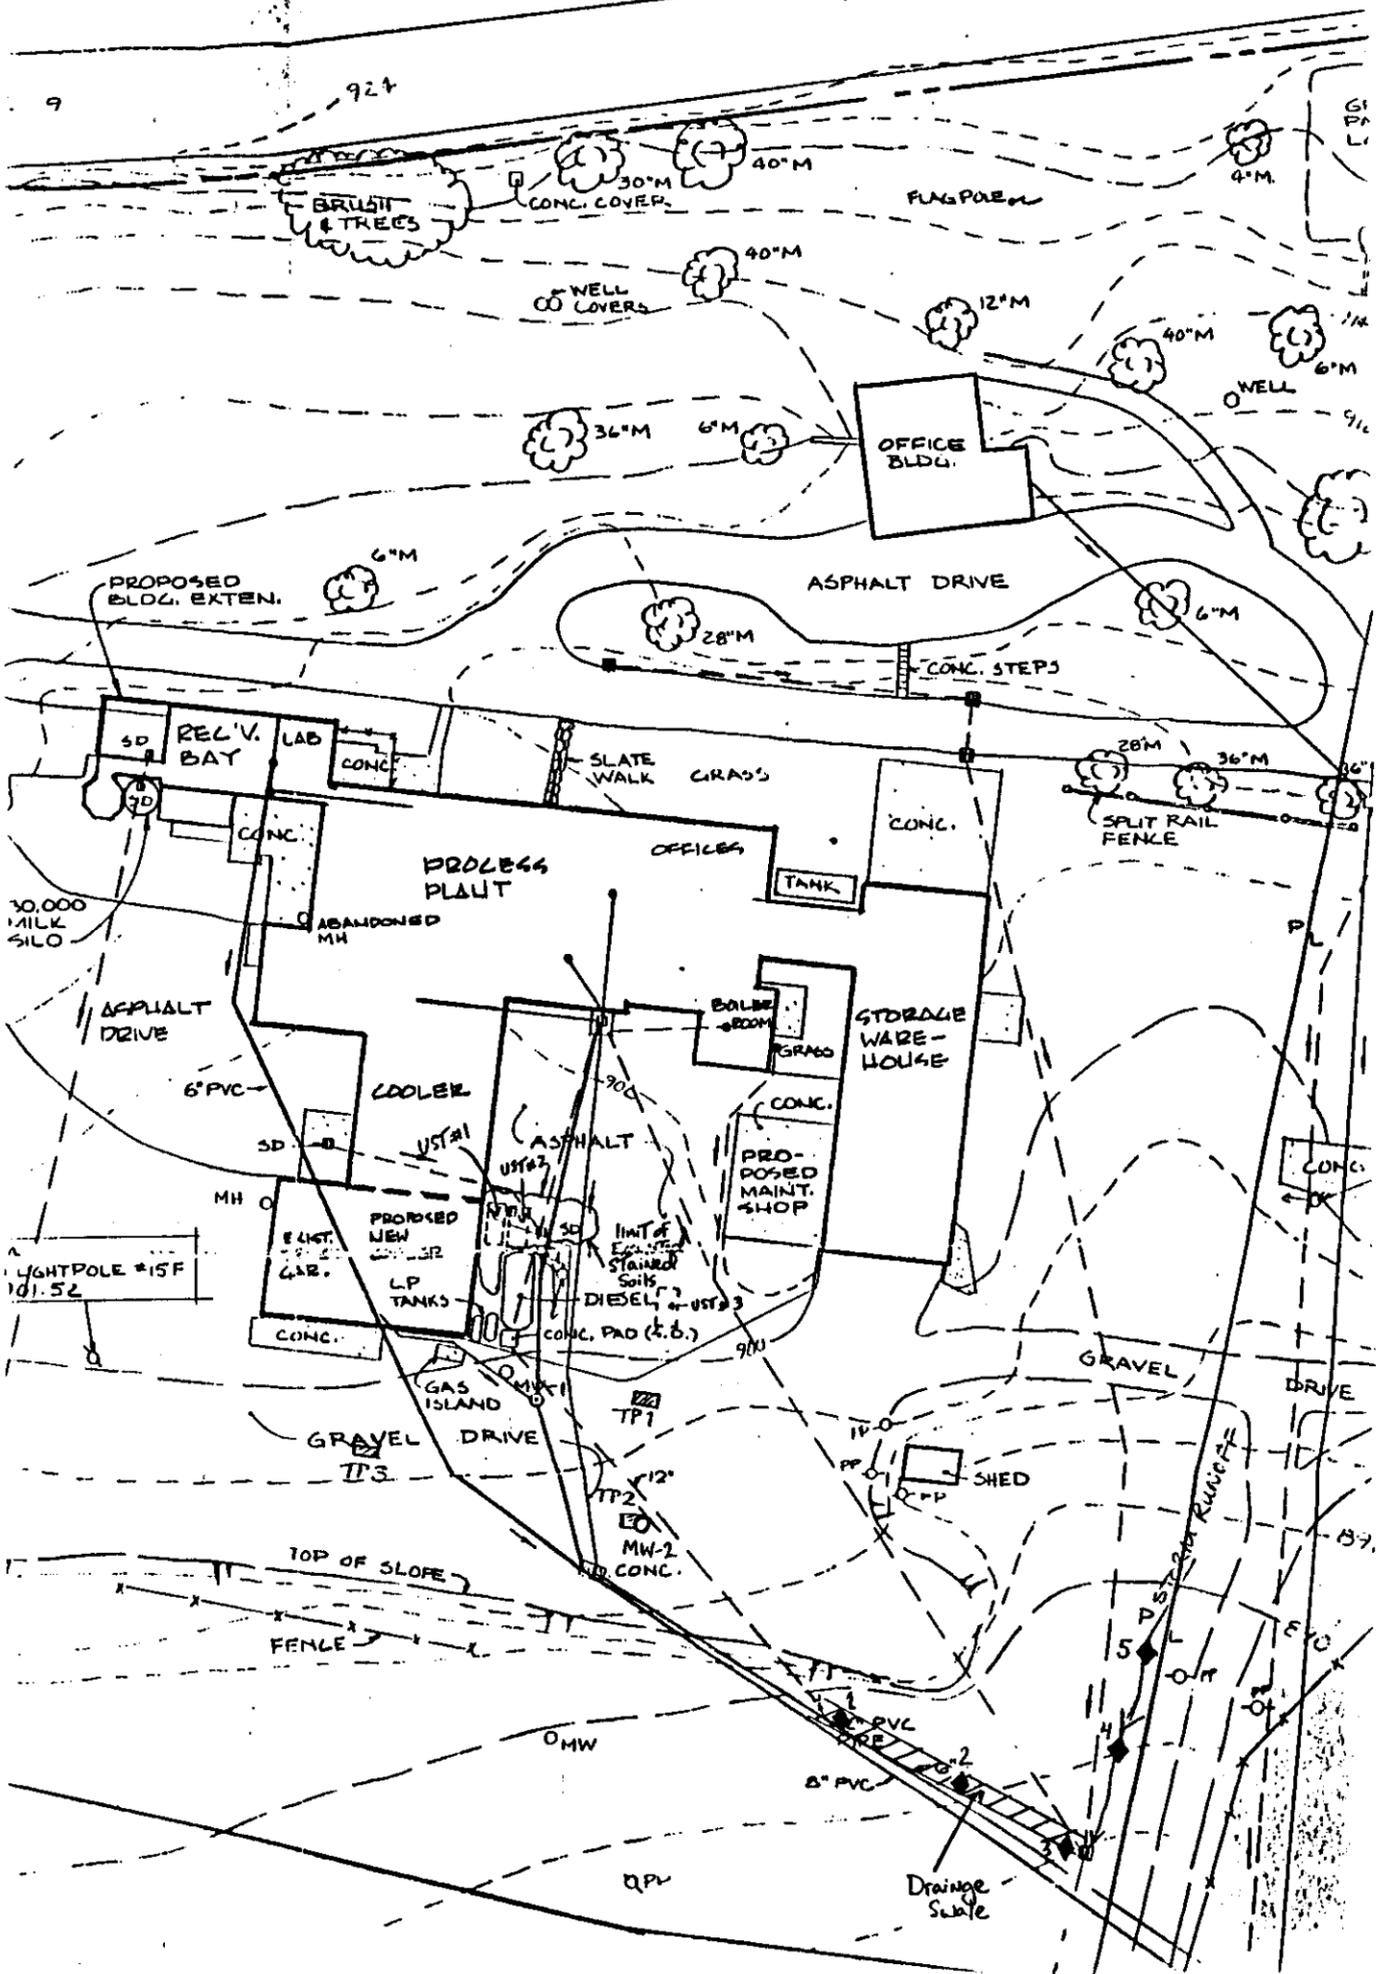
SITE MAP
Sheet 2 of 2
Fairdale Farms, Bennington, VT

The drainage swale and the small stream which reportedly received runoff of diesel associated with the November 26, 1993 overflow of the AST were screened for VOCs with an HNu™ Model PI-101 PID on June 13, 1994. Very low to negligible flow was observed in the drainage swale; water was dripping from the culvert into the swale approximately 165 feet northwest of the AST. A biological sheen was observed on the standing water present in a 0.5-ft to 1-ft wide channel in the swale. A low flow of water (less than 0.5 gallon per minute - visual estimate) was observed in the storm runoff swale flowing southerly to its confluence with the drainage swale on the eastern edge of the access road to the wastewater treatment plant and stockpiled soils. To screen VOCs in the drainage swale, runoff swale, and stream, small test pits were excavated using a clean hand shovel along the bottom and sides of the channels, and the exposed soils and seeping ground water were screened with the PID. In addition, at certain of these same sample locations, the air above standing or flowing water was screened for VOCs with a PID. The table below indicated the stream and swale screening results. Screening locations 1, 2, and 3 were along the drainage swale; locations 4 and 5 were positioned along the storm runoff swale upstream of its confluence with the drainage swale (see Site Map: Sheet 1 of 2 in Appendix A). Screening locations 6 and 7 were located along the stream formed by emergence of storm runoff waters from the underground culvert at a location midway between the Process Wastewater Treatment facility and the Old Lagoon (see Site Map: Sheet 2 of 2).

These drainage swale and stream screening results suggest that residual petroleum contamination resulting from the November 1993 diesel release from the on-site AST continues to impact surface runoff water and shallow soils at the site.

Drainage swale and stream screening results indicate that petroleum contamination resulting from the diesel release from the on site AST has likely impacted surface water and shallow soils at the site. Dissolved petroleum constituents may be migrating offsite to the small, westerly-flowing stream located approximately 2000 feet north of the Fairdale Farms Process Plant. Inspection of the Hoosick Falls, NY, USGS 7.5 minute topographic quadrangle map (1943, photorevised in 1980) revealed that this stream turns northward approximately three quarters of a mile west of Fairdale Farms and eventually flows into the Walloomsac River.

- 5) Residual petroleum contamination resulting from the November 1993 diesel release from the on-site AST apparently continues to impact surface runoff water and shallow soils in the drainage swale and stream at the site.
- 6) A potentially sensitive receptor in the area of the Fairdale Farms site was identified as the westerly-flowing stream located north of the northern property boundary.

- 1) A sample of water flowing in the stream north of the onsite Process Wastewater Treatment Facility Area should be collected and analyzed for petroleum-related constituents by EPA Method 8020. The sample results will be utilized to characterize surface water quality impact at this location and to evaluate the potential impact of dissolved petroleum contaminants on the offsite stream, tributary to the Walloomsac River.
