March 19, 1998

RE: Perry's Oil/Mayo Property, Hardwick (#94-1608) - Site Summary, Fracture Trace Analysis, and Specifications for a Drilled Bedrock Well

Lincoln Applied Geology, Inc. (LAG) is pleased to present the findings relative to the proposed replacement of a drilled bedrock water supply on the Bruce and Cathy Mayo property on Route 14 in Hardwick, Vermont. The Mayo's (and other residences) currently receive treated potable water from a petroleum contaminated bedrock well (new well) on the Perry's Oil Service (POS) property located to the southeast.

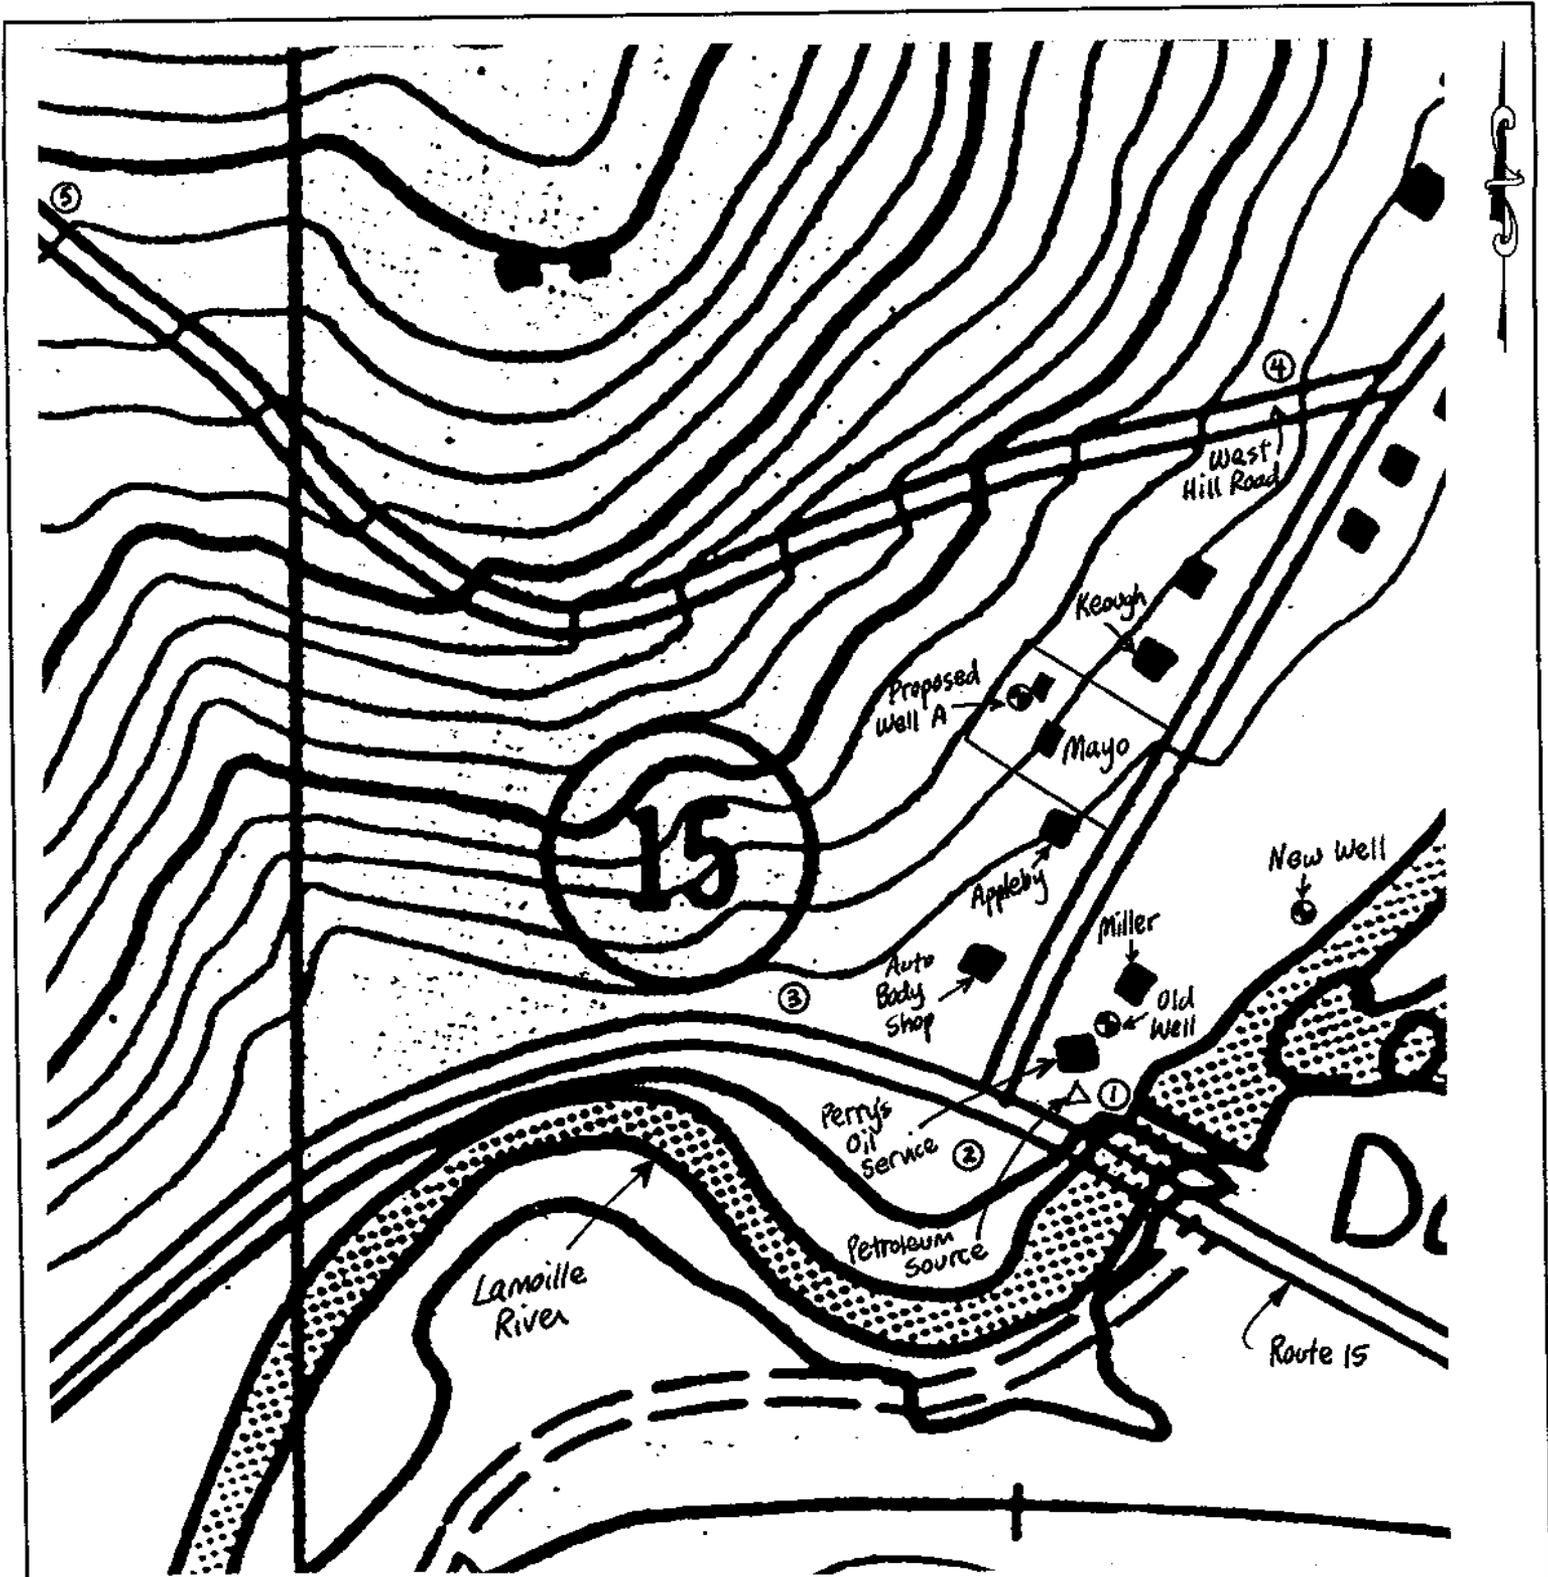
FIGURE 1

The Perry's Oil Service (POS) file was reviewed by LAG at the Sites Management Section (SMS) on November 20, 1997. Correspondence included in the file indicates that the POS property (southeast of the Mayo property) has been a retail gasoline station since prior to 1968. The POS and Mayo properties are shown on **Figure 1**.

Five bedrock outcrops were located within a 1,100 foot radius of the Mayo property on December 11, 1997. These outcrops are numbered 1 through 5 on **Figure 1**. The bedrock is mapped on the Centennial Geologic Map of Vermont (1961) as the Middle Ordovician age (480-460 million year old) Moretown member of the Mississquoi formation, a metamorphosed quartzite and quartz-plagioclase granulite. Spatial orientation data from bedrock structural features including bedding, fractures, and joints were used to evaluate whether dominant bedrock structures may have controlled the contaminant migration from the source area into the old and new wells. These data were also used to determine a suitable location where a drilled bedrock well could be placed on the Mayo's property which would minimize the risk of being contaminated from the identified contaminant plume to the south and southeast.

The new well is located about 375 feet northeast of the source area, and about 290 feet east-northeast of the old well as shown on **Figure 1**. Although it is located outside the north-trending structural zone as related to the source area and the old well, it is located within the east-trending structural zone related to the old well. These data suggest that the new well became contaminated from dissolved contaminants migrating (under pumping conditions) through the east-trending bedrock fractures connecting the old well with the new well. We have limited concern that the proposed Mayo well could become contaminated from contaminants present in the new well since it is not located within either the north or east-trending structural zones related to the new well; it lies 450 feet northwest of the new well; its water demand would be very low (0.6 gpm), and the proposed extraordinary well construction measures should prevent its contamination.

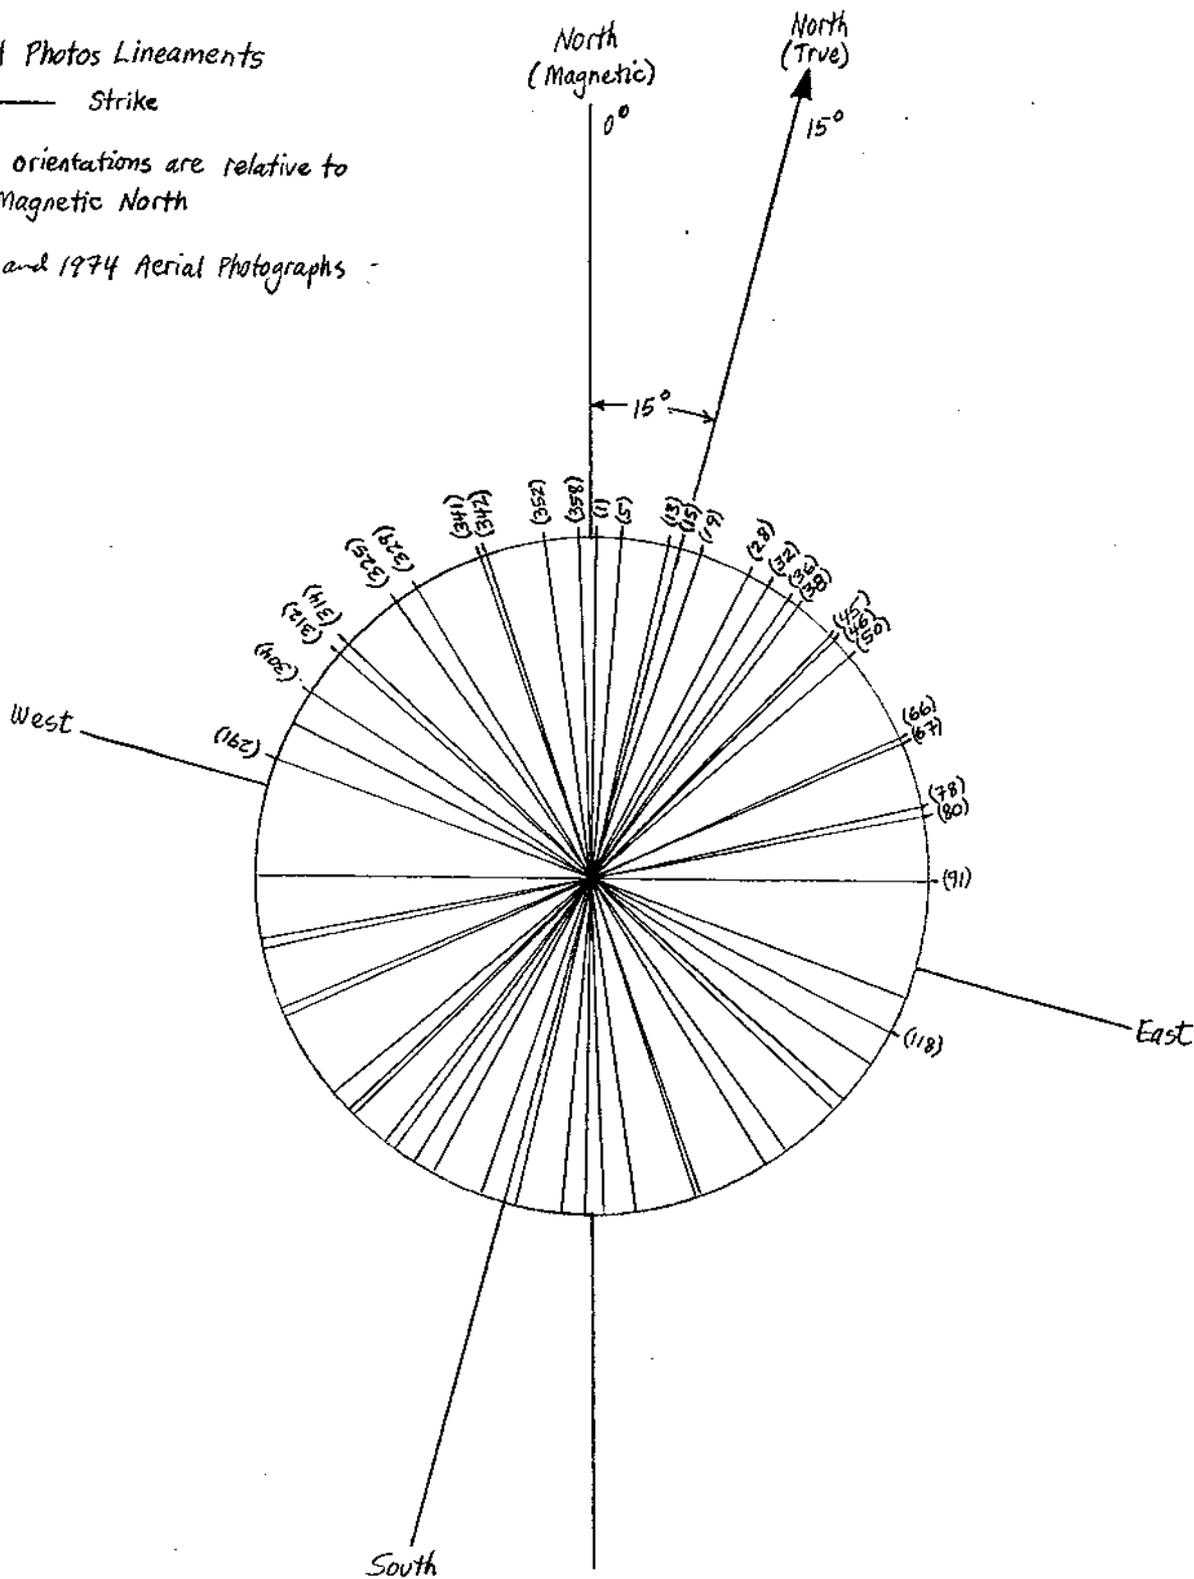
FIGURE 3

Two sets of aerial photographs (dated April 29, 1963 and May 21, 1974) were evaluated to determine the presence of regional and local lineaments or fracture traces detected by visual means. The orientations of 28 lineaments were then plotted on a compass rose included as **Figure 3**. Review of these data indicate that there are no clearly defined lineament "zones". Instead, the lineaments are oriented throughout the compass rose. However, the aerial photos do show relatively prominent lineaments that correspond with north-trending bedrock ridges (strike of bedding and fractures) generally oriented at 341 to 38 degrees (relative to true north at 0 degrees).

Although the aerial photos show widely oriented lineaments as compared to the two structural zones delineated by bedrock outcrop structural analyses, these data do indicate that there are well defined bedrock structural features that appear to have strongly

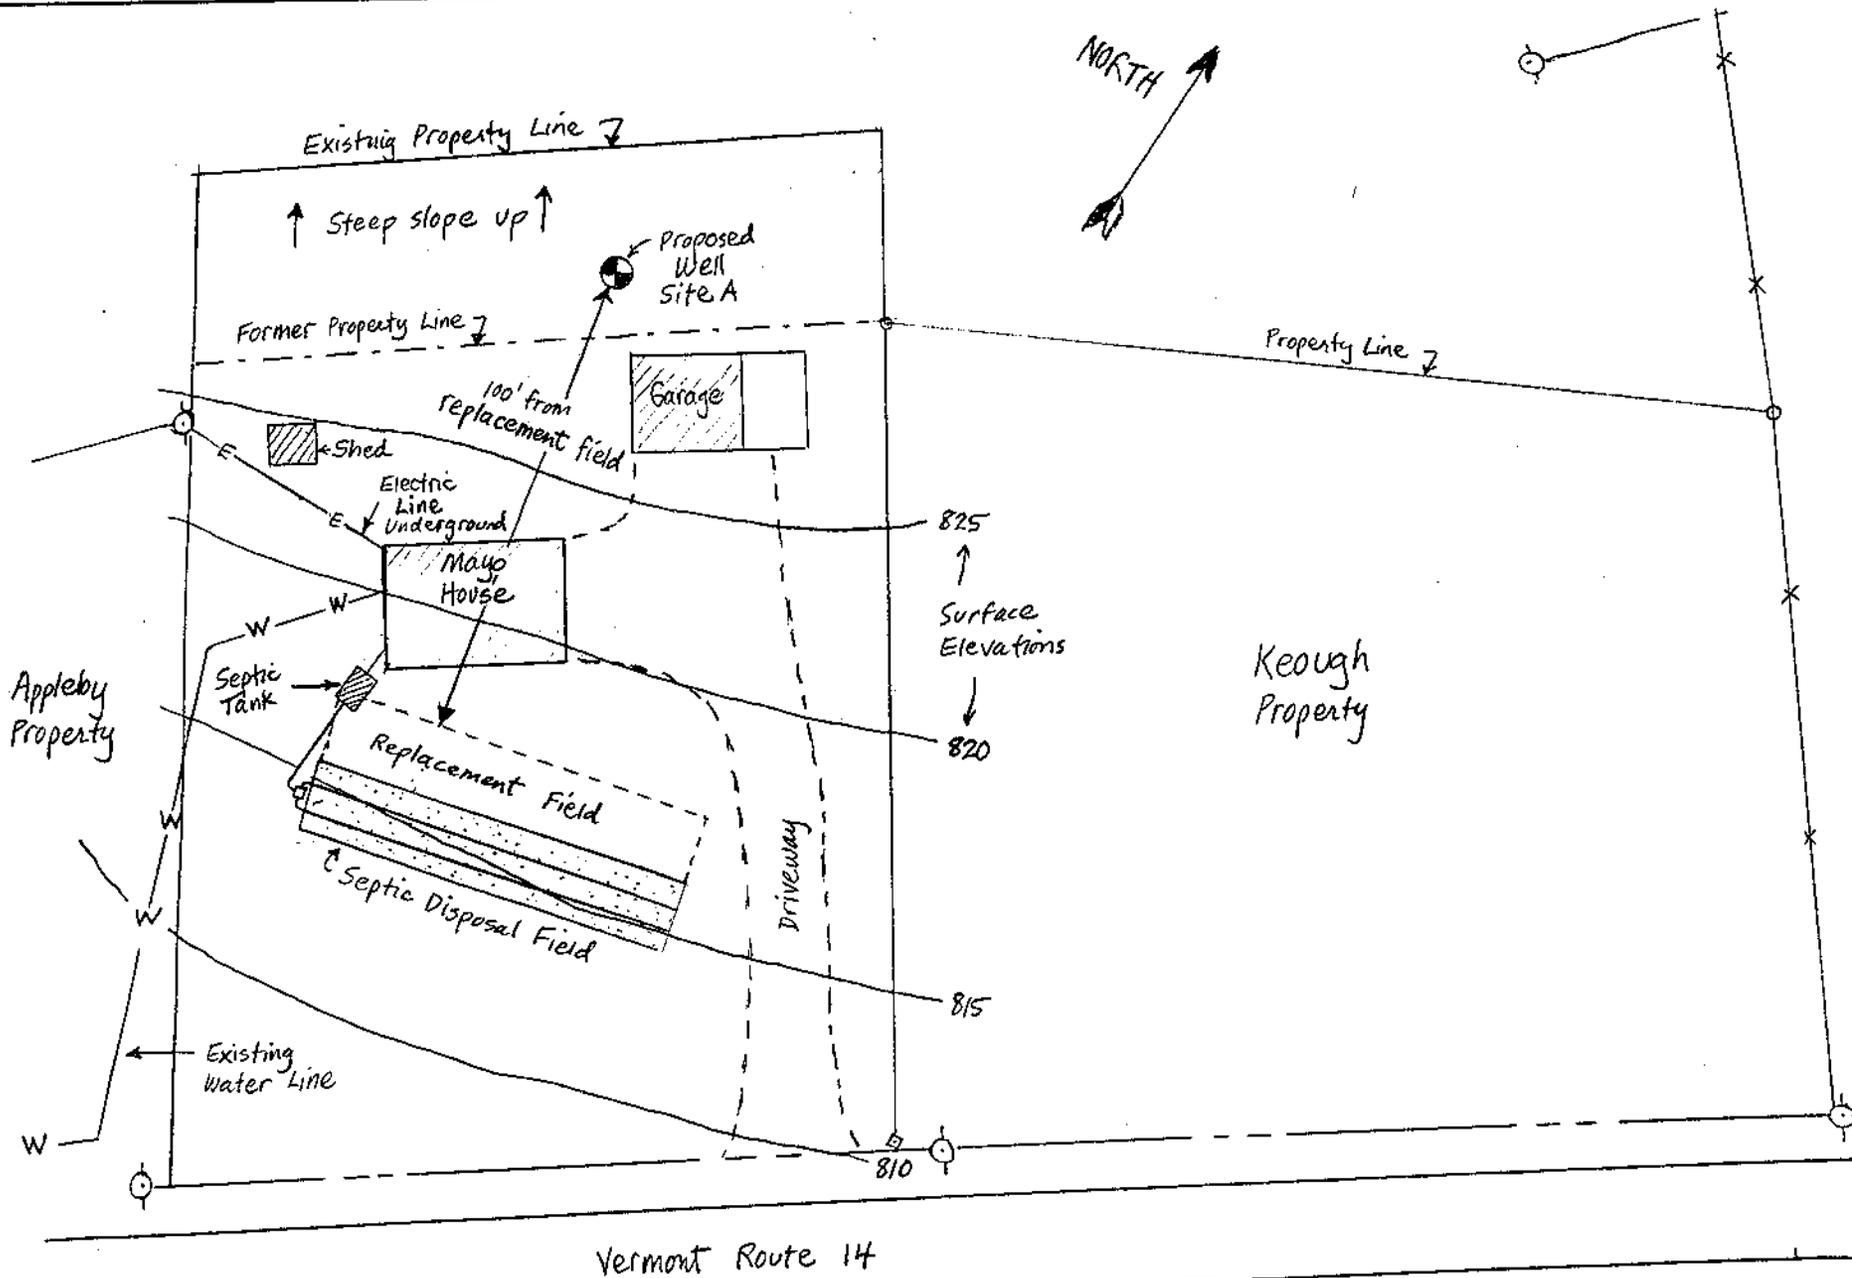
FIGURE 4

As shown on **Figure 4**, the proposed location for the well (site A) is north of the Mayo house and west of the garage near the base of the slope. This is the only location that will meet the required minimum separation distances outlined in the Vermont Water Supply Rule - Chapter 21. The proposed well location is about 25 feet from the northwest property boundary, 25 feet from the garage building, 100 feet upgradient of the replacement septic disposal field (and 115 feet from the existing septic field), and much greater than 100 feet to the Appleby and Keogh downgradient septic disposal fields. The Mayo septic tank is also greater than 90 feet downgradient of the proposed well. ←

Since well site A is located near the base of a steep slope, excavation of soils will be necessary in order to maintain the 100 foot separation distance from the replacement septic disposal field and to maneuver the drill rig in position. Once the well is drilled and completed, the original soil can be backfilled and the slope grade restored after a steel casing extension is placed on the well to bring it a minimum of 1.5 feet above grade.

The proposed well will be drilled to a depth of 300 feet. A 12-3/4" tophole will be drilled to the top of bedrock, and then an 8" air hammer will be used to drill through bedrock to a depth of 100 feet. The borehole will be filled with sufficient neat cement grout to completely fill the annular space between the borehole wall and the exterior of the 6" steel casing when the casing is installed. A temporary plug will be installed in the bottom driveshoe of 102 feet of 6" steel casing (19 lbs/ft). The casing (fully threaded and welded couplings) will be lowered into the borehole and driven into the bedrock, causing displacement of the grout to the surface.
