◆ HOFFER & ASSOCIATES ◆

March 13, 1996

Re: Preliminary Site Investigation, Sylvester's Store, Montgomery, VT
SMS Site # 94-1689

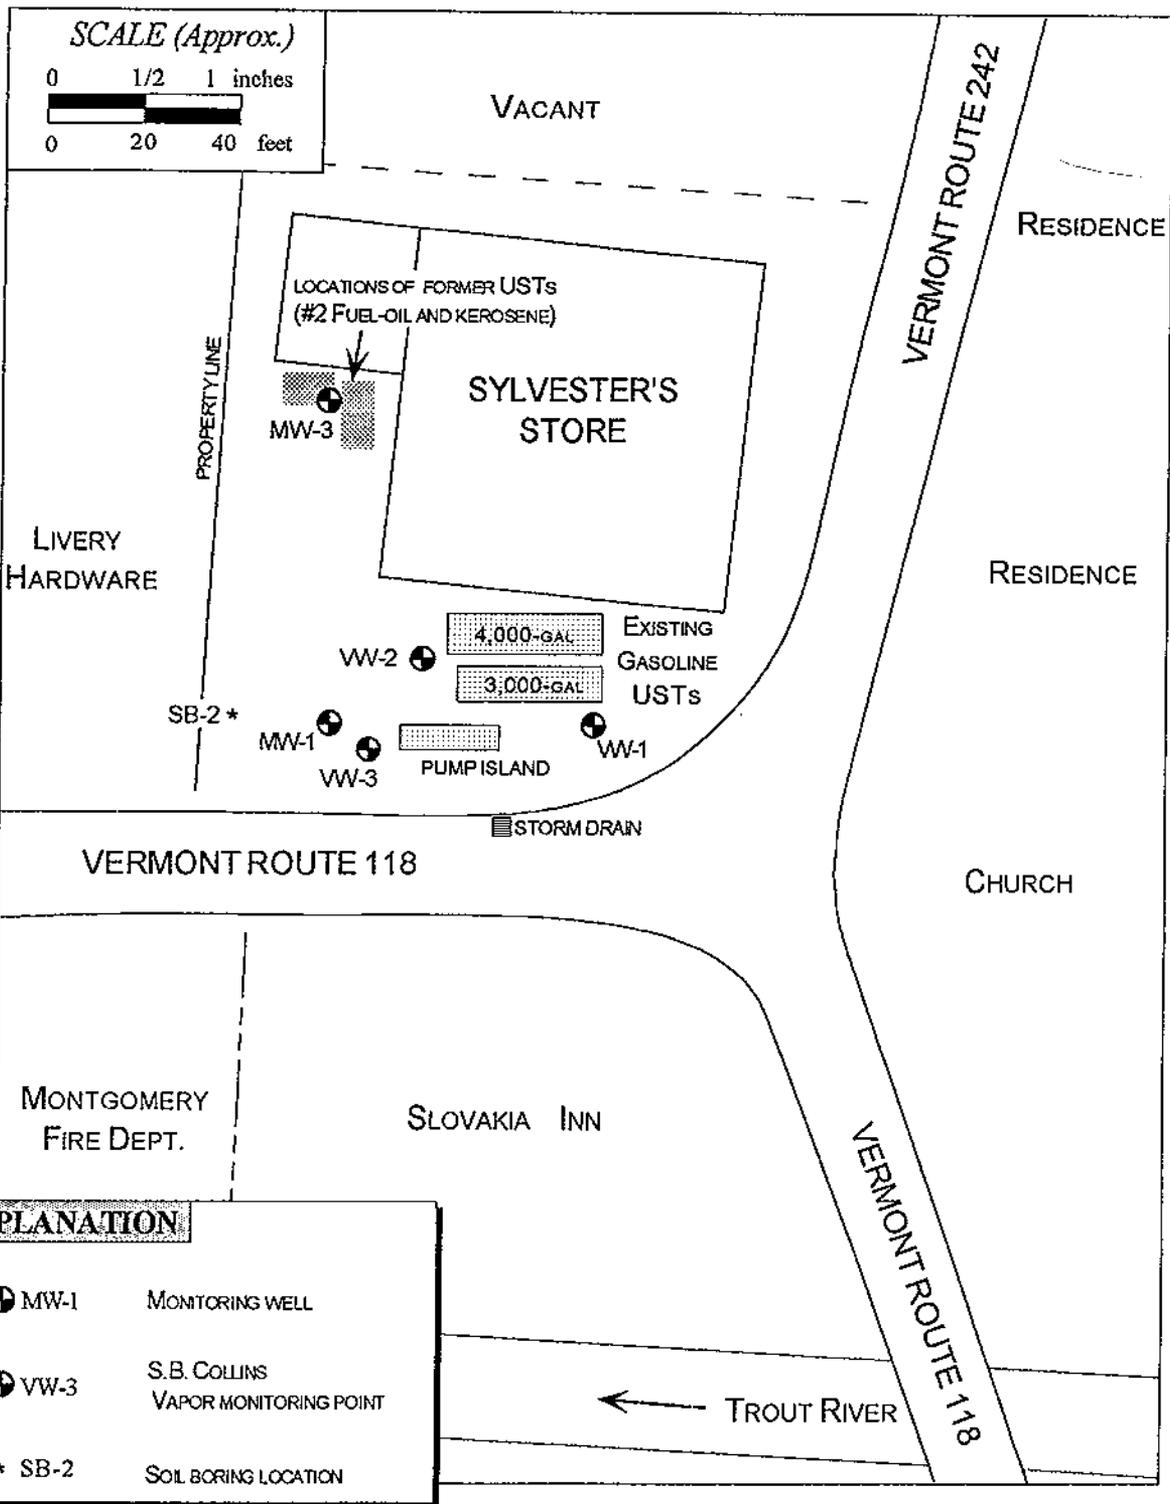
FIGURE 2
 Site map, Sylvester's Store, Montgomery, Vermont,
 SMS Site #94-1689.

Currently, there are two gasoline USTs in use at the site, located between the store and Route 118, as indicated on Figure 2. These USTs and the pumps are owned and maintained by S.B. Collins, of St. Albans, Vermont. Two other USTs, a 550-gallon kerosene and a 1,000-gallon fuel-oil UST were located along the western wall of the store prior to their removal. The former locations of these USTs are shown on Figure 2. The kerosene UST was removed in October 1994, under the supervision of Lincoln Applied Geology, of Bristol, Vermont, and the fuel-oil UST was removed in January 1995 under the supervision of K-D Associates, Inc. (KDAI), of South Burlington, Vermont. Both of these tanks were owned by Ray Sylvester, the previous owner of the property. During the removals of these USTs, petroleum contamination was noted in the soils surrounding the tanks and, as a result, an on-going site investigation was undertaken by KDAI. As part of that investigation, three soil borings were drilled at the site in February 1995. Monitoring wells were constructed in two of the three borings, MW-1 and MW-3. A file review indicated that during the initial monitoring event in February 1995, and a subsequent event in October 1995, both of the monitoring wells were dry. However, photoionization detector (PID) measurements obtained from the well headspaces on both occasions suggested the presence of petroleum contamination in soils surrounding the wells. A site visit by SMS employees in February 1996 confirmed the presence of elevated vapor levels in the monitoring well headspaces.

As indicated by the data, the highest PID readings were obtained in the vicinity of MW-1 and VW-3, located southwest of the USTs and pump island.
