RE: Underground Storage Tank (UST) Removal Inspection at H.N. Sanborn & Son, Chelsea, Vermont (UST Facility ID #6854646)

**UST REMOVAL AT H.N. SANBORN & SON REALTY
SITE PHOTOGRAPHS**

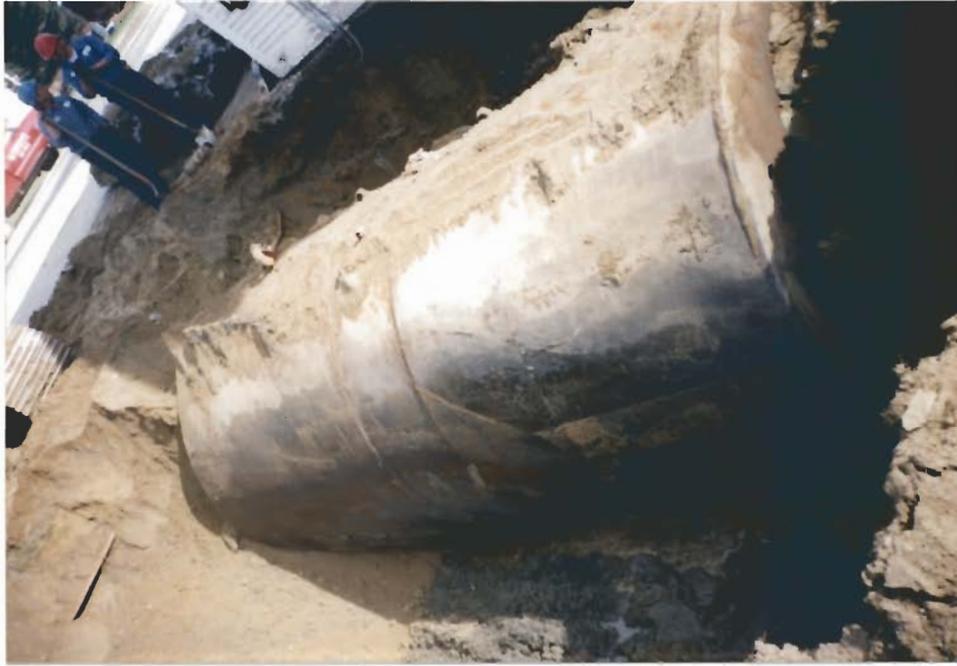
UST #1 IN TANK PIT

As soils were removed from around tank no. 1, groundwater flowed into the excavation and the tank began to float upward from the buoyant forces created by the water in the pit. A slight sheen was observed on groundwater along the northern side of the tank. As the tank was removed from the pit with the excavator, water flowed into where the tank had lain, and the sheen on the water surface was no longer visible. The tank was inspected after it had been removed from the ground. Based on visual observation, the tank appeared to be in good condition. It was only slightly corroded with some pitting in the area that was located near the water/soil interface. No holes were observed, nor was there any evidence that the tank had leaked.

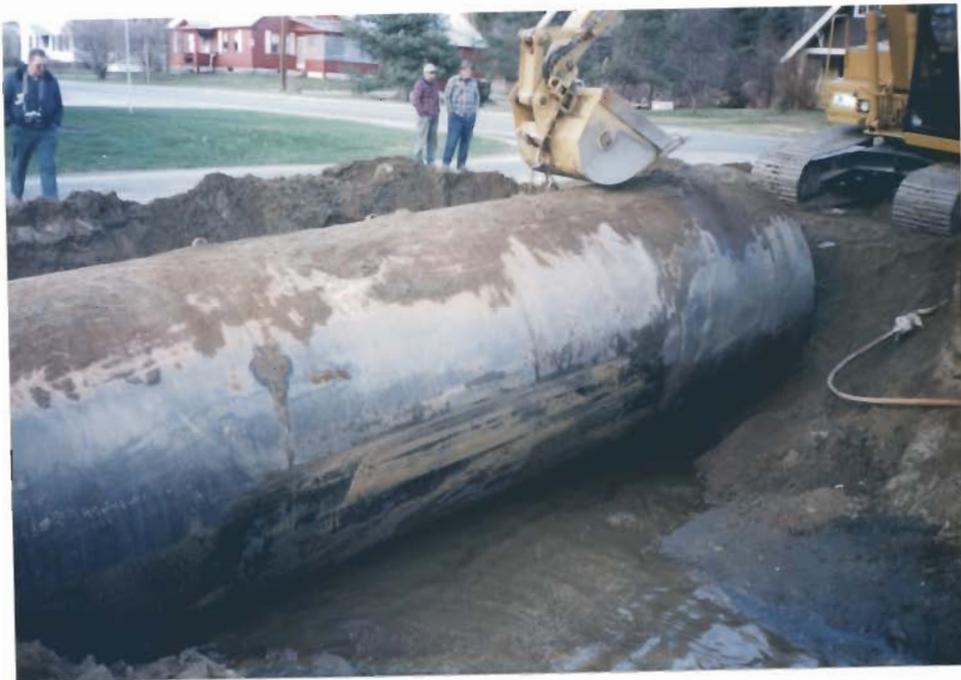
UST #2 IN TANK PIT

Additional soil was removed from the tank pit for the removal of the 10,000 gallon tank (tank no. 2). Screening of these soils indicated a maximum VOC concentration of 200 ppm and a minimum concentration of 35 ppm, with an average of approximately 90 ppm. The tank was inspected as it was removed from the excavation and found to be in similar condition as tank no. 1. No holes were observed in the tank. Black stained soils were noted along the side of the tank. Removal of these soils revealed that the tank was in good condition. As a significant level of petroleum contamination was detected in the soils removed from the ground, the temporarily stockpiled soil was placed on and covered with polyethylene to prevent the spread of contamination to the environment.

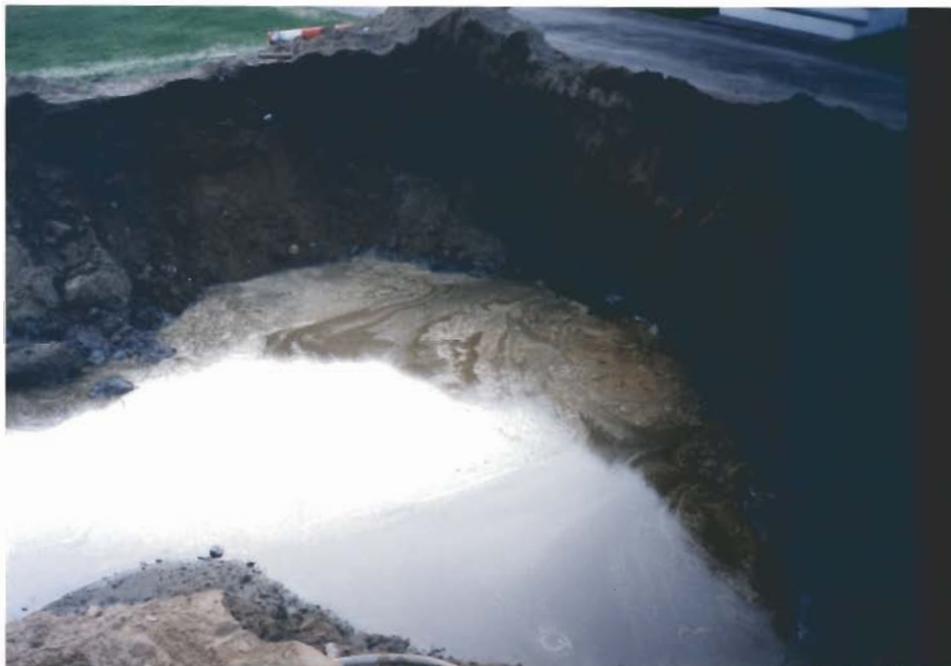
EMPTY TANK PIT

Based on observations made during this tank removal inspection, petroleum contamination appears to have impacted soil and groundwater in the immediate vicinity of the tank pit. The extent of the contamination has not been defined. Based on a visual survey of the vicinity, the most immediate potential receptor to petroleum contamination is the First Branch of the White River, located approximately 100 feet to the west of the tank pit, in the likely hydraulically downgradient direction. The banks of the river were inspected at the time of the tank removal, and no evidence of petroleum contamination was observed.

In response to the petroleum contamination detected in the subsurface at this site, work should be conducted to further define the extent and degree of petroleum contamination at the site. This may be done through the collection and analysis of groundwater samples from the three monitoring wells already installed at the site.
