Re: Investigation of Subsurface Petroleum Contamination for Don's Auto in Derby, Vermont
(Vermont DEC Site # 95-1811)

**REPORT ON THE INVESTIGATION
OF SUBSURFACE
PETROLEUM CONTAMINATION**

**DON'S AUTO
MAIN STREET
DERBY, VERMONT**

VTDEC SITE #95-1811

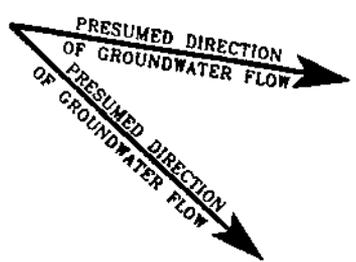
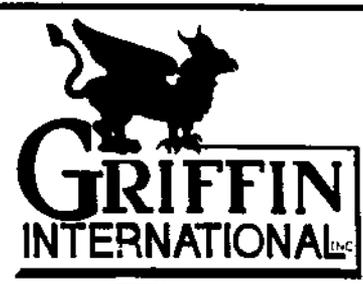
GROUNDWATER ELEVATION MAP

The water table elevations in all on-site monitoring wells were measured on June 26, 1996. After measuring the water table elevations, it was apparent that the aquifer that MW2 is completed in is not likely the same aquifer as in MW1 and MW3. For this reason, the groundwater surface could not be contoured. The available data is inconclusive with regard to

groundwater flow direction because MW1 and MW3 encountered a shallow and presumably perched aquifer. MW2 did not encounter this aquifer. Rather, MW2 encountered a deeper aquifer that MW1 and MW3 apparently did not encounter. Four hundredths of a foot (0.04') of free product was detected in MW2; free product was not detected in MW1 or MW2. It is assumed that the groundwater in the vicinity of the site flows south-southwest towards the Clyde River.

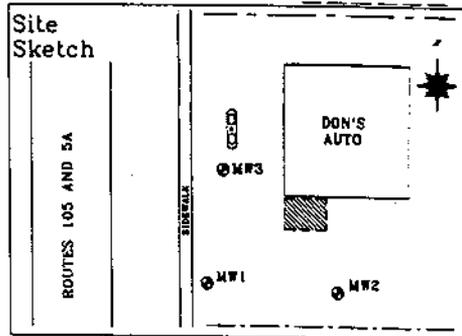
WELL NUMBER MW1

MW1 was drilled southwest of the building at Don's Auto, approximately 30 feet west and 20 feet south of the center of the former UST field. The boring of MW1 intersected damp, brown silt underlain by damp and wet silt with few clay particles and a trace of fine medium sand. MW1 was drilled to 14.5 feet below grade. The water table was intersected at approximately 6 feet below grade. VOC concentrations were non-detect in all of the samples collected from MW1.

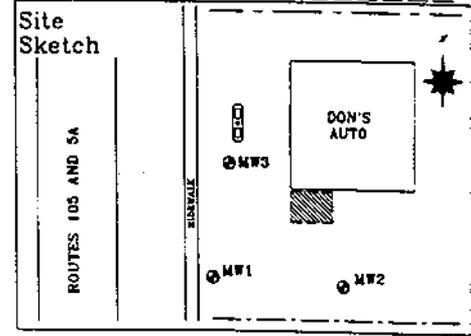
WELL NUMBER MW2

MW2 was drilled approximately 20 feet south and approximately 10 feet east of the center of the former UST field. The boring of MW2 intersected moist, brown silt at 3.0 feet, underlain by damp, brown silt with some very fine grained sand. This soil was subsequently underlain by moist, gray silt with fine and medium graded sand, and a trace of gravel. This soil was subsequently underlain by moist to wet silt, damp silt, and fine sand with some rock fragments. Gasoline odor was detected in the sample collected from 14.5 feet. MW2 was drilled to 17.0 feet below grade, with the base of the well set at 14.5 feet below grade. The water table was intersected at approximately 12.3 feet below grade. VOC concentrations detected in soil samples collected from the vadose zone ranged from 0.2 ppm to non-detect, decreasing with depth. VOC concentrations detected from soil samples collected from the phreatic zone ranged from 6.0 to 110 ppm, increasing with depth.

2) A product recovery program should be implemented on MW2 to determine the free product yield of the well.

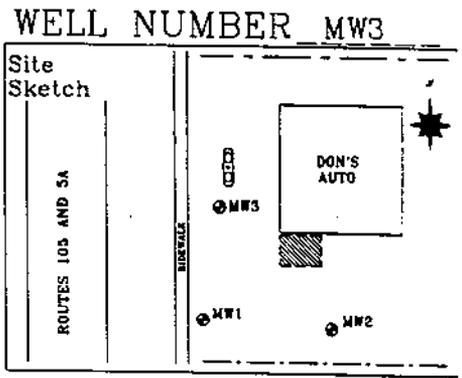
MW3 was drilled approximately 15 feet north and approximately 15 feet west of and up-gradient from the former UST field. The boring of MW3 intersected dry, brown sand and gravel fill underlain by wet, brown silt with few clay and medium to fine sand. This soil was subsequently underlain by black sand 3" thick and exhibiting a strong gasoline odor. MW3 was drilled to 14 feet below grade, with the base of the well set at 13.0 feet below grade. The water table was intersected at approximately 5.5 feet below grade. VOC concentrations were non-detect in soil samples collected from the vadose zone and were greater than 120 ppm in the soil sample collected from the phreatic zone. The highest VOC concentration detected was greater than 120 ppm at 9.5 to 14.0 feet below grade.
