April 14, 1997

RE: AOT/Londonderry Site, Londonderry (VDEC #95-1866) - Receptor Survey & Contamination Summary

Lincoln Applied Geology, Inc. (LAG) is pleased to present this summary report addressing soil and ground water contamination at the AOT/Londonderry site at the intersection of Routes 11 and 100, Londonderry, Vermont. During road construction activities related to installation of a new bridge over the West River in 1995, petroleum contaminated soils were encountered at the intersection of Routes 11/100, located northwest of the bridge. As a result, approximately 1,000 cubic yards of petroleum contaminated soils were excavated, transported to the Agency of Transportation (AOT) facility in East Jamaica, and covered with poly tarps. Fill soils consisting of sand, gravel, and crushed stone were placed as road bed material in the excavated areas, compacted, and the road paved. Storm sewer and underdrain pipes were also installed beneath the road perimeter to convey ground water away from the roadway.

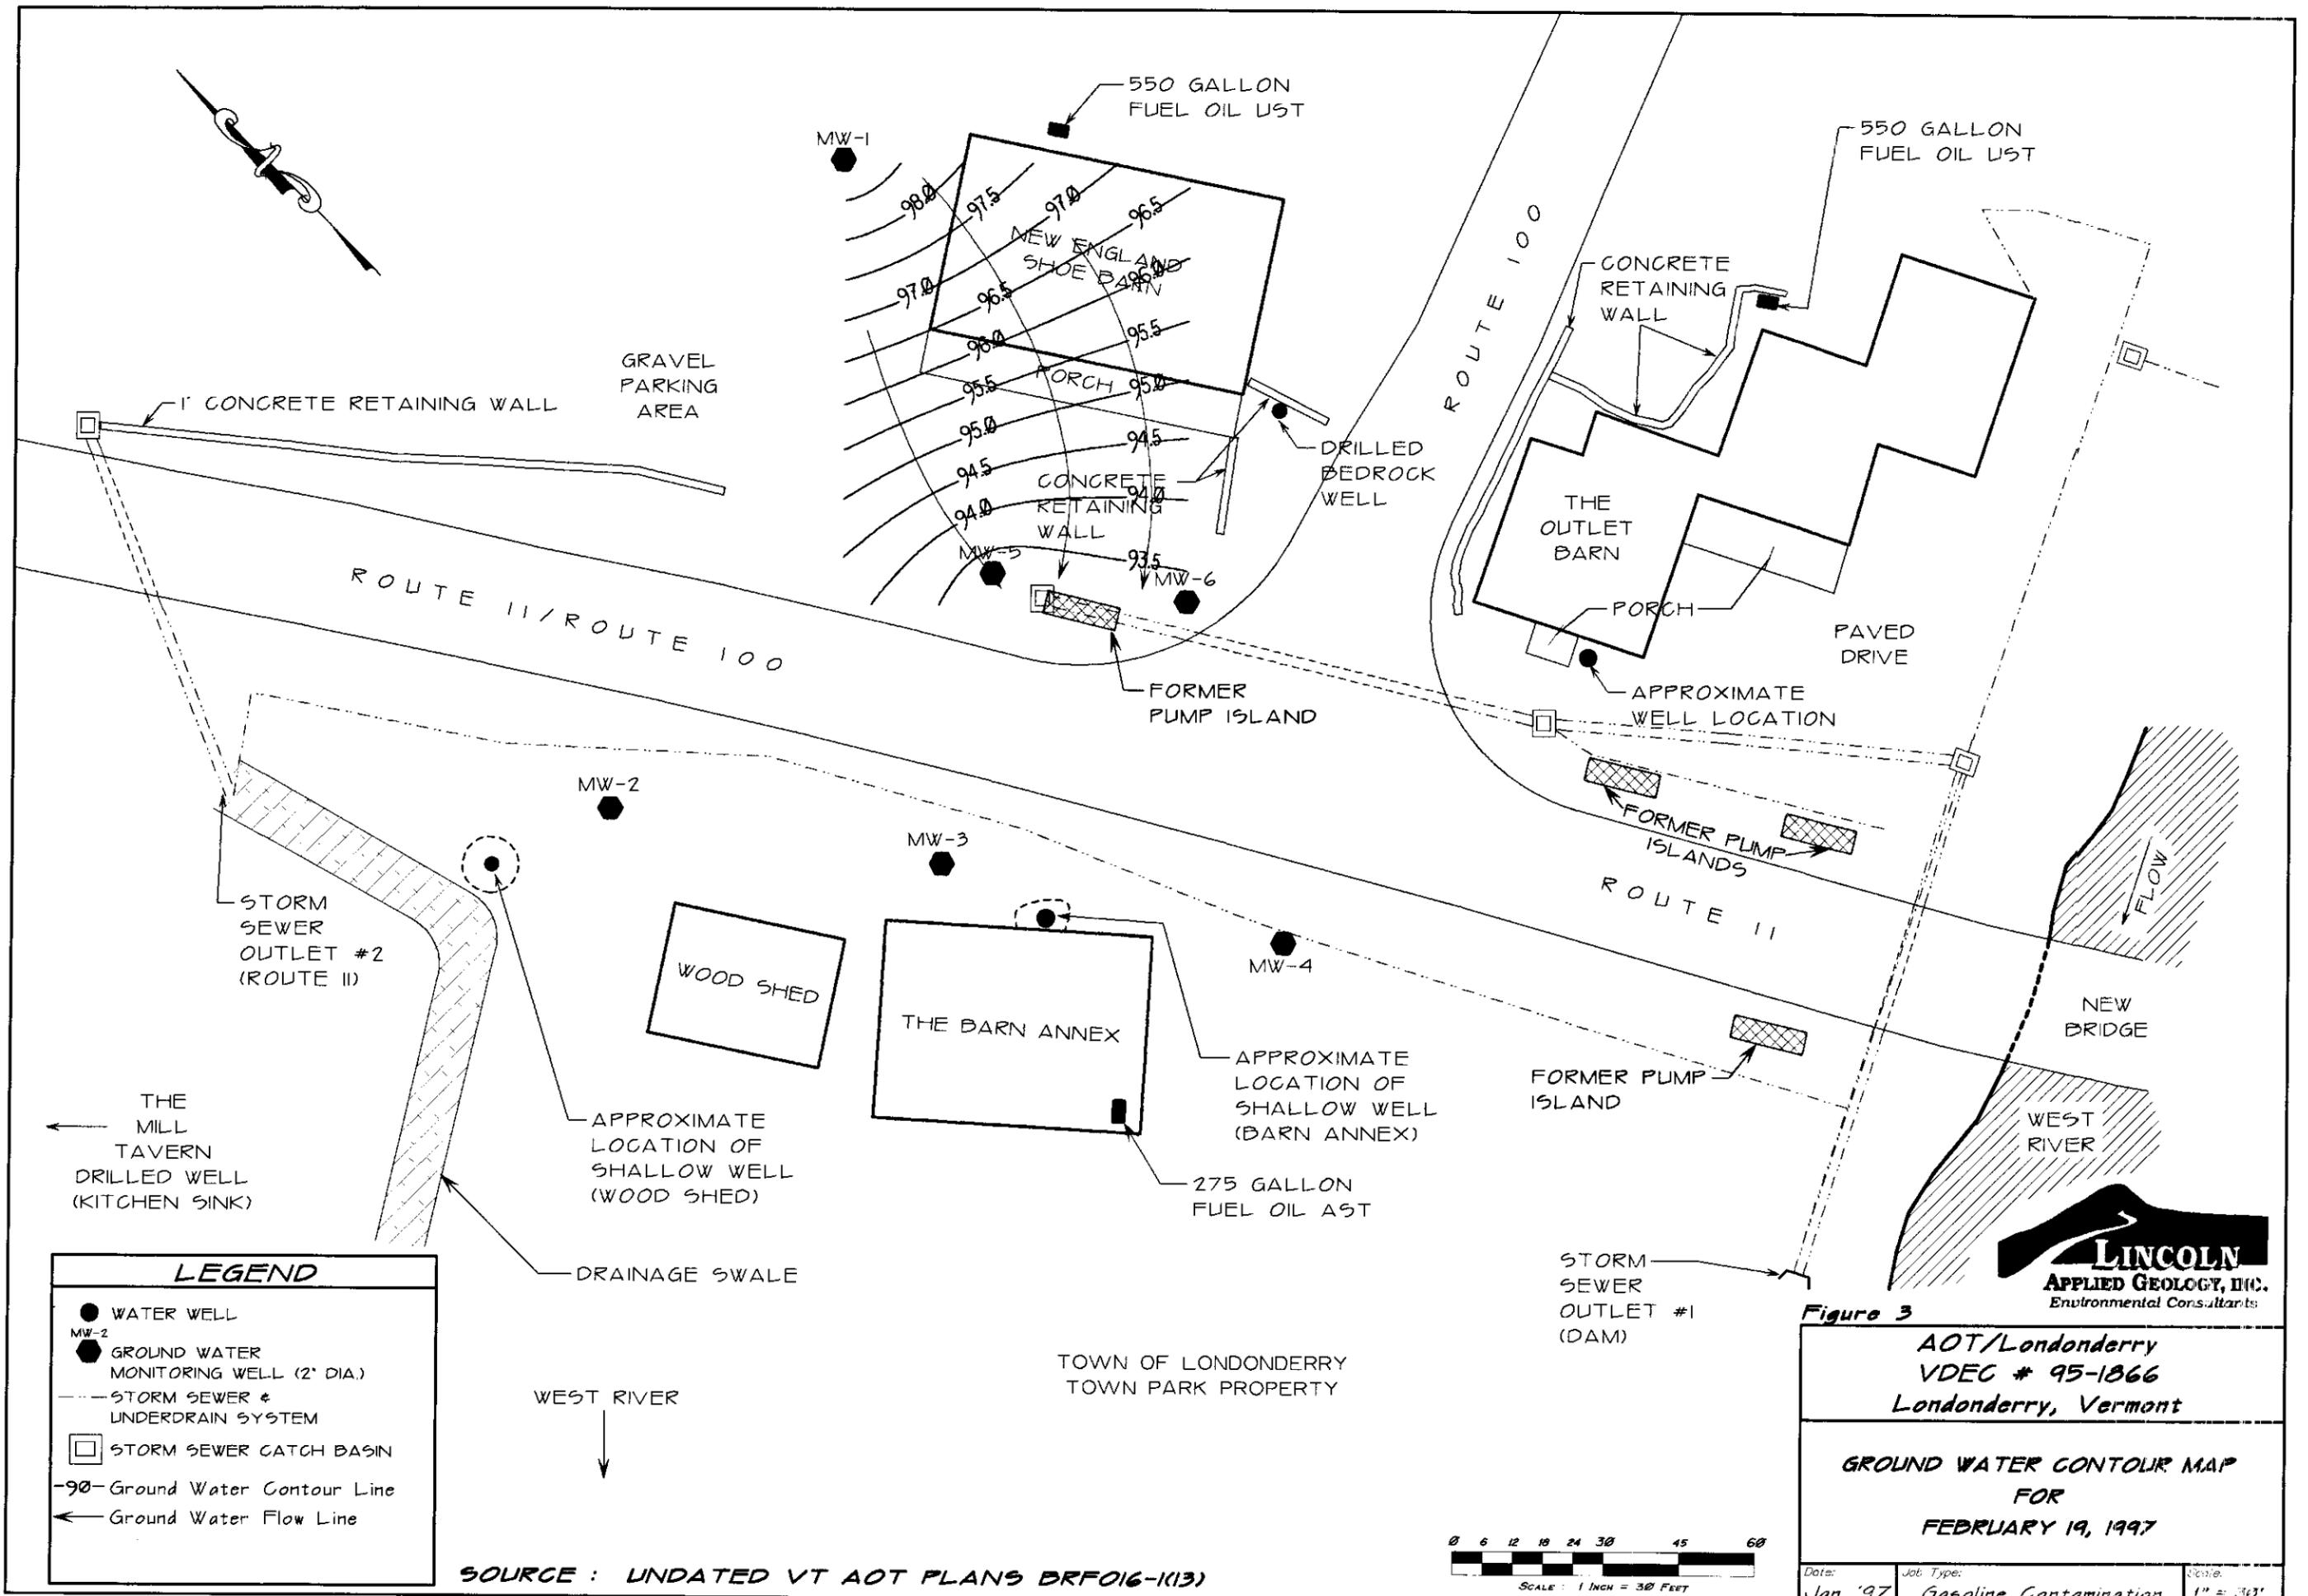
Figure 3

Depth to bedrock (auger refusal) data collected from the six wells and the Dufresne and Henry, Inc. soils excavation data indicate that a bedrock "high" exists at a depth of 3 to 5 feet below grade along Routes 11/100 between the NESB property and the BA property/Wood Shed property. During road construction some of the bedrock was hydraulically hammered apart and removed prior to placement of the road bed. As shown in **Table 2**, ground water was present in MW-1 and MW-3 on January 23, 1997. On February 19, 1997, only MW-1, 5, and 6 on the north side of Routes 11/100 contained ground water, while wells MW-2, 3, and 4 on the south side of the road were dry. As shown on **Figure 3**, the shallow ground water flow direction in the vicinity of the NESB is from the north to the south-southwest. Although the ground water level data collected to date is limited, shallow ground water flow is probably strongly controlled by: the bedrock surface as it relates to the shallow ground water system; and locations and depths of subsurface utility trenches (storm sewer and underdrain) which may provide preferential ground water flow pathways due to their greater permeability as compared to adjacent undisturbed soils. As a result, ground water contamination is likely present in the upper part of the fractured bedrock beneath Routes 11/100 which has preferentially migrated southeast toward the West River within the storm sewer trench.

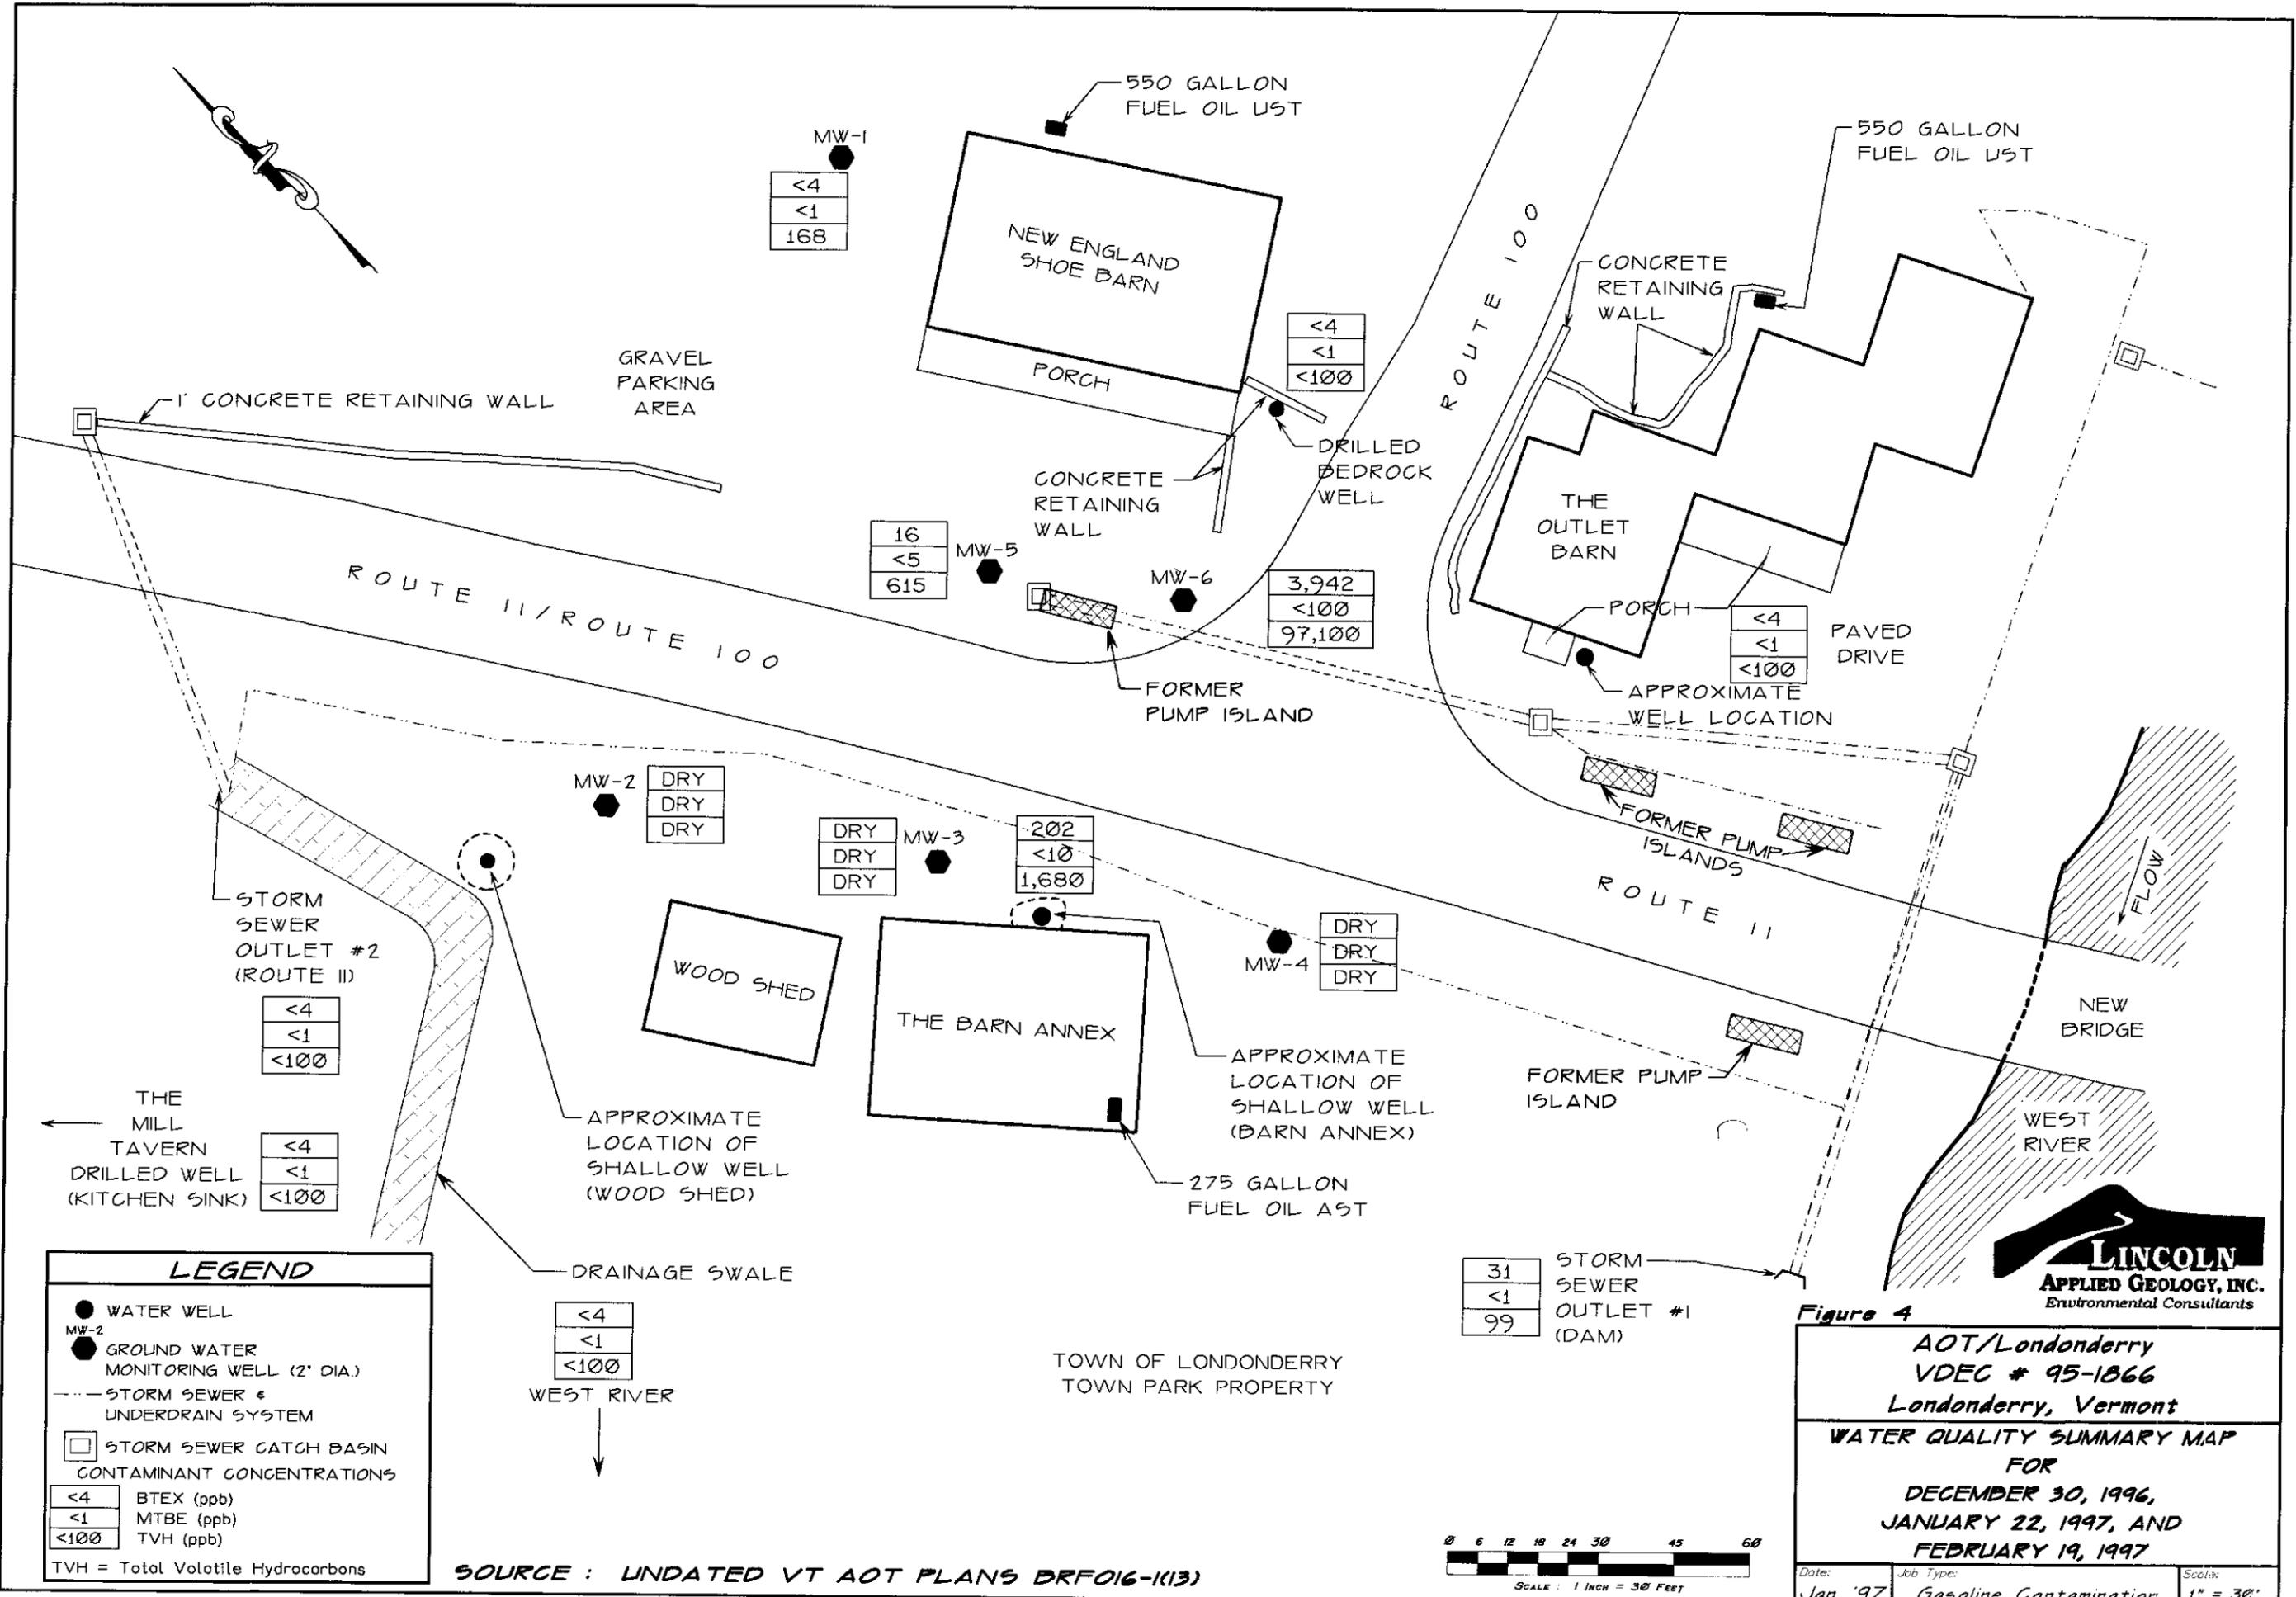
Figure 4

Review of **Table 1** indicates that upgradient well MW-1 contained no detectable levels of BTEX and MTBE, and a low level of 168 ppb TVH. Since the NESB septic system is near MW-1, the low level of dissolved TVH may be caused by low levels of volatile wastes disposed in the septic system, petroleum leaked from vehicles in the unpaved gravel parking lot, or "old" petroleum waste from operation of the former truck service garage that was located on this property. Well MW-5 contained only 1 ppb xylenes, and 615 ppb TVH. These levels are also very low and are attributed to residual "old" gasoline contaminants related to leakage or spillage from the former gasoline UST, delivery piping, pumps, or during refueling events. Moderate levels of "old" gasoline contaminants were detected in MW-6. These include 115 ppb benzene, 147 ppb toluene, 230 ppb ethylbenzene, 3,450 ppb xylenes, and 97,100 ppb TVH. When MW-6 was installed a petroleum "sheen" was present atop water purged from the well. Gasoline contaminants present in soils and ground water associated with the former UST and pump island location (northwest of MW-6) migrated toward the southwest beneath Routes 11/100 into the BA shallow well, and along the more permeable backfill soils surrounding the storm sewer pipe to the southeast. **Figure 4** was prepared from water quality data collected from surface water, bedrock and shallow well ground water, and monitoring well ground water samples collected on December 30, 1996, January 22, 1997, and February 19, 1997. Additional areas of soil and ground water contamination may be associated with the former gasoline pump islands (and USTs?) that existed along Route 11 on the OB property and Town Park property to the south-southeast.

7. Ground water was only present in MW-1, 5, and 6 in February 1997. Ground water flow is toward the south-southwest on the NESB property. Low to moderate gasoline related contaminants were present in the shallow ground water system from MW-5 and MW-6 at the former location of a gasoline UST and pump island. The presence of low contaminant levels in the BA shallow well to the southwest indicates that a low level contaminant plume is present beneath the BA property and probably the Town Park beyond.

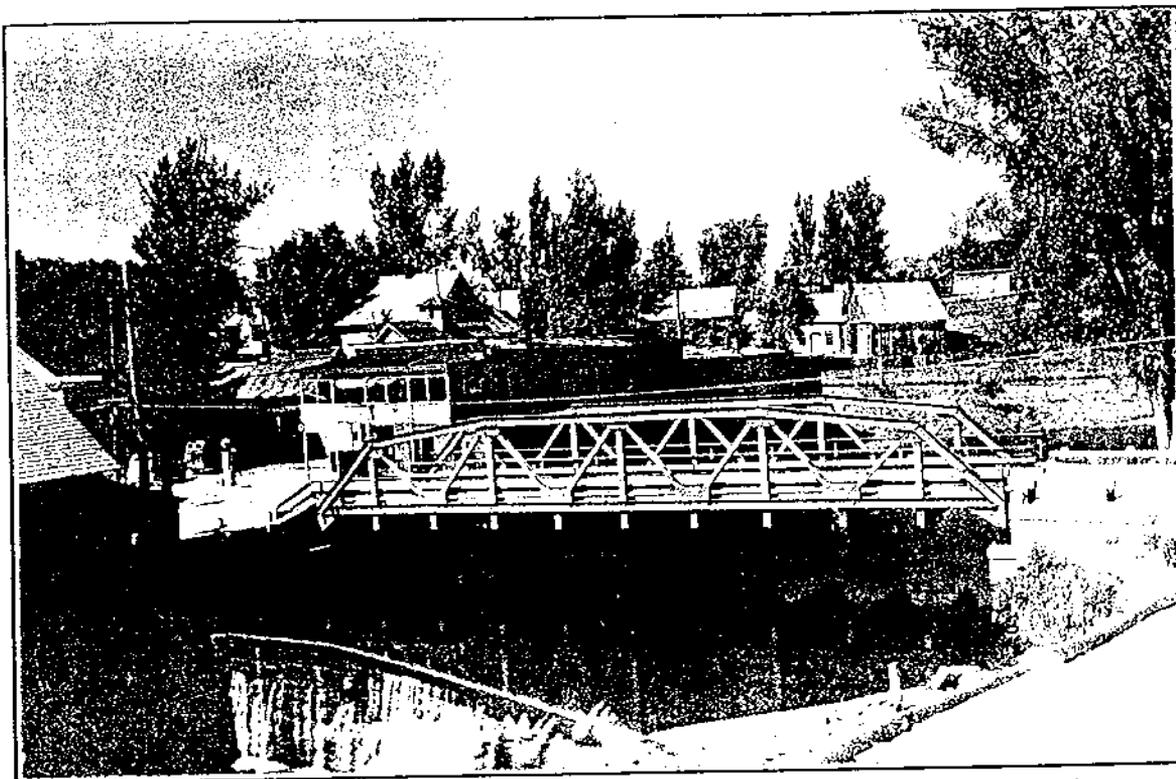
Photograph #1

View to north of West River, bridge, and former gasoline station on The Outlet Barn property.

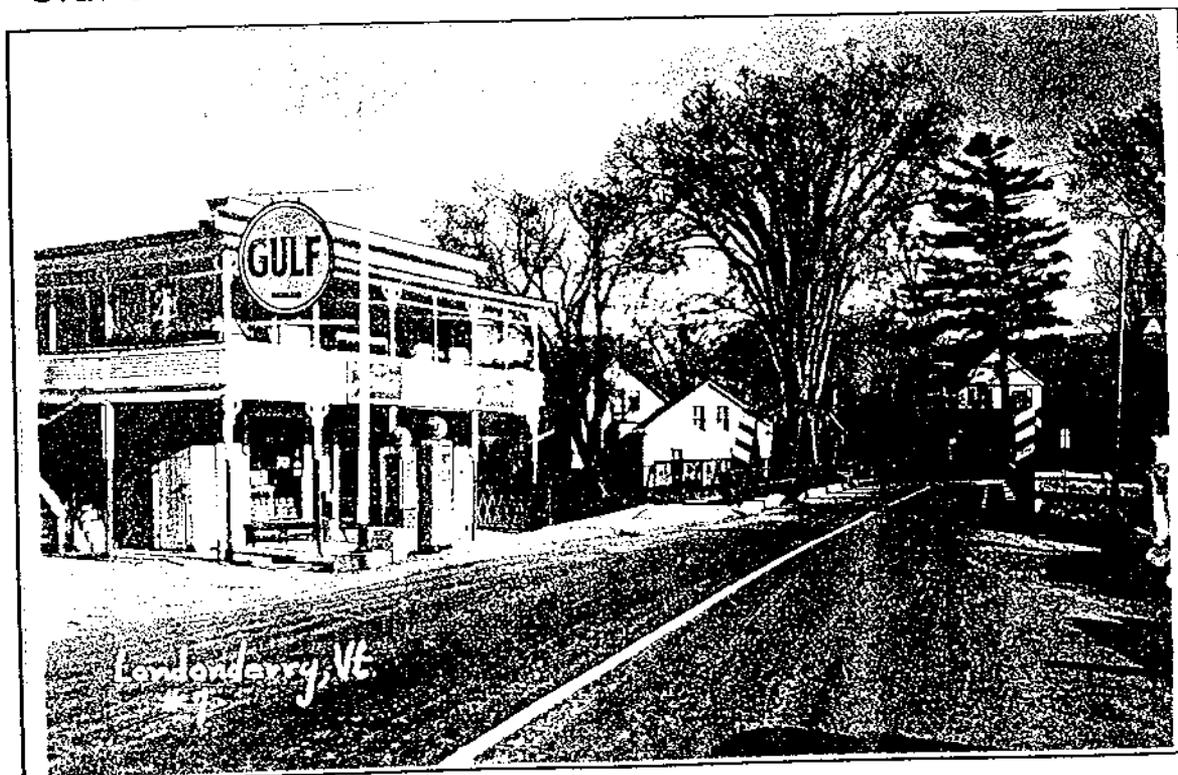
Photograph #2

View to southeast of former Gulf station and gasoline pumps on The Outlet Barn property, bridge, and gasoline pump on the Town of Londonderry property.

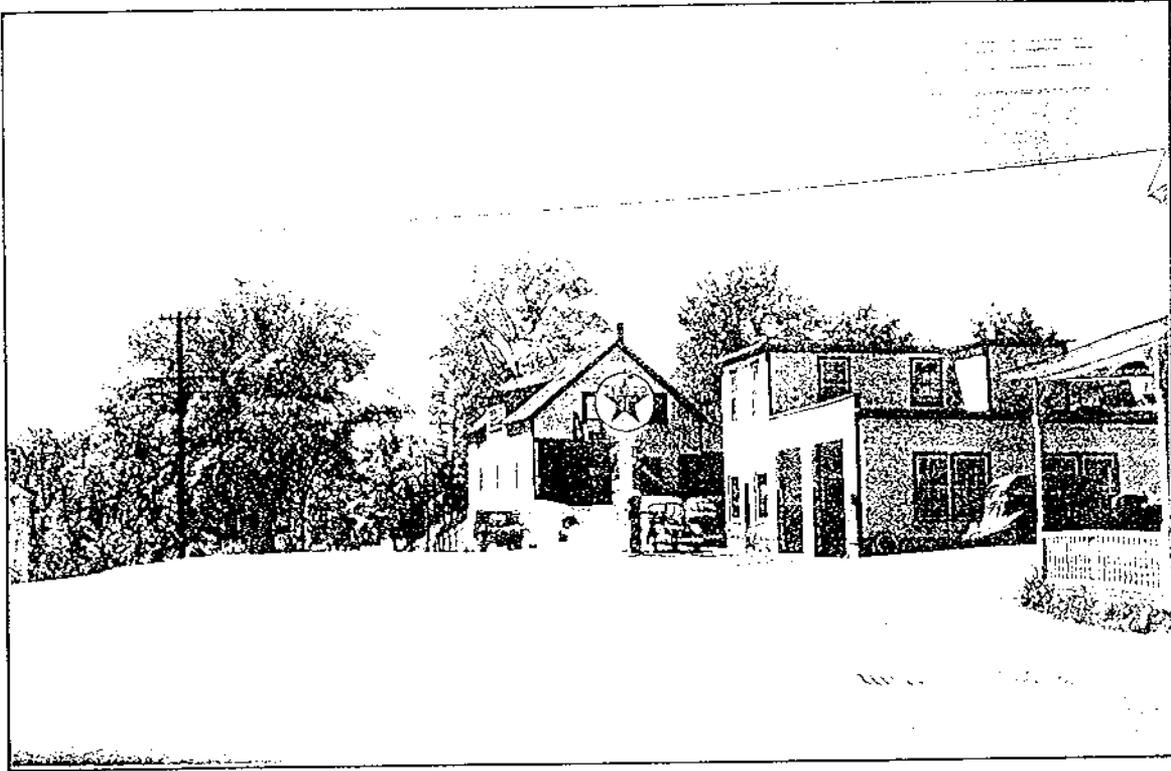
Photograph #3

View of north of former Texaco gasoline station and truck repair garage on the New England Shoe Barn property.

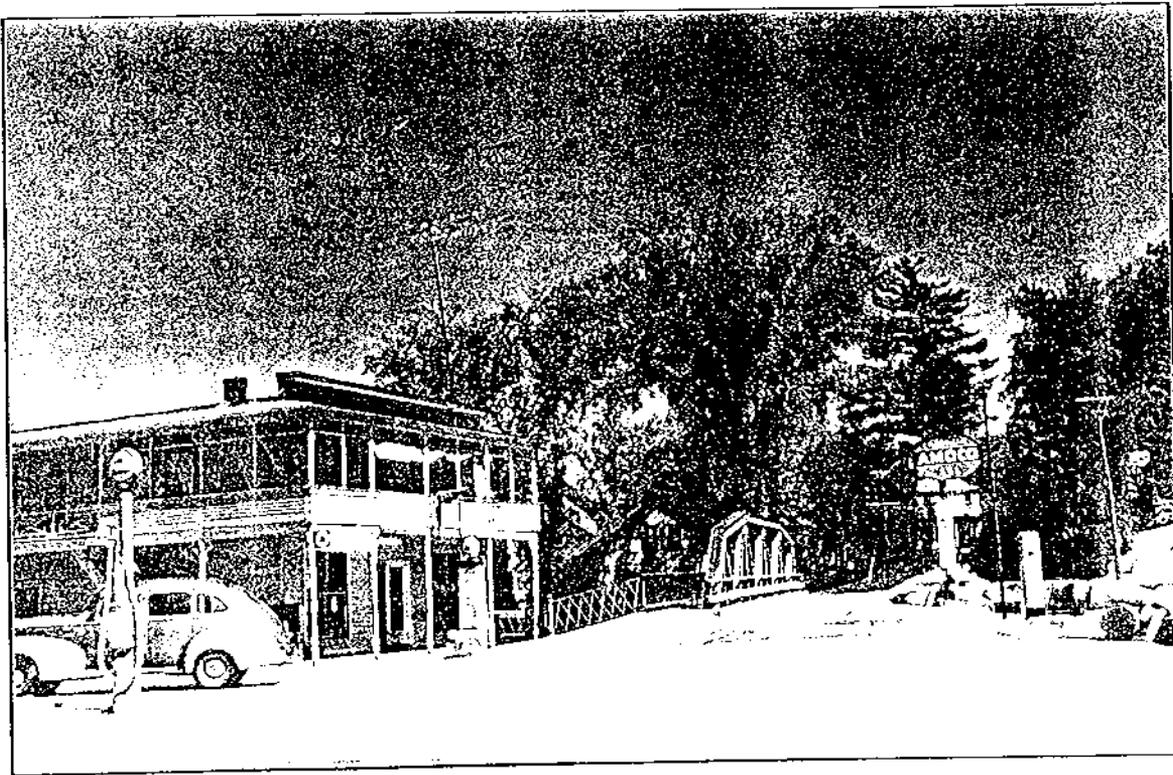
Photograph #4

View of southeast of former Gulf station and Mobil gasoline pump on The Outlet Barn property, bridge, and Amoco gasoline pump on the Town of Londonderry property.
