INITIAL SITE INVESTIGATION REPORT

Heritage Building
 River Street
 Montpelier, VT

VT DEC No. 95-1912
 SEI Project No. 96-597

May 24, 1996

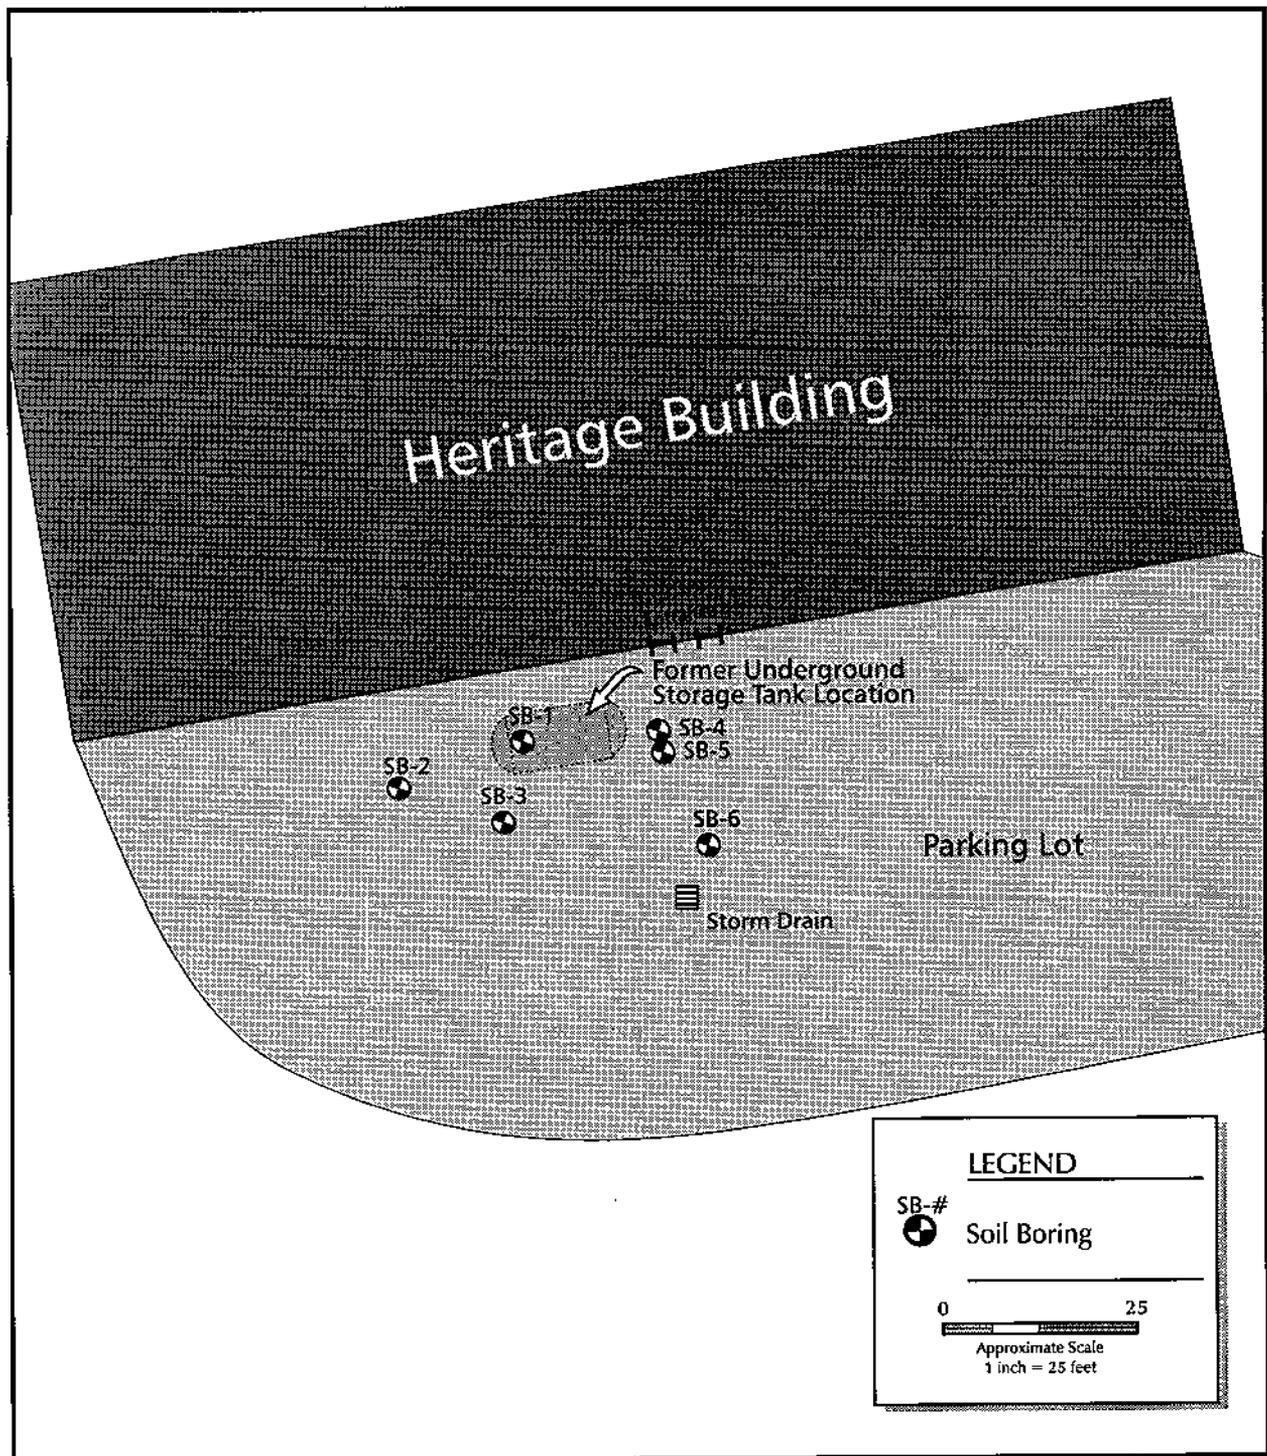
FIGURE 2: SITE MAP
 Heritage Building
 Montpelier, Vermont

On April 30, 1996 Adams Engineering of Underhill, VT, under the supervision of SEI, advanced six boreholes at the site. The purpose of the soil borings was to better define the lateral and horizontal extent of soil and/or groundwater contamination found during the removal of the UST. The borehole locations are shown in figure 2. The soil samples were collected continuously with Adam's vibratory drill rig, logged, split in discrete increments, and placed in ziplock baggies. The head space of each sample was then analyzed for VOCs with a Mini RAE[®] PID. The PID was calibrated on site using 100 ppm Isobutylene and was equipped with a 10.6 eV lamp. The soil boring logs and the VOC results are tabulated below.

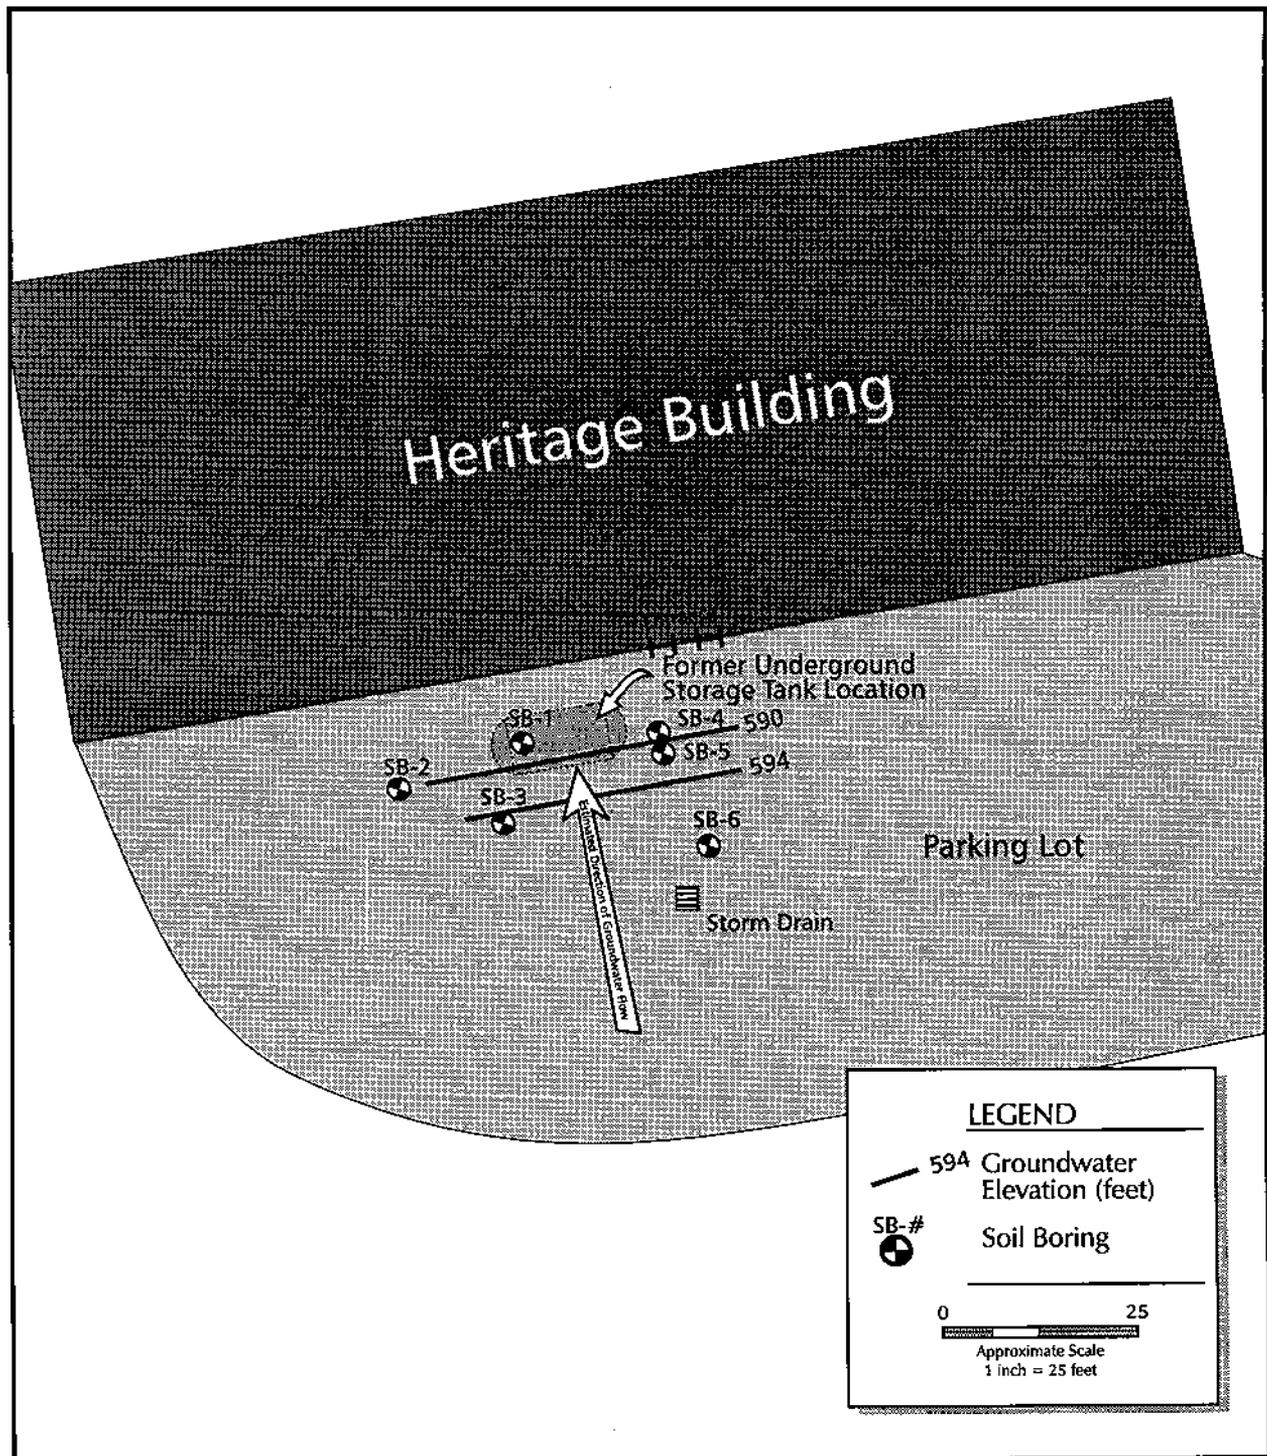
FIGURE 3: GROUNDWATER ELEVATIONS, APRIL 30, 1996
Heritage Building
Montpelier, Vermont

The site is overlain by cobbly backfill which led to poor recovery in many of the borings. A clay layer was observed which dips steeply to the North. It was observed at approximately 2 feet in SB-3 and approximately 11 feet in SB-2. The sediments overlaying the clay layer were primarily sand and gravel and comprise the surficial aquifer at the site. Based on these observations groundwater is flowing to the North (see figure 3).
