Marin Environmental, Inc.

22 August 1997

RE: *Initial Site Investigation Report*
Guay's General Repair, Newport, Vermont 951928

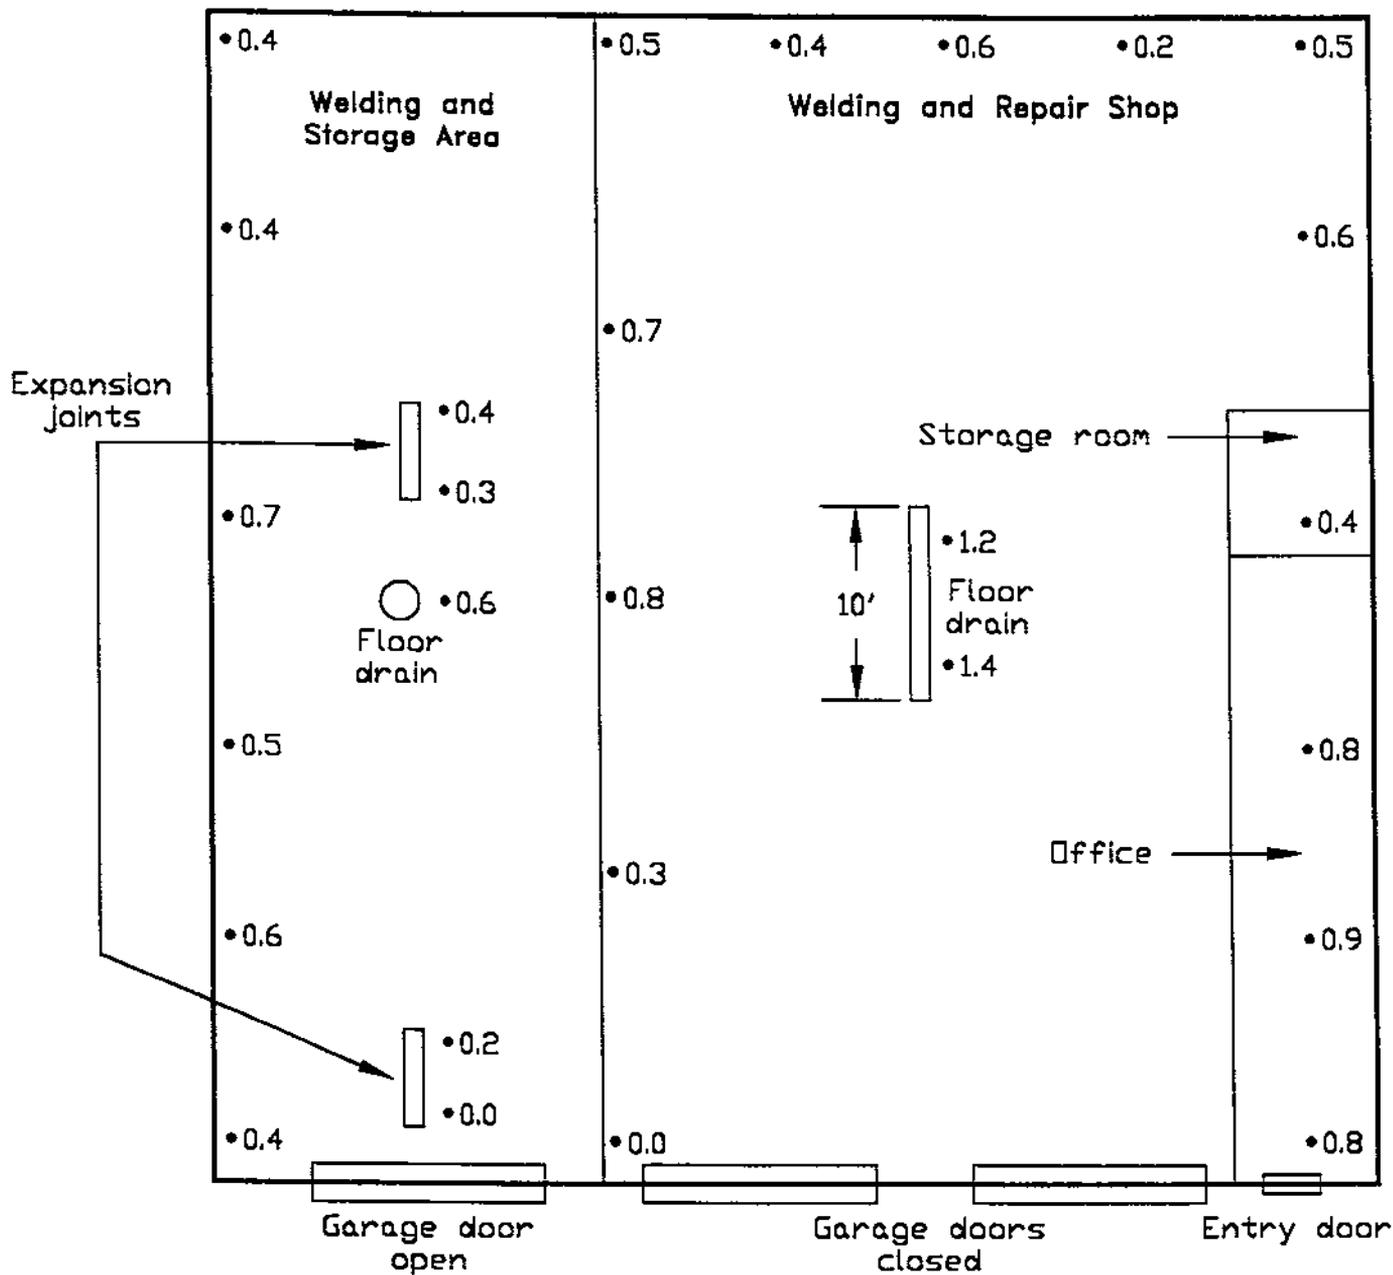
**FIGURE 2.
PID READINGS
INDOOR AIR QUALITY**

- Neither of the two identified sensitive receptors appear to have been impacted by gasoline-related contaminants associated with the former UST.
- No gasoline compounds were detected in a water sample collected from the on-site drinking water supply well.
- Indoor air PID readings along the baseboard perimeters of the welding/repair shop, storage area, and office space ranged from 0.0 to 1.4 ppm, with the highest reading located in the welding/repair shop near the floor drain. Given the building use, the readings are not considered to be significantly elevated above background levels.

No cracks were observed in the floors; however, two floor drains exist in the building. One of the floor drains is located in the center of the welding/repair shop, and the other is located in the center of the storage area. PID readings were obtained along the baseboard perimeter and floor drains of the welding/repair shop, storage area, and office space. PID readings ranged from 0.0-1.4 ppm, with the highest reading located near the floor drain in the welding/repair shop (Attachment A, Figure 2). Given that these measurements were collected in an automotive repair shop, which uses a variety of volatile chemicals, these readings are not considered to be elevated above background levels.
