Initial Site Investigation

June 1997

**Maple Street Site
East Haven, Vermont
DEC Site #96-2008**

THE JOHNSON COMPANY, INC.
Environmental Sciences and Engineering

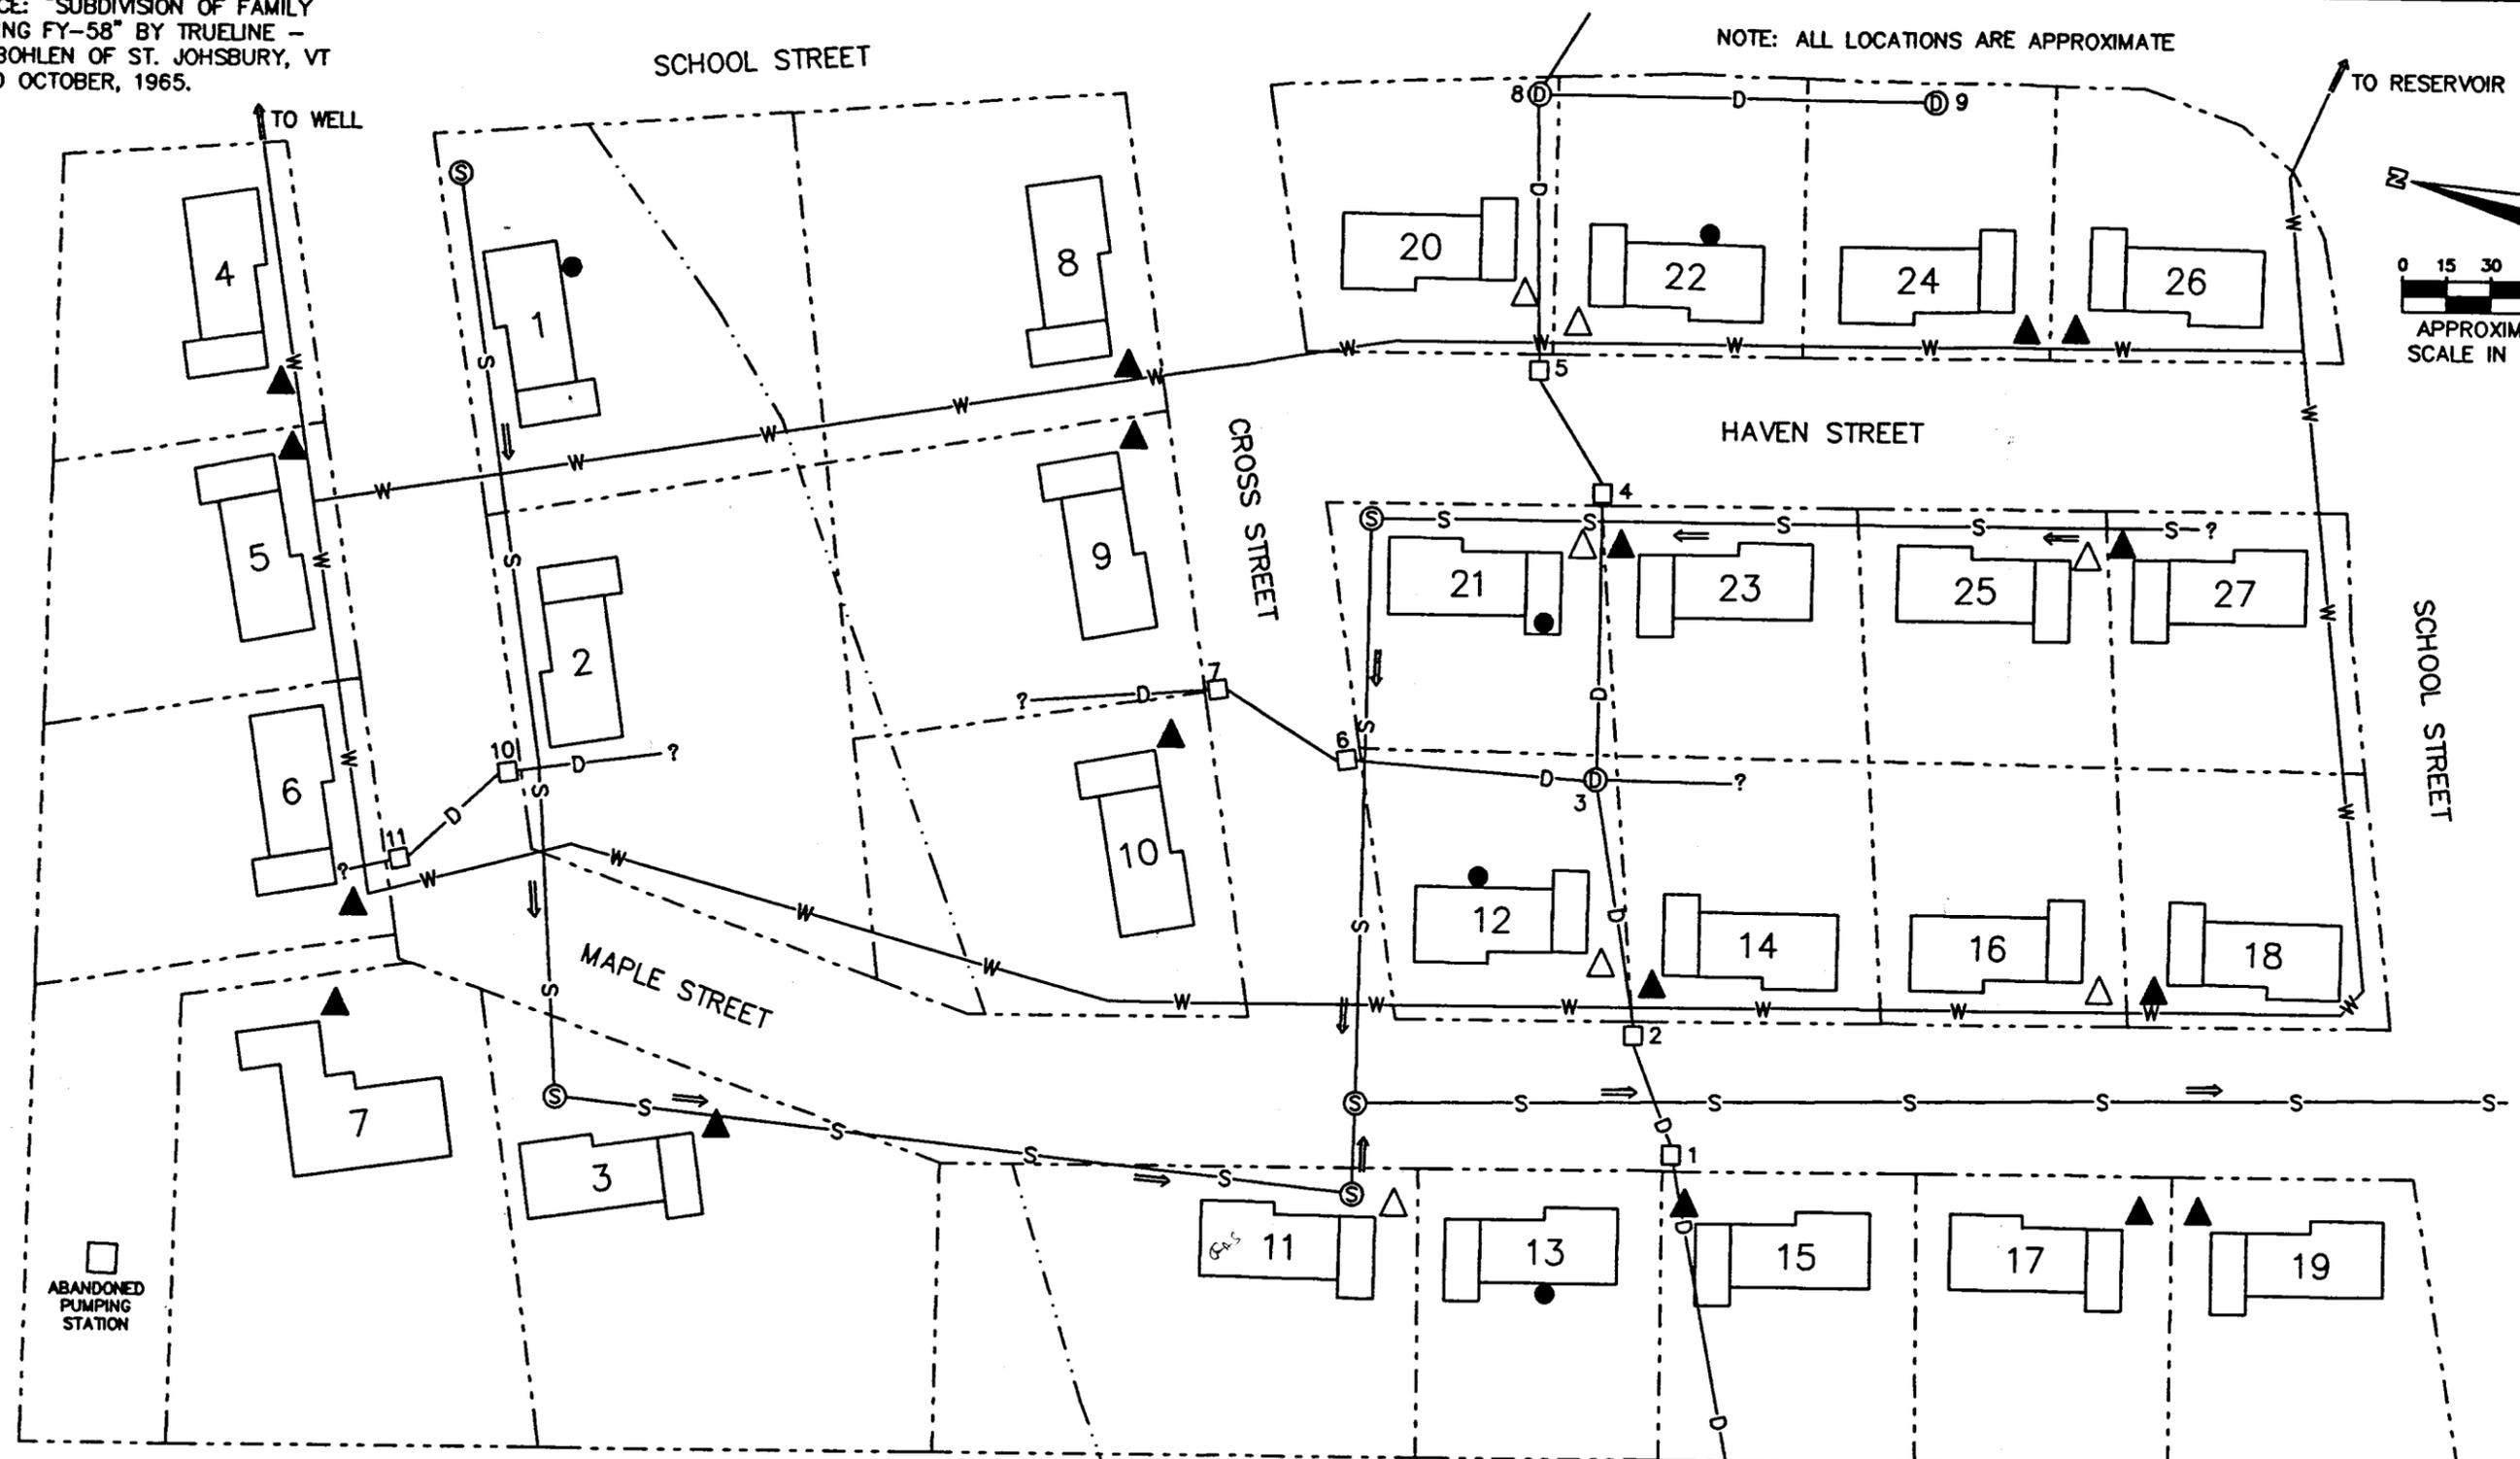
FIGURE 2: UNDERGROUND UTILITIES & STORAGE TANKS

We mapped the storm sewer system to the degree possible by observing the locations of storm grates, manholes, and associated subsurface piping as shown on Figure 2. The invert elevation of all piping is approximately four feet below grade. Also, we acquired maps of the subsurface water supply and sanitary sewer piping with the locations also shown on Figure 2.

Of the other homes located along the storm sewer system upgradient of the replaced culvert location, the homes at #20, #21 and #22 Cross Street now use above ground tanks, although the USTs are still in the ground. The furnace at #23 Cross Street is still connected to the UST system. The status of all USTs within the 27 home neighborhood is shown on Figure 2.

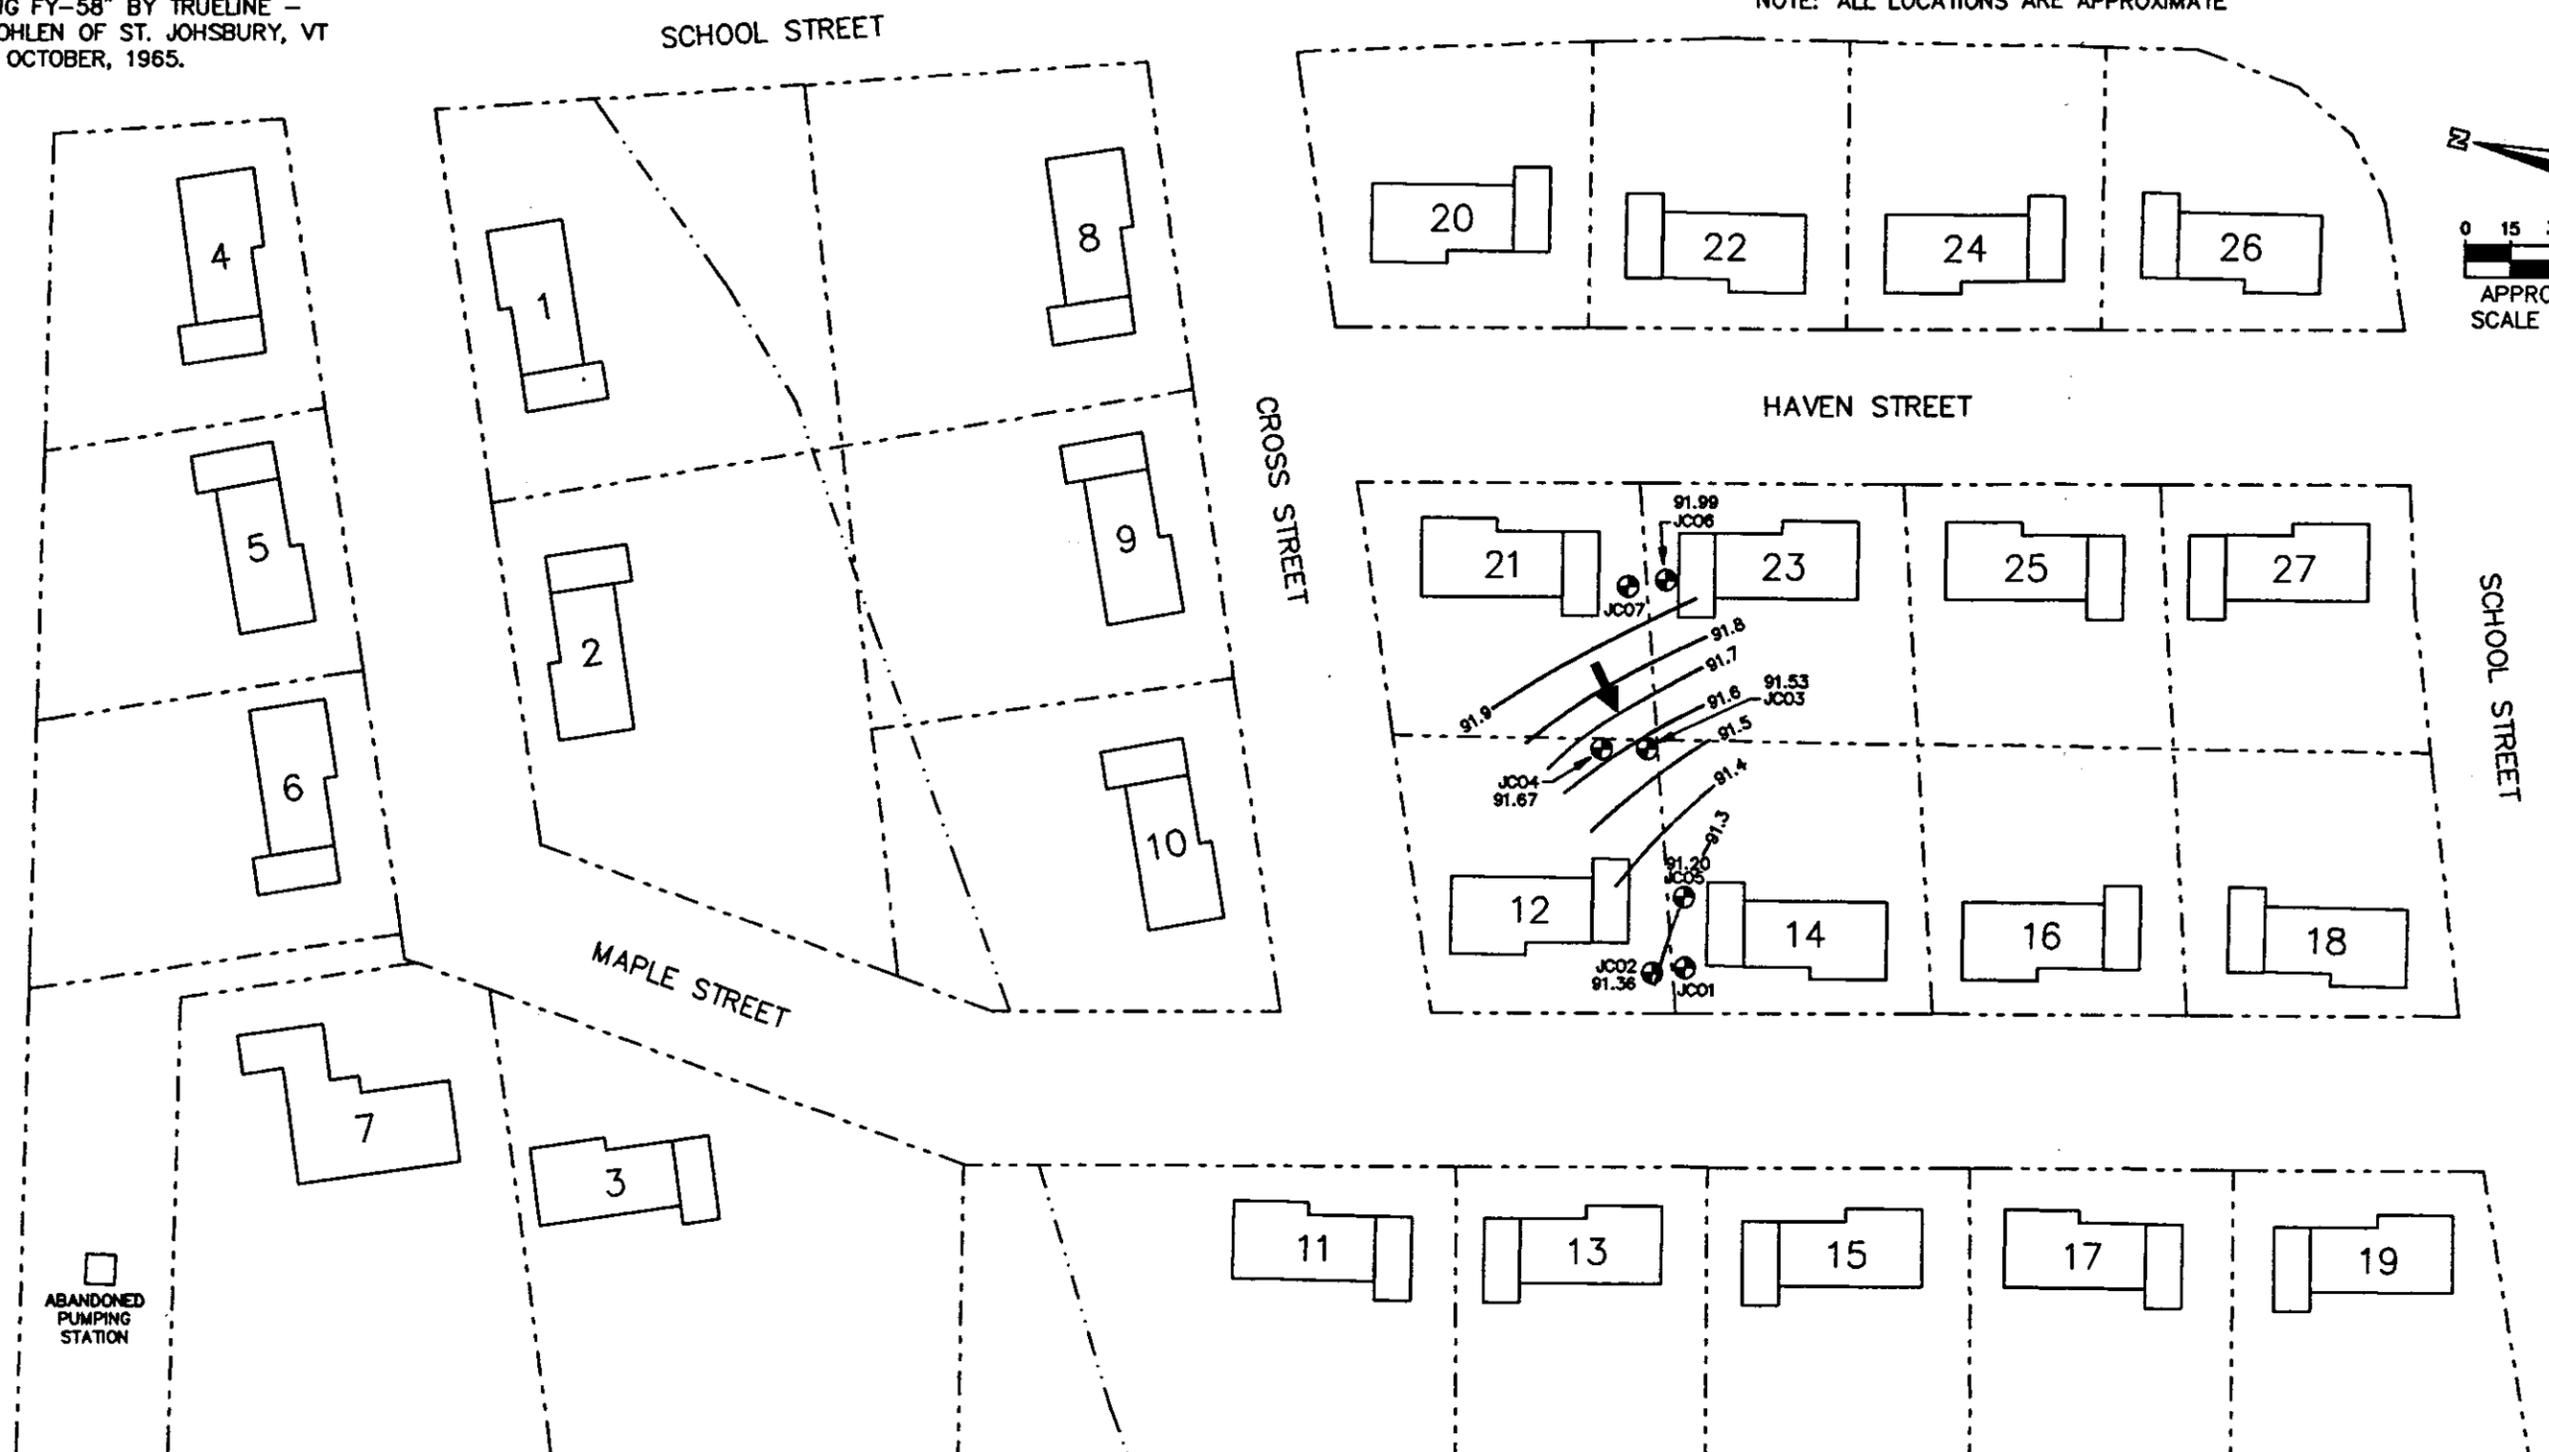
FIGURE 3: TEMPORARY MONITORING WELLS & GROUNDWATER CONTOURS

The groundwater contours developed from the data presented in Table 1 are shown on Figure 3. Because the groundwater surface elevation at temporary monitoring well JCO-1 appears to be anomalously low, possibly because the water level had not yet stabilized at the time of measurement, this data point was not used in the development of the groundwater contour map. As can be noted on Figure 3, the groundwater flow direction is towards the southwest at a very low gradient as would be expected given the hydrogeologic setting of the Site.

Elevated BTEX and TPH concentrations are present in the groundwater samples collected from temporary monitoring wells JCO-1, JCO-2, and JCO-5. These three monitoring wells are located in the vicinity of two fuel oil USTs: the one that formerly served the heating system for #12 Maple Street, and the one that currently serves the heating system for #14 Maple Street. A slightly elevated concentration of xylenes and TPH is noted in the groundwater sample collected from temporary monitoring well JCO-3.

In an attempt to stop the apparent current release of fuel oil, the UST at #12 Maple Street should be immediately removed (closed). Based on the information during this investigation, this is the more suspect UST. This UST is unused and there is no reason for it to remain in the ground. The contaminated soil in the vicinity of the UST should be removed so it does not continue to act as a source of groundwater contamination. Ideally, this work should occur during a period of low groundwater in the late summer/early fall. If it is determined during the closure that leakage was not occurring from this UST, the UST at #14 Maple Street should be closed. If this closure occurs, arrangements will need to be worked out with Mr. Harrington for the replacement of his fuel oil storage system.
