SECONDARY SITE INVESTIGATION REPORT

Pedrozo Residence
 6 Greenfield Terrace
 Montpelier, VT

DEC Site No. 962078
 SEI Project No. 96-630

March 31, 1997

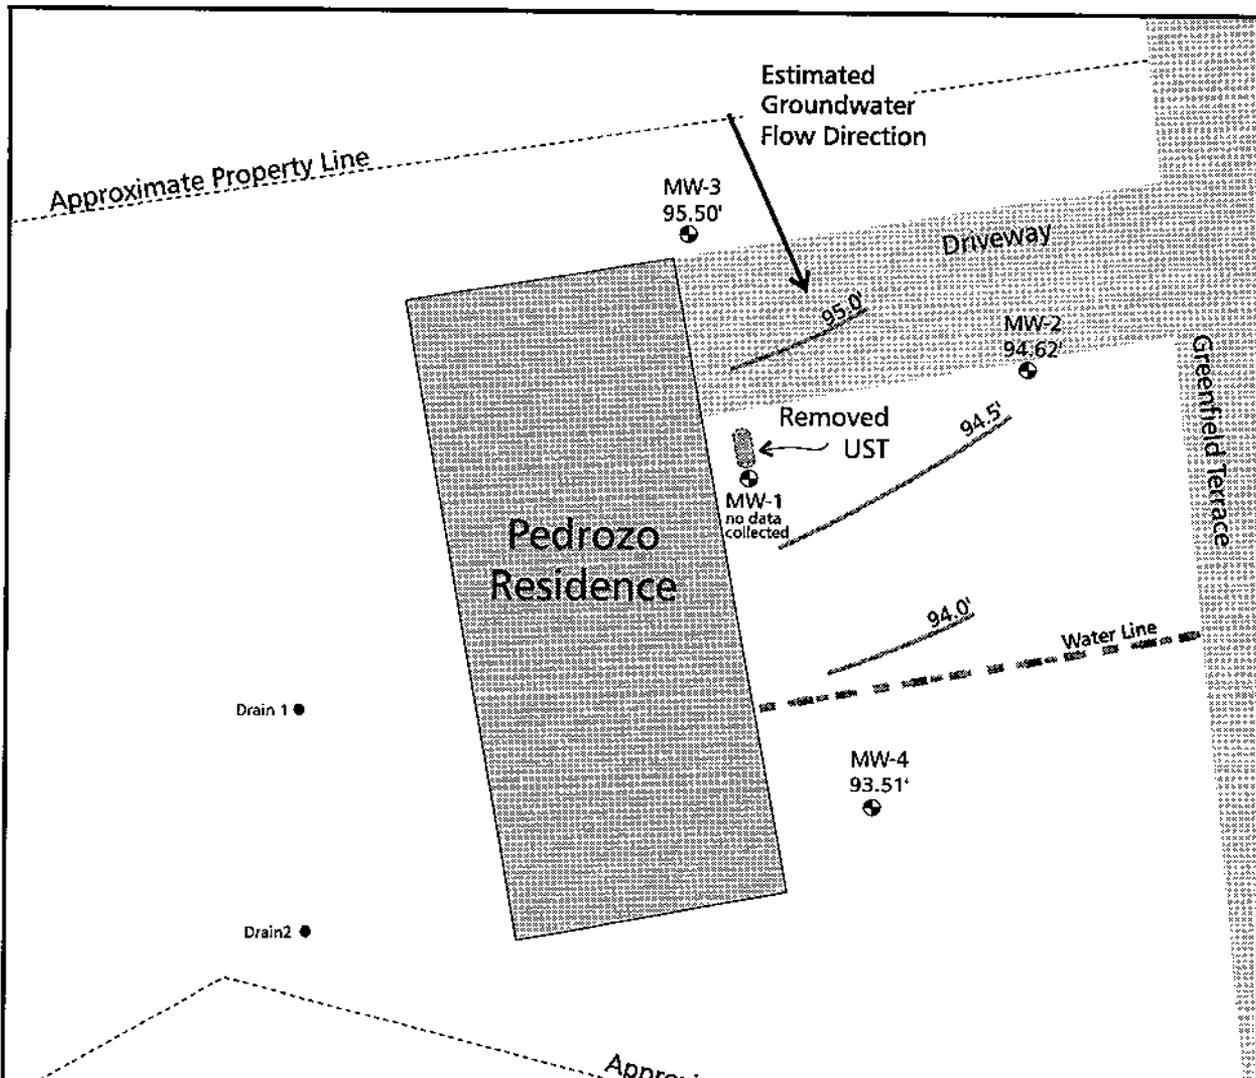
FIGURE 2: SITE MAP AND GROUNDWATER ELEVATION CONTOUR MAP - FEBRUARY 10, 1997
 Pedrozo Residence
 Montpelier, Vermont

Based on our site survey and depth to water measurements collected on February 10, 1997 the groundwater flow direction appears to be to the south. However, as there is a perimeter drain around the house (see our November 4, 1996 report) there is undoubtedly a western flow component near the eastern edge of the house.

The groundwater flow direction is to the south, so that MW-4 is located downgradient of the tank pull area. MW-2 and MW-3 are located to the north and east of the tank pull area, respectively. Although we did not advance additional borings on the west side of the house during this investigation, we did collect both soil and
