# BELL ENGINEERING

October 10, 1996

Re: Investigation / Site Characterization:  
BCC Property  
45-47 Grant Avenue  
Rutland, VT

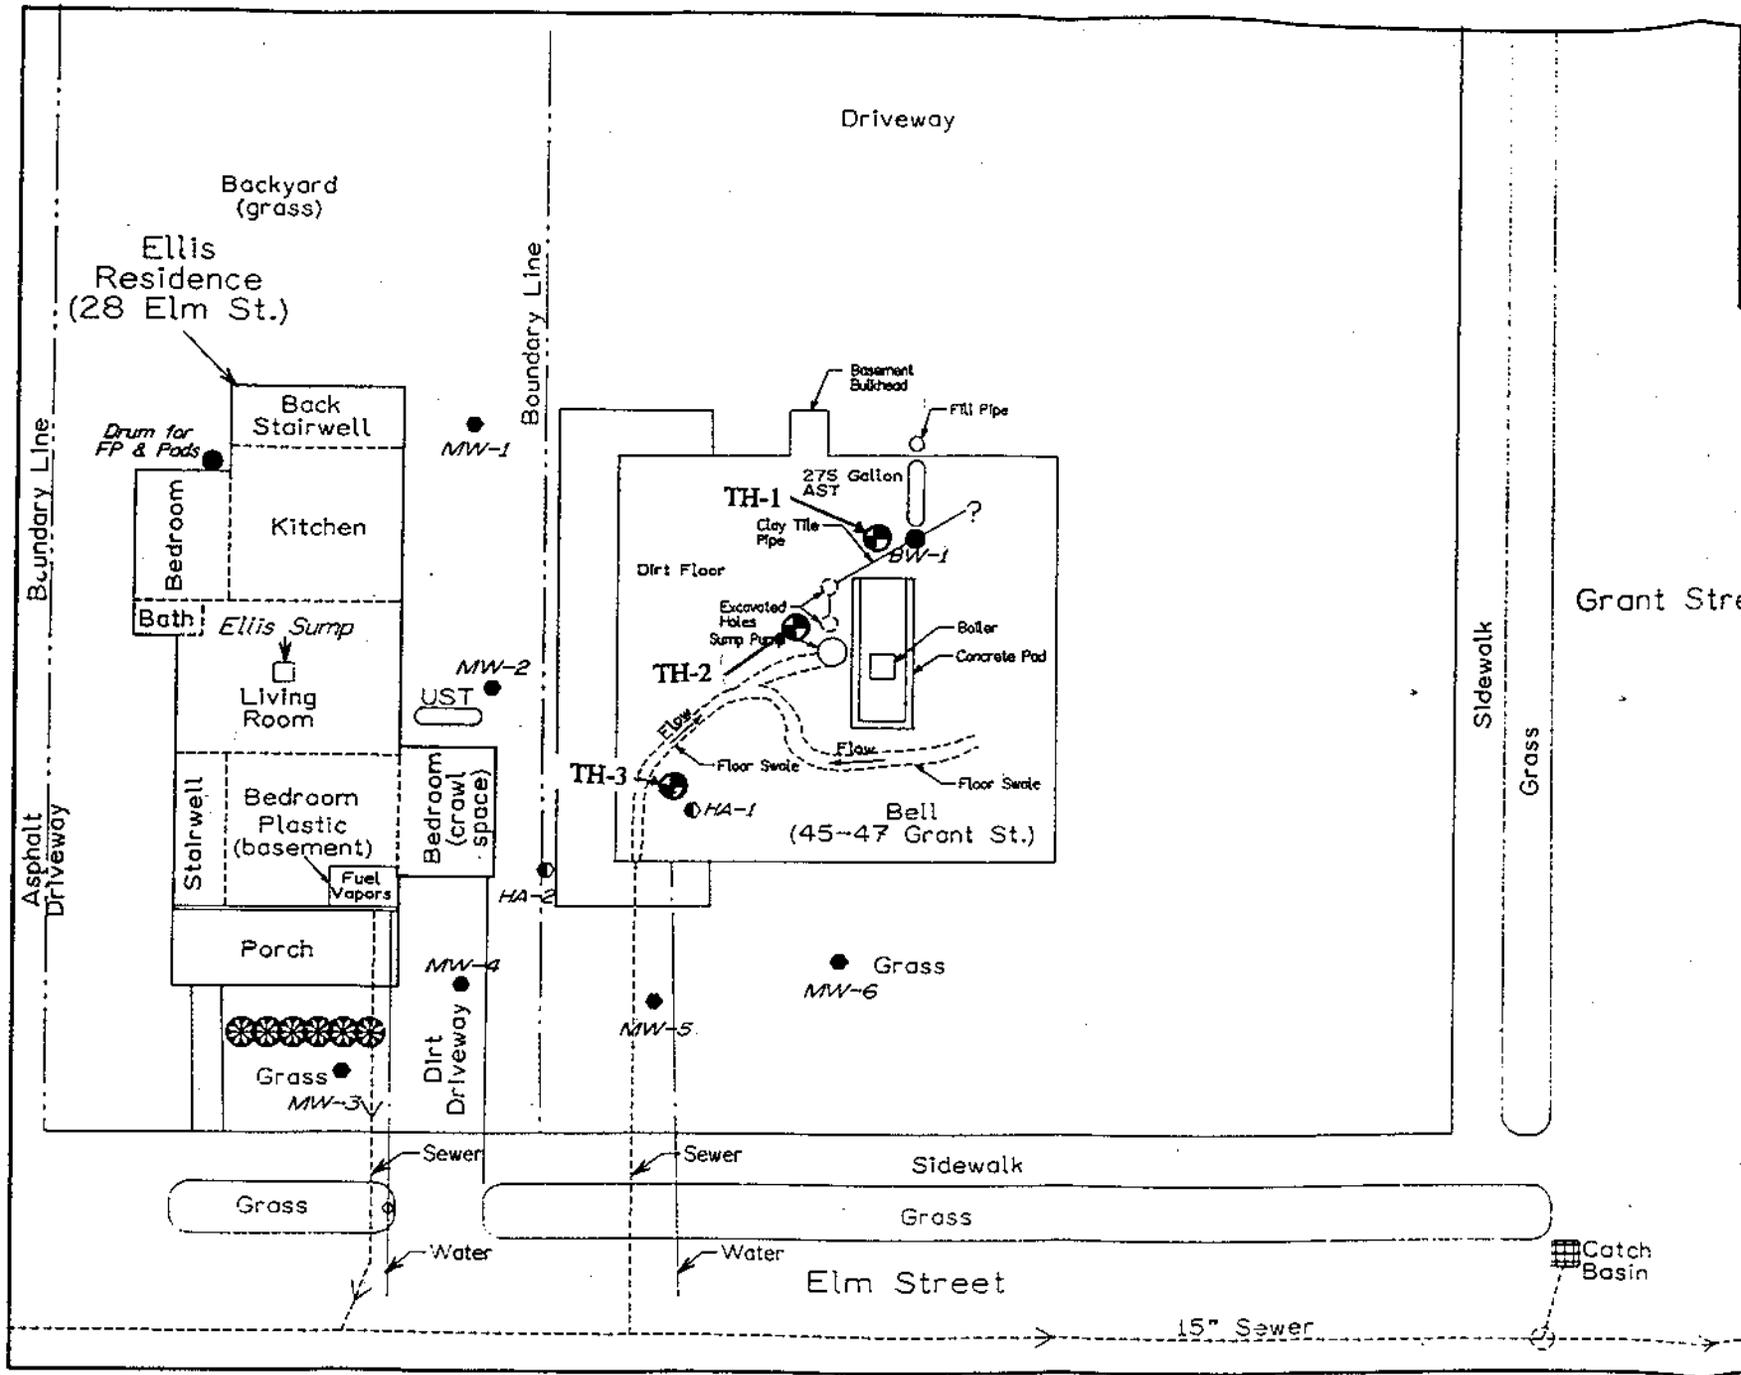
presented in Figure 2.) The results of a round of ground water samples taken by LAG showed elevated levels of TVH in the sump of the BCC property where free product was present and in Monitoring wells MW-3 and MW-4. Personnel from LAG attributed the contamination found in MW-3 and MW-4 to the release from the 275 AST fuel oil tank at the BCC property and not as a result of an abandoned fuel oil UST located alongside the Ellis residence as shown in Figure 2.

Three soil borings were completed in the basement of the BCC property by Bell Engineering, Inc. Approximate soil boring locations (designated as TB-1 through TB-3) are shown on Figure 2 (overlain on the site plan originally prepared by LAG). The borings were conducted to assess the presence of residual petroleum contamination in soil and groundwater in the basement. The borings were conducted with a helical hand auger which provides relatively good soil profiles.

The results of the soil screening showed that only a small area of soil contamination currently exists in the basement - that being the area adjacent to the 275 AST. A relatively

localized area of contamination was encountered. PID readings of a soil sample from TB-1 in the 0-4 inch depth ranged resulted in a peak reading of 64 ppm. Soil samples extracted from approximately 8, 16 and 24 inches had no detectable VOC levels. Soil samples extracted from TB-2 and TB-3 had no detectable VOC levels. Bore holes were installed to approximately 24 inches.

A hand spade was used to aerate surface soils for screening with the PID to determine the extent of the soil contamination in the area of TB-1 and other areas of the basement. It was determined that surface soils in approximately a 5 foot diameter around the tank were contaminated with fuel oil. However, it was apparent that, similar to the soils extracted from TB-1, that the contamination was surficial in nature. It was apparent that the combination of the underlying soils being somewhat restrictive to vertical transport and the high groundwater table tended to minimize soil contamination. Based on the results of the PID soil screening, it is estimated that there are approximately 6.5 cu. ft. of soil assuming an average depth of contamination of 4 inches.

It is recommended that the contaminated soils in the area of the 275 AST be removed to clean soils, drummed and disposed of properly as a hazardous waste. This action is deemed to be adequate to prevent ingestion, contact or inhalation exposure of future occupants of the Grant Street property. Soil removal should be accompanied with PID soil screening to assure complete removal of VOC contaminated soils. As part of this activity it is also recommended that the basement of the Ellis property be screened with a PID to assure that elevated VOC levels are not present.
