INITIAL SITE INVESTIGATION REPORT

Royer's Service Garage

(VT DEC SITE #97-2139)

23 October 1997

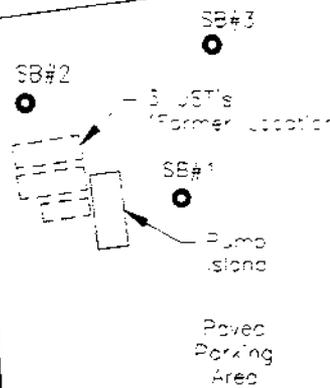
FIGURE 2.
SITE MAP

On 11 September 1997, a MARIN Field Scientist screened thirteen soil samples collected from the on-site soil stockpile, located to the rear of the garage, using a Photovac PE 2020 photoionization detector (PID). The PID readings ranged from 0.0 to 356 ppm, which are above the one ppm VT DEC permissible level for thin spreading. The initial PID readings obtained on 2 December 1996 during the UST closure were between 862 and 1,957 ppm. A summary of the PID reading obtained from the soil stockpile is provided on Table 2. Sampling locations are noted on the site map (Figure 2).

The soil stockpile consists of a single pile approximately 800 square feet in area. Soil samples were collected from the pile for PID screening by diagonally hand auguring approximately one to two feet beneath the surface. Each soil sample was placed in a ziplock-type bag, sealed, and then agitated. The probe of the PID was inserted into the headspace created at the top of the bag. All PID readings were recorded in a field logbook by the on-site Field Scientist. The PID was calibrated on the same day as the site visit with an isobutylene standard to a benzene reference. The stockpiled-soil cover was found with various degrees of deterioration which the property owner has agreed to rectify by re-encapsulation with reinforced, 6-mil polyethylene plastic. The polyethylene was secured with old tires and rocks.

Based on the findings of this investigation and the conclusions stated above, MARIN does not believe that further investigation is warranted at the site. The soil stockpile, located to the rear of the on-site garage, should be monitored semi-annually with a photoionization detector (PID), and the integrity of the stockpile cover maintained. When PID readings have decreased to below one part per million (ppm), permission should be sought from the VT DEC to thin-spread the soils in accordance with established guidelines.
