HOFFER & ASSOCIATES CONSULTING HYDROGEOLOGISTS

August 4, 1998

Re: Status Report, Moran Residence, Stowe, Vermont
SMS Site #98-2402

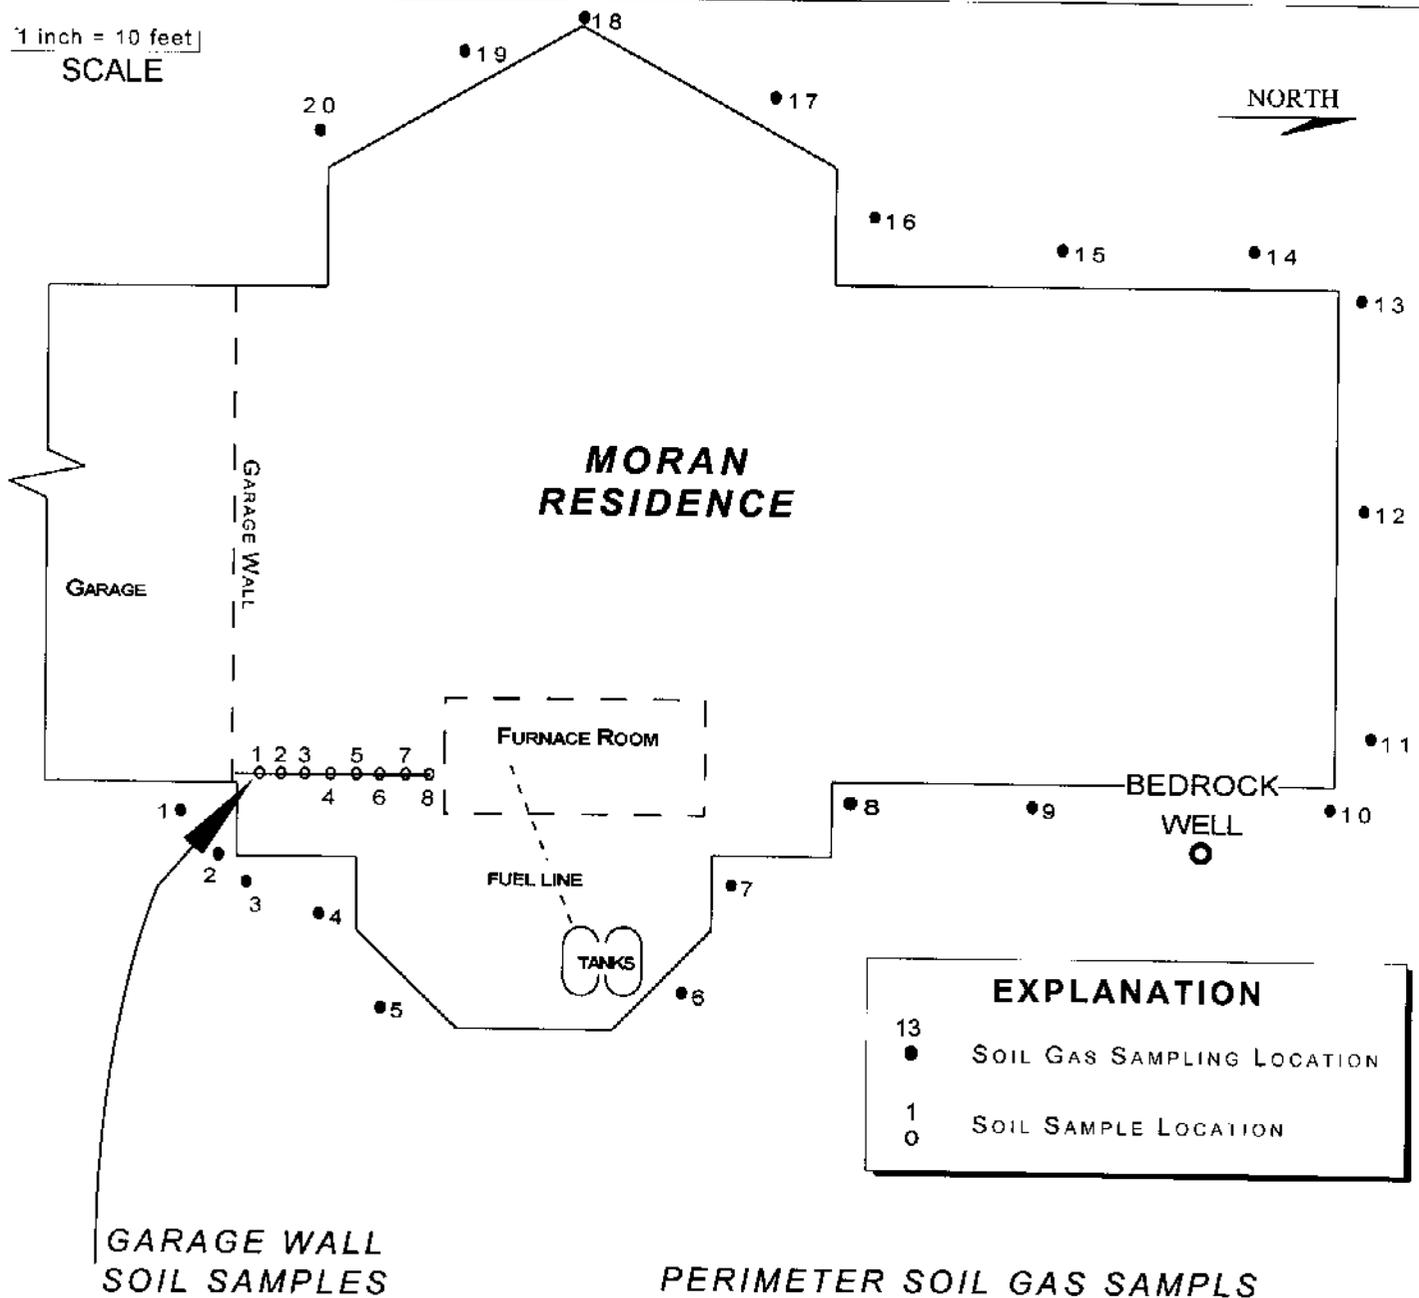
FIGURE 1
SOIL AND SOIL GAS SAMPLING RESULTS, JULY 31, 1998,
MORAN RESIDENCE, STOWE, VERMONT, SMS SITE #98-2402.

On July 31, a soil-gas and soil sampling effort was conducted. Bill Bronner of MTB Builders assisted with drilling through the garage wall and the sampling of the material beneath the foundation. Sampling of the soils beneath the building was conducted by first drilling an approximately one-inch diameter hole in the northern garage wall and then inserting a steel (and later copper) pipe into the sand fill. The pipe was driven in ½ to one foot intervals, removed and the sand core driven out of the pipe into a clean zip-lock bag. The bag was sealed, and the sample allowed to equilibrate for a several seconds prior to inserting the PID¹ tip to obtain a headspace measurement. The location of the soil samples and the respective headspace measurements are indicated on Figure 1. Headspace readings showed relatively little contamination from 0.0 to four feet from the wall, with PID headspace readings from 1.1 to 3.8 parts per million (ppm). Elevated headspace readings were encountered beyond a distance of four feet from the wall, with concentrations in the 500 to 800 ppm range. The highest PID reading was from the 6.0 to 6.5 foot interval, with a reading of 808 ppm. The last sample was obtained from approximately nine feet from the wall, which is estimated to be within four to five feet of the fuel line. No water or free product was observed in any of the soil samples.

A soil-gas survey was conducted around the perimeter of the house. Soil-gas samples were collected by driving a solid, one-inch diameter slam bar to refusal or to five feet, whichever came first. Depths reached were typically between 3.5 and 4.5 feet below grade. The slam bar was then removed, and a copper pipe with the end crimped and slots cut into the sides from the base to about six inches from the base inserted to the bottom of the hole. The PID was connected to the top of the pipe using a section of PVC tubing. The PID remained connected until the concentration indicated stabilized, and the maximum measurement recorded. The locations and recorded measurements from the soil gas survey are shown on Figure 1. The highest PID readings were from soils adjacent to the garage along the western wall, and just south of the tanks (points 1 through 6). In addition, points 8 and 9 returned slightly elevated PID measurements (12 - 13 ppm), although these readings may be suspect due to suspected contamination of the sampling tube. Readings from the north and northeastern sides of the house (points 10 through 16) did not indicate the presence of contamination in this area. Slightly elevated readings were obtained from those points east of the fuel line and the garage (points 17 through 20). The driveway was not sampled due to the relatively shallow depth to bedrock in the area.

All of the polyethylene lines tested, (those connecting the pump to the pitless, and from the pitless to the house and to the waterfall) passed the tightness tests conducted on July 21. In addition, there was no indication of contamination in the excavation to the pitless. Soil samples from beneath the house taken through the garage wall indicated that contamination is present in the sand fill, and becomes more concentrated near the fuel line. Soil gas screening conducted around the perimeter of the building did not conclusively indicate contaminant migration pathways, but did suggest that the area of greatest contamination is immediately surrounding the tanks and those areas south of the tanks (toward the garage). There was little indication of contamination at the northern end of the house during the soil gas survey.

The results of the soil sampling effort through the garage wall indicates the presence of significant amounts of petroleum vapors beneath the building. Due to the permeable nature of the fill used during the construction of the house, a soil vapor extraction system may be effective in removing the lighter-phase components of the fuel oil. We recommend performing some type of pilot test to assess the usefulness of soil-vapor extraction. We may also want to see if some test borings could be extended through the garage wall at lower elevations, in an attempt to access liquid-phase fuel oil.

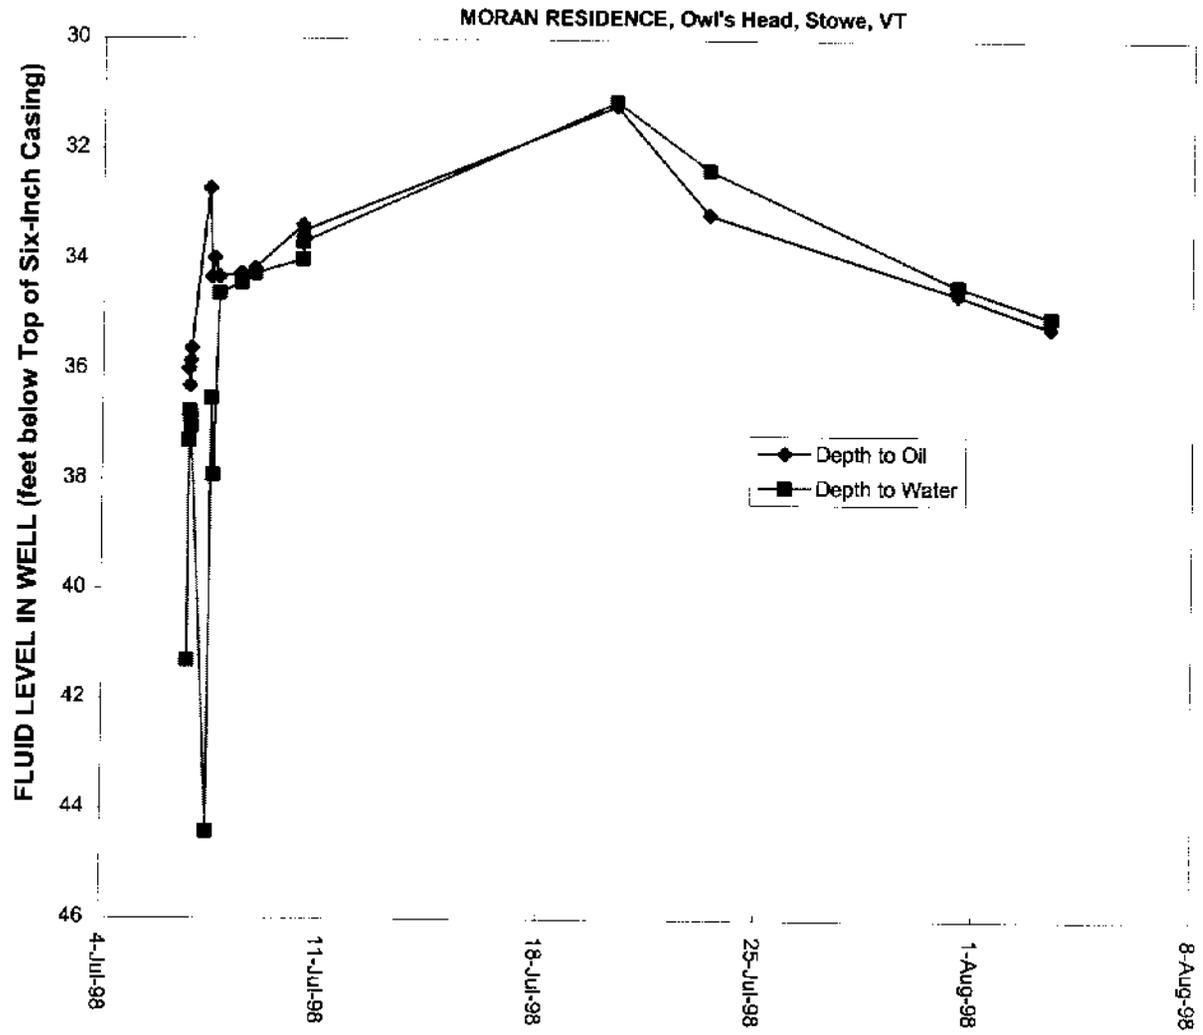
FIGURE 2

Since the meeting on July 20, product thickness in the well has been monitored on a biweekly basis. Measurements are summarized below (see enclosed Figure 2).

Date	Depth to FP (feet)	Depth to H ₂ O (feet)	Product Thickness (ft)
July 20	31.12	31.20	0.08
July 23	32.36	33.16	0.80
July 31	34.45	34.60	0.15
August 3	35.01	35.21	0.20

The packer installation in the well indicates that there is a source of water to the well above the current static water level. The elevation and location of this source is as yet undetermined. Whether the fuel oil entering the well is coming from above the current static level is also unclear. Fuel oil continues to enter the well, although in significantly smaller quantities than initially observed. To date, approximately 75 gallons of free product has been recovered from the well.

Continued monitoring of the static water level in the well, both above and beneath the packer is necessary to determine the nature of the flow gradient in the well, as well as whether free product is entering the well from above or below the packer. In addition, continued operation of the product pump is recommended, at least until the product

thickness in the well is too thin for the pump to work effectively. At that time, sorbents will be employed to facilitate product removal.
