Whetstone Brook Watershed Stream Geomorphic Assessment And River Corridor Plan May, 2008

Prepared by:

Landslide Natural Resource Planning
P O Box 311
East Middlebury, VT 05740

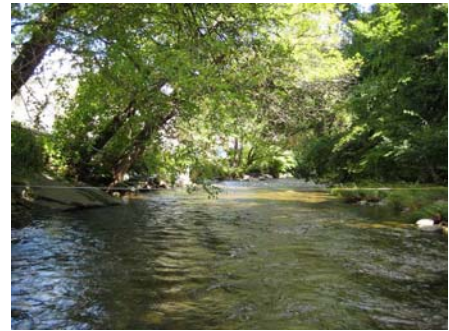
M01C

M01 – The first reach on the Whetstone Brook is in the heart of downtown Brattleboro at the confluence with the Connecticut River. It was historically straightened (80%), hard armored (23%) and channelized and the adjacent valley was filled. The sub-watershed is 72% developed and there are 17 storm water inputs throughout the reach. There was an old Mill Pond where the current Food Coop is located that was filled in order for development to occur on the site. The reach is in a broad valley and is a C3 stream type by reference. The reach was segmented four times: segment A is in a rock gorge and was not assessed; segments B and D are incised and entrenched, though it is difficult to distinguish between active downcutting versus filling of the adjacent floodplain. Both of these segments are currently F3 type streams. Segment C is a C4 stream type with access to a floodplain forest along the right bank.

There is interest by the Brattleboro Food Coop to restore riparian vegetation and public access on their four acre site during re-construction of their building. The floodplain forest on segment C is a good candidate for conservation and segment D has potential for floodplain restoration with berm removal.

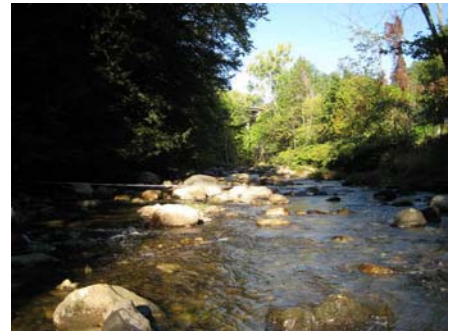
M02 – This reach is located in a semi-confined valley and is a B Plane Bed by reference but is narrowly confined due to a human caused change in confinement from an abutting road. The reach is 29% straightened and 17% hard armored and the sub-watershed is 60% developed. The dominant corridor land use is urban but the dominant watershed land use is forest. The stream is entrenched and incised in this reach but it remains a B Plane Bed stream type. There are three bridges on M02 (one is a double on Interstate 91) all of which are floodplain constrictions but not channel constrictions. Both the habitat and geomorphic conditions are rated “fair” and the dominant adjustment process is widening.

Due to the narrow and deep valley and constraints from the road, there is limited conservation or restoration potential for this reach.

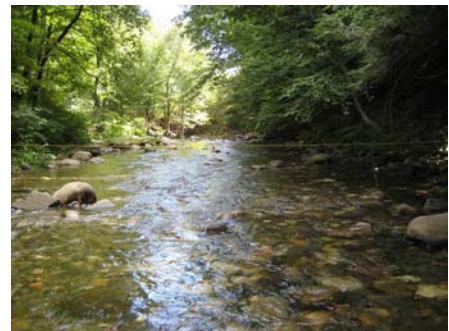
M03 – This reach is located in a very broad valley type and is a C Riffle Pool type by reference. It was segmented three times due to the presence of a series of bedrock grade control in the middle of the reach that form a bedrock gorge that was not assessed. At the top of this segment is a former mill pond/dam site. It is 46% straightened with eight

percent hard armoring. The sub-watershed is currently 70% forested and 13% urban and the corridor is 40% urban.

Segments A and C are currently F type streams due to entrenchment. They are over-widened, straightened, and eroding. The reference channel width is 55' and the current channel width is 61' and 15% of the right bank is currently eroding. The habitat condition is good and the geomorphic condition is fair with widening being the dominant adjustment process.

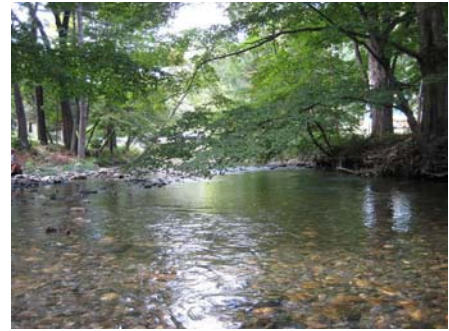
M04 – This reach is located in a very broad valley and is a C Riffle Pool stream type by reference but it is currently entrenched and incised, making it an F Riffle Pool. The valley type changed to narrowly confined due to the presence of Route 9. The soils are mapped alluvium and the channel is 100% straightened with 764 feet of eroding banks and 880' of revetments on the left bank. The geomorphic condition is Fair and the habitat condition is Fair.

There are two bridges in this reach. The covered bridge at the down stream end is a floodplain constriction and a newer concrete bridge in the middle of the reach that is a channel constriction with deposition above it.

There is potential for conservation and restoration on this reach. The Farmer's Market site along the left bank floods, though it has some small berms. It has potential for floodplain restoration while at the same time continuing use as a seasonal market. Up stream on the right bank, there is a coniferous flood plain forest with restoration and conservation potential.

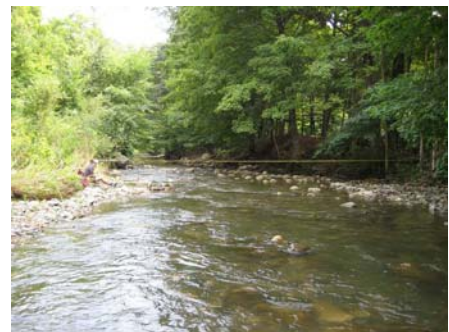
M05A

M05 – This reach is located in a very broad valley and is a C Riffle Pool stream type by reference. The slope is one third of reach M06 making it a natural deposition area. It was segmented twice due to channel dimension. Highly erodible alluvium is the dominant geologic material. The

valley confinement has been altered by Route 9 and is presently narrowly confined. Bonneyvale Brook enters near the middle of the reach. Urban development in the corridor is 54% and the dominant buffer width is 0 to 25 on both banks. There are seven storm water inputs along the reach and it was extensively dredged after the 1973 flood (Cahoon, interview). Both segments are incised and entrenched with Segment A currently being an F3 Riffle Pool and segment B being a B3 stream type. Segment A has two undersized bridges that are channel constrictions with deposition above and below them.

Segment A will likely remain actively managed in the near

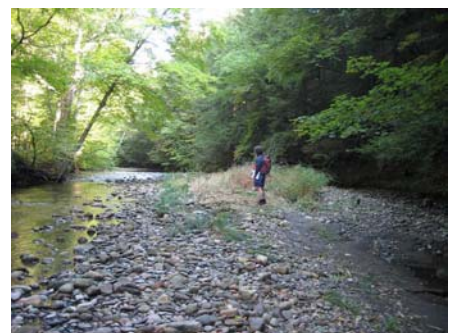
M05B

future. There is potential for floodplain restoration/conservation in segment B.

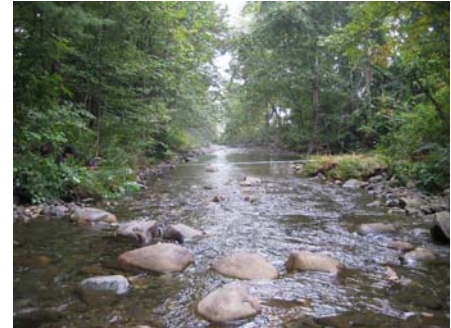
M06 – This reach is a C Riffle Pool stream type by reference and is located in a very broad valley. It was segmented three times for channel dimension. The soil is highly erodible alluvium. Segments A and C are F3 Riffle Pool stream type and segment B is a C3 Riffle Pool with access to floodplain in a meadow that is owned by the Vermont Land Trust and does not have a riparian buffer. The reach is currently 71% straightened, extensively bermed on the right bank, has eight storm water inputs, and seven meander migrations noted. The river corridor is 58% urban development, the watershed is 44% urban development and there are nine storm water inputs along the reach. There is a bridge on Segment C that has deposition above and below it but is not undersized. Segment A has an 11 acre wetland that was lost to development.

M06C – straightened section of river.

The dominant adjustment for Segments A and C is widening and planform. Segment B is planform. Habitat condition is Fair for all three segments.

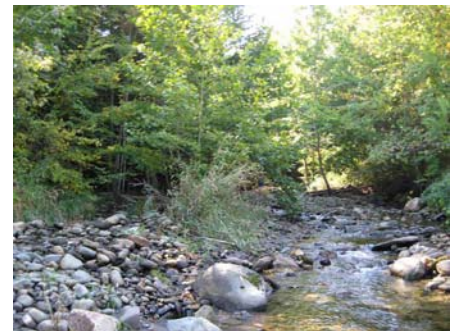
M07 – This reach is a Cb Riffle Pool by reference, located in a very broad valley type. It is currently a B4 with aggradation, widening and planform adjustments on-going. There is human caused change in the valley confinement to semi-confined due to Route 9. There are two bridges on the reach, both of which have deposition above and one of which has deposition below and is skewed to the stream, though not undersized. The other structure is both a channel and

M07 – Aggradation u/s of first bridge.

floodplain constriction. Geomorphic and habitat condition are both fair and there are six large point bars in the reach. The dominant soil type is highly erodible alluvium and the reach is 92% straightened. This reach is 47% developed with residential development being extensive in the river corridor.

Addressing the undersized and misaligned structures in this reach would allow for increased sediment transport. There is an eroding bank heading toward a private resident that needs to be stabilized. Otherwise, no additional development should be allowed to occur within the river corridor on this reach.

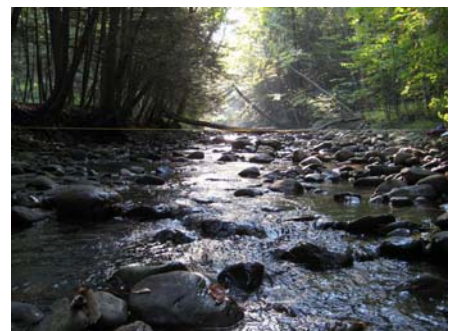
M08A

M08 – This reach is a Cb Plane Bed in a Broad valley type by reference. It was segmented twice due to

planform and slope. Segment A is currently a Cb Plane Bed and Segment B is a C Riffle Pool. Segment B is the downstream end of major planform adjustment that is occurring on Reach M09 due to historic straightening upstream and a dramatic change in channel slope. There are multiple flood chutes and meander migrations in the segment. Segment A is located on highly erodible alluvium though the right bank has extensive ledge along it and there is a natural constriction in the valley type. Both habitat and geomorphic condition are good for Segment A. Geomorphic condition is Fair for Segment B and habitat is Good. There are no storm water inputs on this reach!

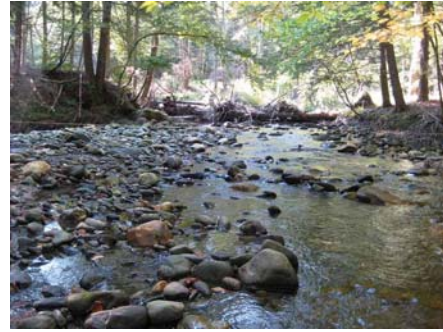
M08B

This entire reach is a candidate for corridor conservation due to the notable lack of encroachments in the corridor.

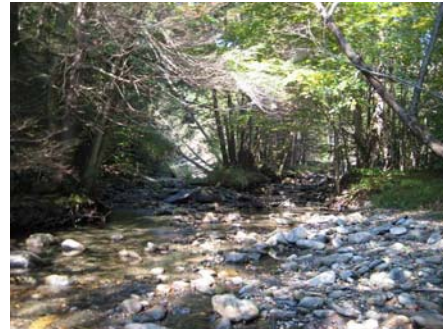
M09A

M09 – This reach is a Cb Plane Bed stream by reference, located in a very broad valley setting. Segment B is a B Plane Bed by reference. The dominant geologic material is highly erodible alluvium, the left riparian buffers are intact and the right buffer is 0-25’ and though the corridor has 30% urban development. Groundwater inputs are abundant and the channel is 51% straightened. The reach was segmented in two during the Phase 2 Assessment due

to planform and slope, channel dimension, substrate size and depositional features. Both segments have a human caused change to valley width, from very broad to narrow for segment A and to semi-confined for segment B, due to Route 9. Segment A is currently a C4 Riffle Pool stream type with very active planform adjustment, aggradation and widening occurring. There is one private bridge that is both a channel and floodplain constriction with deposition above and below it. There are multiple bar features and eight flood chutes in this segment and there are three mass failures on the right bank totaling 403’ in length. There is recent windrowing and dredging at the upstream end of the segment. Both habitat and geomorphic condition are fair.

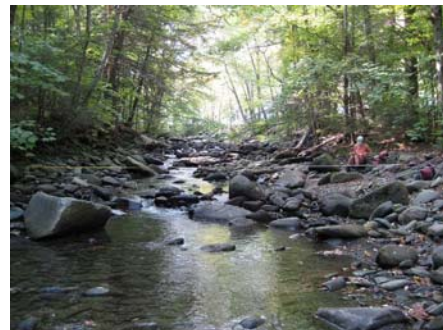
M09B

Segment B is currently a B3 Plane Bed stream type. There is one private bridge at the downstream end of this segment that is a floodplain constriction with deposition below it. 26% of the left bank is actively eroding and 11% of it is hard armored. There are numerous gravel bars, five flood chutes, two steep riffles and one headcut. Both habitat and geomorphic condition are fair with widening and planform being the dominant adjustment processes.

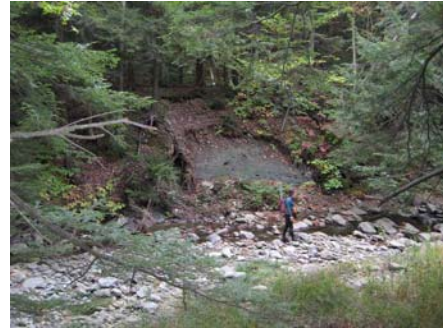
M10B

Segment B has multiple flood chutes, steep riffles, stormwater inputs, four mass failures, and significant encroachment from Rt 9. There are numerous point, side and mid channel bars, however, it remains a B stream type with sedimented riffles. It is in channel evolution stage III, widening, most likely due to increased flows from multiple stormwater inputs.

Conservation of the right bank is critical for this reach.

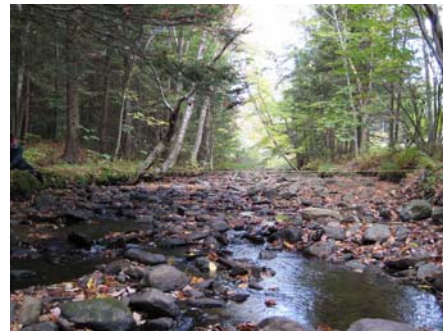
M11A

M11 – This reach is 1.2 miles long and located in a narrowly confined valley. It is Cb Cobble by reference and it has a small run of river dam at the head of it. The dominant geologic material is highly erodable till. It was segmented five times due to channel dimension, grade controls, planform and slope, valley width and bedrock gorge (not evaluated). The riparian buffer is >100' on both banks and groundwater inputs are abundant.

Segment A is semi-confined due to a human caused change in the valley width (Rt. 9). It is incised and entrenched, causing a stream type departure from Cb to Fb. There is one undersized bridge with deposition above and below it. It is nearly 100% straightened. The habitat is in good condition and it is in fair geomorphic condition.

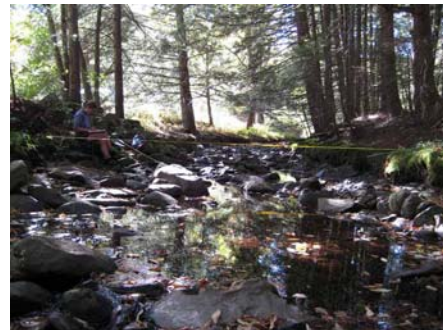
M11B

Segment B was historically straightened and bermed, though it has grade control at the downstream end and ledge along the left bank, preventing bed and bank erosion. It is broadly confined and is entrenched from a C to a B stream type. Both the habitat and geomorphic

conditions are good.

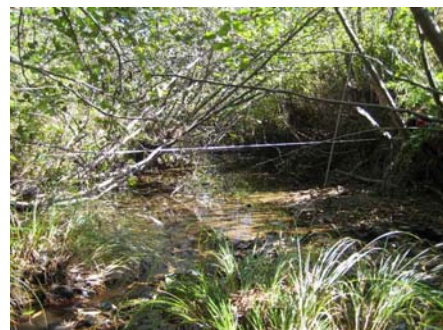
M11C

Segment C is a sub-reach with reference stream type E. It is currently an E stream type in a very broad valley with abundant wetlands adjacent on the left bank. There is one undersized double culvert at the downstream end with deposition below it. There are multiple flood chutes, though both habitat and geomorphic condition are good.

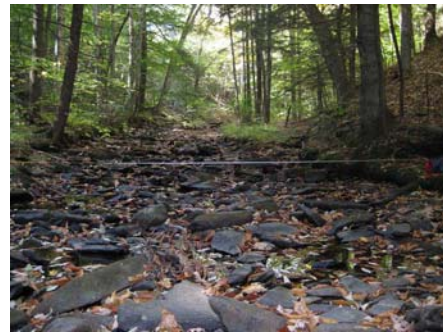
M11D

Segment D is semi-confined and is downstream of a rock gorge and run of river dam. There is significant ledge along both of the very steep valley walls with eight flood chutes, multiple stormwater inputs and two gullies. It is a B stream type by reference and currently.

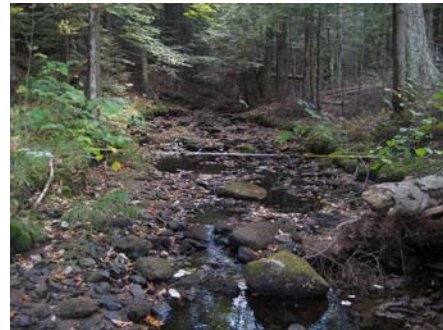
M12B

Segment B is a B riffle pool stream type by reference and currently due to the channel bed being dominated by bedrock grade controls – there are seven. It has one channel constricting culvert at the downstream end with deposition above and below. Both the habitat and geomorphic conditions are good.

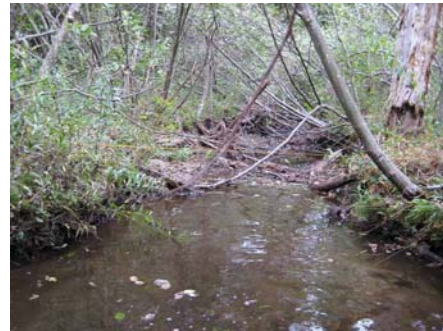
M12C

Segment C is an E riffle pool by reference and currently.

This is a meandering E type stream that travels through wooded and shrubby forests with one beaver pond in the middle and a ROR dam at the u/s end. The VHD stream theme is very inaccurate for this segment. Both the habitat and geomorphic conditions are good.

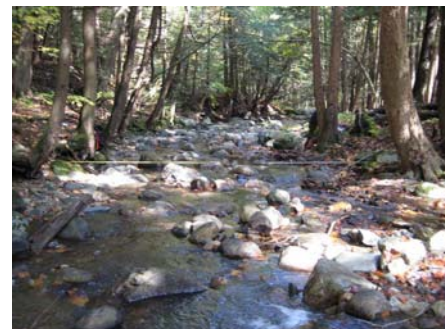
T1.01A

Segment A is a narrowly confined B riffle pool by reference and currently. There are few corridor encroachments, lots of large woody debris, five stormwater inputs and one channel constricting bridge. There are numerous mid, point, side and diagonal bars. The segment is historically incised, currently over-widened and entrenched. There is an un-improved path along the left bank. The dominant adjustment processes are widening with planform. There are multiple flood chutes and significant erosion. There is evidence of past channel management. Habitat condition is good while geomorphic condition is fair.

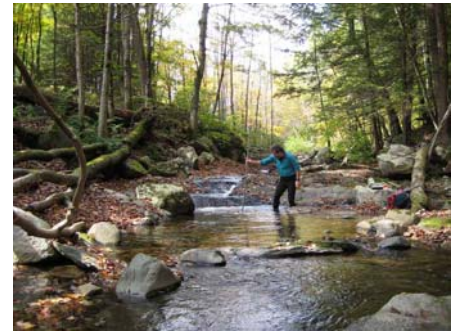
T1.01B

Segment B has incised to cause a stream type departure from B to F. There are four channel spanning grade controls and an old mill dam near the upstream end of the segment. The segment is over-widened and has eroded to bedrock likely due to both increased and concentrated flows caused by the constriction at the old dam site and straightening upstream of there.

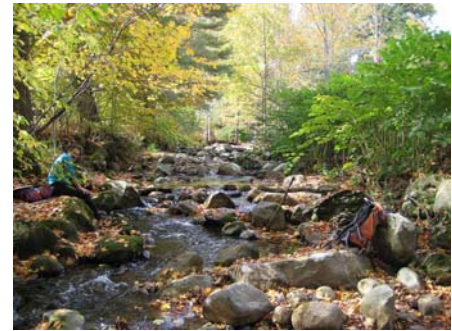
T1.01C

Segment C is a sub-reach with a reference stream type C riffle pool. It is currently departed to an F riffle pool stream type. It has 0-25' of riparian buffer on the right bank and 26-50 on the left bank. There is one channel constricting bridge with deposition above and below and the segment is nearly 100% straightened. This segment is historically degraded and incised but the channel width is quite close to the reference (26' current, 25.9' Phase 1 reference). It is remarkably stable given the channelized straight planform. Both habitat and geomorphic condition are fair.

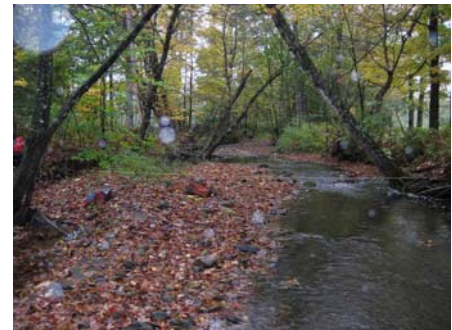
T1.02A

Segment A is entrenched and incised with sedimented riffles. It is currently in stream type departure from C to F. There is one channel constricting bridge with deposition above and

below it. There are multiple point, side and diagonal bars present. The segment is straightened, bermed and eroding. Both habitat and geomorphic condition are fair. It is currently undergoing planform and widening.

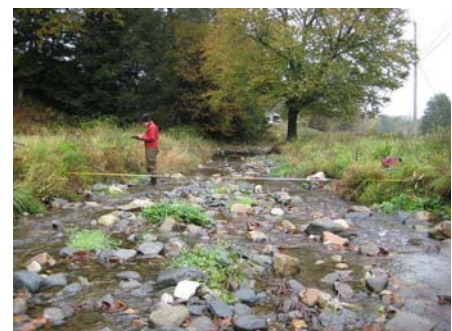
T1.02B

Segment B was segmented for channel spanning grade control. It is a C riffle pool stream type by reference and currently. It is a short segment that stands out due to the existence of floodplain access. There is one channel constricting bridge with deposition above and below it. Both habitat and geomorphic conditions are fair with minor widening and planform adjustment.

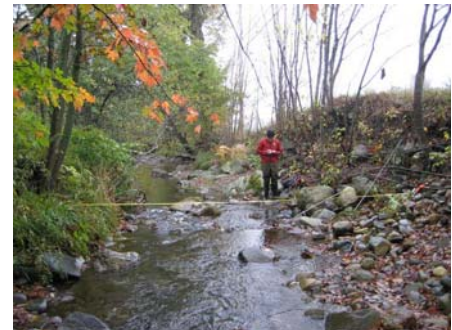
T1.02C

Segment C is departed to an F step pool. It is almost 100% straightened and bermed and lacks riparian buffers. There is an old meander scar on the left terrace. Both habitat and geomorphic conditions are fair.

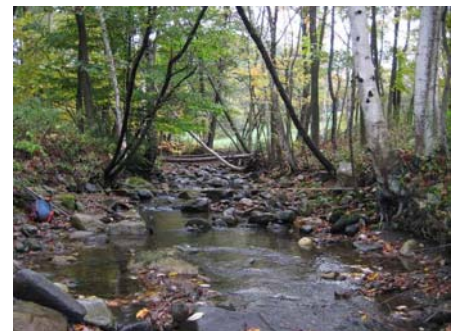
T1.03A

Segment A has four channel spanning grade controls. There is one floodplain constricting bridge with deposition below. The segment is 93% straightened and 20% bermed along the left bank causing a stream type departure from Cb to B. Both habitat and geomorphic conditions are fair.

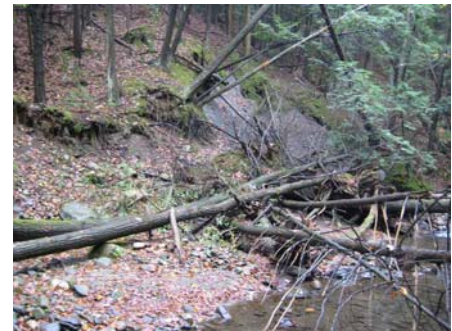
T1.03B

Segment B is not straightened, has few encroachments and has intact buffers. It is in reference regime as a Cb riffle pool stream type undergoing major planform adjustment with widening. This segment has multiple flood chutes and mass failures that may have been triggered in Oct. 2005 during the "Alstead, NH" storm. Habitat condition is good and geomorphic condition is fair.

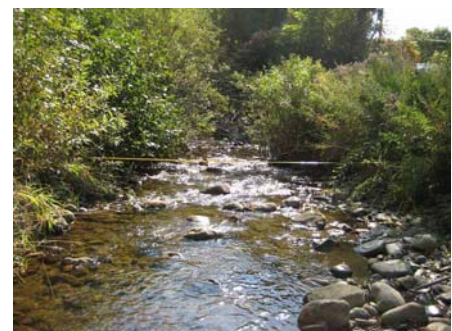
T2.01A

Segment A is historically straightened, bermed along the right bank and hard armored for half of its length. It is currently a C riffle pool stream type. There is one bridge that is a floodplain constriction with deposition below. The habitat condition is fair and the geomorphic condition is good.

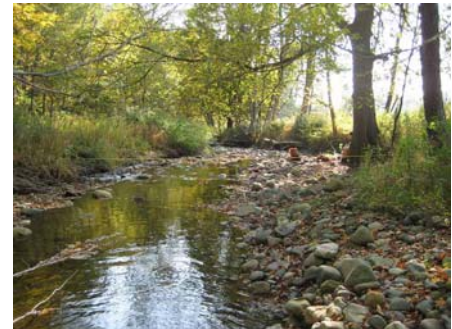
T2.01B

Habitat condition is fair and geomorphic condition is good.

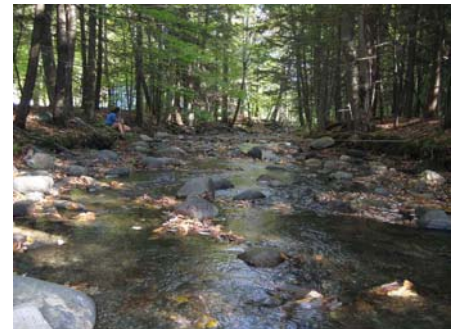
T2.02C

Segments A, C and F are currently Cb riffle pool stream type. They were historically straightened and bermed and are not incised with good access to floodplain. Habitat condition is good and geomorphic condition is fair. The dominant adjustment process is minor aggradation and widening with moderate planform adjustment. They are in channel evolution model F stage IV. Segment A has an old mill pond on it.

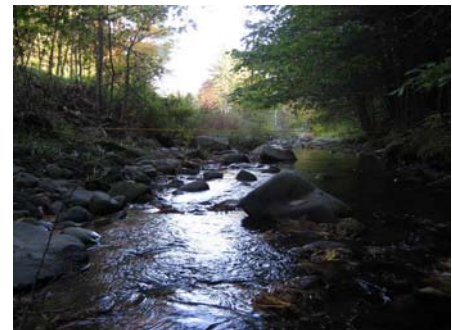
T2.02B

Segments B and D are sub-reaches with reference stream type B riffle pool and they are currently in B riffle pool stream types. Both segments are historically degraded and rebuilding floodplain with "hard armor" on the left bank from the road bed. Habitat condition is good and geomorphic condition is fair. They are in channel evolution model F stage II.

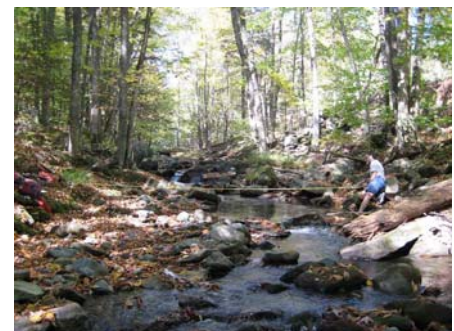
T2.02E

Segment E is also a sub-reach with reference stream type B step pool. It is currently a B step pool stream type with two channel spanning grade controls. The dominant left buffer width is 51-100' and the sub-dominant is 0-25'. There is one
