HOOSIC RIVER

Phase 2 Stream Geomorphic Assessment

Pownal, VT

FINAL REPORT

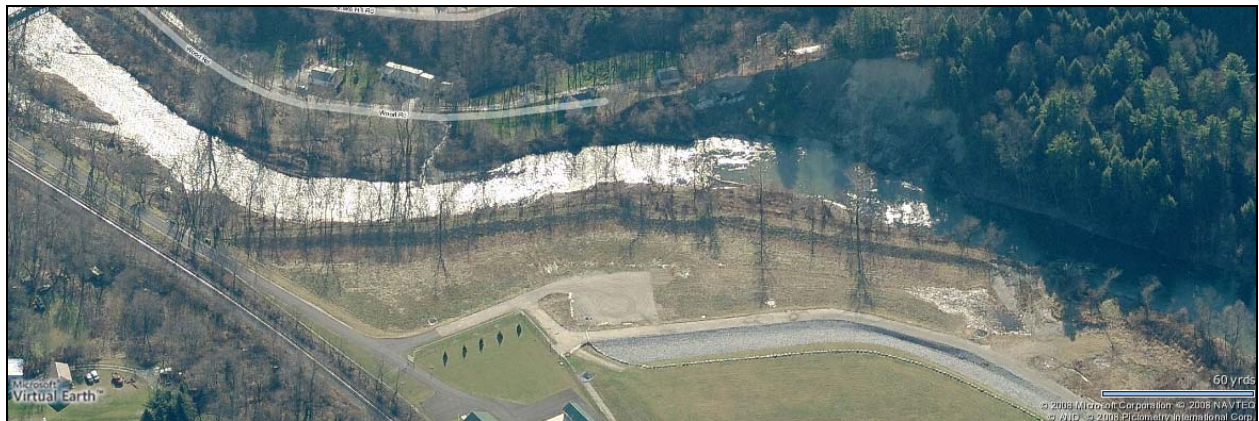
In Reach M02, adjacent to the new water treatment facility (WWTF), a berm on river right (pictured below) is reducing sediment and flood flow storage capacity on the floodplain and appears to be increasing erosion and sediment transport as evidenced by the mass failure on river left. Floodplain storage and corridor width could be increased in this area by removing the berm. To protect developments such as the WWTF and residential properties behind it, the berm may need to be offset back from its current position to provide at least a small floodplain for flow and sediment attenuation.

Aerial view berm along the Hoosic River in Reach M02 (Microsoft Virtual Earth, 2009)

However, this former floodplain area is particularly sensitive due to the remediation of historic hazardous wastes from the tannery (see photographs on the following page), so berm removal or offset may not be feasible here.

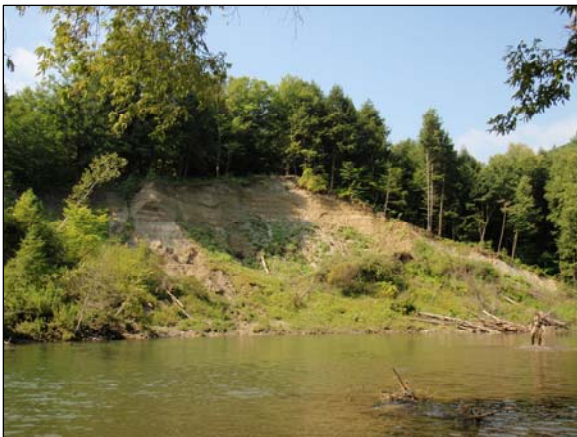
As described above, Reach M02 is artificially confined on the right bank by a berm to prevent inundation of the hazardous waste remediation site, and to protect the new waste water treatment facility. It is well established that many hard bank protective structures, designed to protect investments in the corridor, may not be sustainable in the long-term and will either fail or transfer excess stream energy, and thus the erosion problem, further downstream. In the case of the mass failure in Reach M02, due to the confined nature of the reach, localized resistive or redirective methods may be implemented to prevent further erosion.

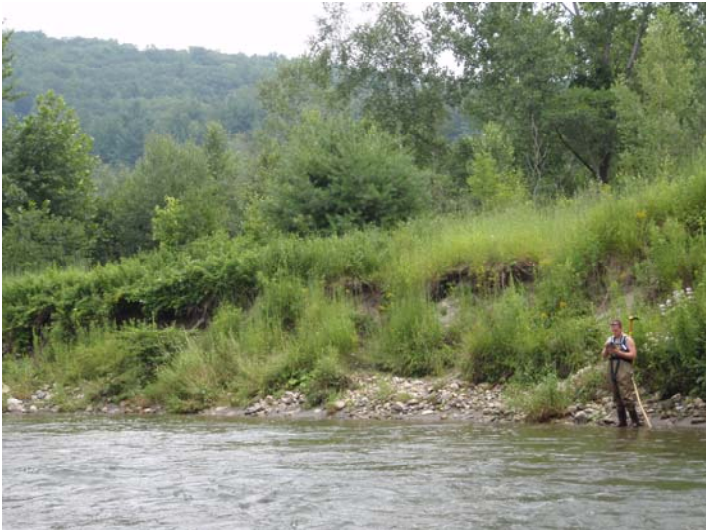
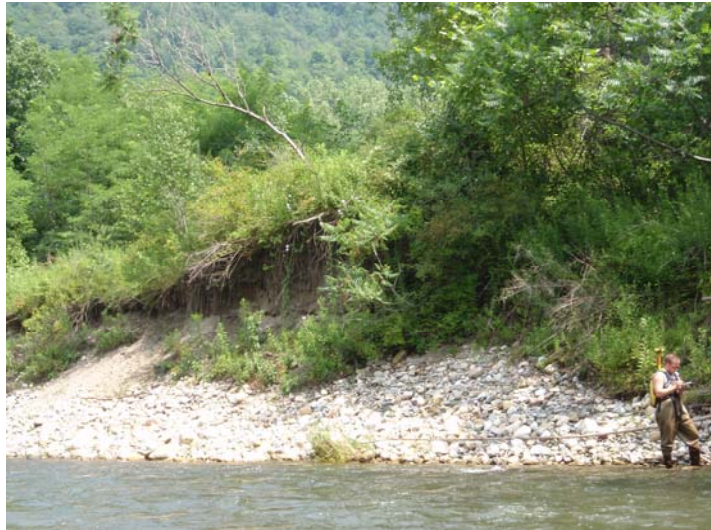
Segment ID: M06	Photo #: 15	Date: 7/31/08	View: RB	Segment ID: M06	Photo #: 16	Date: 7/31/08	View: RB
Description: 9' erosion across from flood chute/bar				Description: 12' erosion across from flood chute outlet

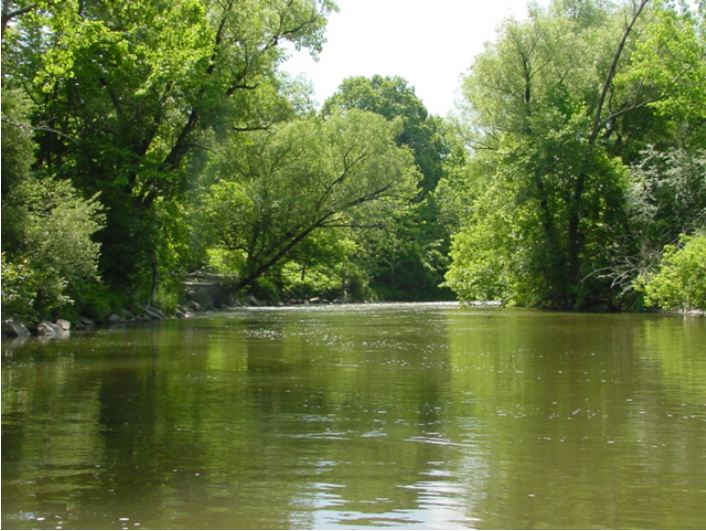
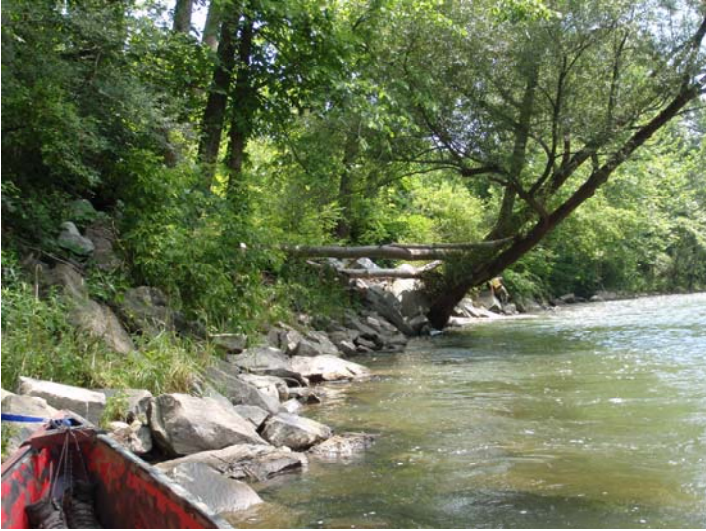
Segment ID: M06	Photo #: 17	Date: 6/25/08	View: US	Segment ID: M06	Photo #: 18	Date: 7/31/08	View: US RB
Description: US from island/terrace area (rip-rap on L)				Description: Close-up of RR loose rip-rap below railroad

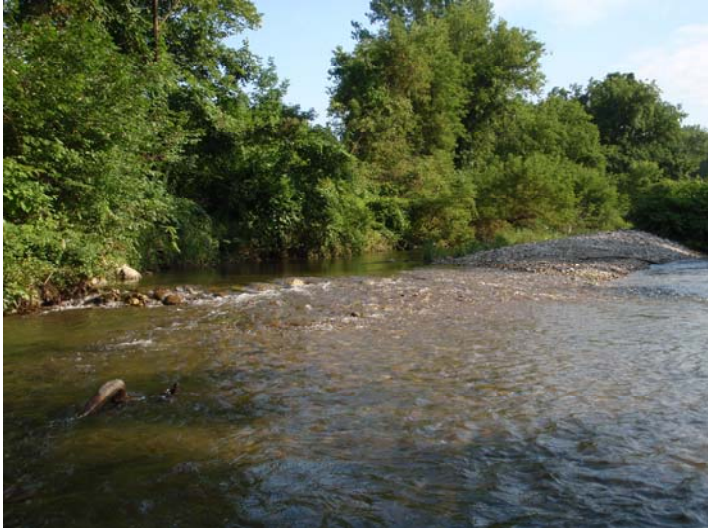
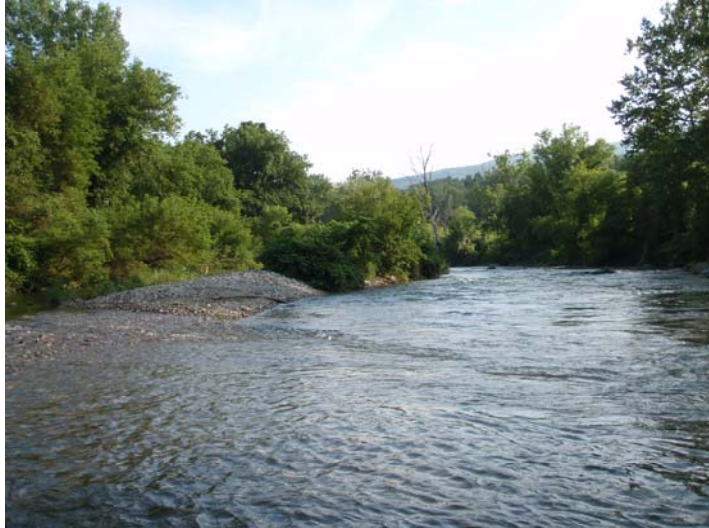
Segment ID: M05	Photo #: 33	Date: 7/31/08	View: US	Segment ID: M05	Photo #: 34	Date: 7/31/08	View: US
Description: Mid-channel bar above bridge; RR channel on left				Description: Mid-channel bar above bridge; main channel on right

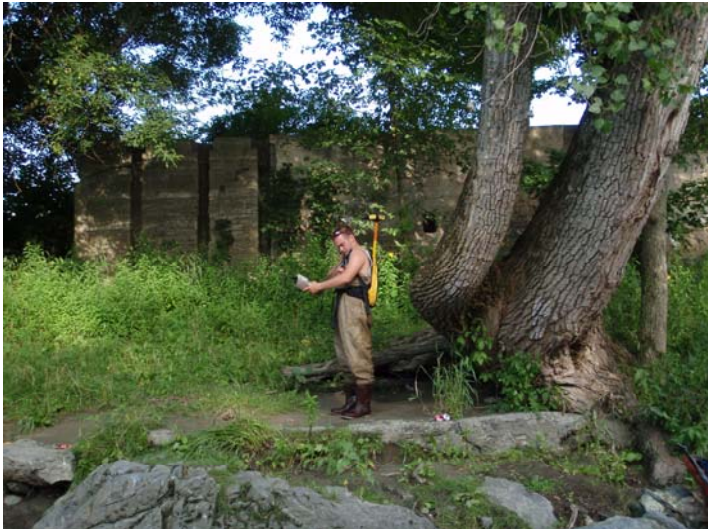
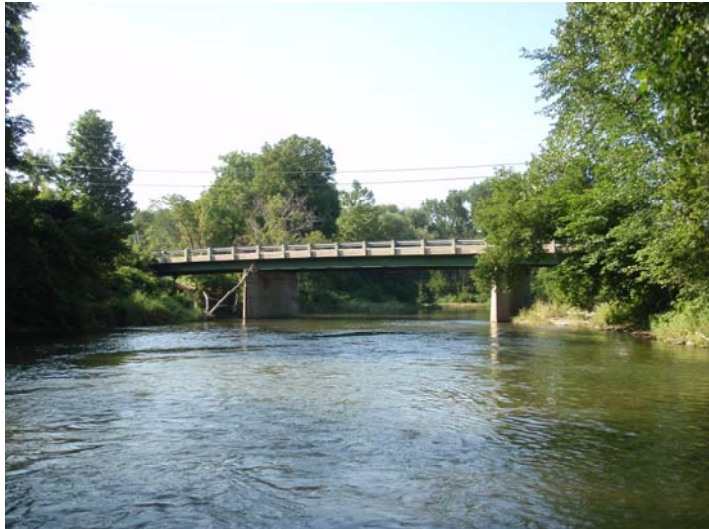
Segment ID: M05	Photo #: 35	Date: 7/31/08	View: RB	Segment ID: M05	Photo #: 36	Date: 7/31/08	View: DS
Description: Concrete foundation on RR above bridge				Description: Inlet of Main Street Bridge

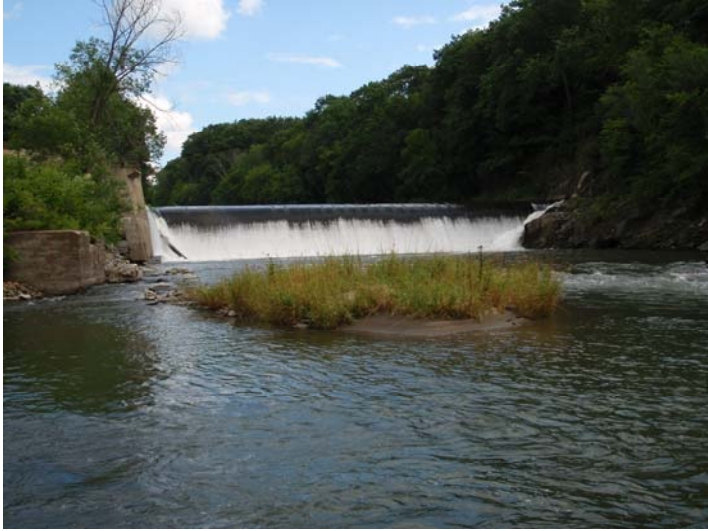
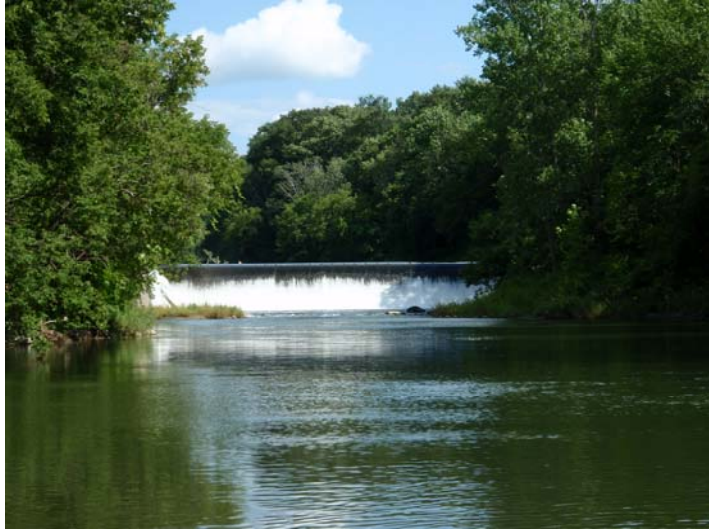
Segment ID: M03-A	Photo #: 69	Date: 8/1/08	View: US	Segment ID: M03-A	Photo #: 70	Date: 8/1/08	View: US
Description: Dam (sedimentation in foreground, bedrock R, foundations L)				Description: Dam

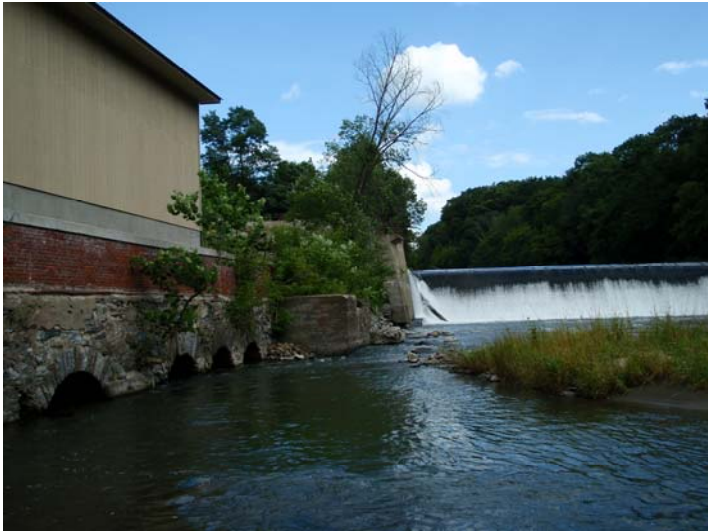
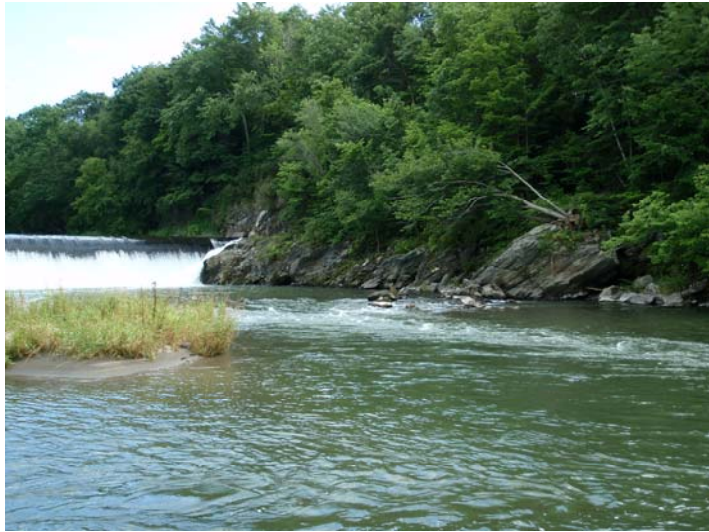
Segment ID: M03-A	Photo #: 71	Date: 8/1/08	View: US RB	Segment ID: M03-A	Photo #: 72	Date: 8/1/08	View: US LB
Description: Old tannery foundations below dam				Description: Bedrock on LB below dam (sedimentation in foreground)

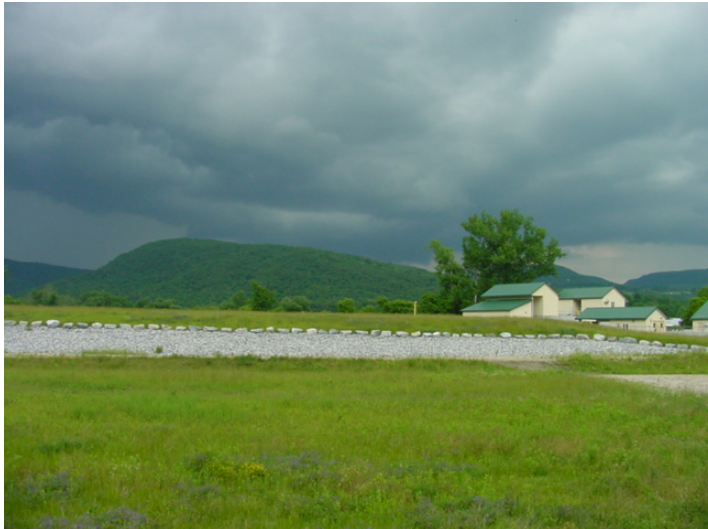
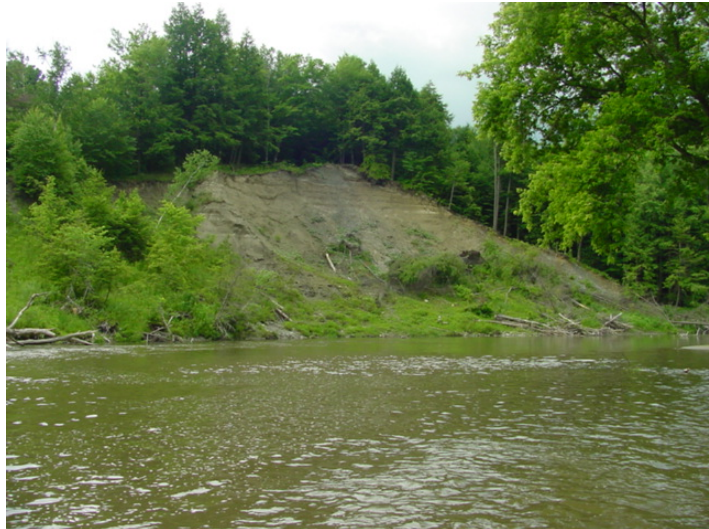
Reach M02 is the shortest reach, flowing for just over half a mile from the upper end of the wastewater treatment facility (WWTF) to the end of an agricultural field below it. The left corridor has some sparse residential development at the upper end of the reach, but is primarily forested, while the right corridor is mostly occupied by the open land of the WWTF (Photo 87), with some agricultural land at the downstream end. The naturally very broad valley is confined to narrow width by human encroachments, defined on the left by the natural mountainside slope usually continuous with the bank, and on the right by the railroad. A berm runs almost the entire length of the WWTF property on the right (over 2,200 feet). Portions of this berm were excavated and redesigned during the Superfund clean-up and redevelopment of the former tannery lagoon complex where the WWTF now sits (see Section 1.3). Between the end of the berm and the start of the agricultural field (approximately 170 feet), the buffer is less than 25 feet (Photo 100) and the bank is covered in a reinforcing carpet-like material (Photos 102 and 103). Across from the berm near the upper end of the reach, there is a substantial mass failure approximately 50 feet high where the mountainside is actively eroding (Photos 88 through 90).

Segment ID: M02	Photo #: 87	Date: 6/24/08	View: RB	Segment ID: M02	Photo #: 88	Date: 6/24/08	View: LB
Description: Wastewater treatment facility (WWTF) in right floodplain				Description: Mass failure across from WWTF

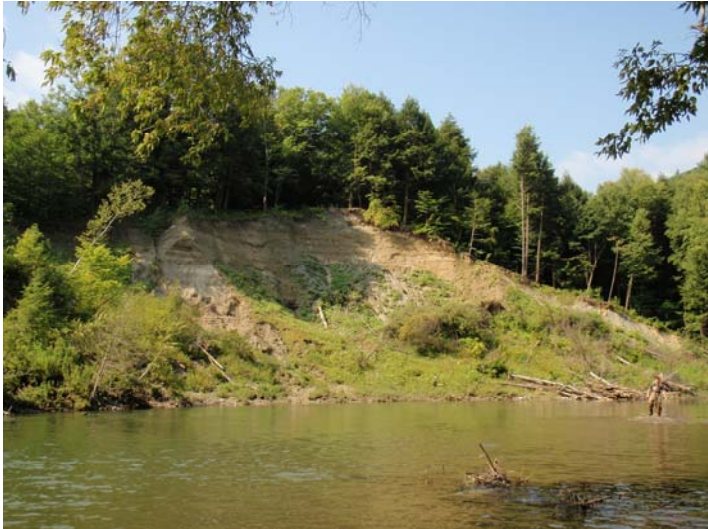
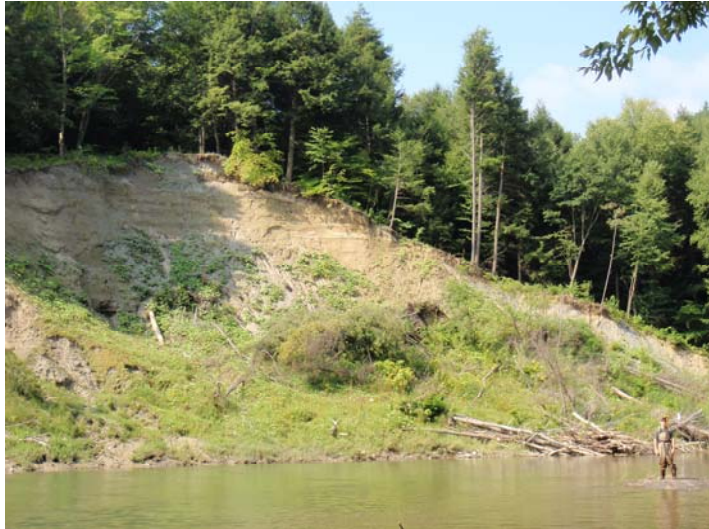
Segment ID: M02	Photo #: 89	Date: 8/18/08	View: LB	Segment ID: M02	Photo #: 90	Date: 8/18/08	View: LB
Description: Mass failure across from WWTF				Description: Mass failure across from WWTF

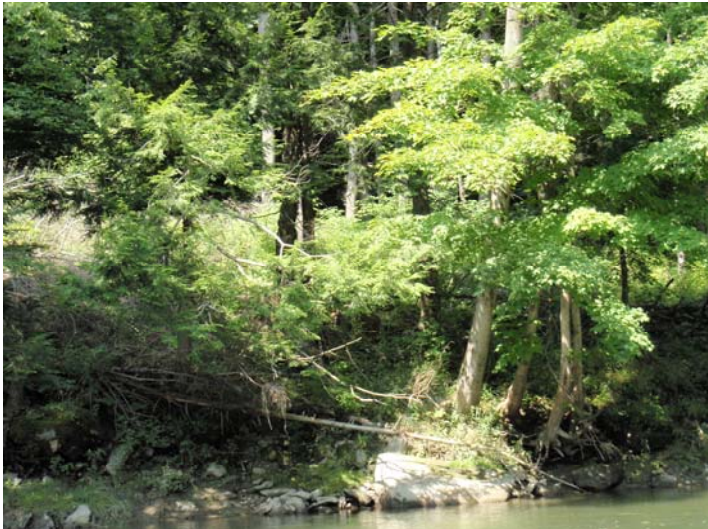
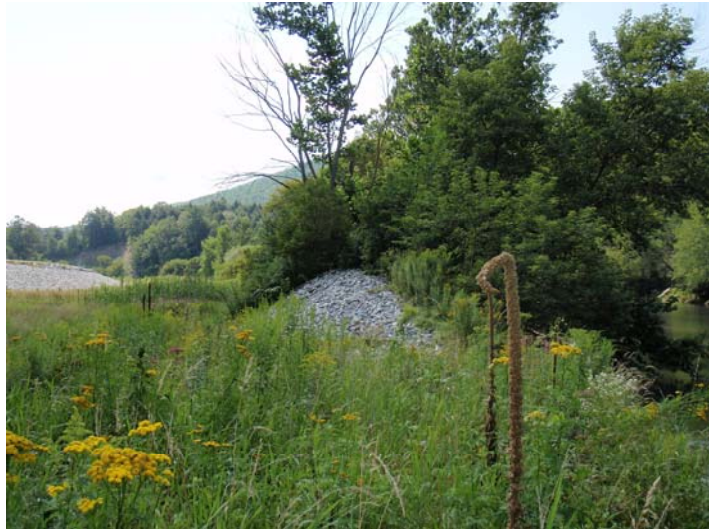
Segment ID: M02	Photo #: 101	Date: 8/18/08	View: DS RB	Segment ID: M02	Photo #: 102	Date: 8/18/08	View: RB
Description: Buffer <25' section below WWTF berm				Description: Carpet-like material on bank below buffer <25' section
