Ompompanoosuc River Corridor Plan

West Fairlee to Thetford, Vermont
April 28, 2011

Bear Creek Environmental, LLC
297 East Bear Swamp Road
Middlesex, Vermont 05602

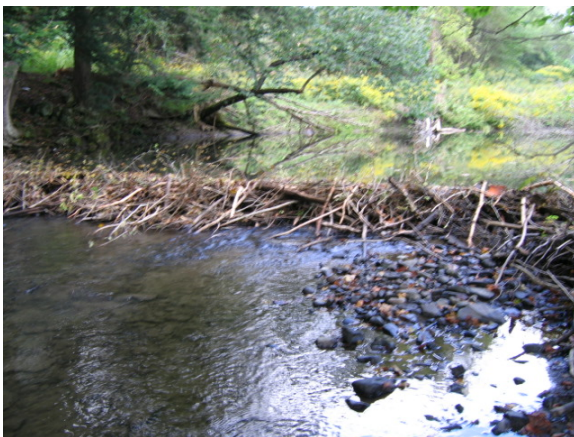
Segment R15-A is only about 800 feet in length. The upper end of the segment ends adjacent to the southern end of an abandoned mill building that was recently razed. A beaver dam (Figure 4.1) near the downstream end of the segment was impounding (Figure 4.2) all but the lower 200 feet of stream channel at the time of the Phase 2 assessment in early September 2010. The impounded conditions precluded a full rapid geomorphic assessment (RGA); however, an attempt was made to measure a cross section at the lower end of the segment to assist with determining a stream type. Buffers less than 25 feet in width are common along the east bank immediately upstream of the beaver dam. Given the active beaver activity, this would not be a good buffer planting location; however, a “no mow zone” to allow the vegetation to grow back would be beneficial. Overall, the geomorphic condition is “fair”.

Figure 4.1 Beaver dam at lower end of R15-A

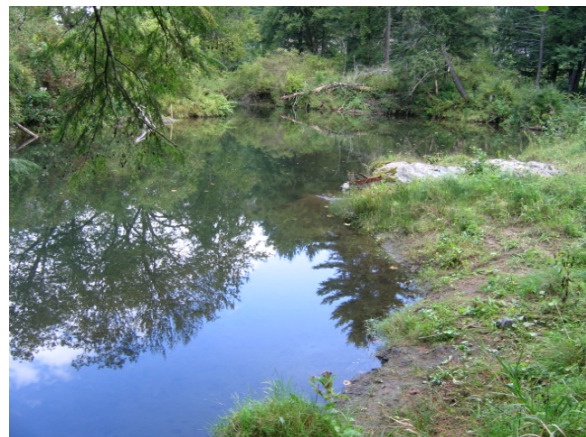
Figure 4.2 Impounded section of channel in R15-A

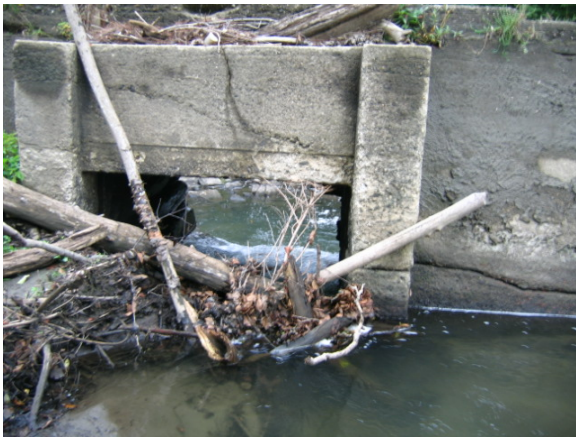
Figure 4.3 Constriction at dam in R15-B
(Looking downstream)

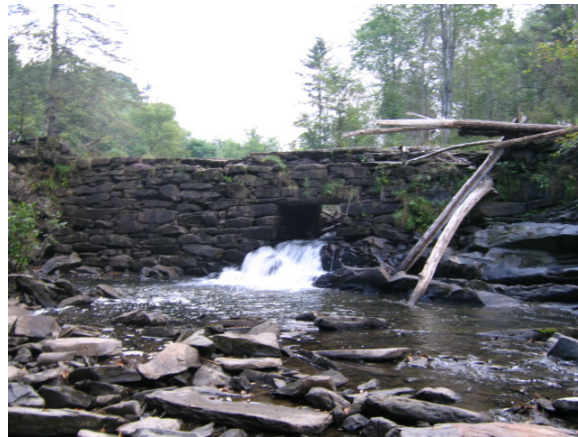
Figure 4.4 Constriction at dam in R15-B
(looking upstream)

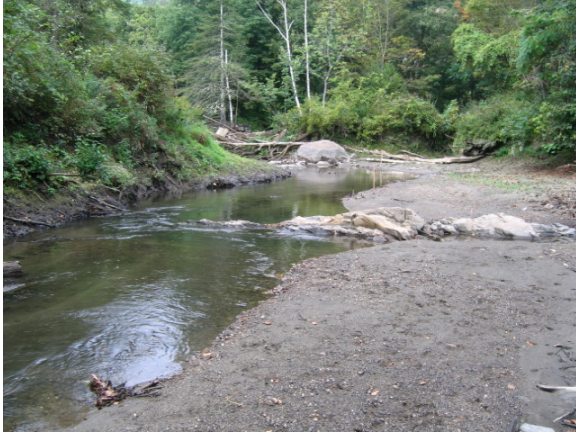
Figure 4.5 Sediment deposition upstream of dam

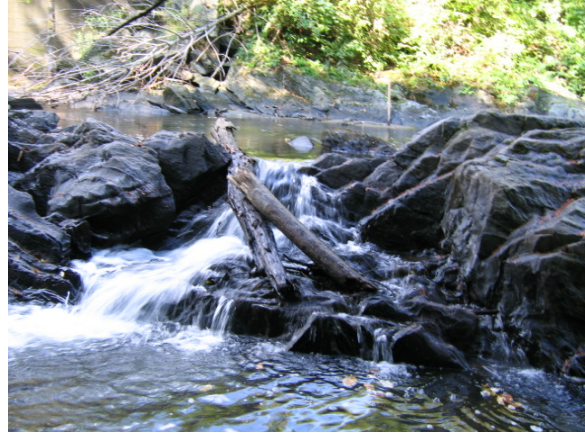
A full rapid geomorphic assessment could not be completed in Segment R15-B due to the bedrock gorge with multiple ledge grade controls (Figure 4.6). The ledge grade controls are providing vertical stability within the reach by preventing the bed from incising.

Figure 4.6 One of many ledge grade controls in R15-B.

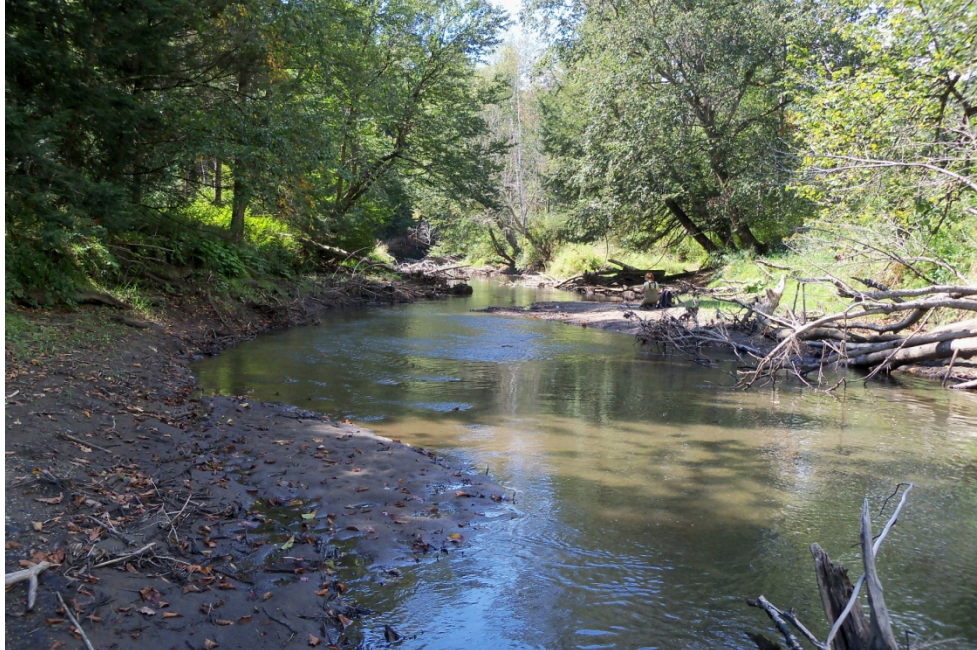
Figure 4.7 The bed substrate of reach 16 is dominated by sand.

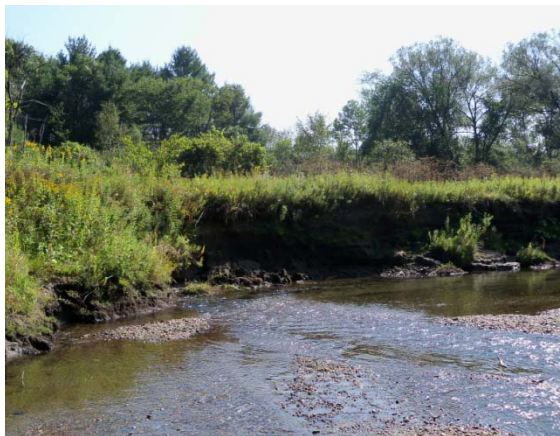
Figure 4.8 Extensive bank erosion in Reach R17

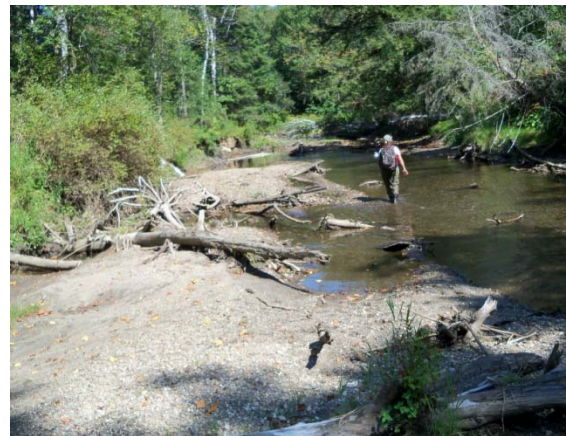
Figure 4.9 Large depositional features

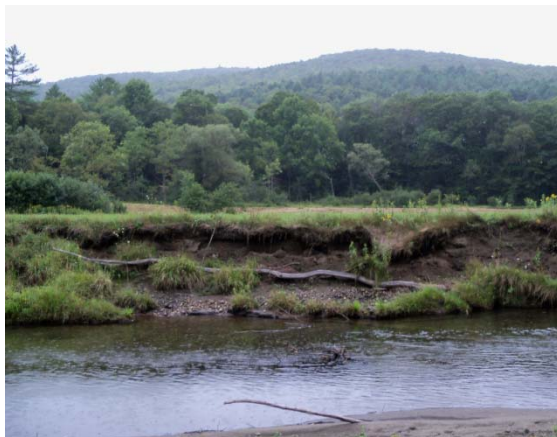
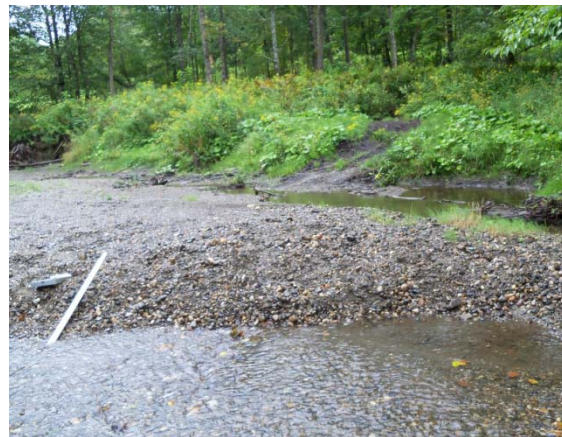
Figure 4.10 Lack of buffer & extensive bank erosion **Figure 4.11** Recent gravel extraction location in R18

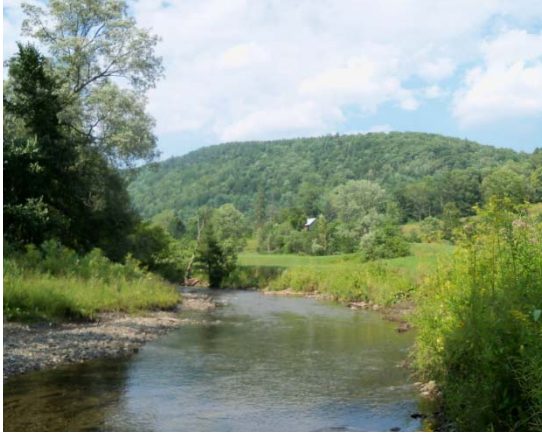
Figure 4.12 Historically straightened.

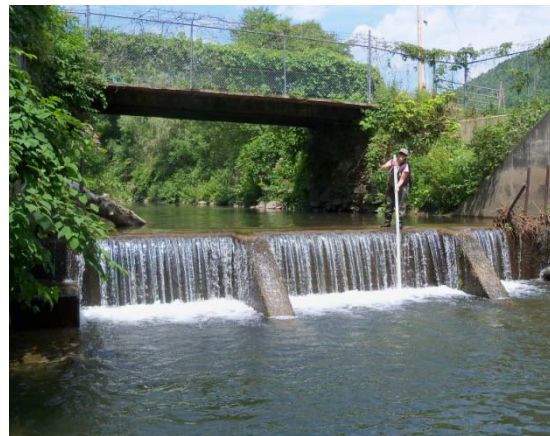
Figure 4.15 Geer dam in segment R19-B

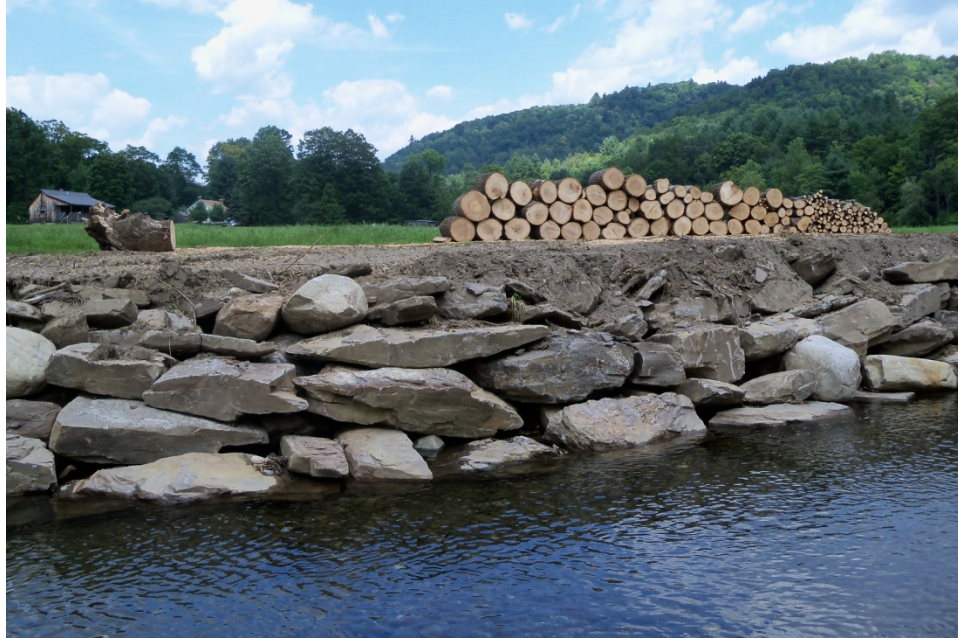
Both at the lower and upper ends of segment 19-B, the channel appears to have been pushed up against the valley wall. The channel is held in a straightened path with riprap. About 20 percent of each bank has hard bank armoring (i.e. concrete) or riprap. In areas where riprap is not present, bank erosion is common. Nearly half of the west bank has buffers less than 25 feet. About 35 percent of the east bank has buffers in the range of 0-25 feet; however, the dominant buffer width on that side is greater than 100 feet. Figure 4.16 shows an area of bank, where trees were recently cut down and the bank was stabilized with riprap.

Figure 4.16 Newly installed riprap with trees cut along the bank in segment R19-B

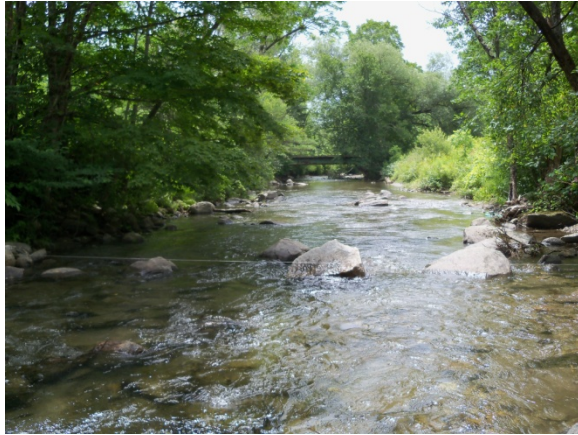
Figure 4.17 Straightened channel

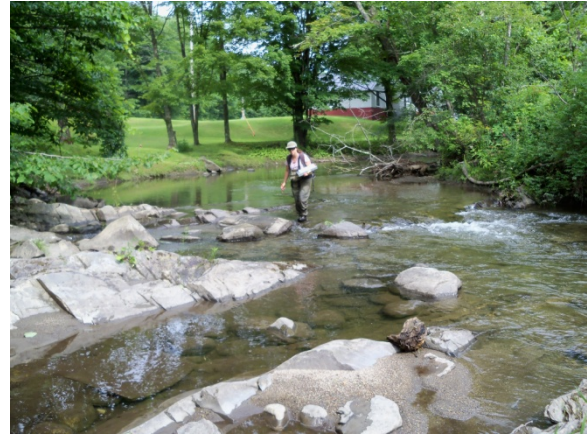
Figure 4.18 Ledge grade control in R20-A

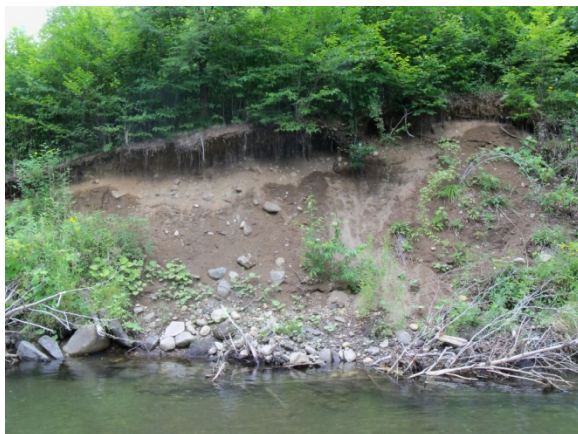
Figure 4.19 Mass failure on east bank

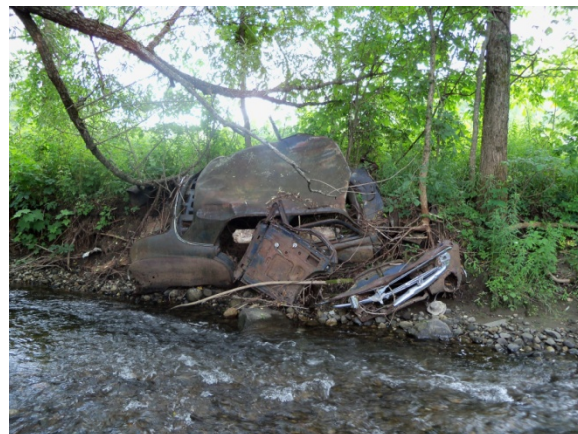
Figure 4.20 Bank erosion and old automobile

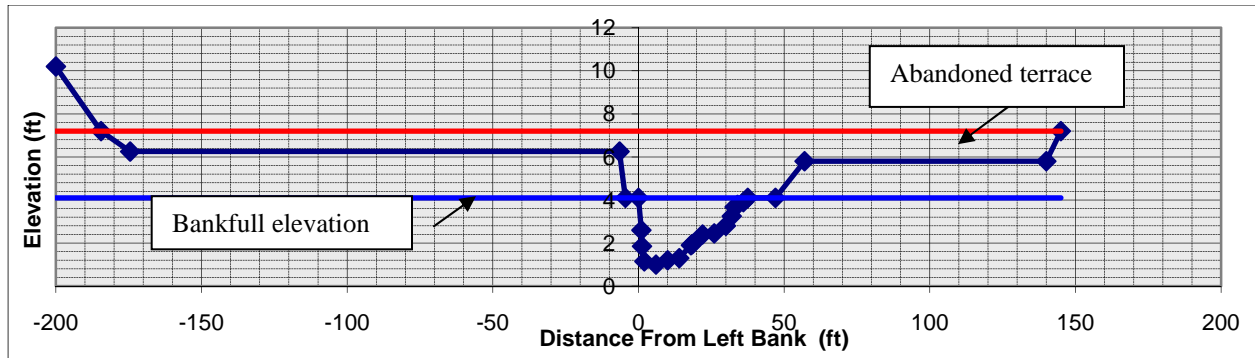
Segment R21-A is 0.8 miles in length. Approximately 55 percent of the channel length has been straightened, primarily for agricultural purposes. The channel has incised historically as shown in the graph of the cross section below (Figure 4.21). The new bankfull elevation (depth where the water overtops the banks and spills out into the floodplain) is currently about two feet lower than the abandoned terrace (i.e. former floodplain before the channel incised). In this case, the channel is moving from the widening stage into the stabilizing stage of the channel evolution model. A very narrow juvenile floodplain (bankfull bench) is starting to develop on the right (west) bank. A bankfull bench, a flat area along the channel, forms at the elevation of the *bankfull discharge*. A bankfull discharge occurs about once every one to two years and is responsible for shaping river channels. The red line in the graph below shows the width of the floodprone area (an area whose extent is at an elevation twice the bankfull elevation) that would be accessed during a large flood event. The floodprone width of the cross section from R21-A is about 330 feet. The difference in the elevation of the abandoned terrace and the bankfull elevation is also illustrated in Figure 4.22.

Figure 4.21 Channel cross section for segment R21-A (graph is vertically exaggerated for illustration purposes)

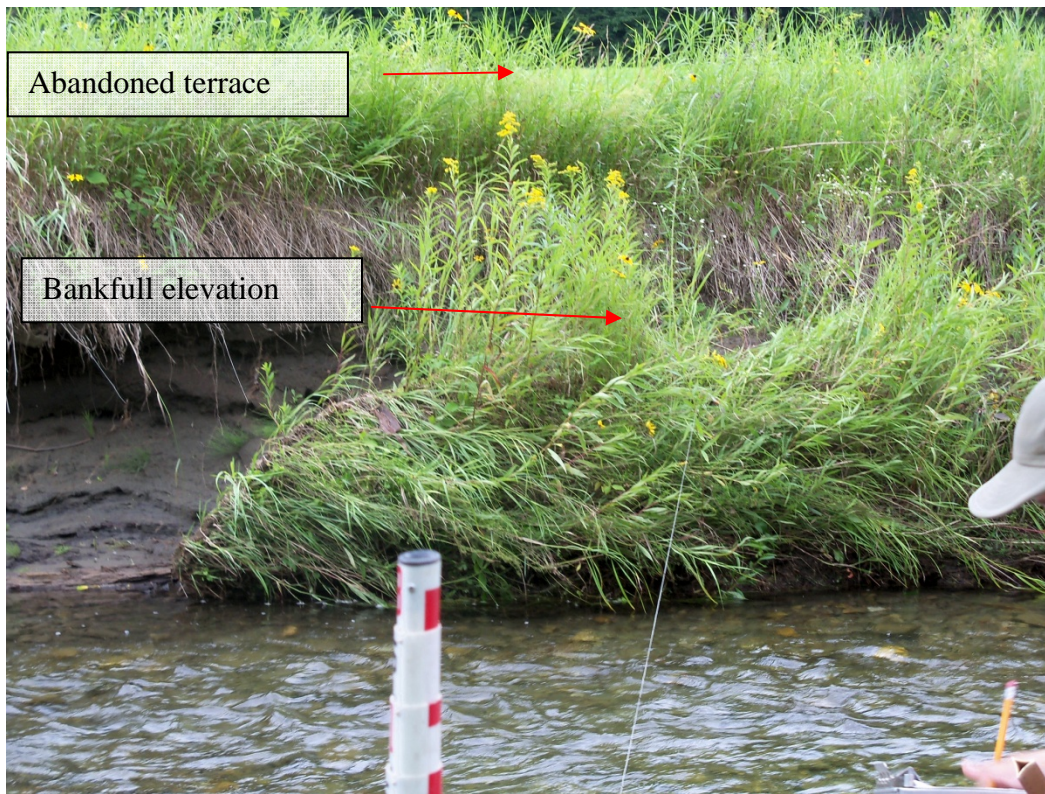
Figure 4.22 Cross section measurement in segment R21-A, showing incised channel.

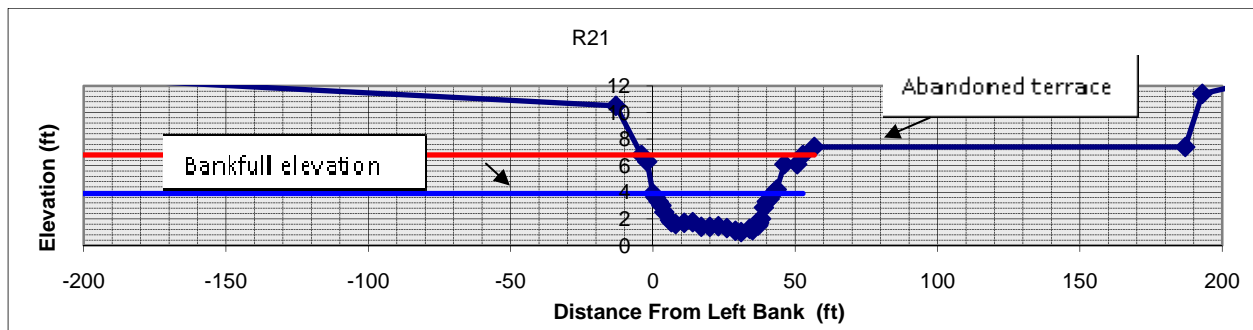
Segment R21-B is a short segment of just over 1,000 feet in length near the West Fairlee/Vershire town line. Floodplain access is poor within this segment. As shown in Figure 4.23, the abandoned terrace is about 3.5 feet higher than bankfull. The floodprone width of this “F” channel is only 57 feet, and is much narrower than the floodprone width of the “C” channel shown in Figure 4.21. The channel in R21-B is just starting to go through a widening process. Trees on the bank and riprap are preventing the channel from widening further. There is virtually no floodplain available at a bankfull discharge, and the sediment is transported through rather than being deposited on the floodplain. The overall geomorphic condition of segment R21-B is “fair”.

Figure 4.23 Channel cross section for segment R21-A (graph is vertically exaggerated for illustration purposes)

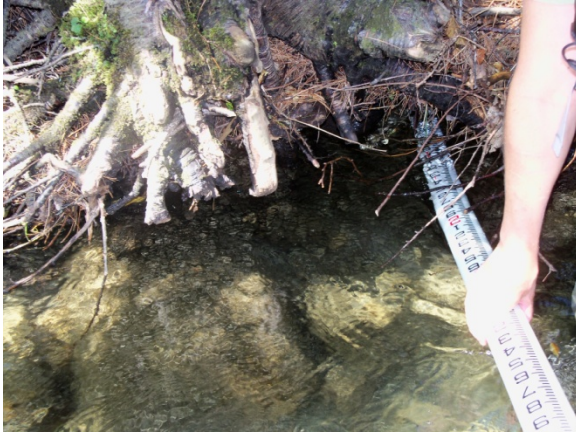
Figure 4.24 Stable undercut bank in segment R21-B

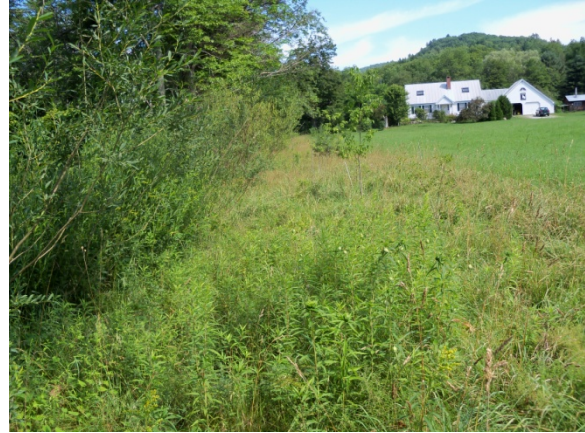
Figure 4.25 Planted buffer on east side of channel

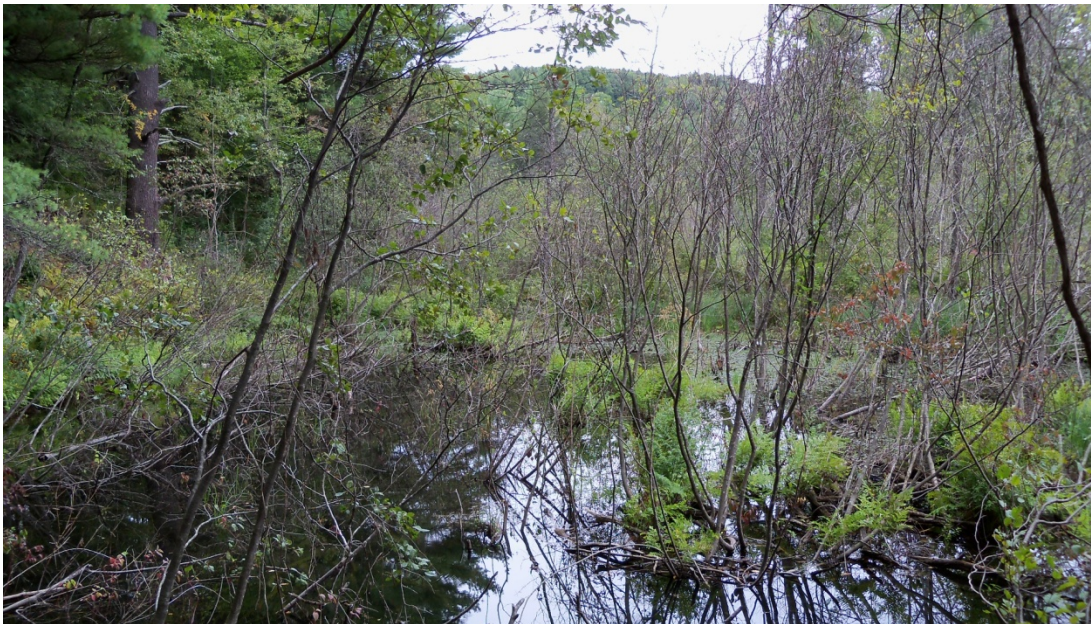
Figure 4.26 Wetland impounded by beaver dam in reach R16T2.01 of the Lake Fairlee Outlet

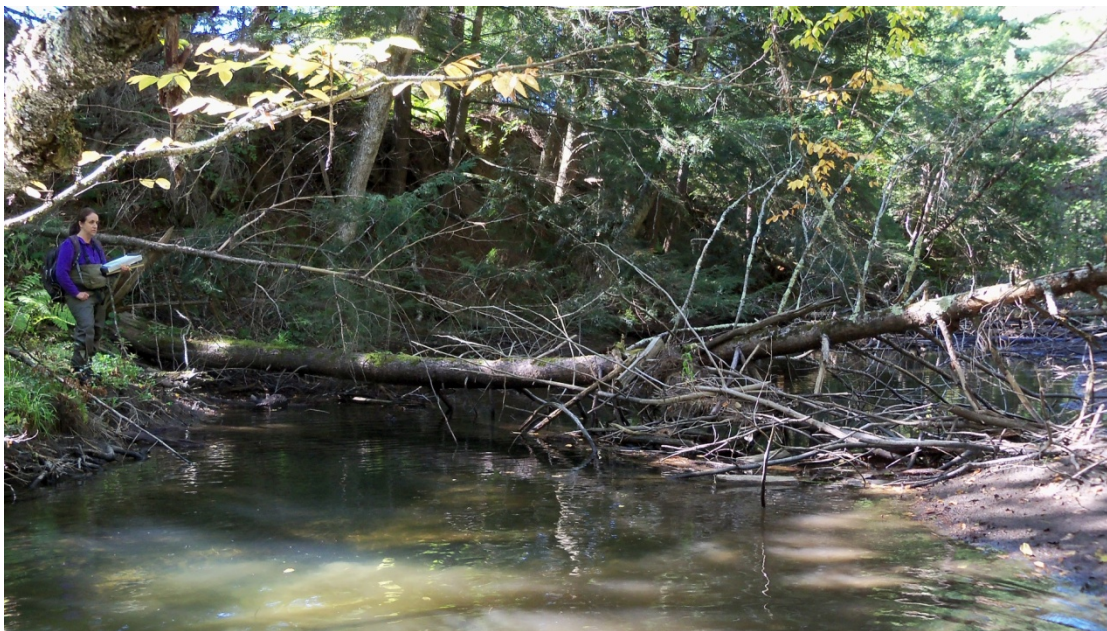
The habitat condition for RI6T2.02 is at the high end of the “fair” range. Woody debris cover was outstanding, with logs and debris jams creating cover (Figure 4.27). Coarse particulate organic material (CPOM), which is an important source of food and cover for aquatic insects, was present both in the margins and channel. There is a high percentage of silt (30%) making the substrate less suitable for the colonization by water quality sensitive species and for trout reproduction. Connectivity of habitat scored low, because of the man-made obstruction (Lake Fairlee Dam). The dam is fourteen feet in height and is creating a system obstruction for movement of fish and other aquatic species (Figures 4.28 and 4.29).

Figure 4.27 Debris jam at reach break between RI6T2.02 and RI6T2.01

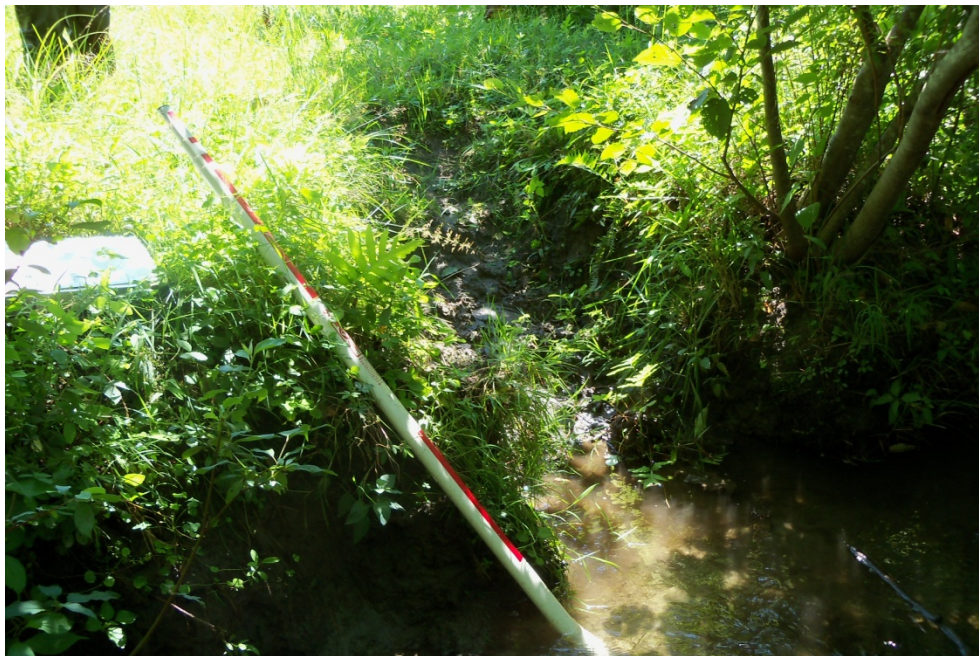
There are no corridor encroachments (roads, development, improved paths, railroads, etc.) in R16T2.04-B. Impacts to this segment are predominately from active livestock grazing in the riparian corridor. The livestock are causing bank erosion and are trampling the vegetation in the buffer (Figure 4.32). The channel has undergone historic incision and is currently widening. There is moderate to high erosion at the base of both banks in the riffle section, and moderate lateral bank erosion on the outside bends. About one-half the length of both banks has active erosion. Alders on the near bank are providing root structure to hold the soil and reduce further channel widening. The overall geomorphic condition is “fair”.

Figure 4.32 Animal crossing and eroded bank

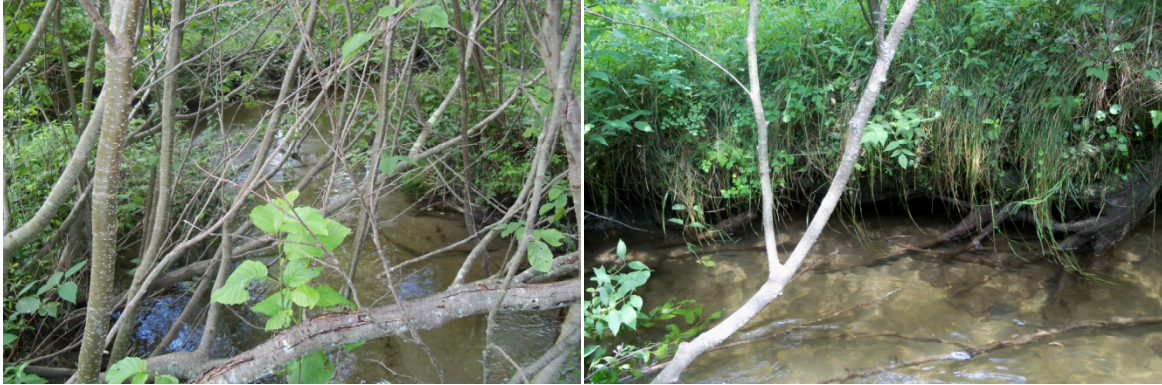
Figure 4.33 Alders providing good root structure **Figure 4.34** Undercut bank providing good cover

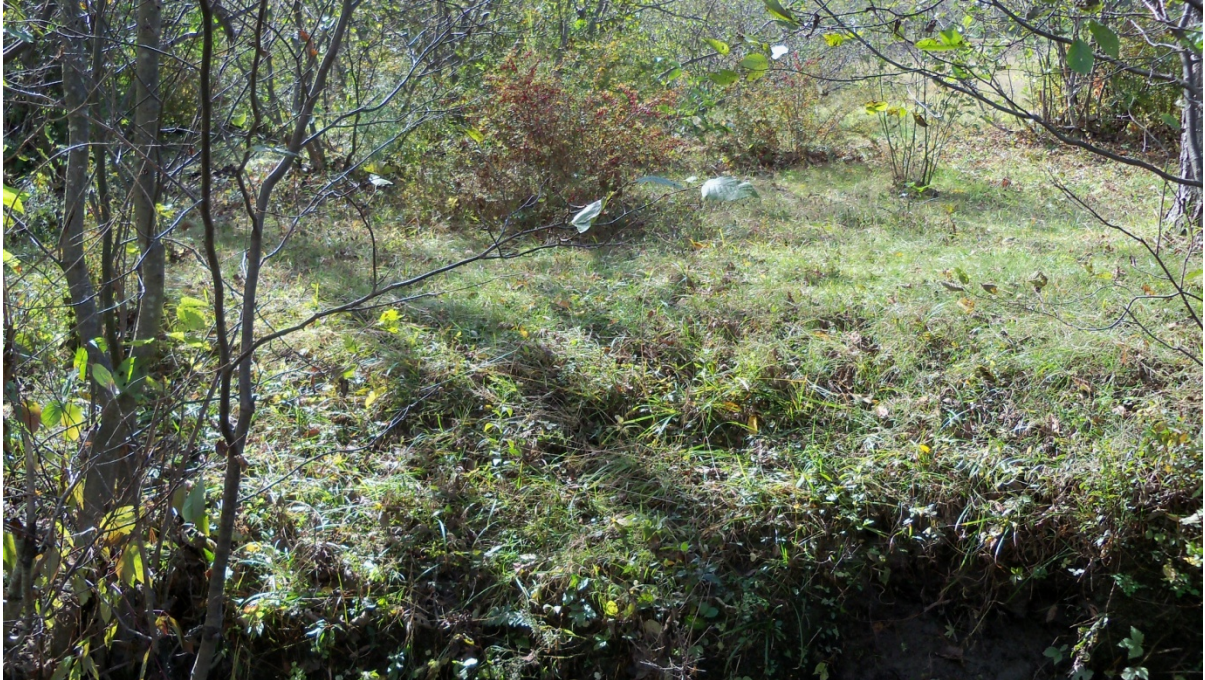
Figure 4.35 Lack of buffer along the near bank and invasive plant species in the background in R16T2.05-A

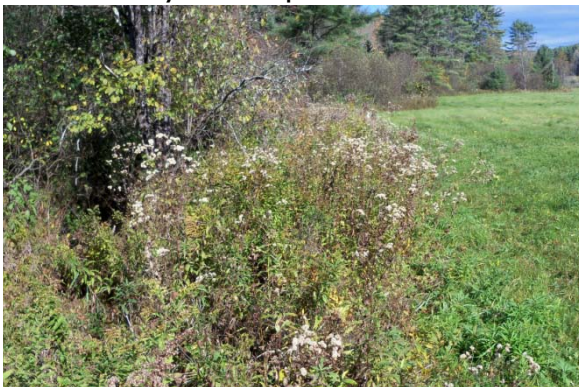
Figure 4.36 Lack of buffer along east side of channel

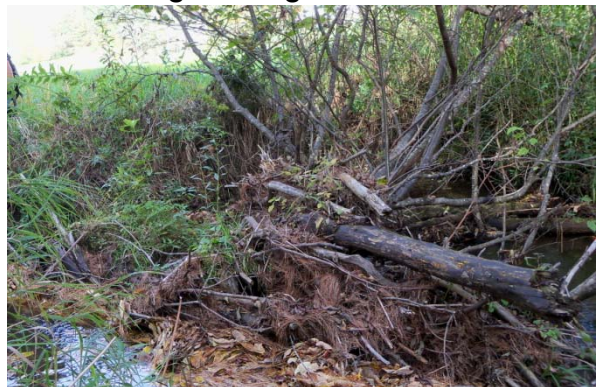
Figure 4.37 Habitat debris jam in R16T2.05-B

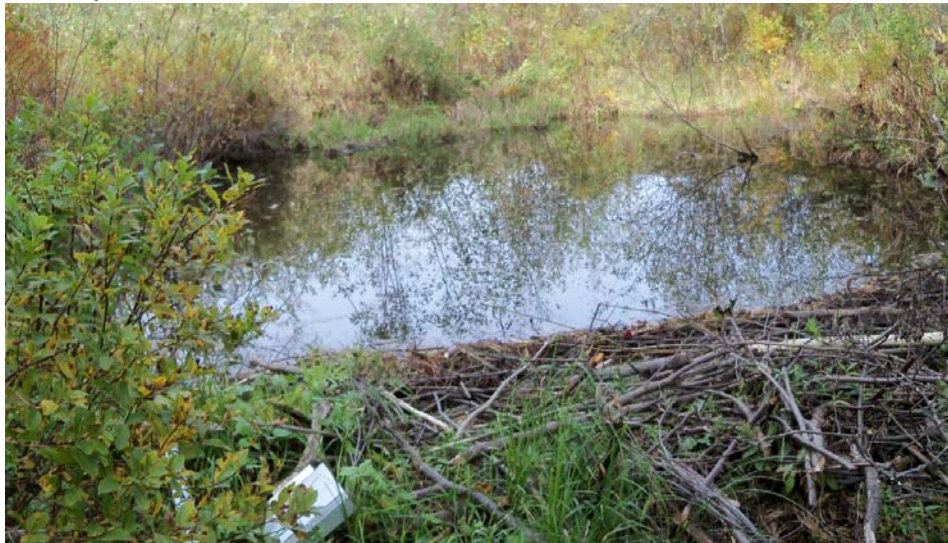
A large beaver dam at the lower end of R16T2.05-C is impounding the channel (Figure 4.38). Two smaller beaver dams were in place near the upper end of segment C at the time of the Phase 2 assessment. A full Phase 2 assessment could not be completed due to the extent of the impounded flow. Segment C is in good condition with dominant buffer widths of greater than 100 feet. Hay fields are in the eastern corridor, and the subdominant buffer width on the east side is 51-100 feet. The reference channel type is “E” and the valley type is very broad.

Figure 4.38 Large beaver dam at downstream end of R16T2.05-C

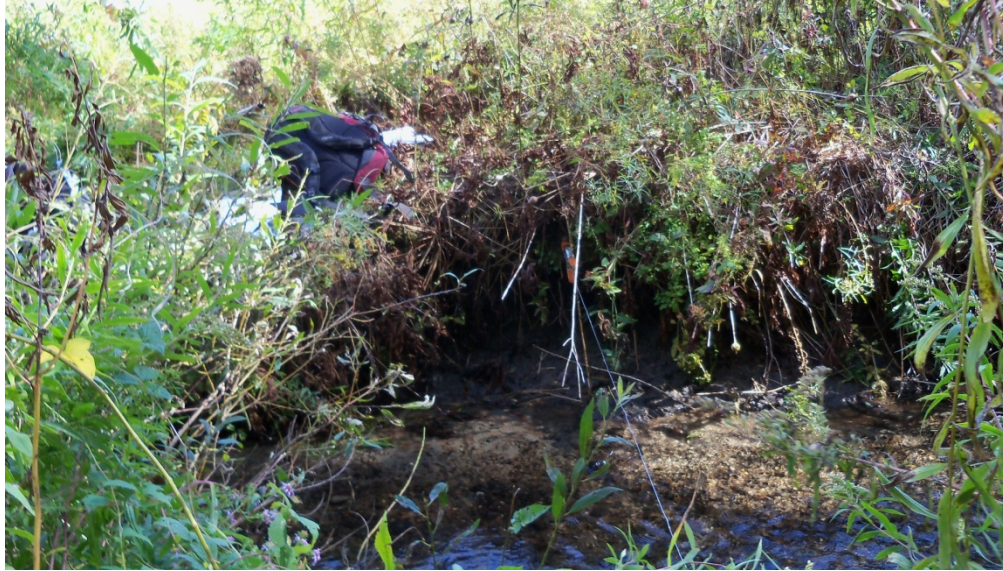
Figure 4.39 Bank erosion indicative of channel widening in segment R16T2.05-D

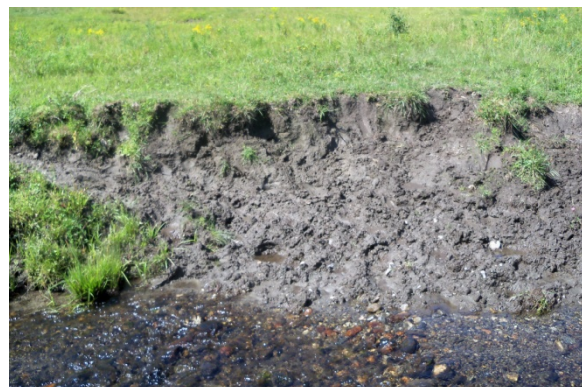
Figure 4.45 Trampled stream banks from horses

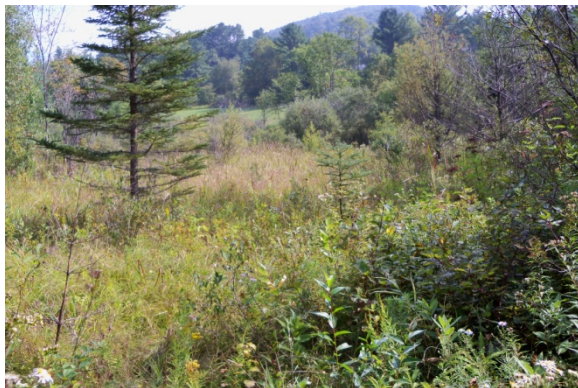
Figure 4.46 Wetlands in buffer and corridor

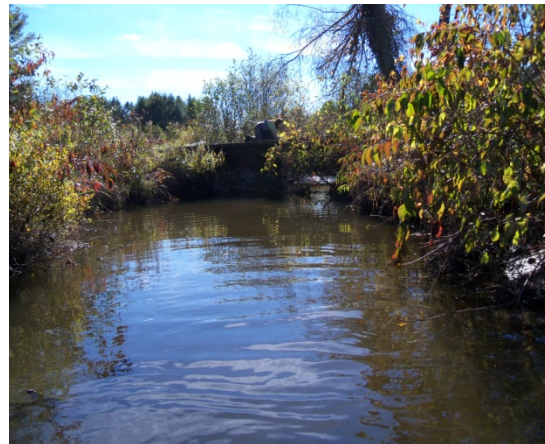
Figure 4.52 Impounded channel below farm bridge

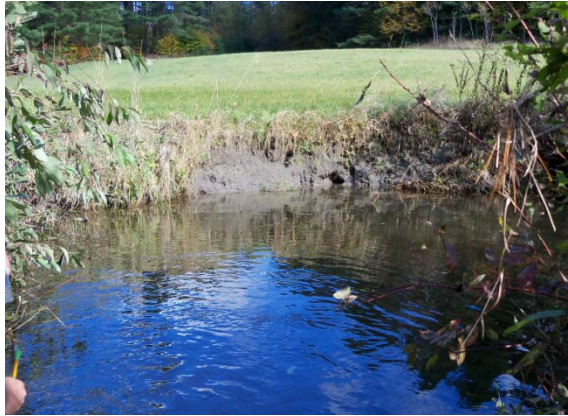
Figure 4.53 Lack of buffer and bank erosion

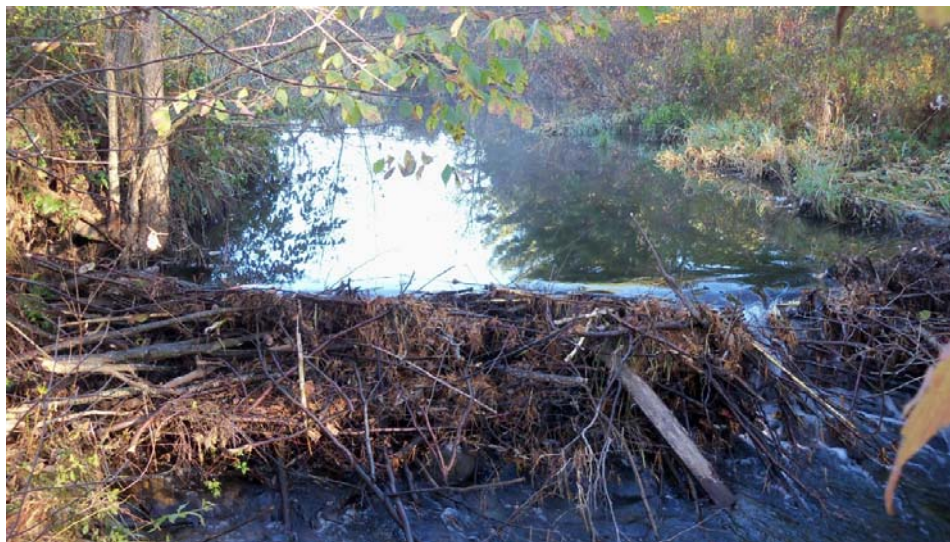
Figure 4.55 Beaver dam impounding flow in reach R16T2.03S1.01-C of Middle Brook

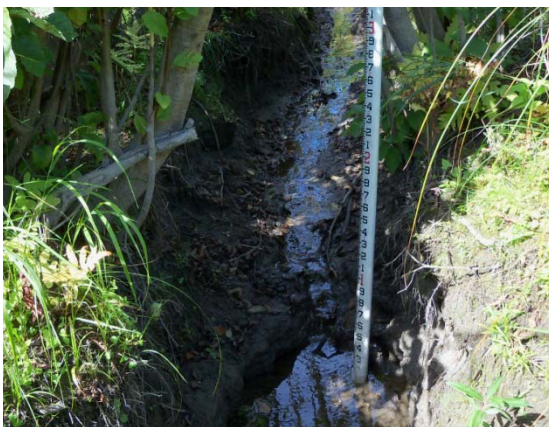
Figure 4.56 Active head cut in clay soils in swale

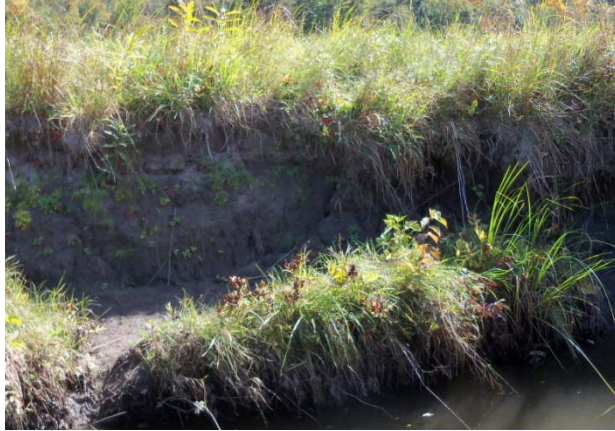
Figure 4.58 Bank erosion and lack of buffer

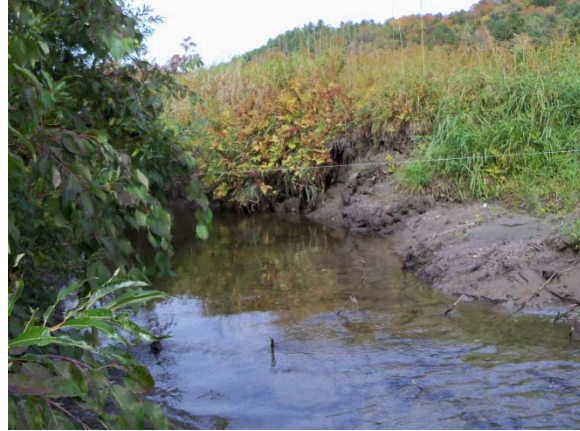
Figure 4.59 Bank slumping and typical channel

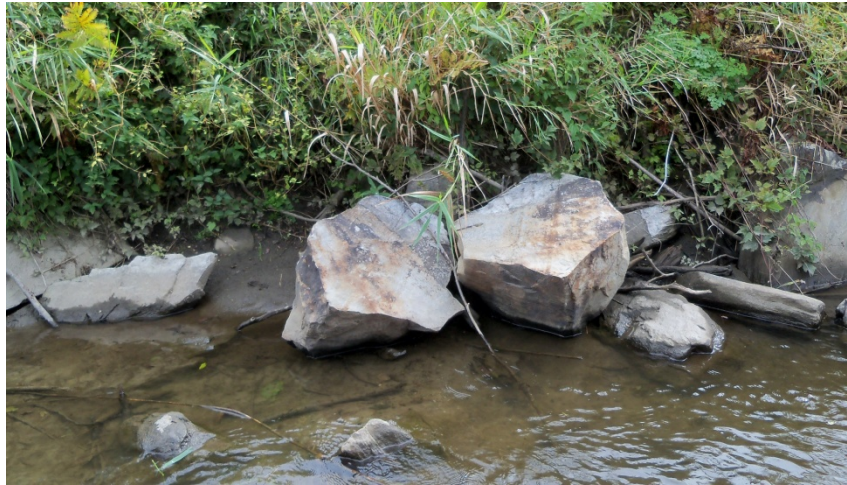
Figure 4.61 Outflanked riprap in R16T2.03S1.02-B

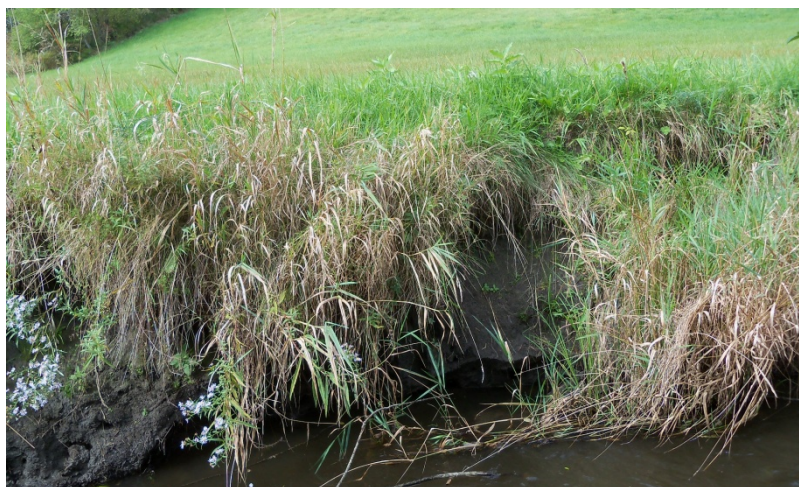
Figure 4.62 Bank erosion and lack of buffer along straightened channel

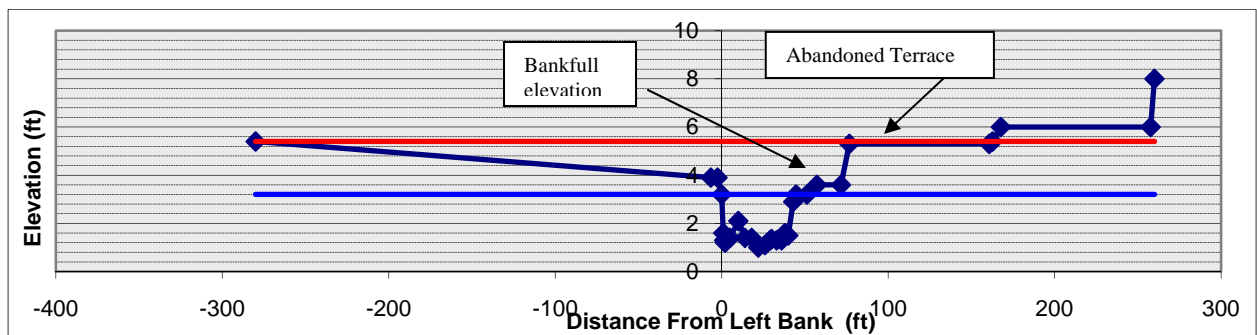
Figure 4.63 Graph of channel cross section for segment RI8T3.01-A
 (The graph is vertically exaggerated for illustration purposes.)

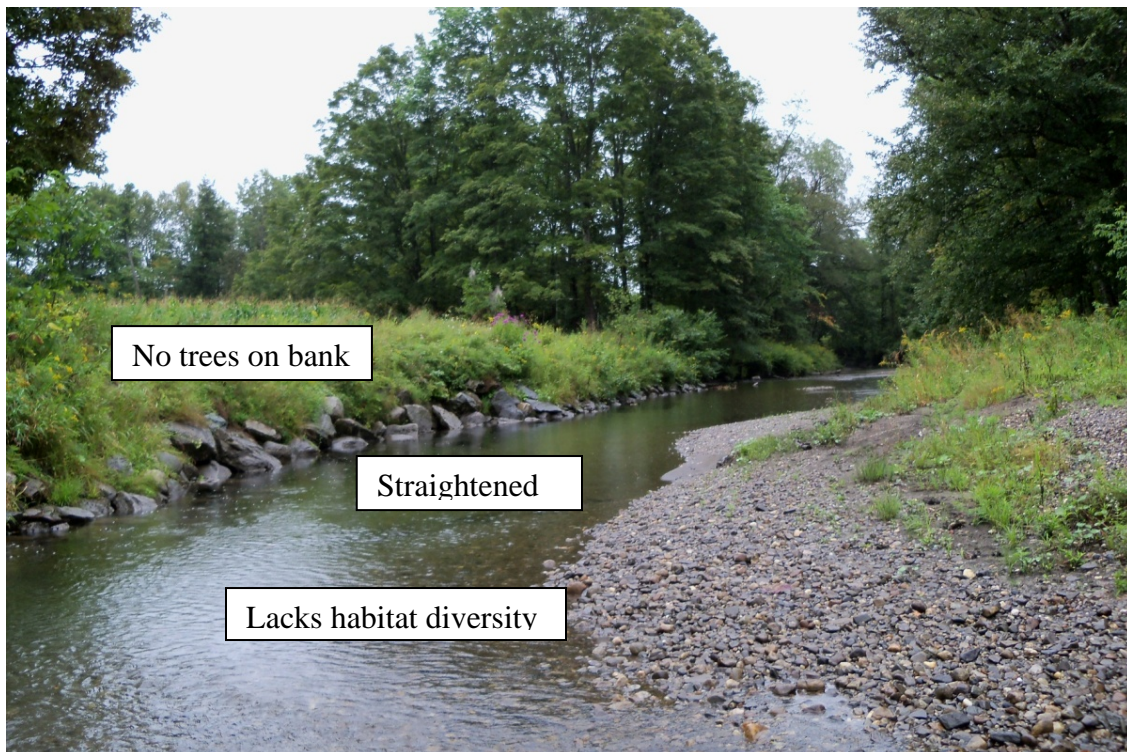
Figure 4.71. Segment R18 rated “fair” for habitat. The segment lacked large woody debris, riparian vegetation and was shallow and wide where the channel had been historically straightened.

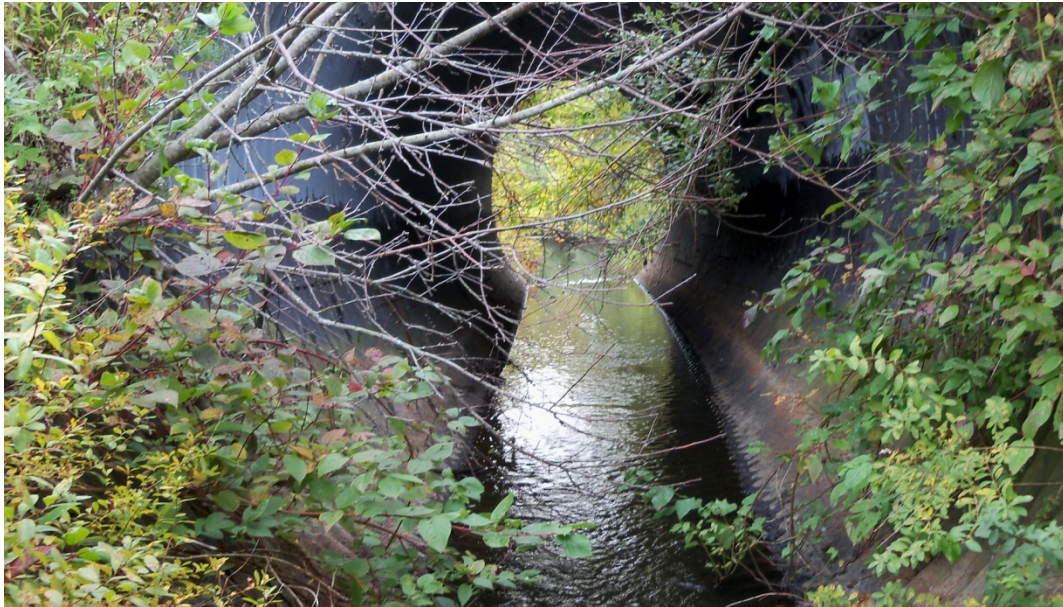
Figure 4.77. Reduced aquatic organism passage and geomorphic incompatibility at Middle Brook Road Culvert
