**Brewster River Phase 1 & 2
Stream Geomorphic Assessment Summary
March 15, 2013**

Fitzgerald Environmental Associates, LLC.
18 Severance Green, Suite 203
Colchester, VT 05446

Lamoille County Planning Commission
PO Box 1637
52 Portland Street, Second Floor
Morrisville, VT 05661

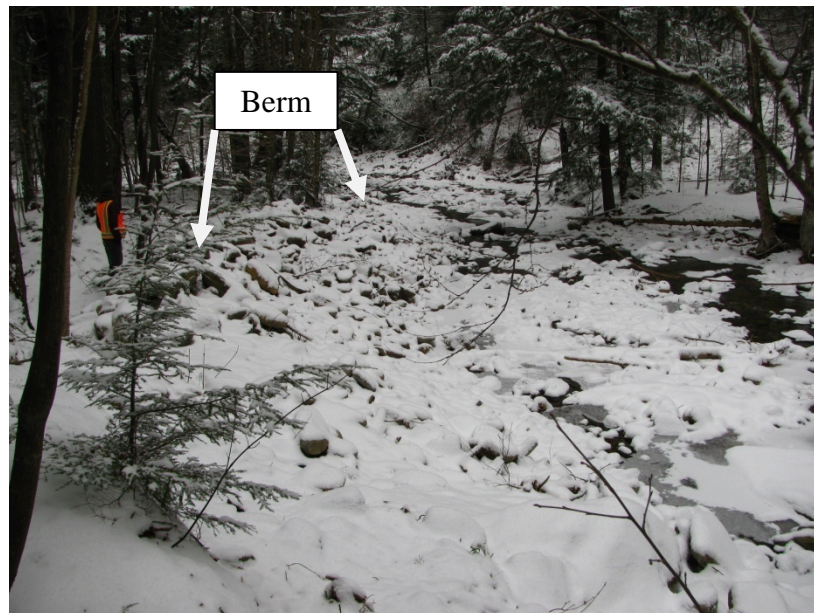
Figure 6: Berming along the left bank in Reach M12

Dredging and berming were observed during windshield surveys in reaches M12 and M14 (Figure 6). The channel dredging and berming along the left (south) bank were likely in response to recent flood events and were likely an attempt to restrict channel migration towards a hiking trail and condominiums in the left (south) corridor.

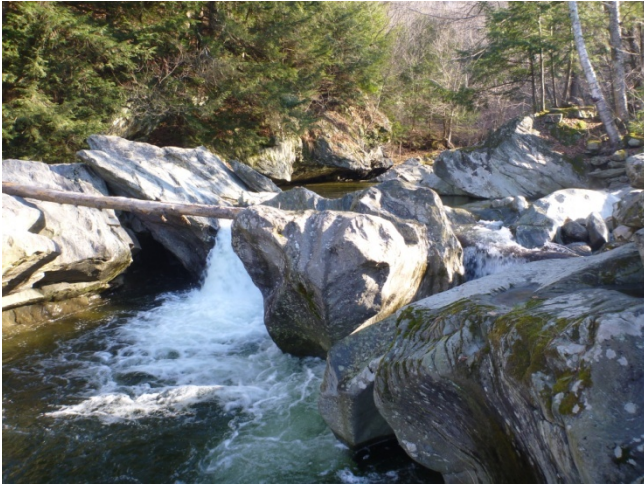
Figure 8: Grade control in M02

Ten natural grade controls exist along Reaches M02-M04. In each of these reaches, these bedrock areas act as controls on vertical stability and have caused the historic deposition of alluvium along the channel and valley bottom in the areas upslope of the controls. A long bedrock gorge runs through Reach M02 and contains 7 channel spanning bedrock grade controls as well as remnants of several old mill dams (Figure 8). A large waterfall (Brewster River Gorge/Jefferson Falls) is found in Reach M04 (Figure 9). Additionally, one human-enhanced grade control is found in Reach M03 and is associated with a popular swimming area.

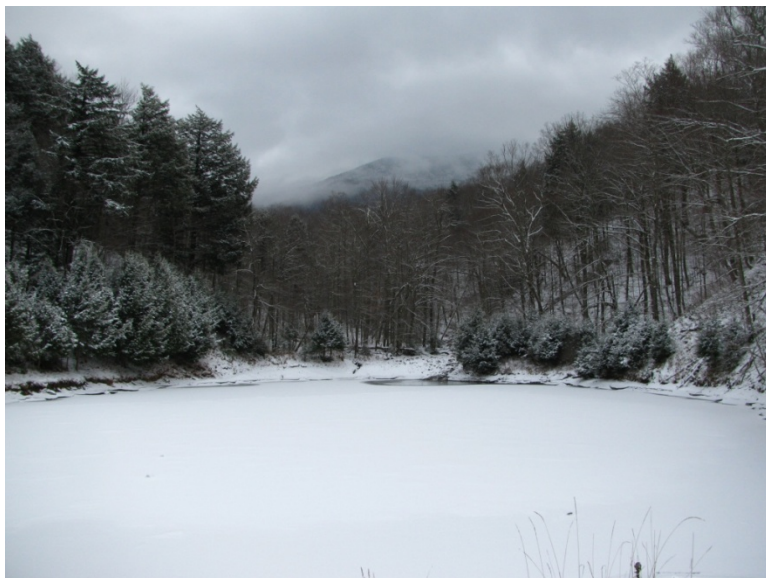
Figure 11: Smuggler’s Notch snowmaking pond above Reach M14

Mainstem: There is one impoundment on the mainstem that is considered a large (e.g., upstream impoundment is wider than channel width) run-of-the-river impoundment that is actively managed to change discharges or volumes. A 200’ long by 30’ high earthen dam is located at the top of reach M14 and creates a 1.5 acre pond used for snowmaking withdraws at the Smuggler’s Notch ski resort (Figure 11). This flow regulation is listed as a “high” impact.

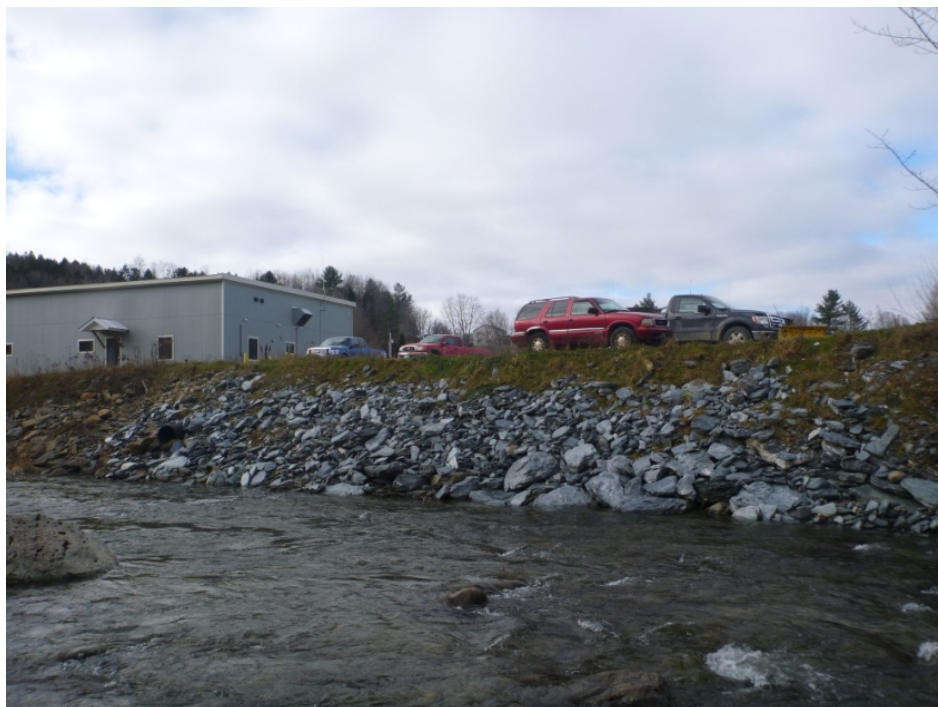
Figure 12: Bank armoring in Reach M01

Bank armoring and revetments were noted in detail for reaches M01-M04 during Phase 2 assessments, and as observed during the windshield survey for the remainder of the mainstem and reach T7.01. Mainstem areas where bank armoring was noted were primarily in the vicinity of bridges and buildings near the stream channel. Extensive armoring was present in Reach M01 along two commercial properties on the left bank, under three bridges, and on the toe of the slope along the mass failures (Figure 12). More than one-third (37.2%) of the channel length in this reach was armored, resulting in a “High” impact rating. Additionally, some armoring was noted primarily along road embankments in Reaches M02, M09, M12, M14, and T7.01.

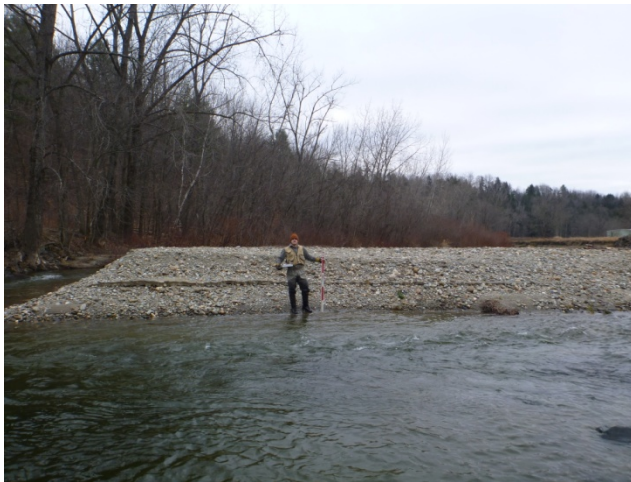
Figure 14: Large mid channel bar in Reach M01

Sediment depositional features (e.g., point bars, mid channel bars, etc.) were evaluated using the 2011 Bing aerial imagery, and were confirmed and/or refined during the field observations. Reaches with multiple types of depositional features indicated where upslope sediment supply exceeded the transport capacity. These areas represent conditions that are favorable for increased lateral channel migration that could endanger adjacent infrastructure and properties. Depositional areas in the undeveloped reaches along VT Route 108 may play an important role in sediment storage. Reaches M06, M09, and M11 appear to be storing large amounts of coarse sediment within the river corridor, resulting in reduced downstream sediment loading in Jeffersonville Village. In general, reaches with high impacts from depositional features were found at large channel slope changes or the confluence of tributaries and subtributaries that are carrying high sediment loads. Five mainstem reaches were identified with these conditions, including M01 (Figure 14), M04 (Figure 15), M06, M09, and M11. Additional detailed data about the types of depositional features and their relative impacts for all reaches are found in the reach reports found in Appendix A.

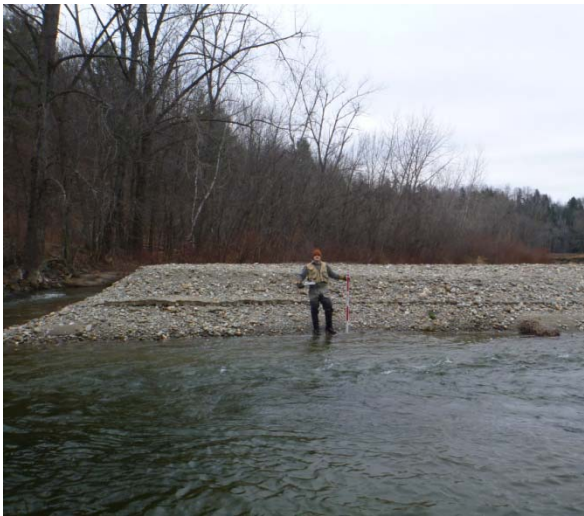
Reach M01 was segmented due to a change in channel dimensions, slope, and stream type approximately ½ mile up from the confluence with the Lamoille River. Segment A extends 2680 feet upstream from the Lamoille River. This segment is in a very broad valley and has a channel slope of approximately 0.6%. Armoring and buffer impacts are present along the VT Rte. 15 corridor. Two bridges are located in the lower portion of the segment (VAST trail bridge and VT15). A major rain event in the Spring of 2011 caused the Brewster River to spill over and follow VT Rte. 15 southward with major flooding in the village of Jeffersonville. The channel immediately upstream of VT Rte. 15 underwent significant channel migration and aggradation during this event (see Figures 18 and 19).

Figure 20: Large coarse gravel bar immediately upstream of VT Rte. 15, approximately 12,000ft² and 2-4 feet above water.

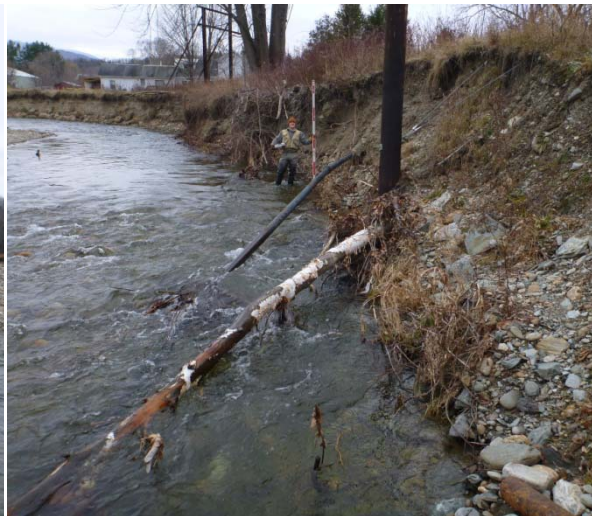
Figure 21: 400 feet of bank erosion upstream of VT Rte. 15

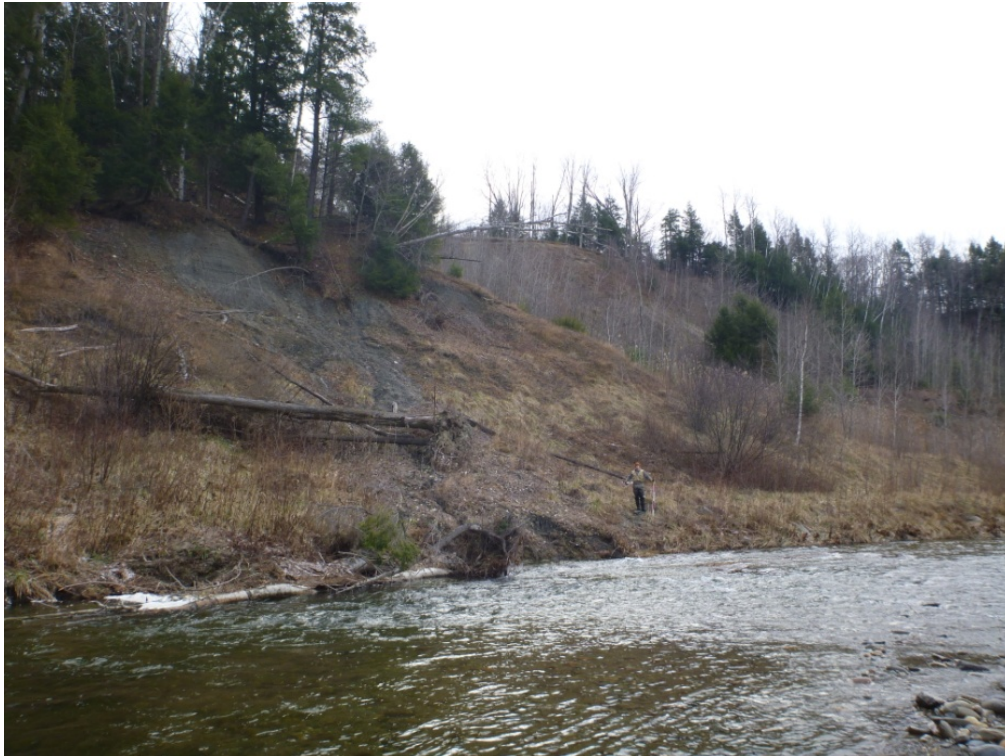
Three large mass failures are present along the right bank in M01-A. The downstream failure occurred in 2006. The two larger mass failures initiated three different times in April-July 1999. These mass failures have been well studied and it is estimated that 30,000m³ of sediment were deposited in the 1999 events. Additional mass failures were recorded along the reach in 1911, 1919, 1942, and 1954 (Becker et al., 2009). An extensive restoration effort was undertaken to clean up and stabilize the area following the 1999 slides. Bank armoring along these features is currently stable but future erosion of the valley toe could trigger additional slumping (Figure 20).

Figure 22: A 180' by 70' Mass failure on the right bank. The largest mass failure (350' by 150') is in the background approximately 100' from the channel

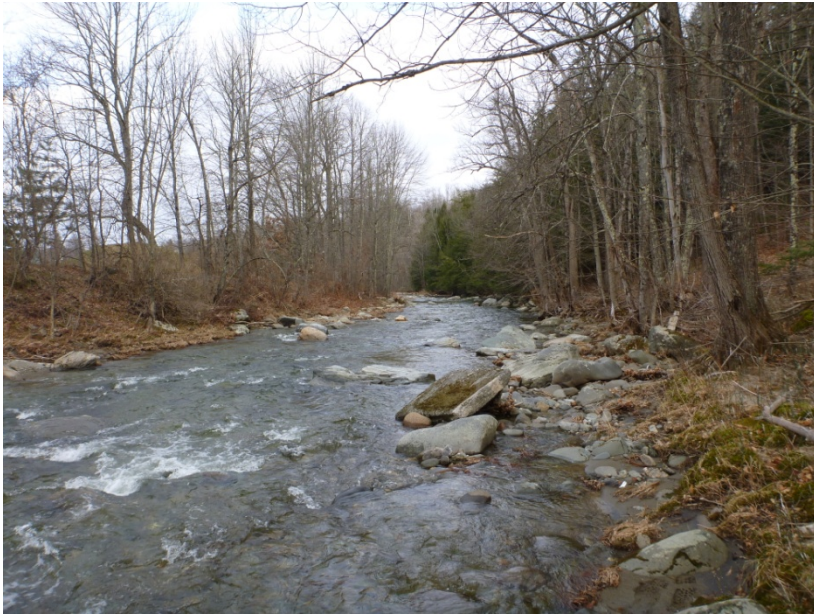
Figure 24: B_c channel morphology in segment M01-B

failures where the channel increases in slope and is classified as having B_c channel morphology and plane bed bedform (departed from riffle-pool by reference). The segment has a slope of approximately 1.3% (Figure 22). The right corridor is well buffered with the exception of a private residence accessed by a private bridge at the top of the reach. The right valley wall is typically continuous to the

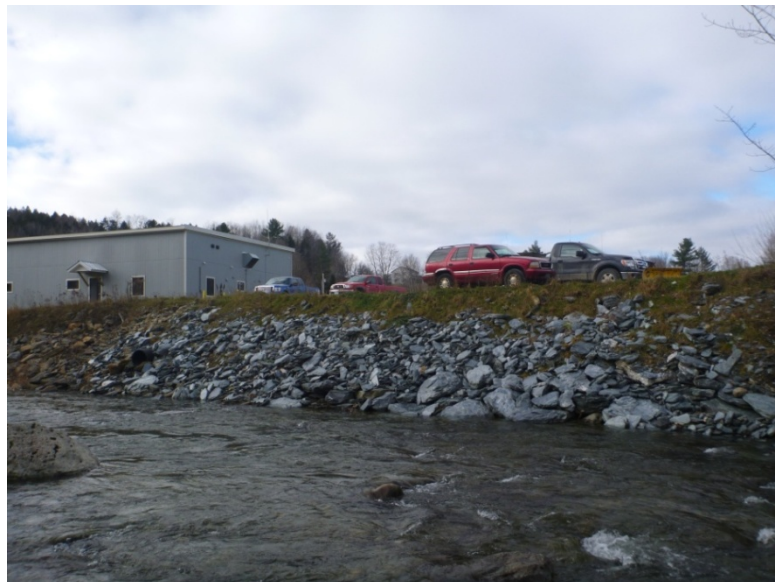
Figure 25: Left bank armoring and development

channel. The left corridor has a narrow (30') vegetated buffer for most of the reach and then extends over a large floodplain occupied by athletic fields. A commercial property with extensive bank armoring is present in the left corridor at the top of the reach (Figure 23). This segment is different from M01-A in that it is found in a transitional setting from steeper sloped,

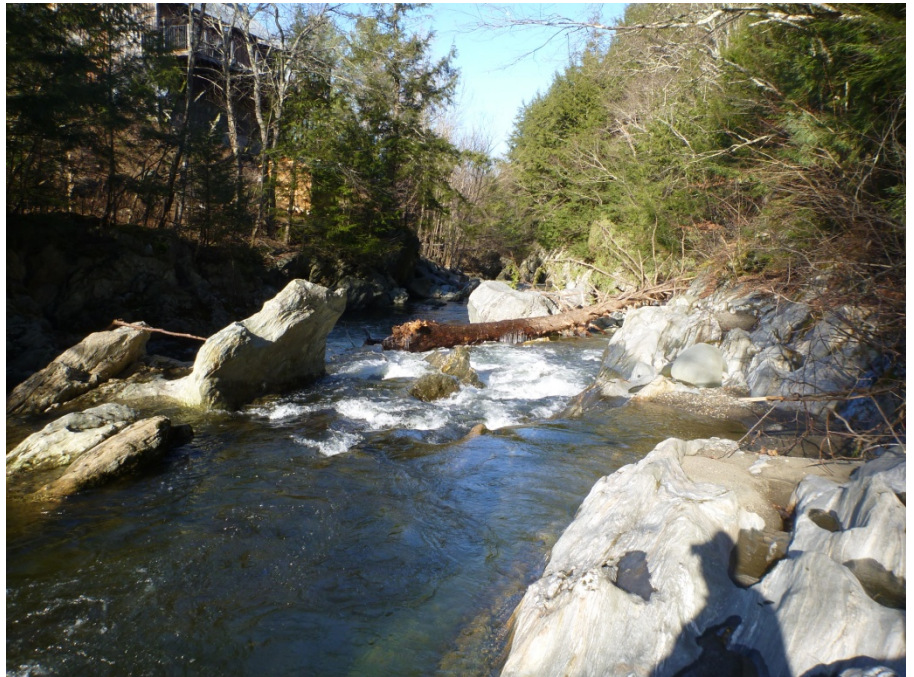
Figure 26: Bedrock gorge typical of Reach M02

Several old walls from historic mills were present along the reach but are no longer causing any major channel constriction. Several houses were present in the immediate left corridor; however impact is minimal due to the stable bedrock banks and steep valley walls.

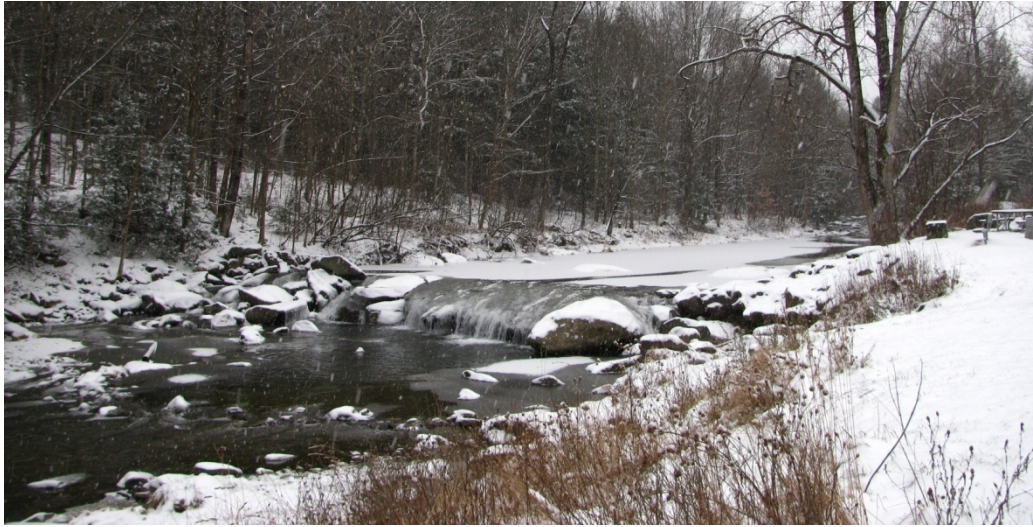
Figure 27: Combined natural and man-made grade control at swimming area in M03

Reach M03 is 1605' long and runs from the Canyon Rd covered bridge to the reach break at a valley wall constriction and bedrock grade control. A gravel parking area is present in the lower left corridor and is used to access a swimming area and trails to the upstream waterfall. A grade control is present at the swimming area that appears to be a bedrock outcrop and boulders spanning the channel with concrete poured over to form a dam (Figure 25). This was likely constructed to create a swimming area on the upstream side, which has since fully filled in with gravel and cobbles.

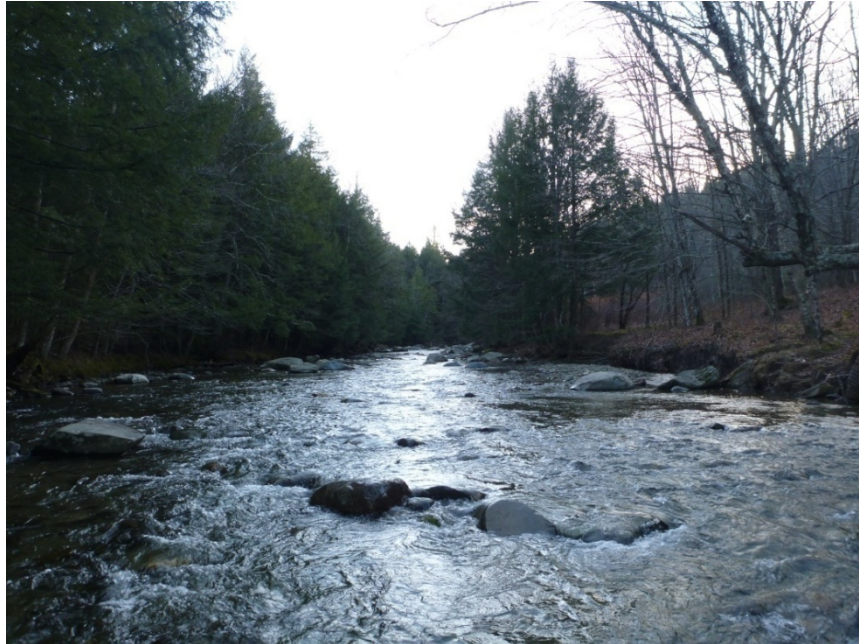
Figure 28: Reach M03 looking upstream from the cross-section

There is very little floodplain storage in this reach due to the naturally confined valley setting, and therefore there is limited potential to increase floodwater or sediment storage in the channel or floodplain. This reach, and upstream reach M04, may naturally adjust between B-type and F-type geometry depending on the deposition and bench formation along the channel margins in between flood events, and the resulting entrenchment ratios.

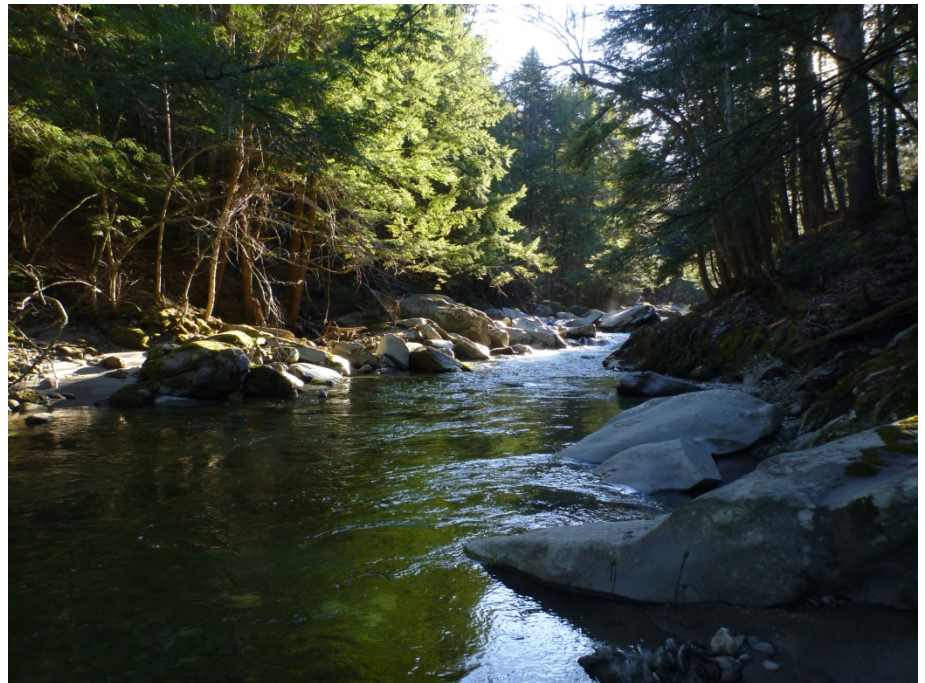
Figure 29: Valley wall constriction at the reach break between M03 and M04

Reach M04 is 1607' long and runs from the reach break at a valley wall constriction (Figure 27) to the reach break above the large waterfall. A channel spanning bedrock grade control is present at the bottom of the reach. A large depositional area is located immediately downstream of the waterfall with numerous bars found throughout the reach (Figure 15). A large flood chute runs along the right valley wall cutting through the elevated floodplain forest below the waterfall. The entrance to this flood chute is approximately 5-6' above current bankfull elevation, however it appears to have been accessed during recent flooding events. Overall channel slope is approximately 5.6% and channel slope below the waterfall is approximately 1%. The reach is classified as type B_a with plane-bed bedform. The cross-section was taken at a representative riffle in the middle of the reach. The substrate was predominately cobble (43%) and coarse gravel (30%) with a median particle size of 70mm. The width-to-depth and entrenchment ratio are 29.9 and 1.1 respectively. The entrenchment is

very low due to recent channel enlargement during episodic flooding events. The dominant process in this reach is widening with increased deposition. Bedrock and boulder substrate underpinning the stream has limited vertical migration. A channel evolution stage of III was selected for the reach using the F channel evolution model. This reach has a “Fair” rating for geomorphic and habitat assessments and a stream sensitivity of “High”.

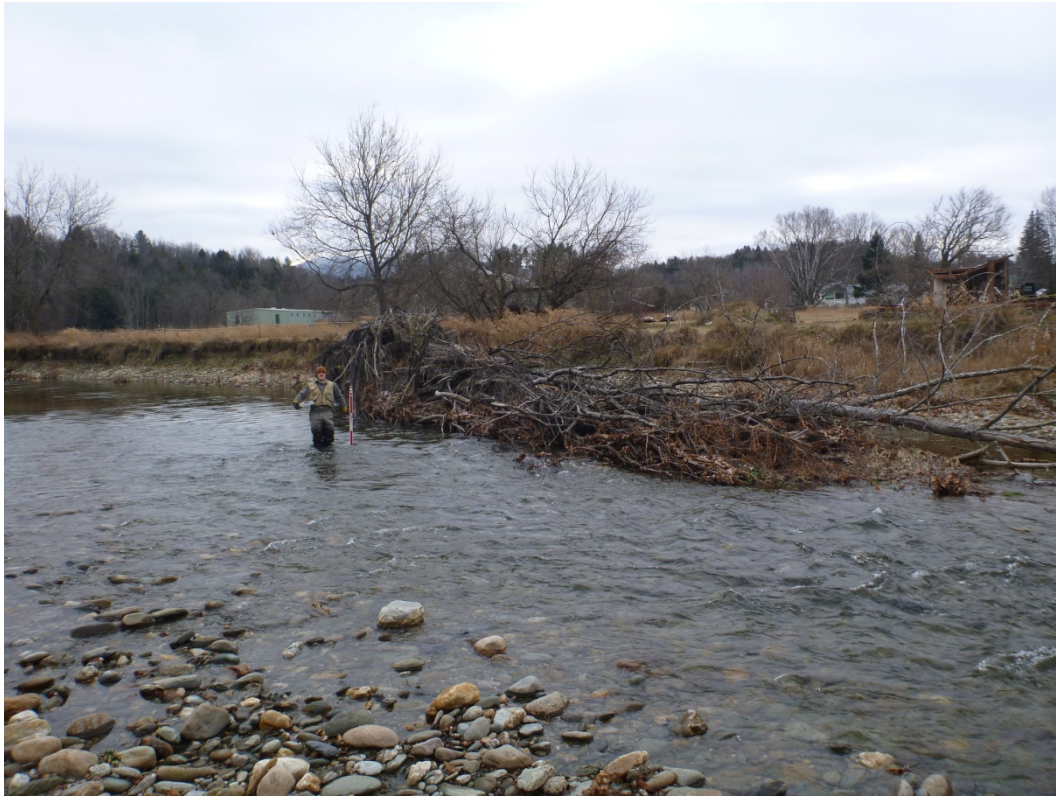
- Step 3.2 – right riparian buffer – sub-dominant – "0-25". I do not see any reduction of buffer width in this area other than at the mass failure with less veg. but is not a managed veg. Why 0-25 as subdominant? Sub-dom was 26-50, changed to none. Originally classified as 26-50 due to the parking area at Rte. 15, but this is small percentage of total reach.
- Step 4.4 – Debris Jam – Was this channel spanning? If yes, is it causing local issues/impacts such as sediment build up/flow diversion that would impact flooding? Folks are pretty sensitive in this area about debris jams, so just looking to get an idea of if this is something to monitor for possible flood issues. The debris jam was not channel spanning, it was a large tree with root wad along the left bank reaching the middle of the channel at an angle. See below photo.

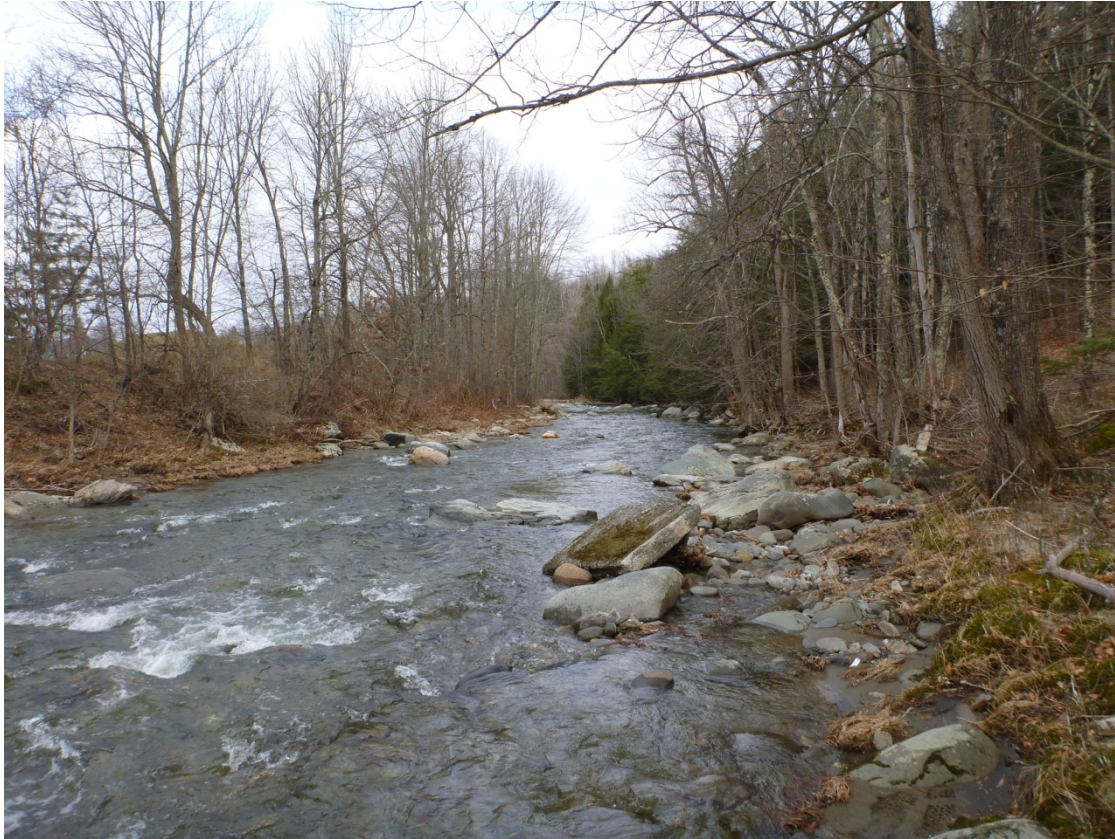
There isn't much natural floodplain in this reach to begin with b/c of the setting. See photo below taken from XS looking downstream.
