**Phase 2 Stream Geomorphic Assessment
of
Walloomsac River and Roaring Branch,
Bennington County, Vermont
FINAL REPORT**

March 2007

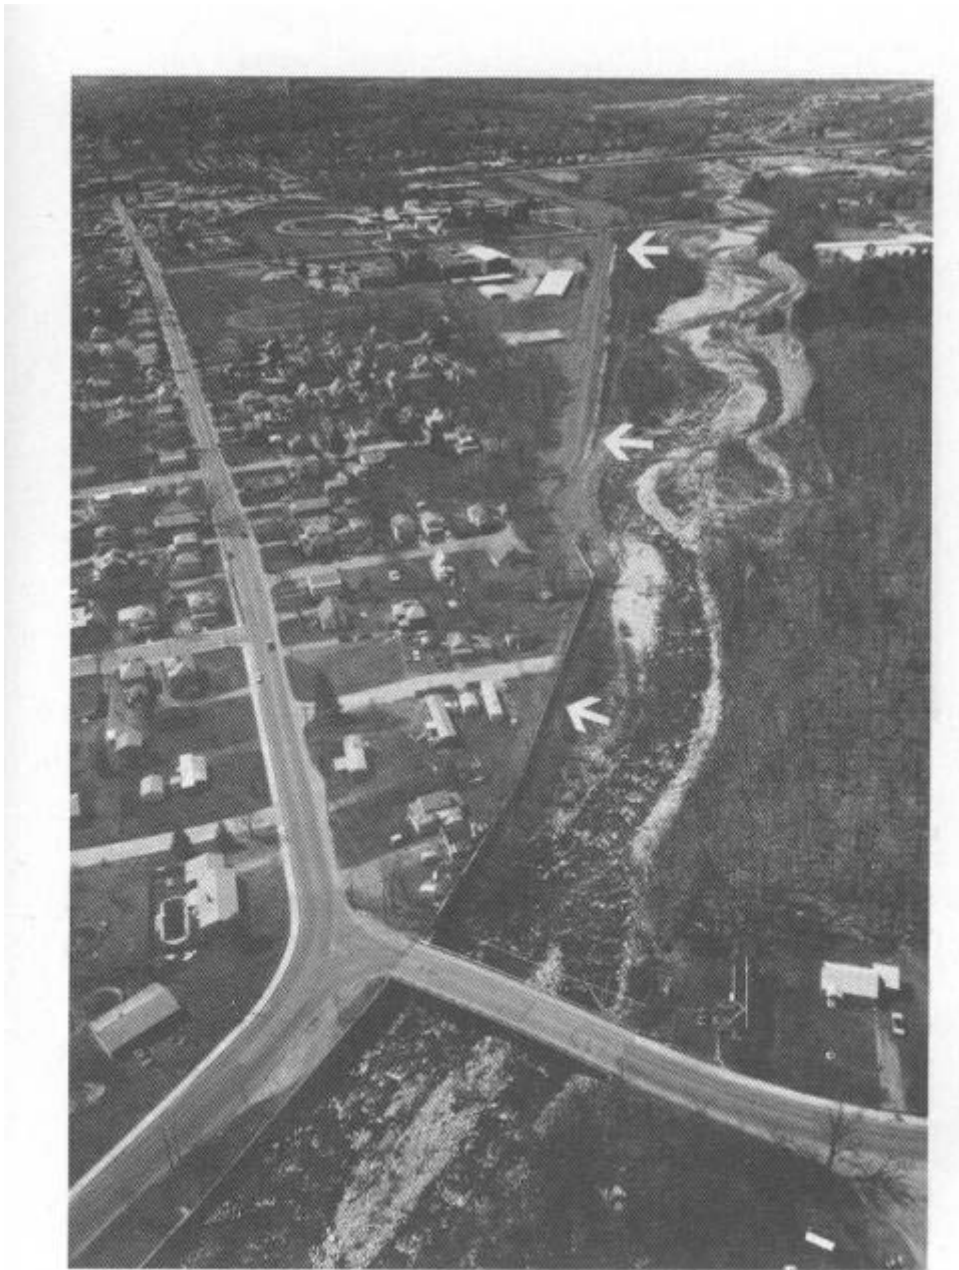
The Bennington Local Protection Project protects Bennington from damage caused by the floodwaters of Roaring Branch. The left photo shows a section of the 1,472-foot-long concrete floodwall (bottom arrow); the beginning of the 3,180-foot-long dike (middle arrow); and the end of the dike (top arrow). The Brooklyn Bridge spans Roaring Branch in the lower part of the photo.

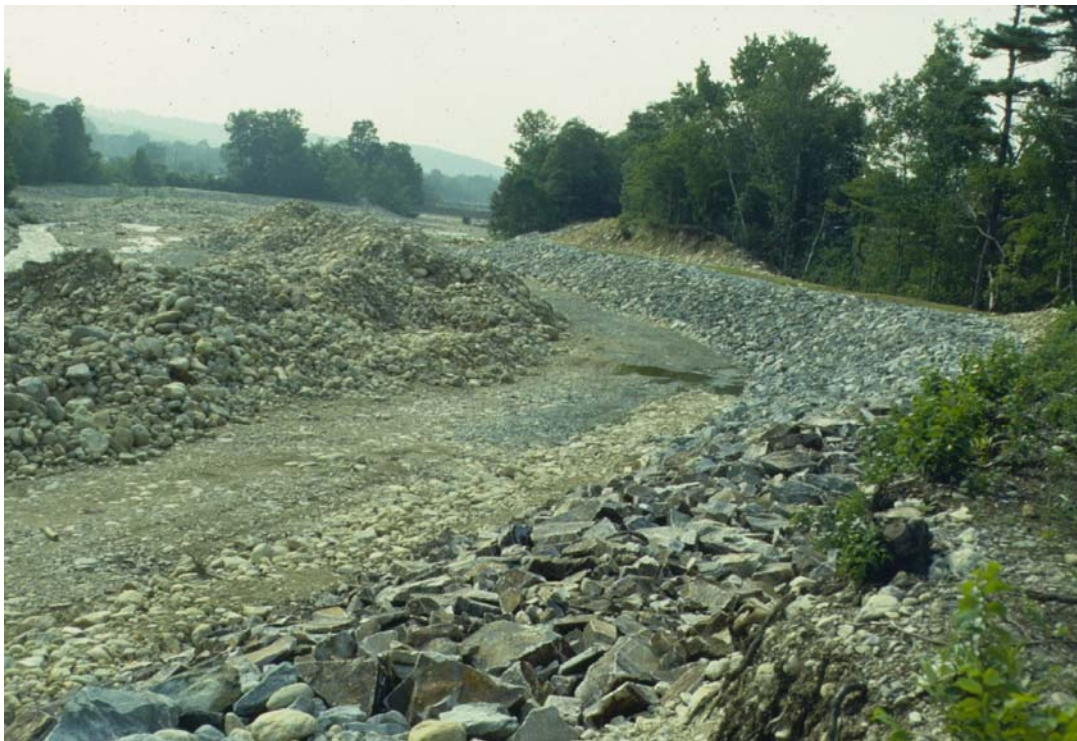
Plate 4: Roaring Branch, Reconstruction of Failed Berm Following 1987 Flood.

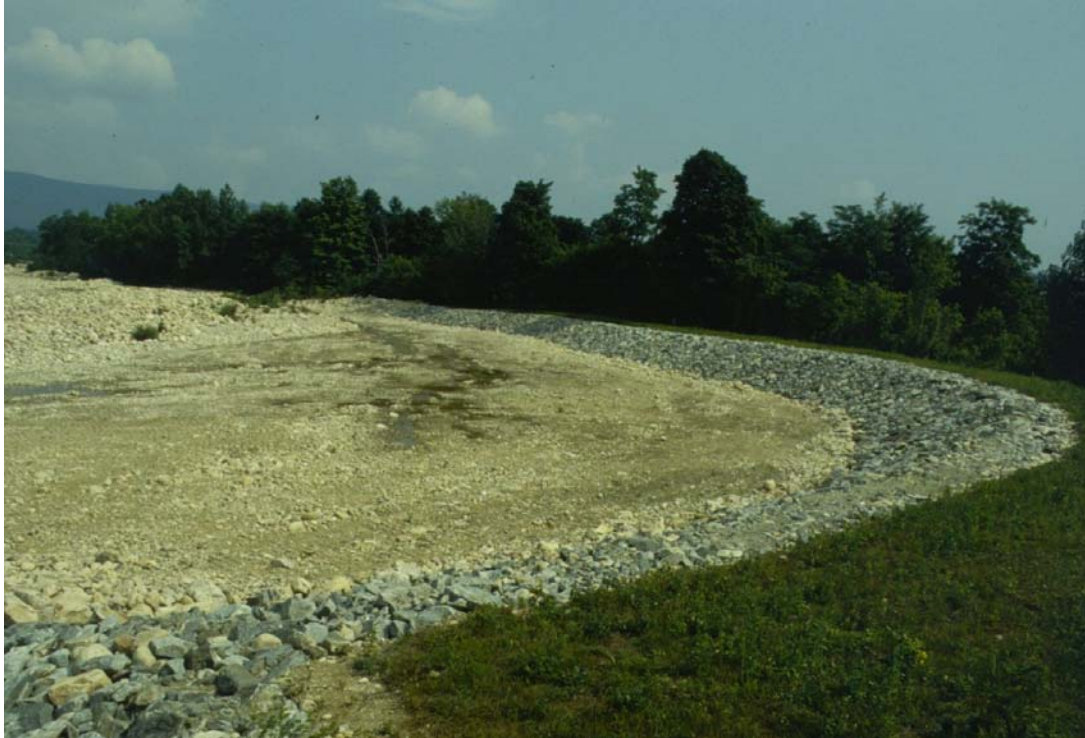
Plate 5: Bank Armoring Following 1987 Flood, Roaring Branch Upstream of Park St. Bridge.
