From: Joseph Guzelak <jguzelak@ENPRO.COM>
Sent: Thursday, February 05, 2015 5:12 PM
To: 'dmorin@luhs18.org'
Cc: Moran, Matt
Subject: WMD616-2014 Hanley residence spill report
Attachments: spill report summary.pdf

RE: Residential fuel oil spill: WMD616-2014

On December 17, 2014 you contacted ENPRO Services, Inc. to respond to a heating oil release from an outside 275 gallon above ground storage tank (AST) at your residence. The following is a summary of observations, actions and sampling results related to clean up efforts.

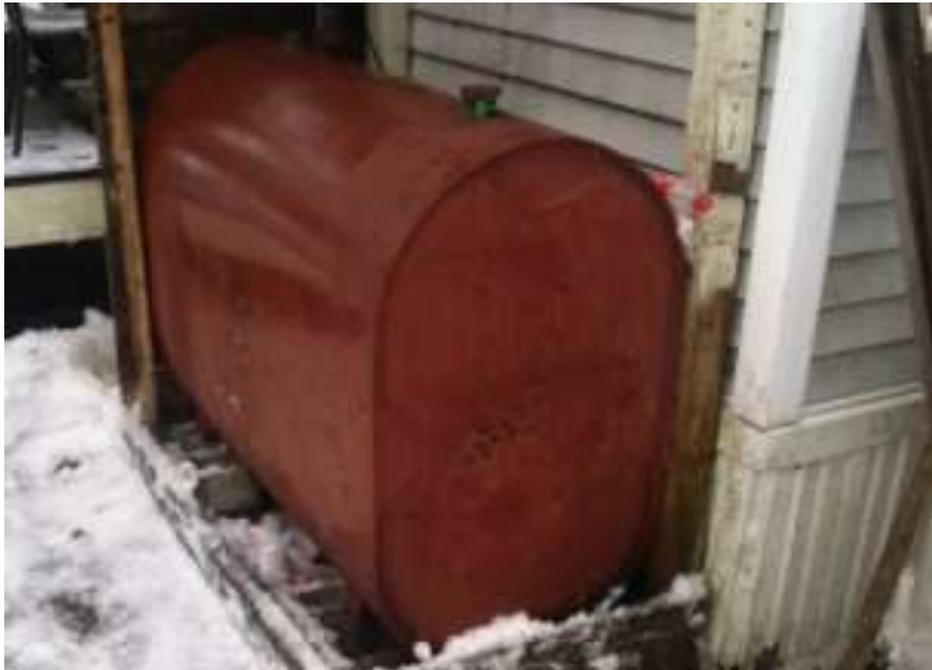
ENPRO Services, Inc. was informed that the release occurred as a result of leakage from your fuel tank supply line. Your fuel tank had a wood frame around it with some insulation board. The frame helped retain some of the fuel oil released, but a portion of the release migrated outside of the framing and flowed along the northeast corner of the concrete slab the mobile home is positioned on and into the ground. A small amount of oil migrated under the house suspended on top of a pool of melt water from the roof, but was captured using oil only sorbent pads.

275 gallon AST with wooden framing

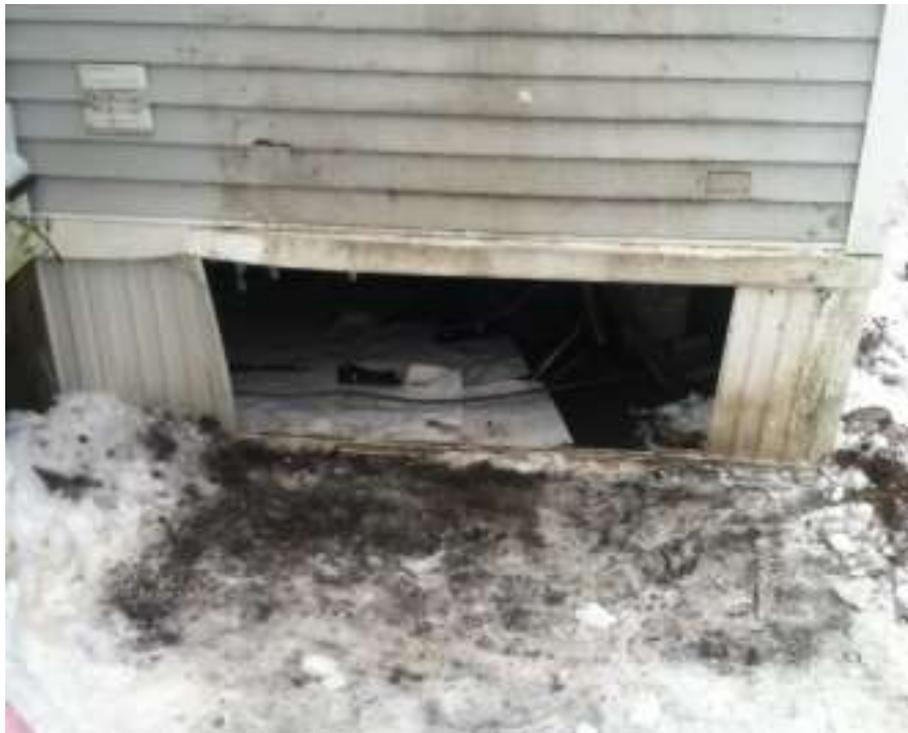
275 gallon AST removed and access to release under mobile home

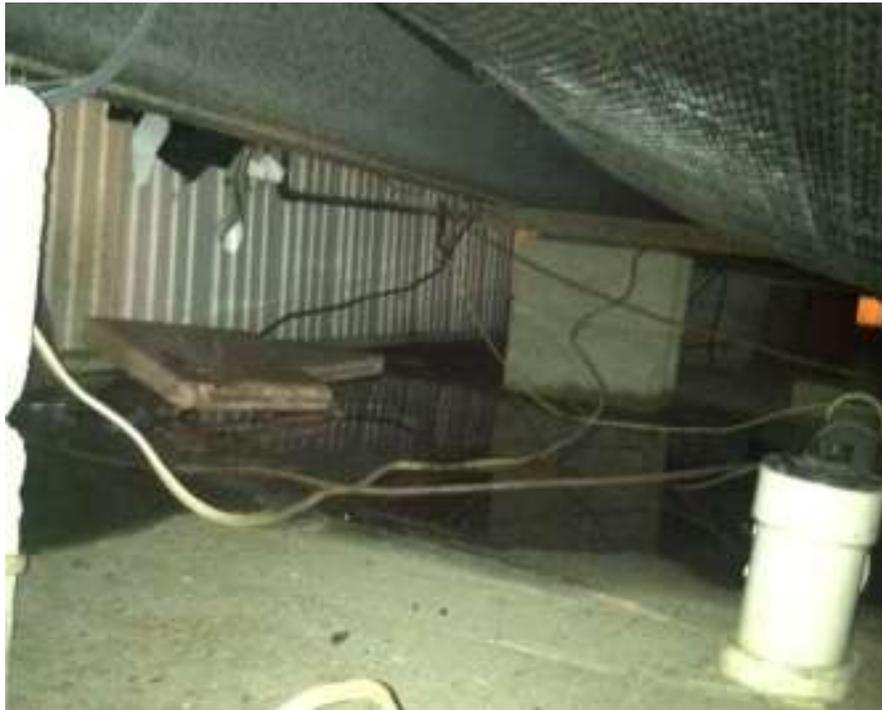
Fuel on pool of water under mobile home

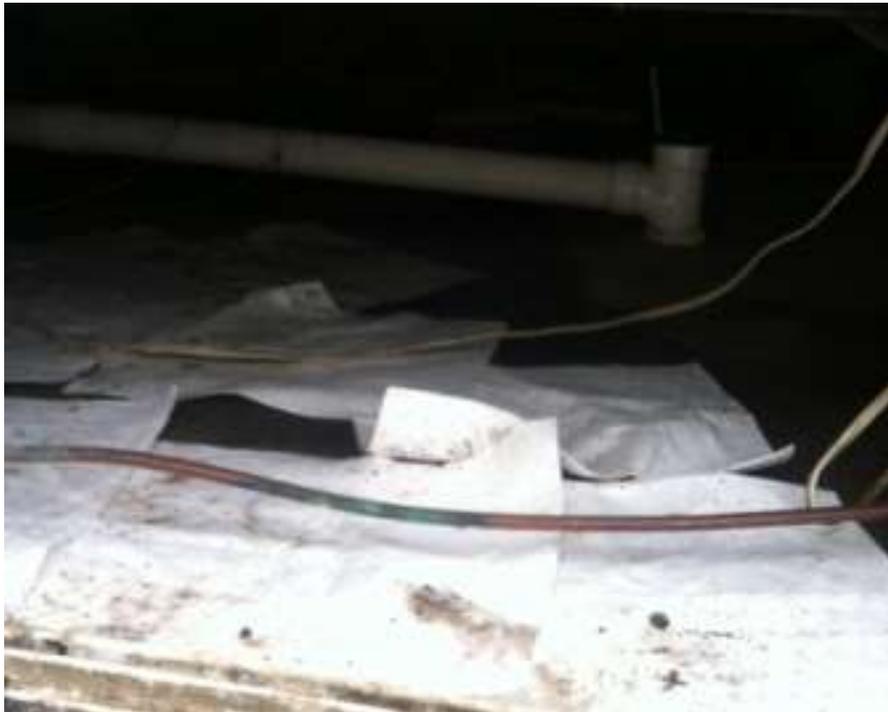
Corroding copper supply line running under mobile home

ENPRO Services, Inc. recommends that no further action is warranted in regards to this release at this location. However, as can be seen in the last photo, the supply line is corroding and it is recommended that it be replaced.
