STORMWATER MANAGEMENT PLAN FOR FAIRFIELD

FINAL REPORT

Stone Project ID 12-145

January 23, 2014

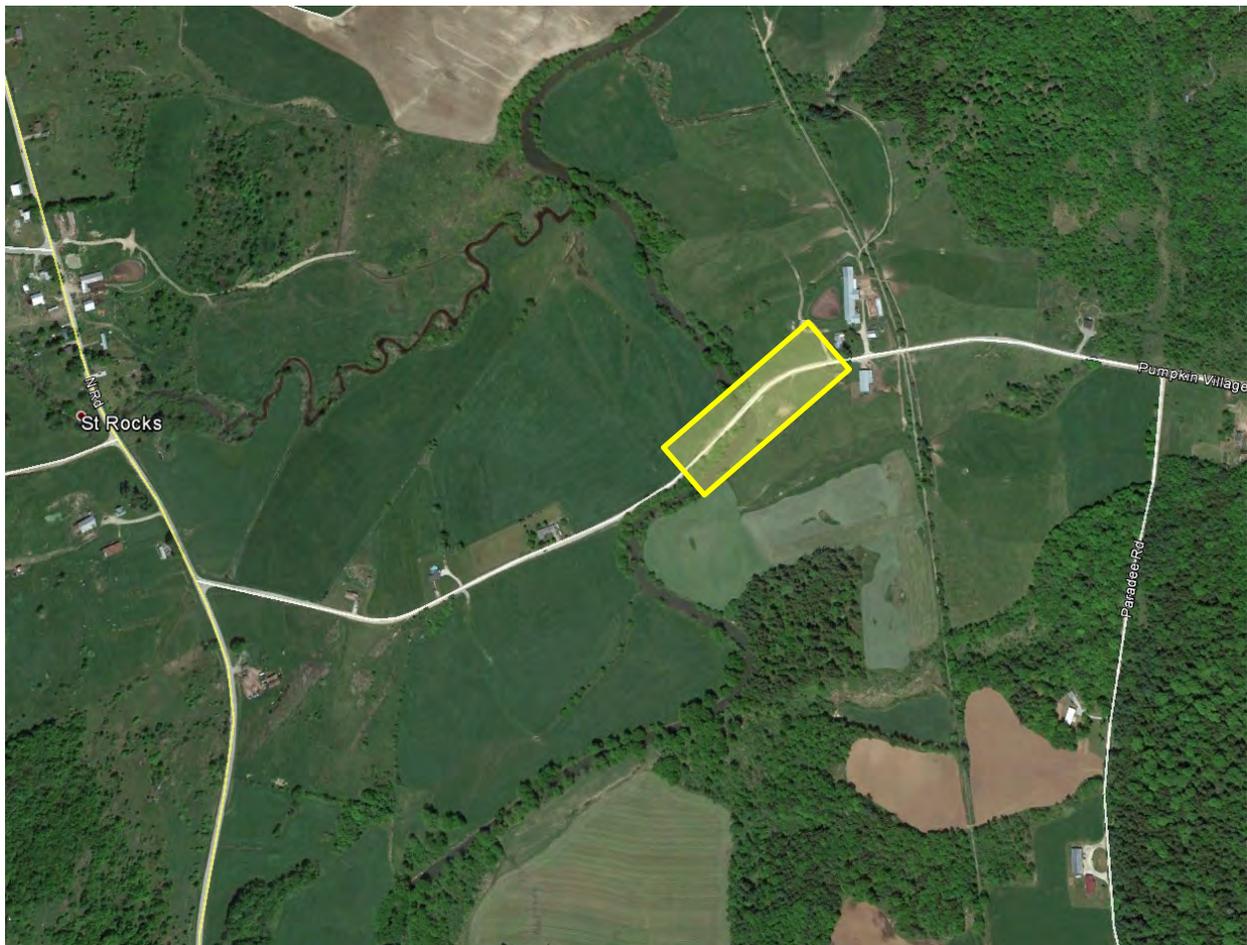
The portion of Pumpkin Village Road that runs from North Road to Wanzer Road was found to be in poor condition (see highlighted area on Figure 1, below). Sediment from the road surface washes to and accumulates at areas where the road shoulder is low, including the Black Creek crossing.

Figure 1. Pumpkin Village Road Problem Area. An area of eroding road surface on Pumpkin Village Road is highlighted.

The problems along Pumpkin Village Road could be addressed by crowning the road surface to shed water toward the ditches and at the same time improving the roadside ditches and reducing the high shoulder that runs most of the length of the road to promote sheetflow.

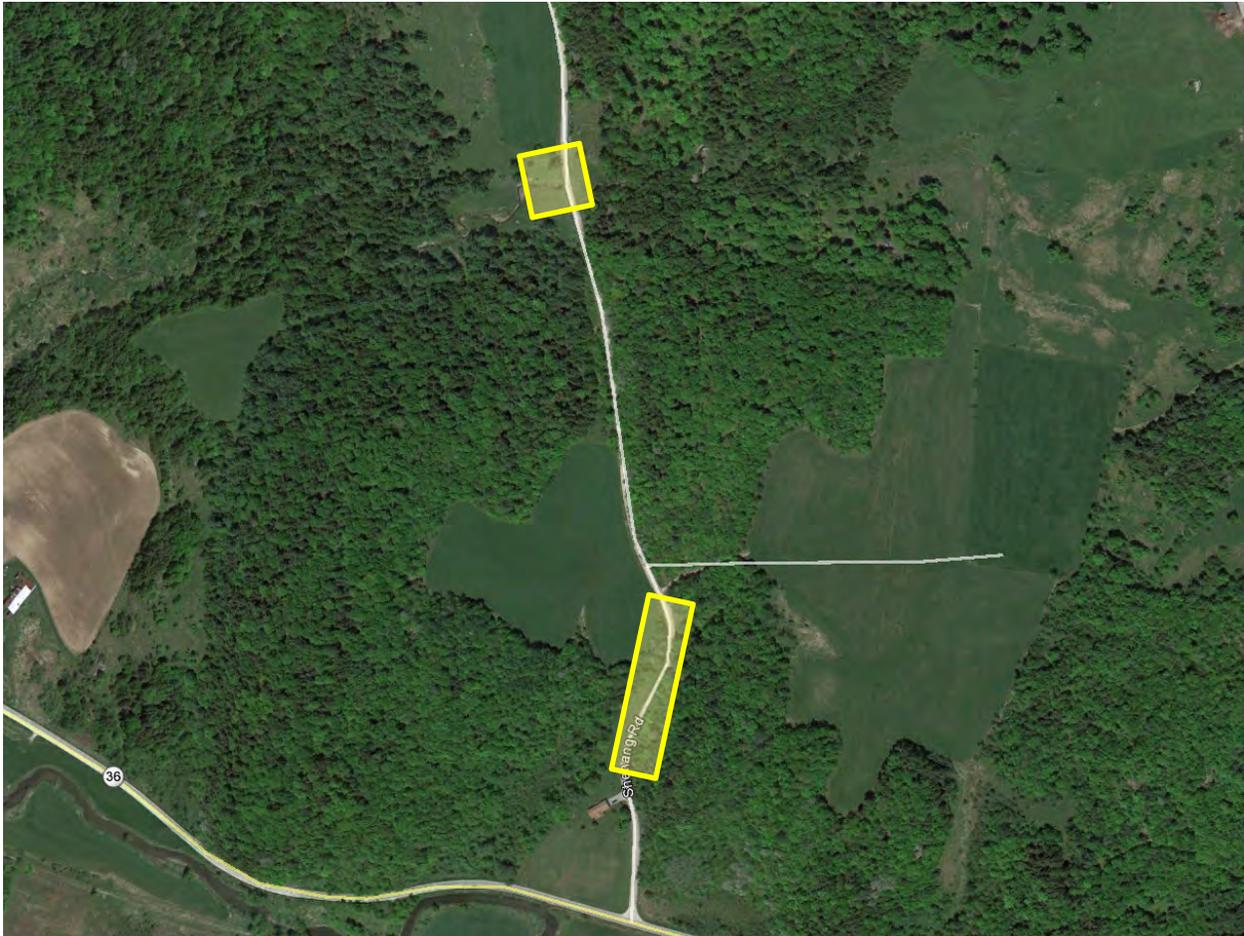
Figure 2. Shenang Road Problem Areas. Northern highlighted area indicates the culvert replacement opportunity; highlighted location toward the southern end of Shenang Road indicates the ditch improvement opportunity.

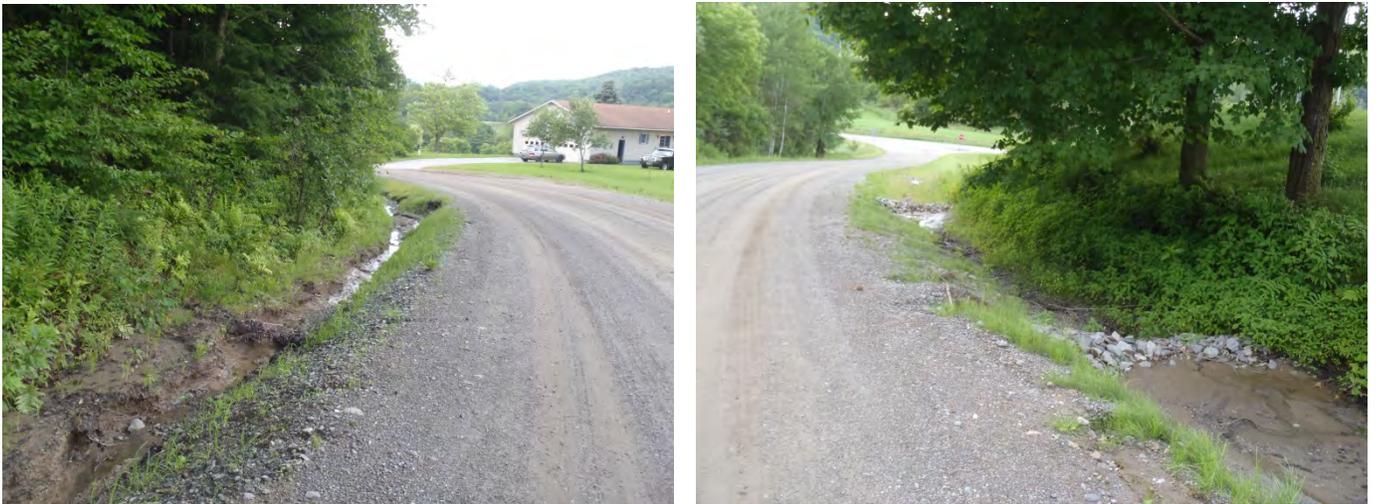
The stone lined ditches on the west side of Shenang Road are in need of cleaning (Figure 3). There is a significant buildup of sediment behind each of the stone check dams. The ditches along the east side of the road are deep and narrow, which has resulted in bottom incising. There appears to be enough space at the road shoulder to create parabolic (wide “U” shaped) ditches, replacing the narrow “V” shaped ditches. Ditches with gradual side slopes (maximum 2H: 1V ratio) and a wide bottom (at least 2 feet) are preferred. Seed and mulch should be applied to all raw earth surfaces with grades less than 2%, biodegradable, non-welded matting and seed should be used on ditches with grades between 2% and 5%, and stone lining should be installed in ditches with grades greater than 5%. Stone check dams could also be incorporated into the design, especially on slopes greater than 5%. Check dams should be comprised of a well graded stone matrix 2 to 9 inches in size. Dams should not exceed 2 feet in height and check dam crest should be at least 6” below the top of the ditch.

Figure 1. Ditch erosion along eastern side of Shenang Rd, and heavy sediment buildup behind check dams along western side of the road.

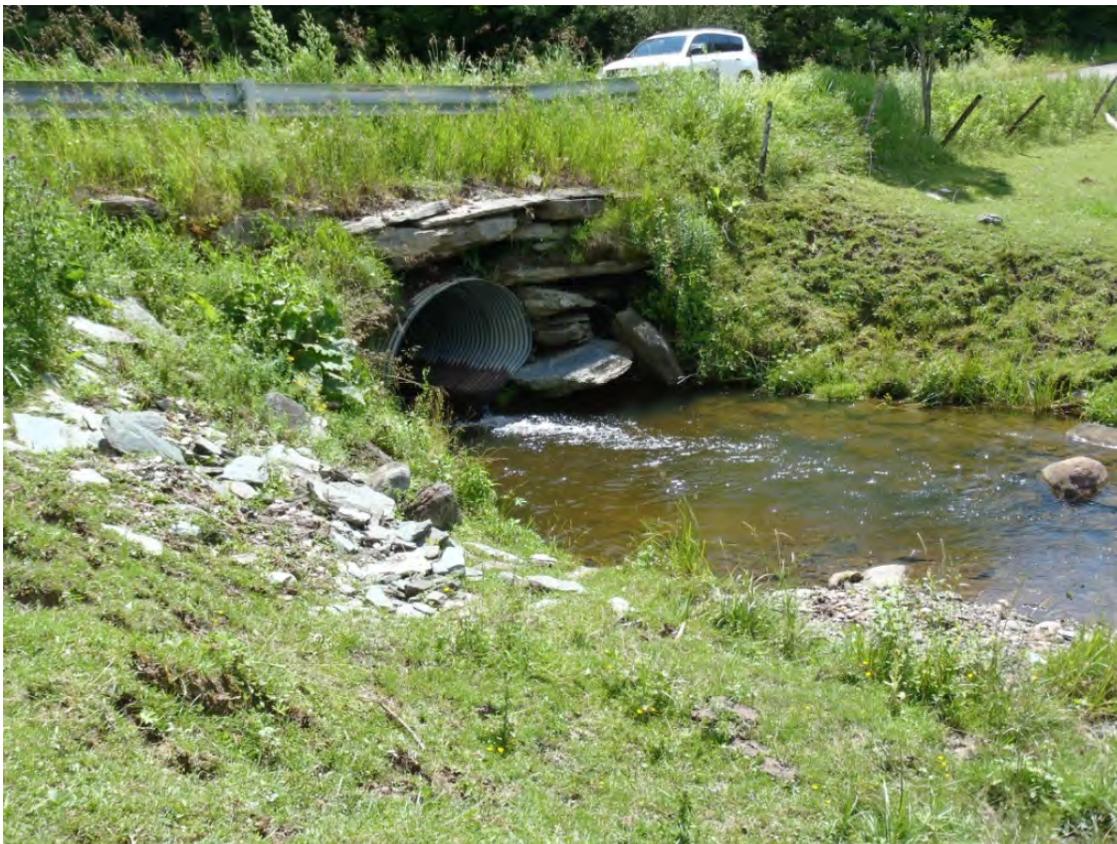
A culvert, which conveys an unnamed tributary to the Black Creek beneath Shenang Rd, is too short for the current width of the road, resulting in unstable conditions at both the inlet and outlet. Generally, vegetated slopes should be at least to 2:1 (horizontal to vertical) to maintain stable conditions. Erosion of the over-steepened slopes surrounding the culvert will lead to deteriorating road shoulder conditions in the near- to medium-term. In addition, the existing culvert pipe is undersized (approximately one-half bankfull width) and perched approximately six inches above the stream bottom at the culvert outlet.

Figure 2. Outlet of undersized culvert carrying unnamed tributary to Black Creek under Shenang Rd.

In general terms, the replacement culvert should be long enough to accommodate 2:1 slopes at the inlet and outlet, and sized such that it matches the stream’s bankfull width and can be buried 1/6th bankfull stream width to provide a natural bottom.

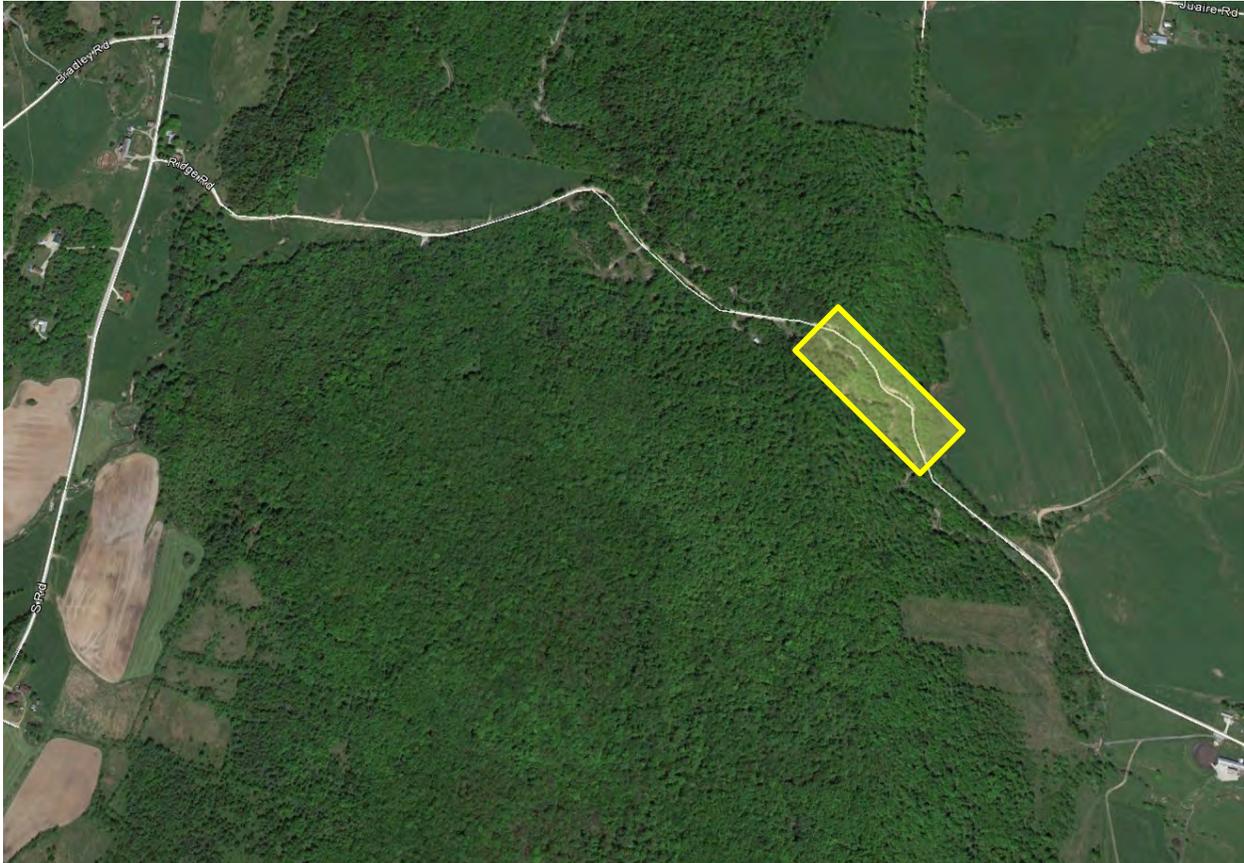
Portions of the roadside ditch along Ridge Road, starting about four miles east of the intersection with South Rd, are narrow with steep backslopes. This ditch geometry has increased the velocity of water in the ditch during storm events, leading to incision and bank slumping. Ditches could be stabilized by making them wider, with a parabolic-shaped bottom. The ditch may need to be stone lined in sections where the grade is steeper than 5%. Stone check dams are also recommended in order to reduce flow velocities and limit sediment transport.

Figure 5. Ridge Road problem area. An area of ditch erosion is highlighted.

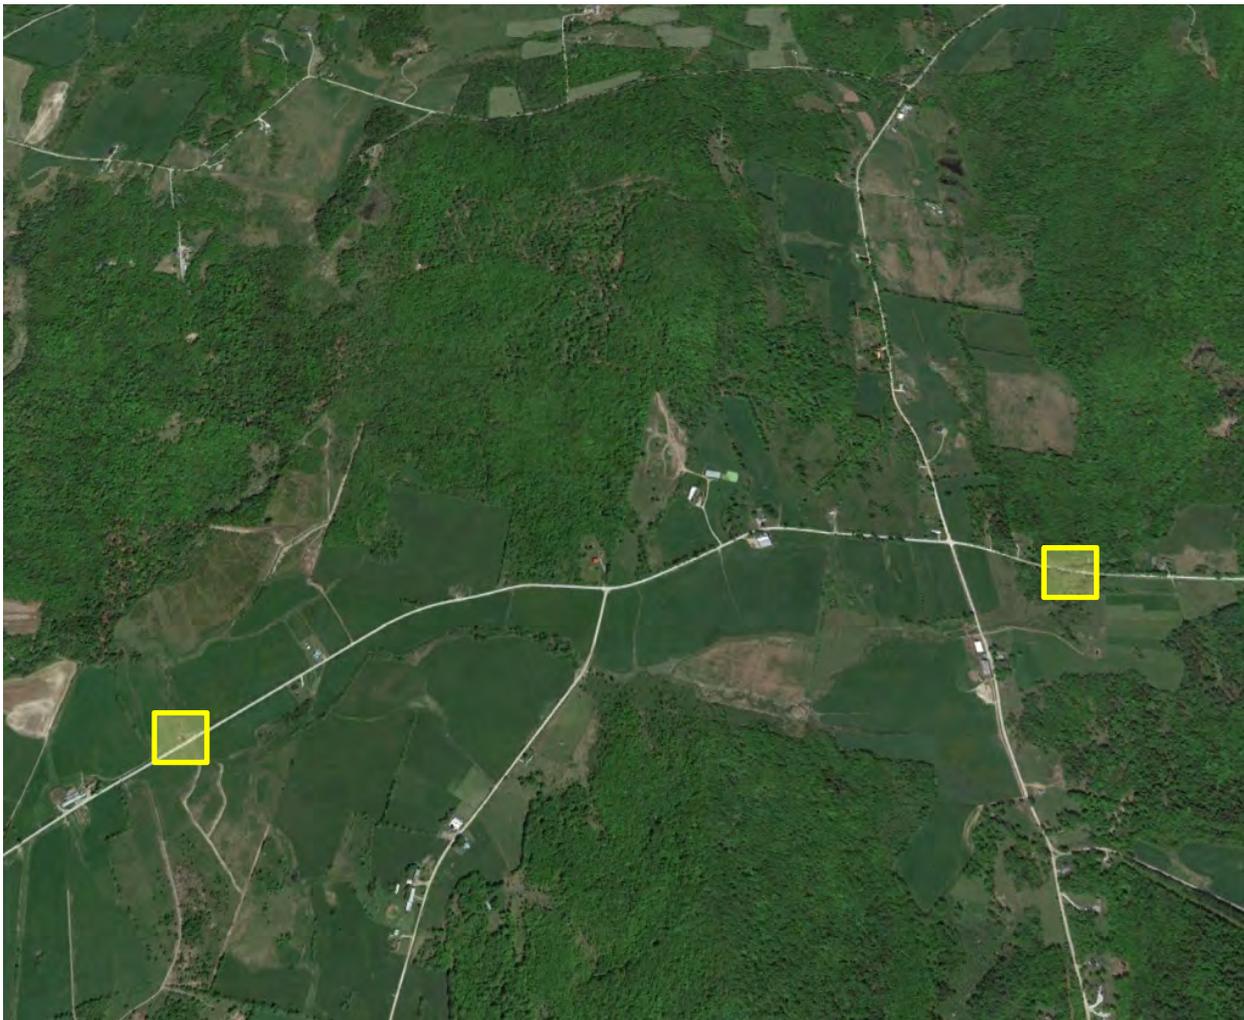
Figure 6. Locations of two potential improvement areas along Chester A. Arthur Rd are highlighted.

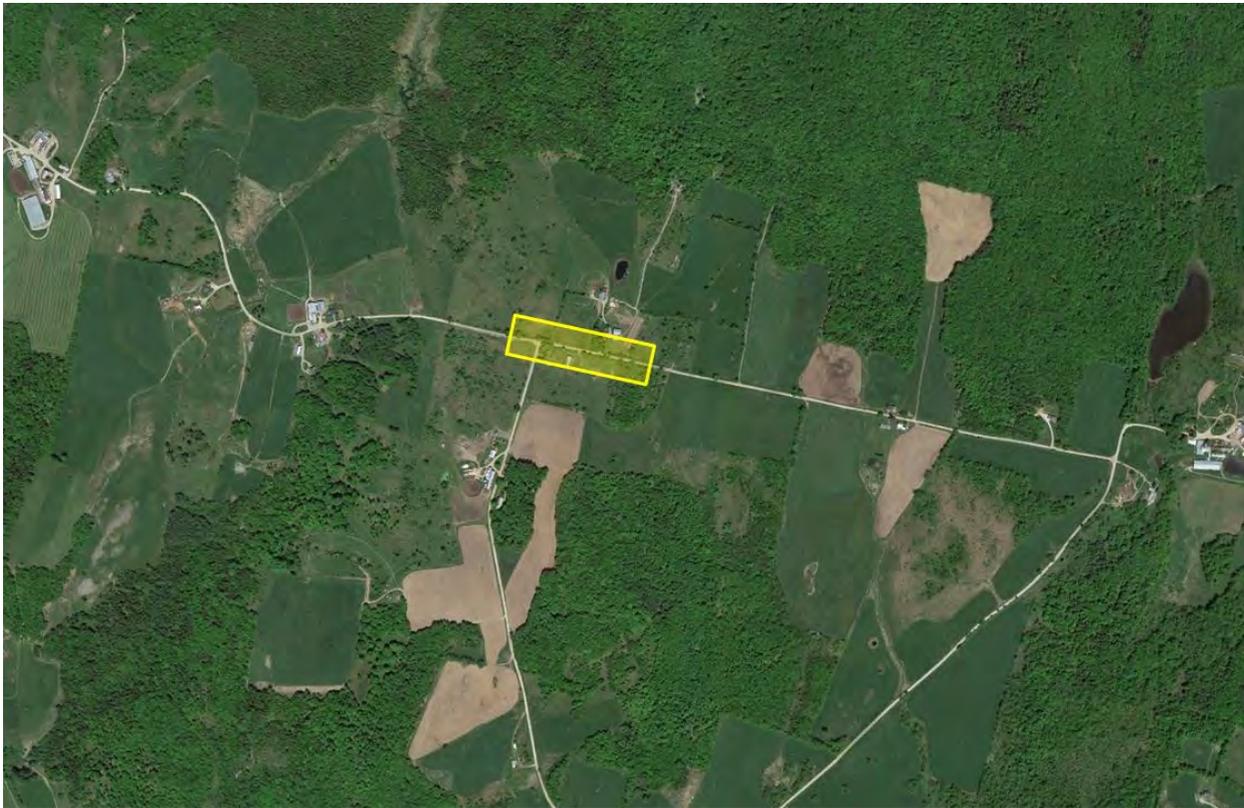
Several stormwater improvement opportunities were identified on the portion of Northrop Road west of Talcott Road (Figure 9). This is another area where a ridge has formed between the road crown and the ditch, which prevents runoff from leaving the road surface and entering the ditches as sheetflow. The excess water has formed a “secondary swale” in the roadway near the edge of the travel surface, leading to increased sediment transport and accelerated erosion. Sediment from the road surface is now clogging portions of the ditches near Talcott Rd. Additionally, the existing ditches are too narrow and deep, which has led to bottom incising and bank slump. Again, there appears to be enough space at the road shoulder to create parabolic ditches to replace the narrow “V” shaped ditches. Ditches with gradual side slopes (maximum 2H: 1V ratio) and a wide bottom (at least 2 feet) are preferred, and should incorporate stone lining and check dams in steeper sections to control water velocities.

Figure 9. Location of potential improvement area along Northrop Rd.

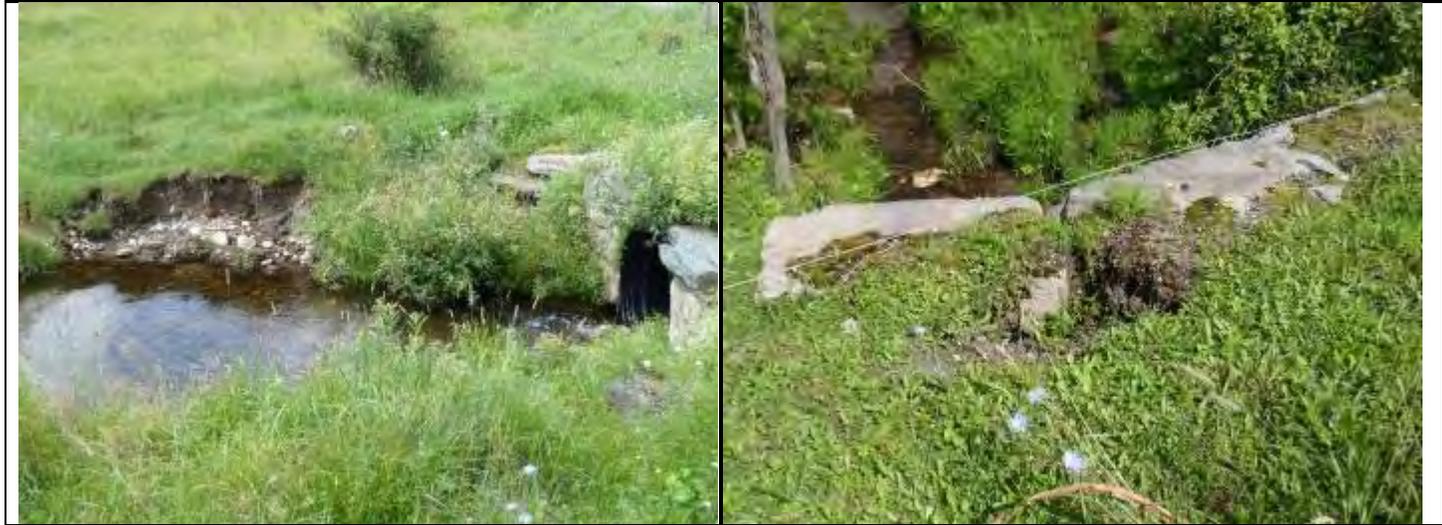
Photo 1. Culvert outlet, bank erosion and scour pool **Photo 2.** Behind retaining wall at culvert inlet

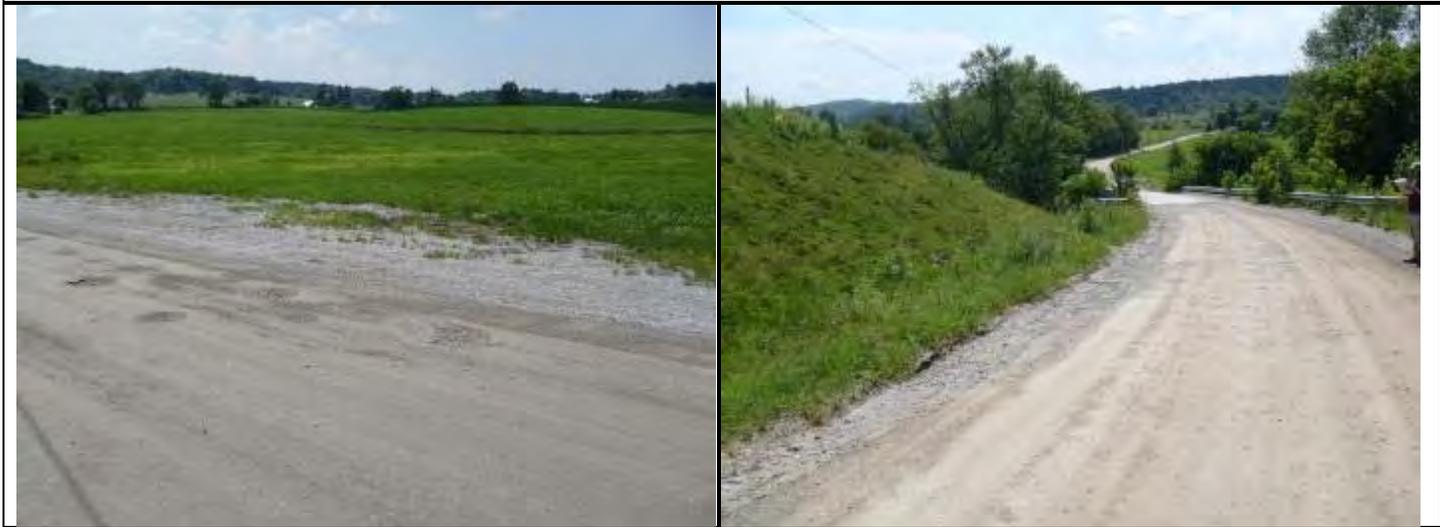
Photo 1. Evidence of roadway eroding into adjacent field	Photo 2. Road shoulder erosion
---	---------------------------------------

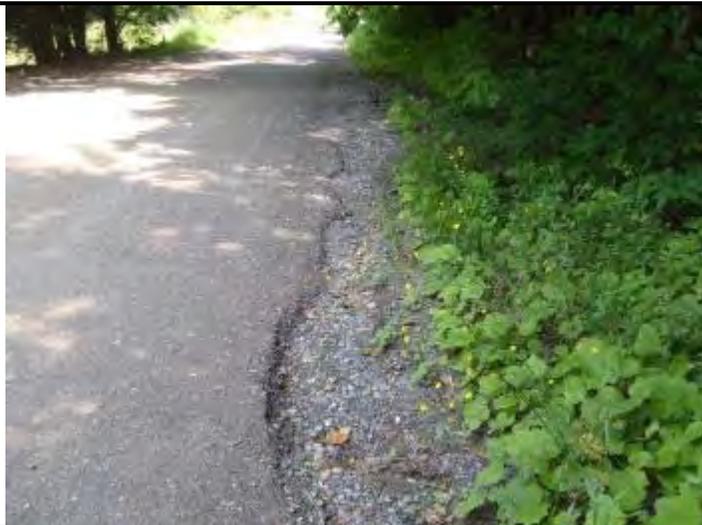
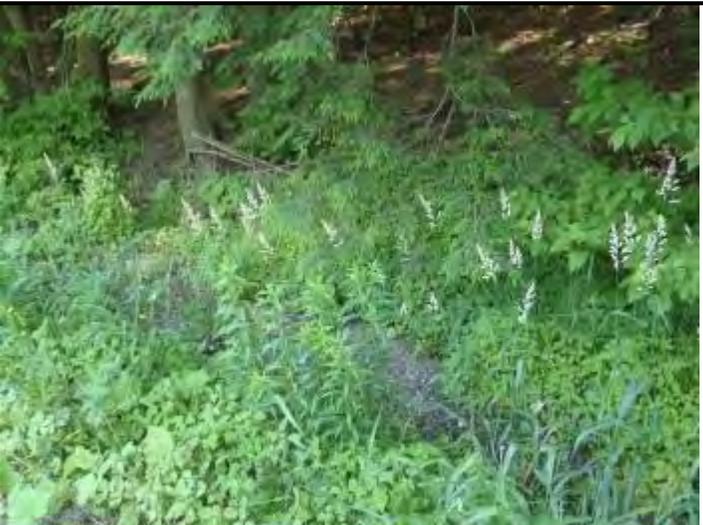
Photo 1. Road shoulder erosion	Photo 2. Sediment deposit in ditch

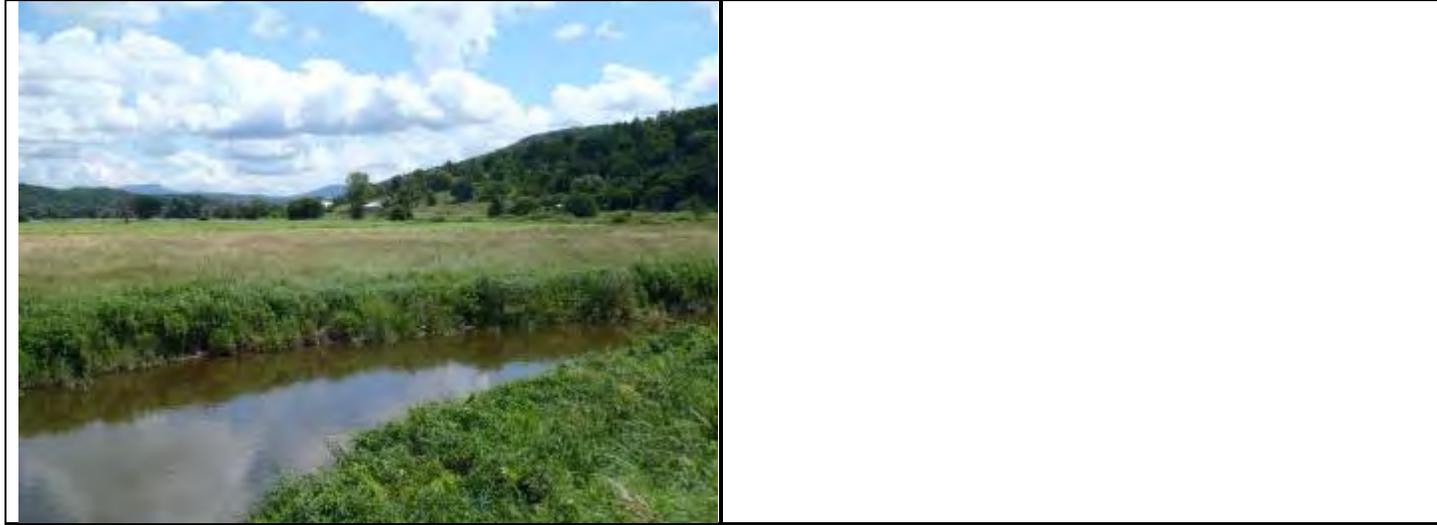
Photo 1. Small berm along streambank

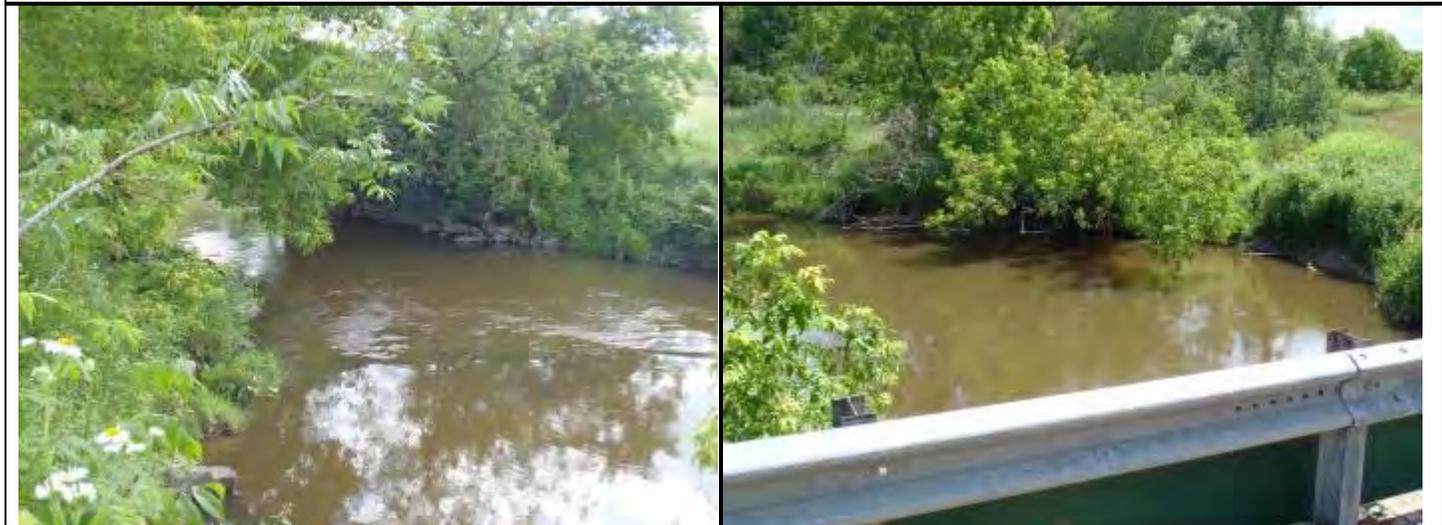
Photo 1. View downstream from easternmost bridge

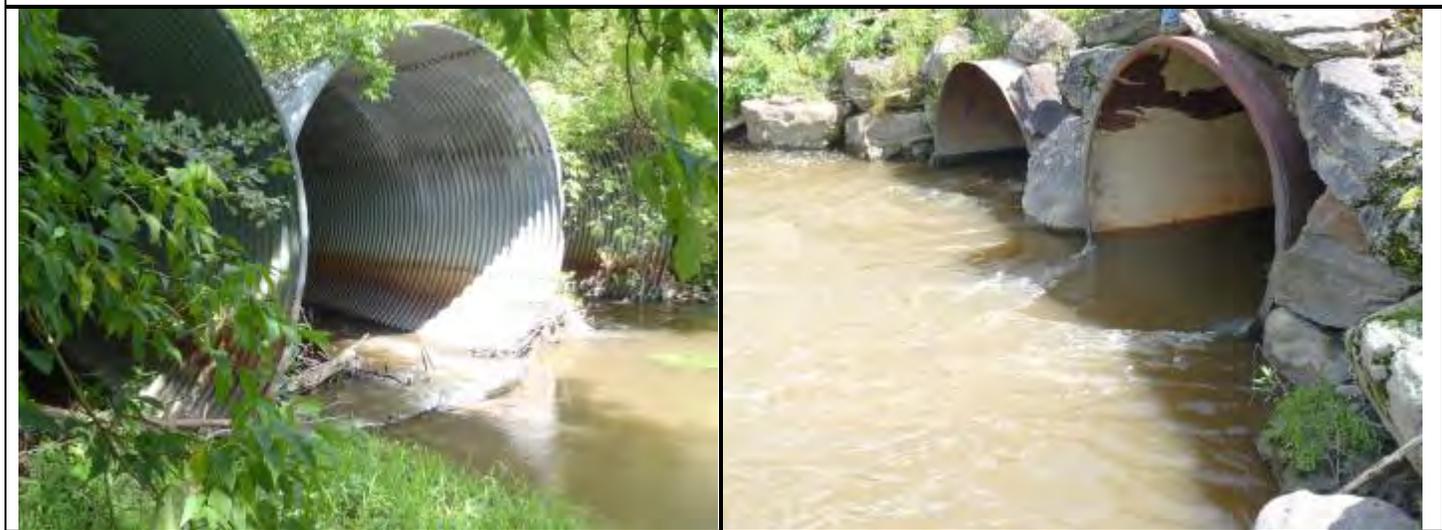
Photo 1. Rail Crossing, three 20' culverts, upstream **Photo 2.** Farm road crossing, two 8' culverts, downstream

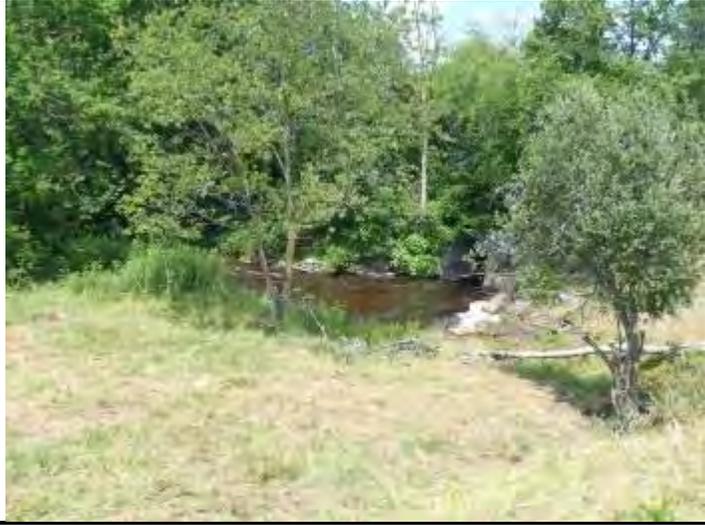
Photo 1. Upstream end of culvert

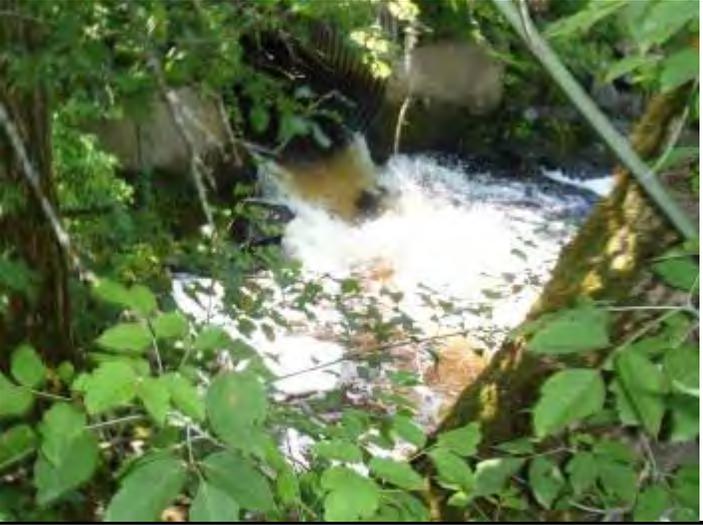
Photo 2. Perched outfall

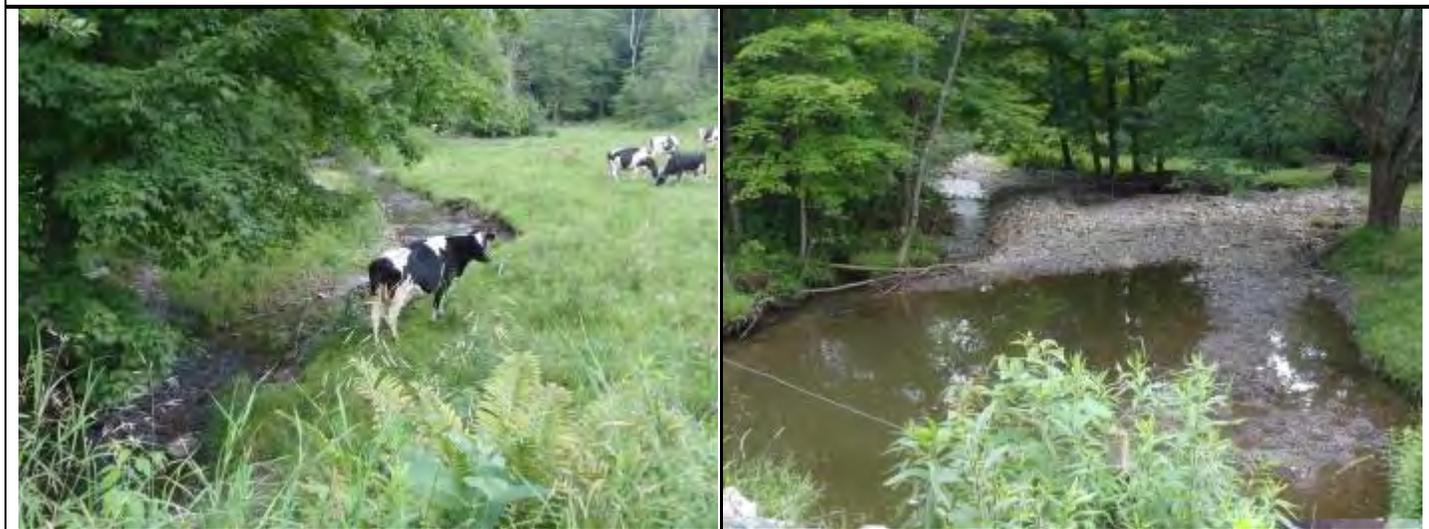
Photo 1. Direct animal access

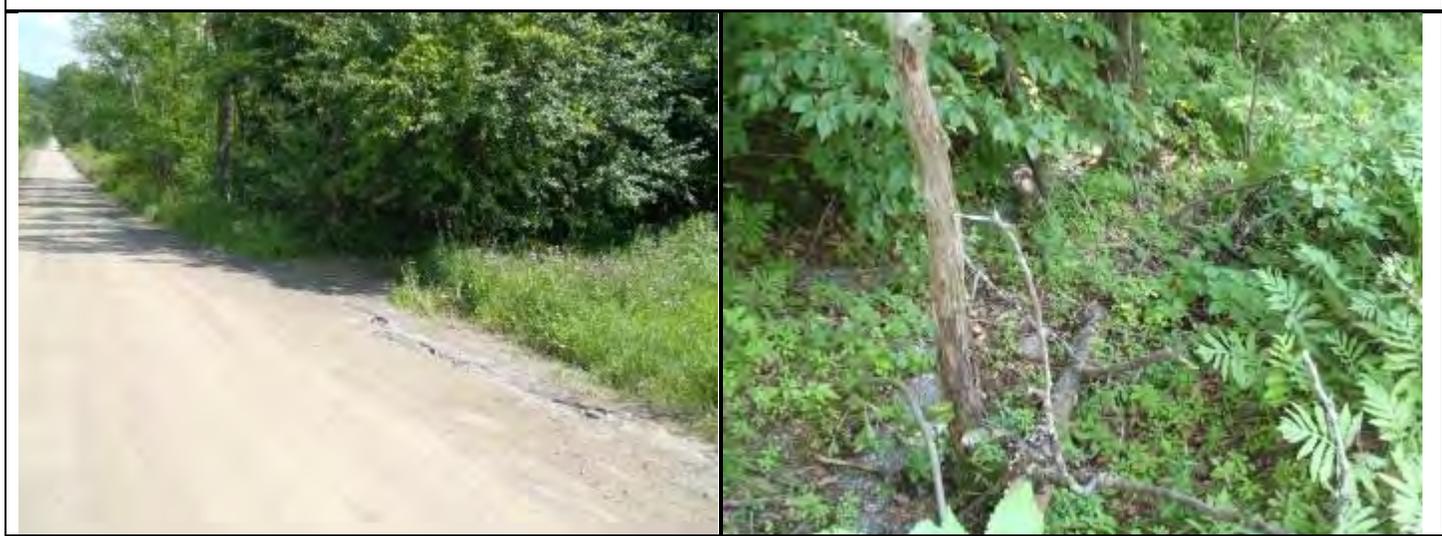
Photo 1. Roadside erosion **Photo 2.** Evidence of sediment deposits

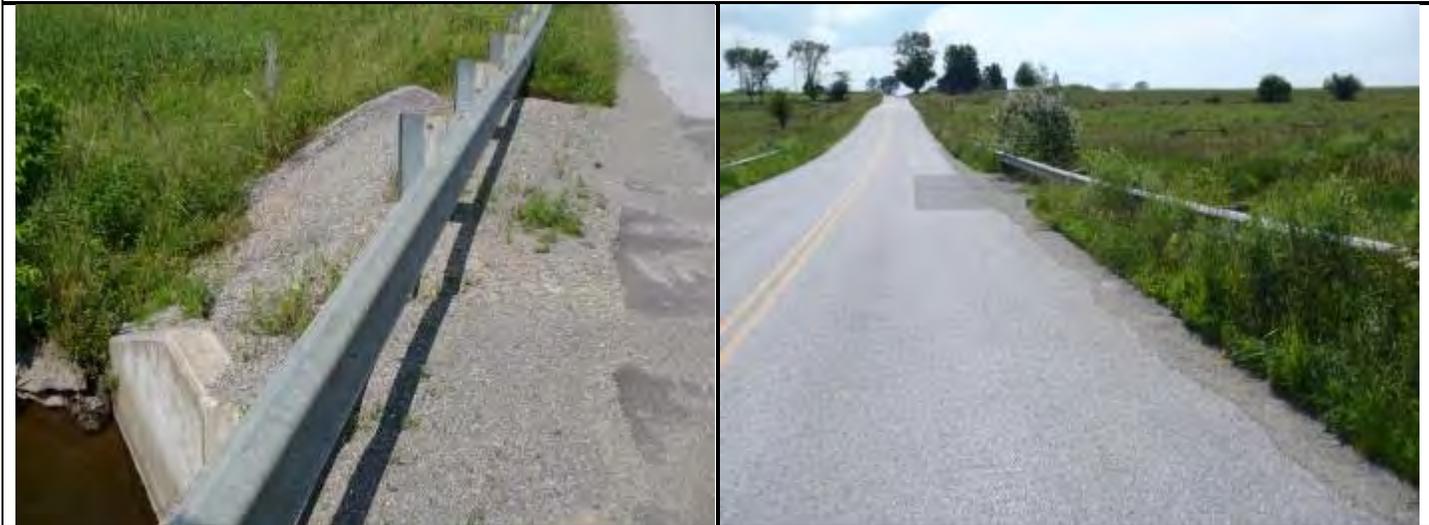
Photo 1. Sediment deposited at bridge

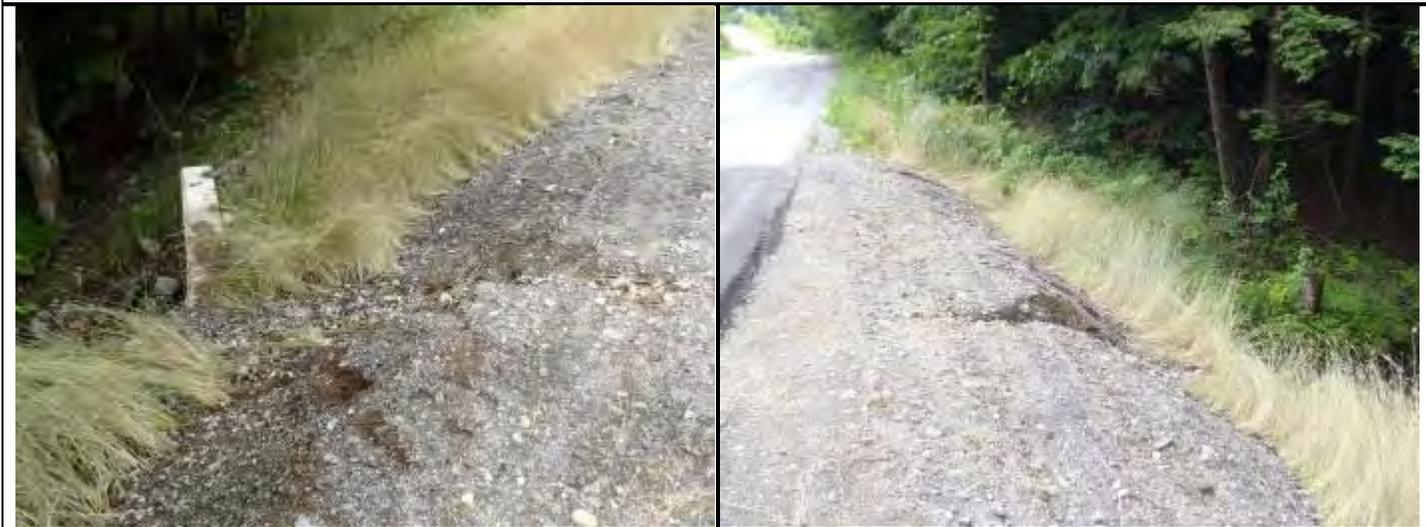
Photo 1. Shoulder slumping into stream

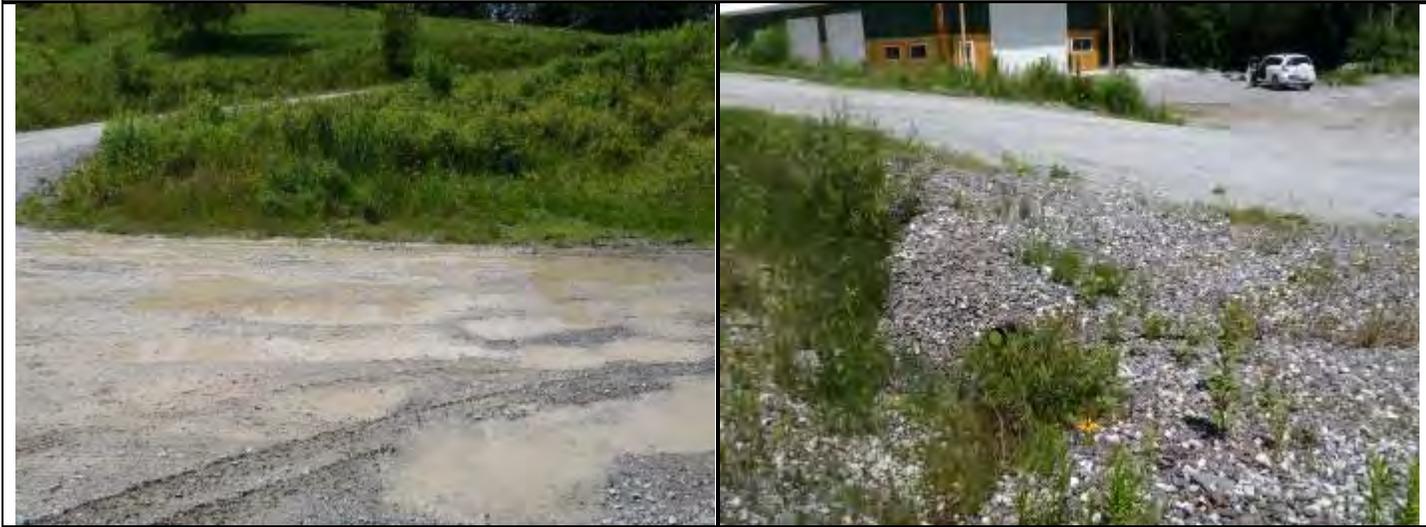
Photo 1. Water flowing over Branon Road

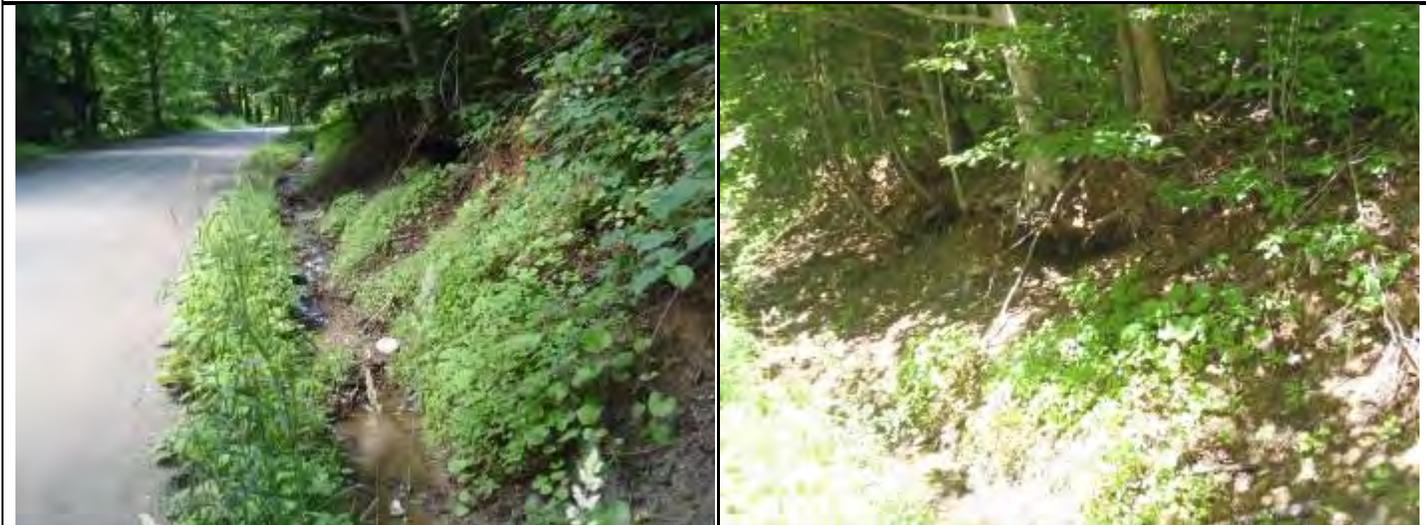
Photo 1. Roadside ditch erosion **Photo 2.** Bank slumping

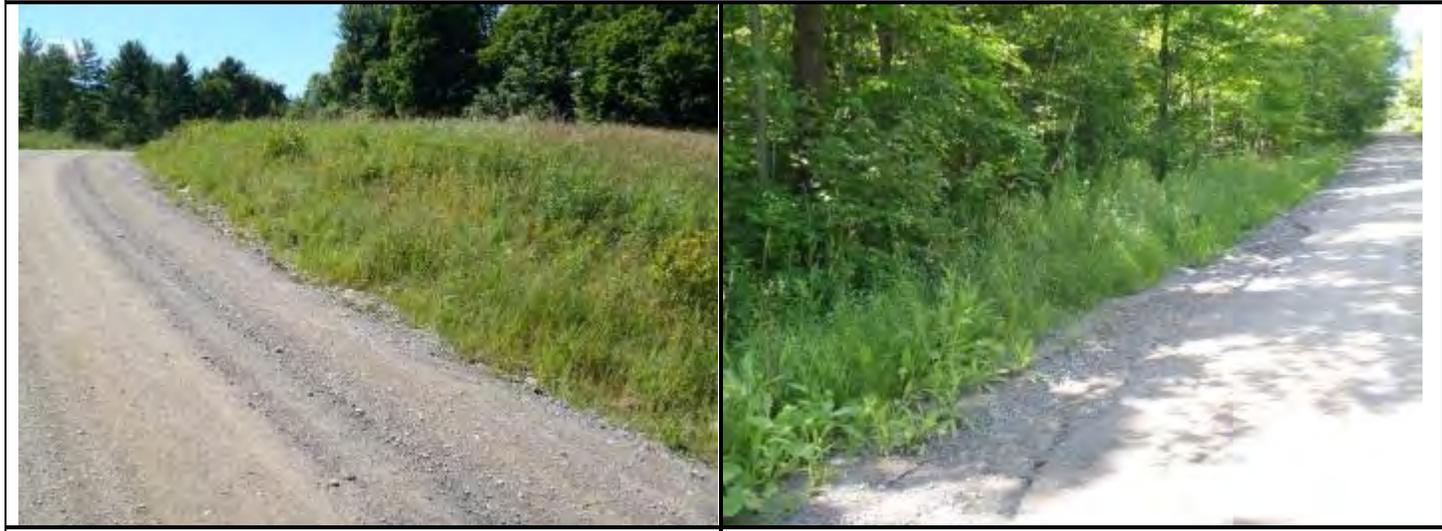
Photo 1. Road shoulder erosion **Photo 2.** More road shoulder erosion

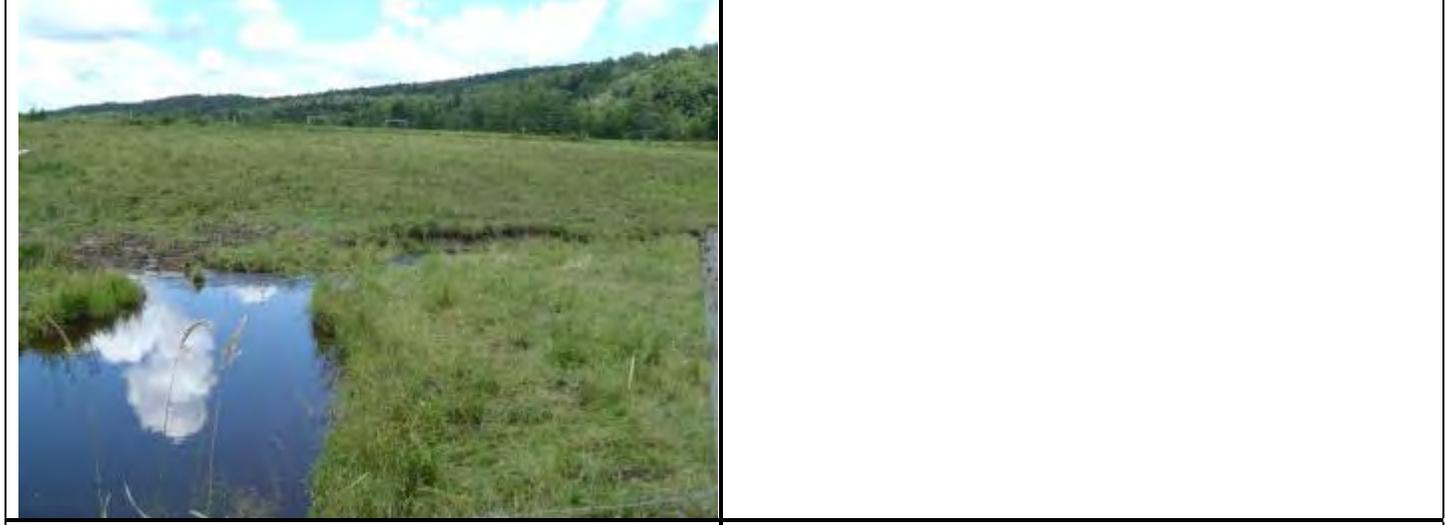
Photo 1. Failing streambank in active pasture
