Bennington IDDE
 Outfall Code: BTN-9

Bennington Outfalls

WATERSHED
CONSULTING ASSOCIATES, LLC
 430 Shelburne Road
 Burlington, VT
 watershedca.com
 802.497.2367

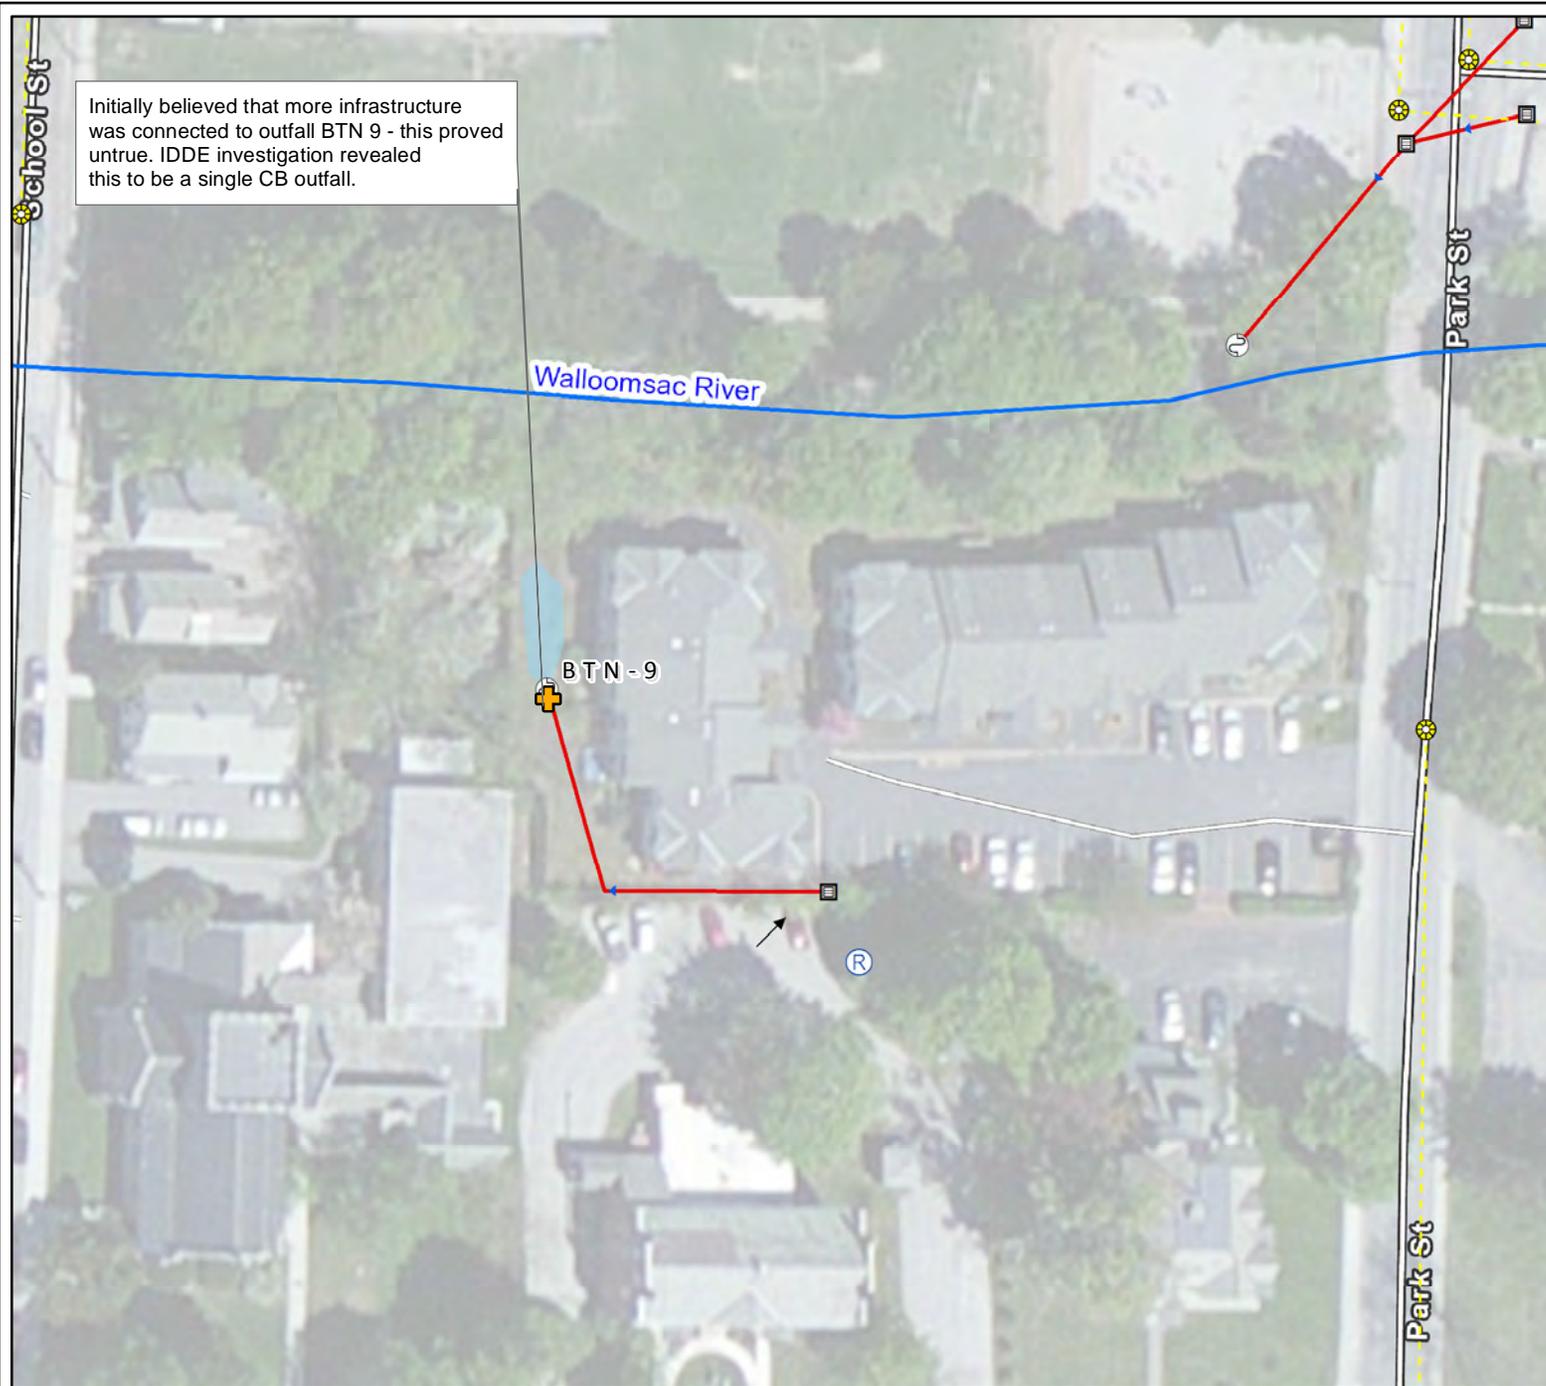
Results:
 6-12-15
 pH: 7.52
 Conductivity (uS/cm): 605
 Temperature (C): 17.7
 Ammonia (mg/L): 1.45
 E. coli (MPN/100ml): Not Tested
 Detergents (MBAS, ppm): 0.75
 Chlorine (mg/L): 0
 Potassium (ppm): 2
 ECS Alert: N/A

Initial visit on 6-12-15 - sampled from pooled water.
 Return visit in 7-15 found no pooled runoff.
 Believe detergents to be linked to car washing in residential building parking lot.

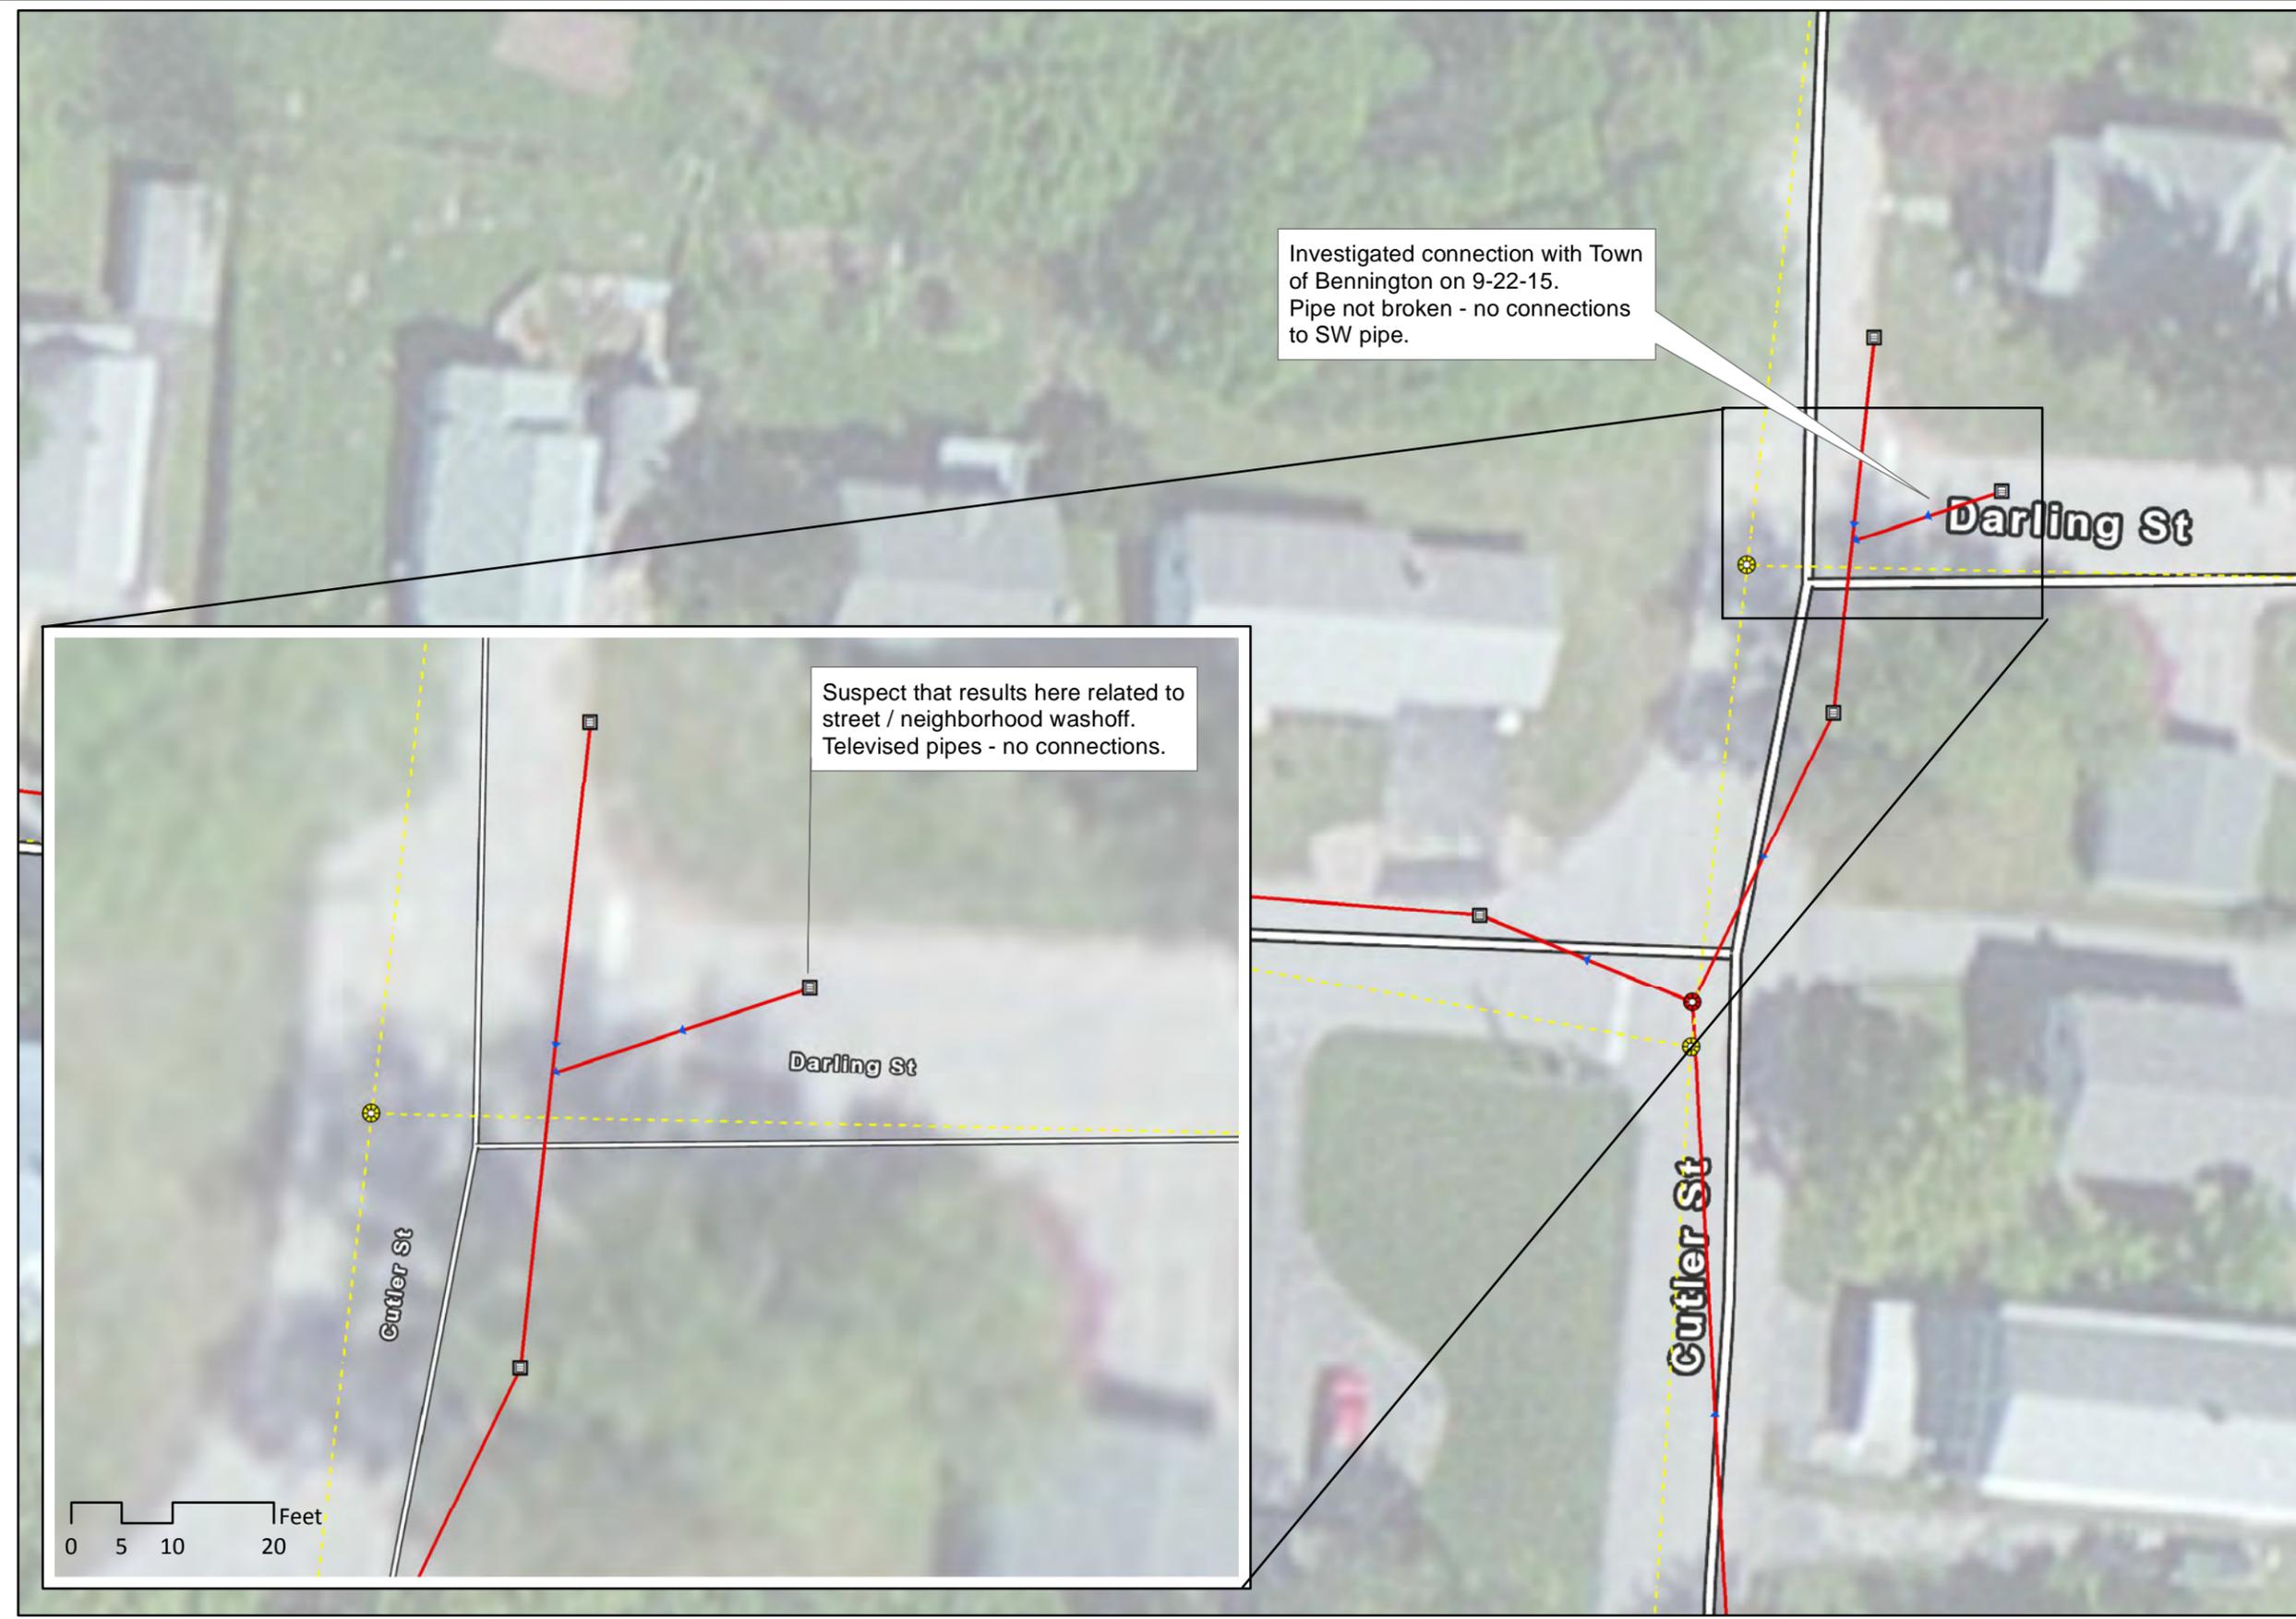
Bennington IDDE
Outfall Code: BTN-11
Infrastructure Code: CB-1081

Investigated connection with Town of Bennington on 9-22-15.
Pipe not broken - no connections to SW pipe.

Suspect that results here related to street / neighborhood washoff.
Televised pipes - no connections.

Results:
9-2-15
pH: Not Tested
Conductivity (uS/cm): Not Tested
Temperature (C): Not Tested
Ammonia (mg/L): 2.77
E. coli (MPN/100ml): 199
Detergents (MBAS, ppm): 0.75
Chlorine (mg/L): Not Tested
Potassium (ppm): Not Tested
ECS Alert: 2x (both canines)

Pooled water in CB sump. Sampled from sump for lab analysis. Found high detergent and bacteria 9-3-15.
Televised pipes 9-22-15. No suspect connections found.
Do not suspect chronic illicit discharge.

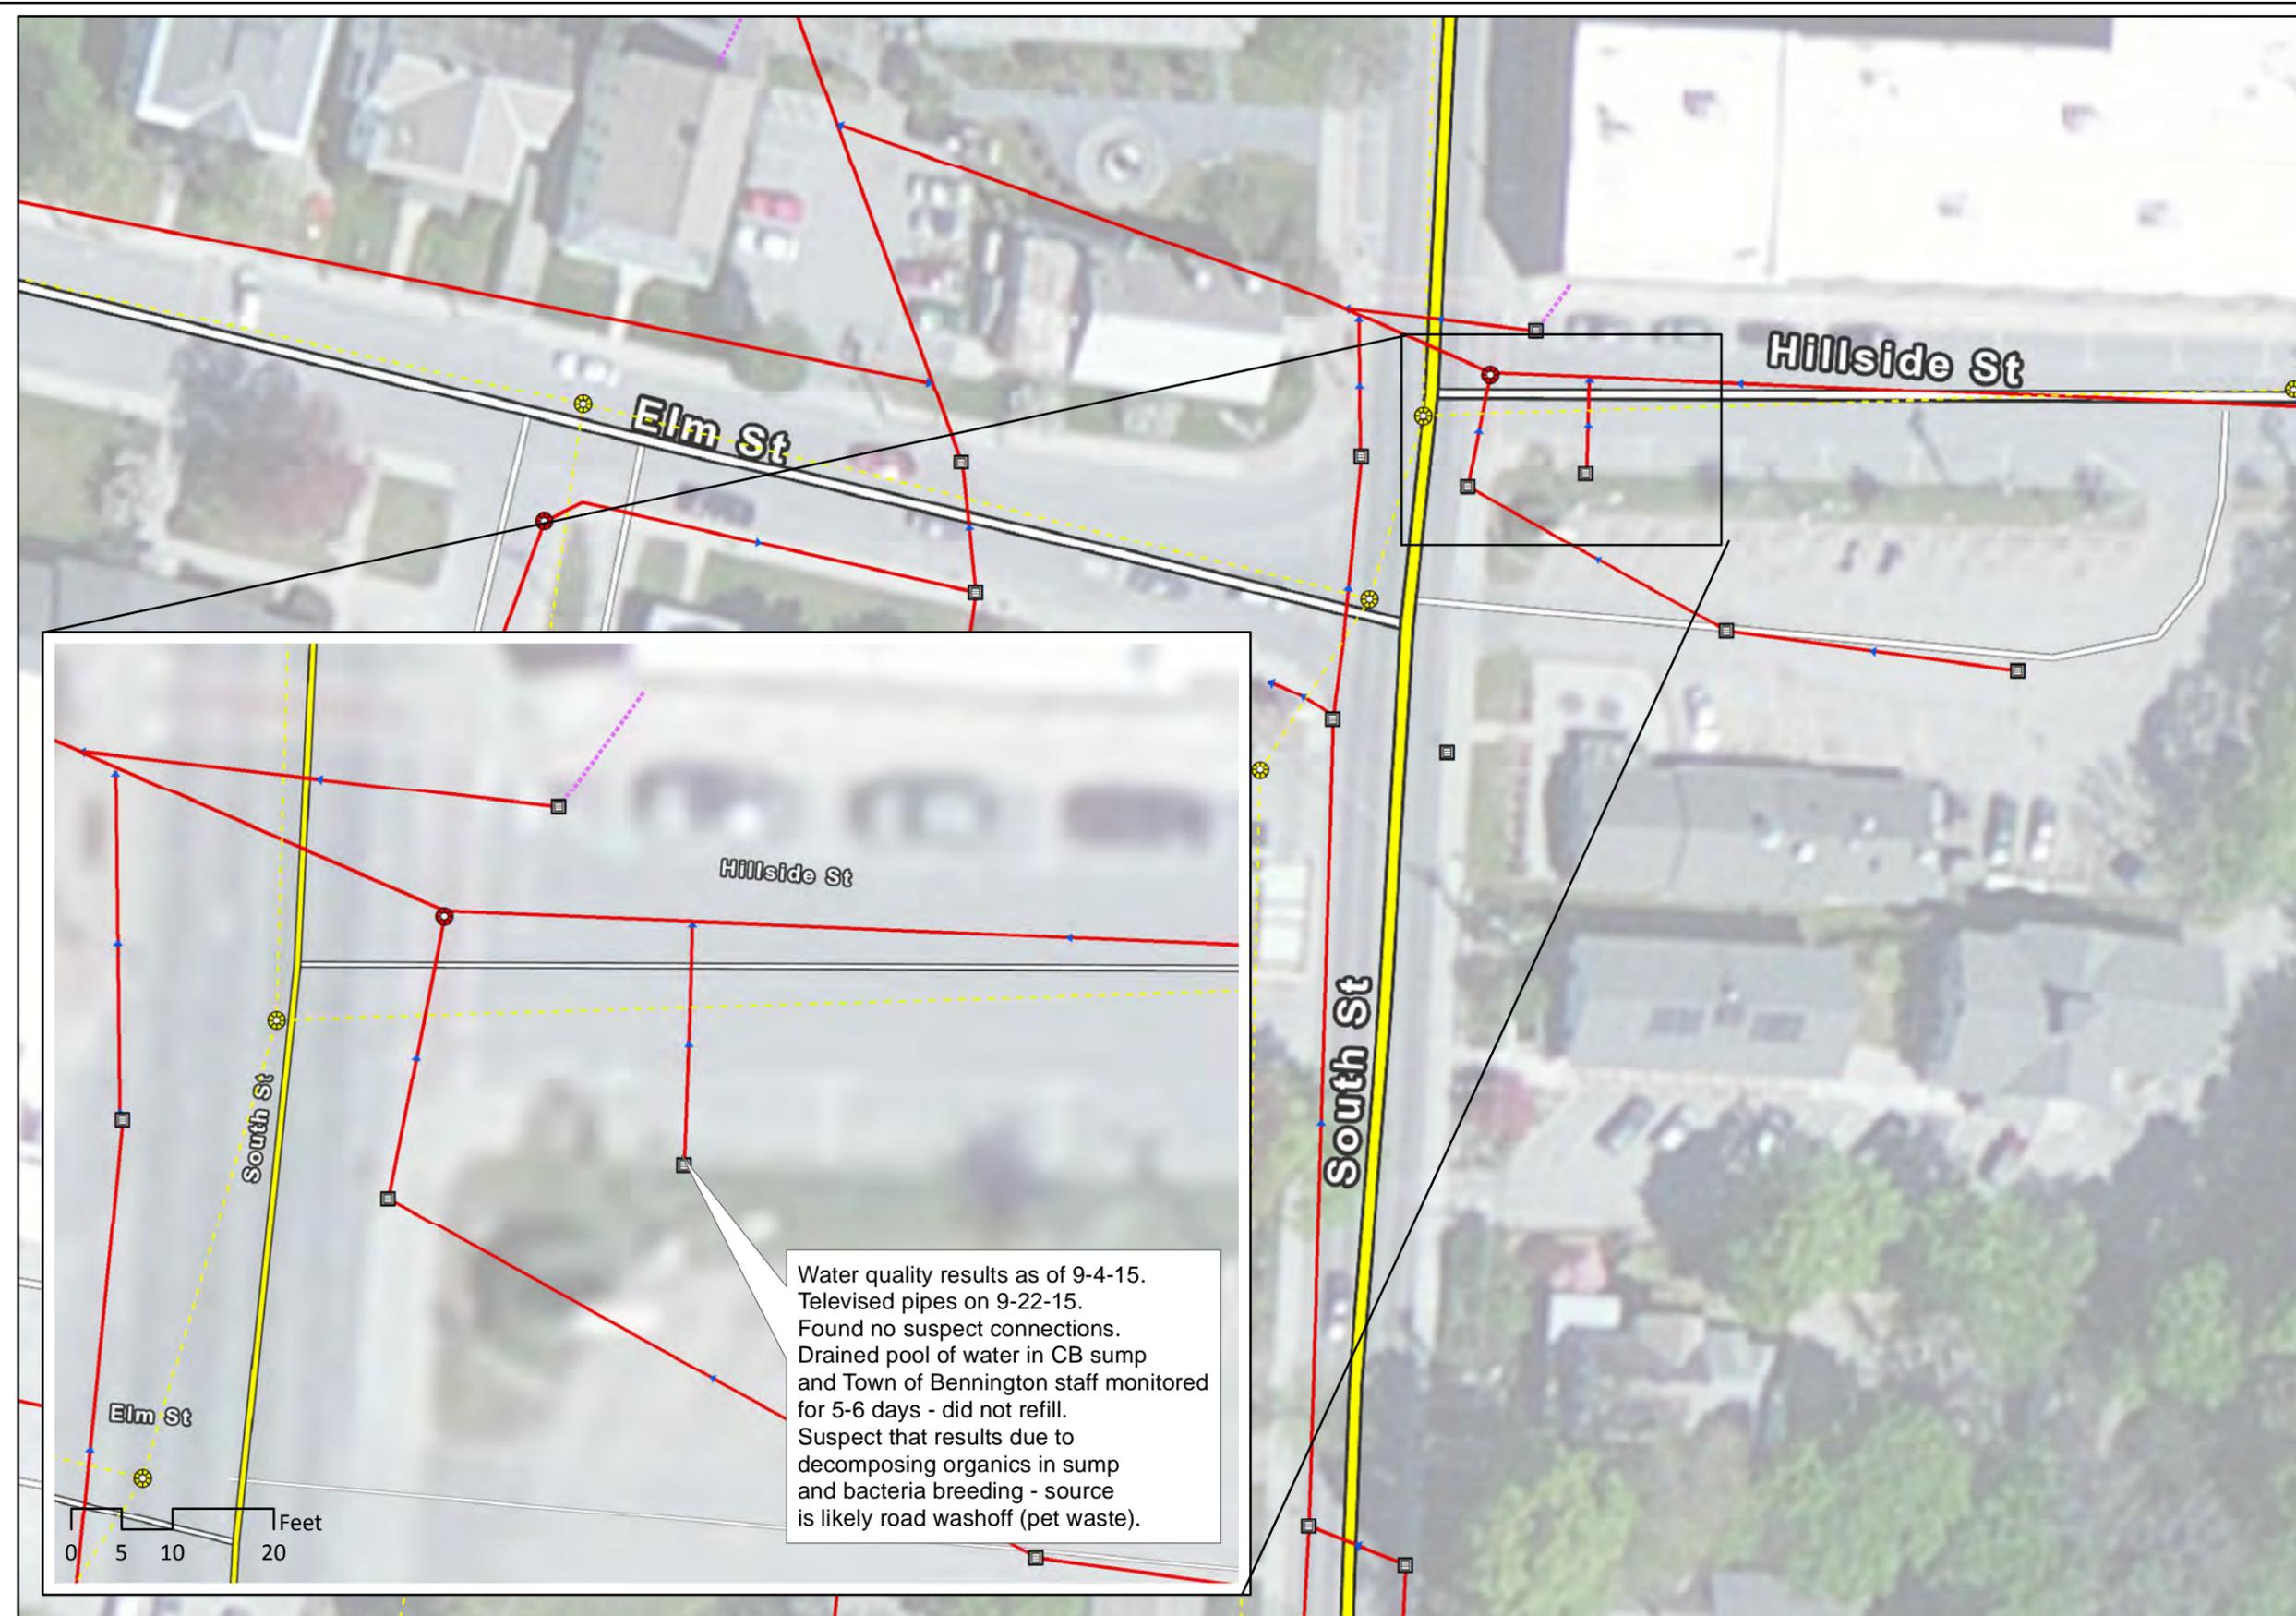
Bennington IDDE
 Outfall Code: BTN-11
 Infrastructure Code: CB-1384

Results:
 9-2-15
 pH: Not Tested
 Conductivity (uS/cm): 280
 Temperature (C): Not Tested
 Ammonia (mg/L): 1.56
 E. coli (MPN/100ml): >2400
 Detergents (MBAS, ppm): 0.75
 Chlorine (mg/L): Not Tested
 Potassium (ppm): Not Tested
 ECS Alert: 1x (one canine)

Pooled water in CB sump on 9-4-15. Sampled for lab (results above).
 Televised pipes and drained sump on 9-22-15. Found no suspect connections. Sump remained dry over next 5-6 days (observed by Town of Bennington). Suspect that bacteria result due to breeding in anaerobic and temperature conditions in sump. Ammonia reading likely due to decomposing organics. Detergents possibly road washoff.

Water quality results as of 9-4-15. Televised pipes on 9-22-15. Found no suspect connections. Drained pool of water in CB sump and Town of Bennington staff monitored for 5-6 days - did not refill. Suspect that results due to decomposing organics in sump and bacteria breeding - source is likely road washoff (pet waste).

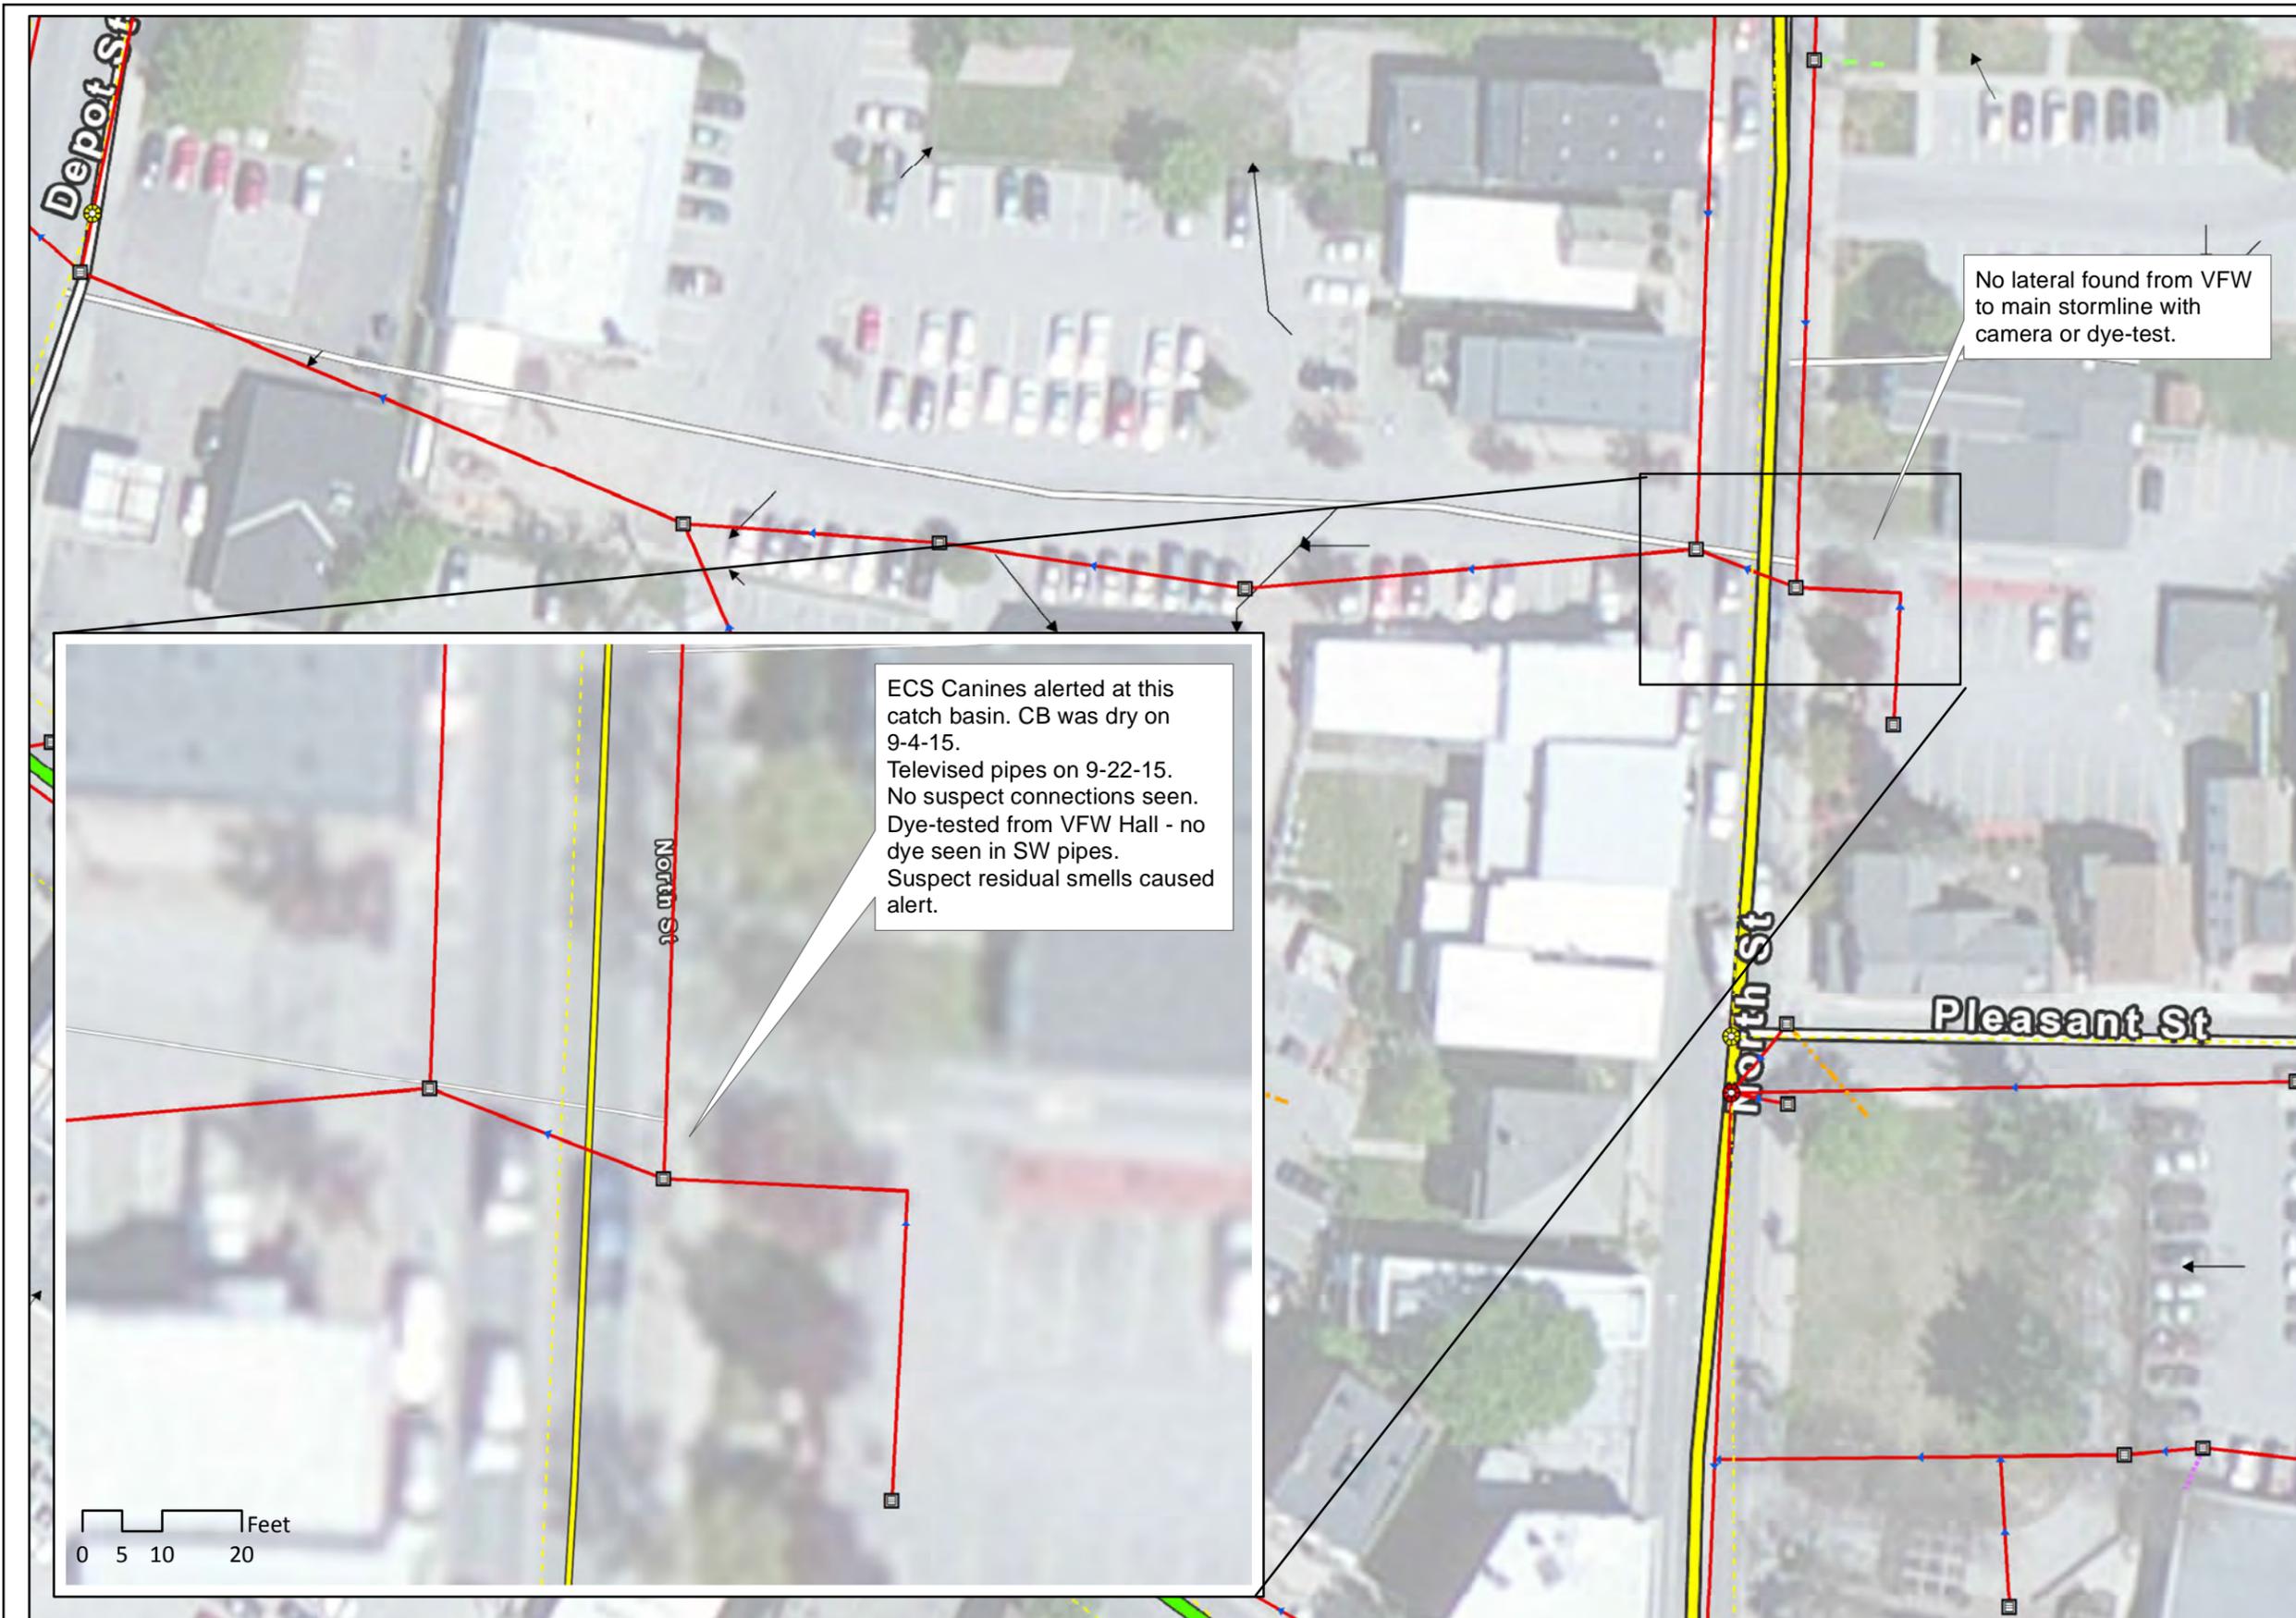
Bennington IDDE
 Outfall Code: BTN-18
 Infrastructure Code: CB-42

Results:
 9-2-15
 pH: Not Tested
 Conductivity (uS/cm): Not Tested
 Temperature (C): Not Tested
 Ammonia (mg/L): Not Tested
 E. coli (MPN/100ml): Not Tested
 Detergents (MBAS, ppm): Not Tested
 Chlorine (mg/L): Not Tested
 Potassium (ppm): Not Tested
 ECS Alert: 2x (both canines)

Televising pipes and dye-testing showed no suspect connections. No alerts upstream - no water flowing or pooled. Do no suspect chronic illicit discharge.

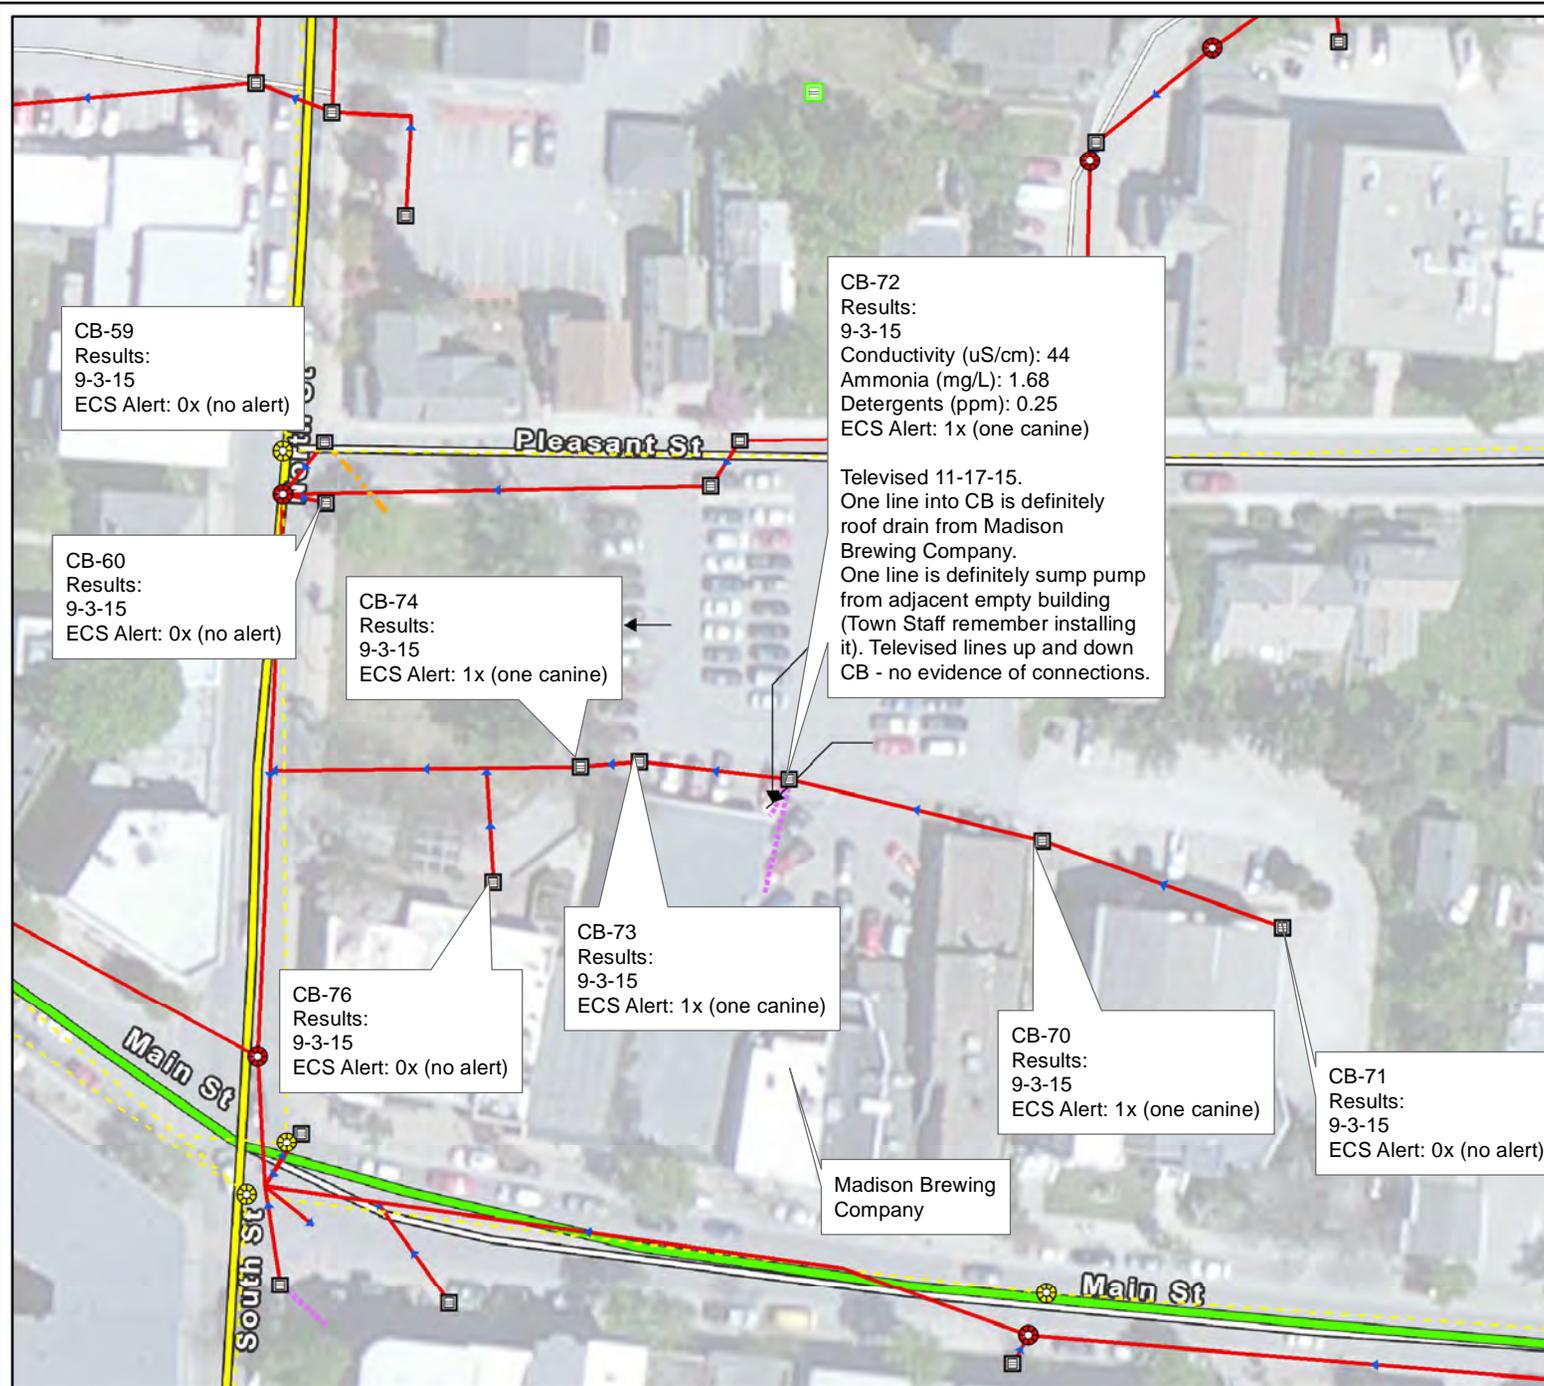
Bennington IDDE
 Outfall Code: BTN-18
 Infrastructure Code: CB-72

Result:
 9-3-15
 pH: Not Tested
 Conductivity (uS/cm): 44
 Temperature (C): Not Tested
 Ammonia (mg/L): 1.68
 E. coli (MPN/100ml): Not Tested
 Detergents (MBAS, ppm): 0.25
 Chlorine (mg/L): Not Tested
 Potassium (ppm): Not Tested
 ECS Alert: 2x (both canines)

Both canines alerted here 9-3-15.
 Televised line 11-17-15 with Town of Bennington. No evidence of possible connections. Do not suspect chronic illicit discharge.

Televised 11-17-15.
 One line into CB is definitely roof drain from Madison Brewing Company.
 One line is definitely sump pump from adjacent empty building (Town Staff remember installing it). Televised lines up and down CB - no evidence of connections.

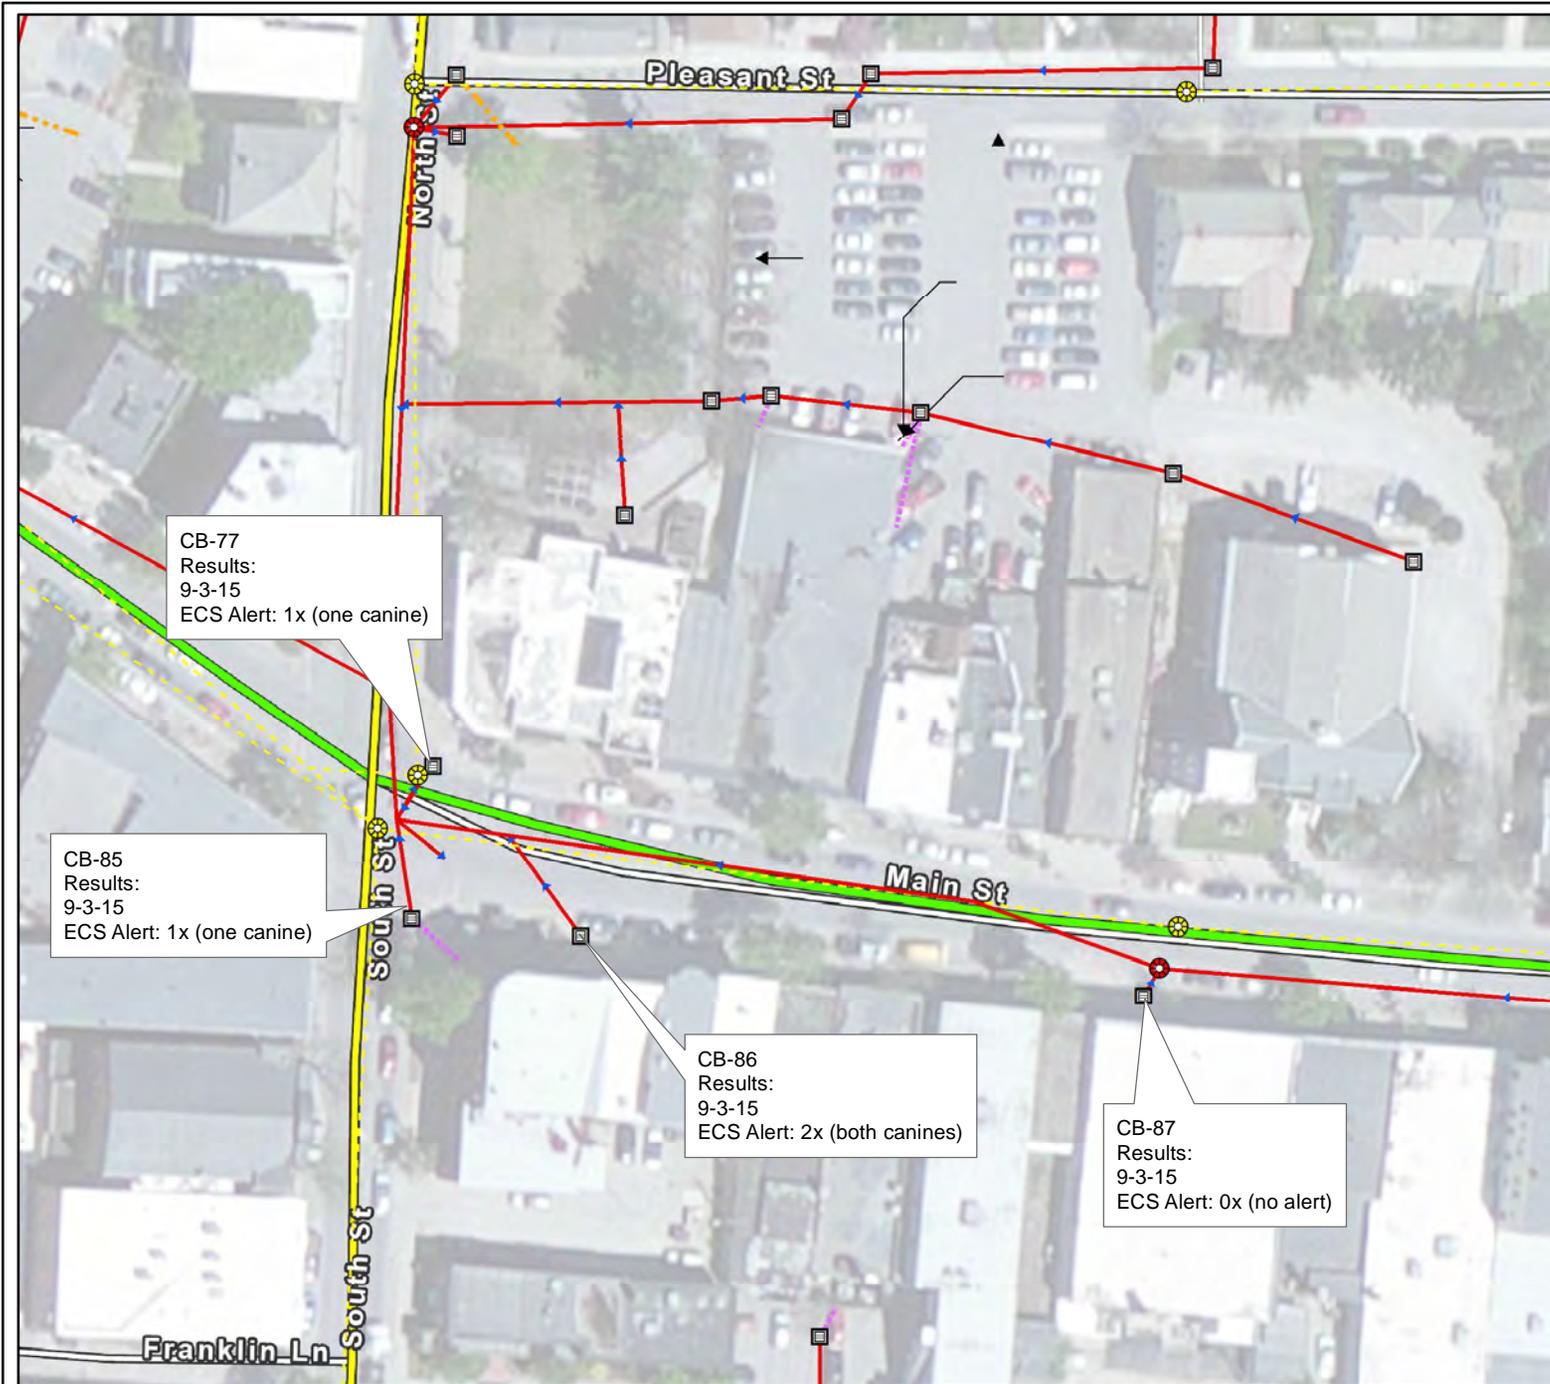
Bennington IDDE
 Outfall Code: BTN-18
 Infrastructure Code: CB-86

Result:
 9-3-15
 pH: Not Tested
 Conductivity (uS/cm): Not Tested
 Temperature (C): Not Tested
 Ammonia (mg/L): 0.42
 E. coli (MPN/100ml): 63
 Detergents (MBAS, ppm): 0.75
 Chlorine (mg/L): Not Tested
 Potassium (ppm): Not Tested
 ECS Alert: 2x (both canines)

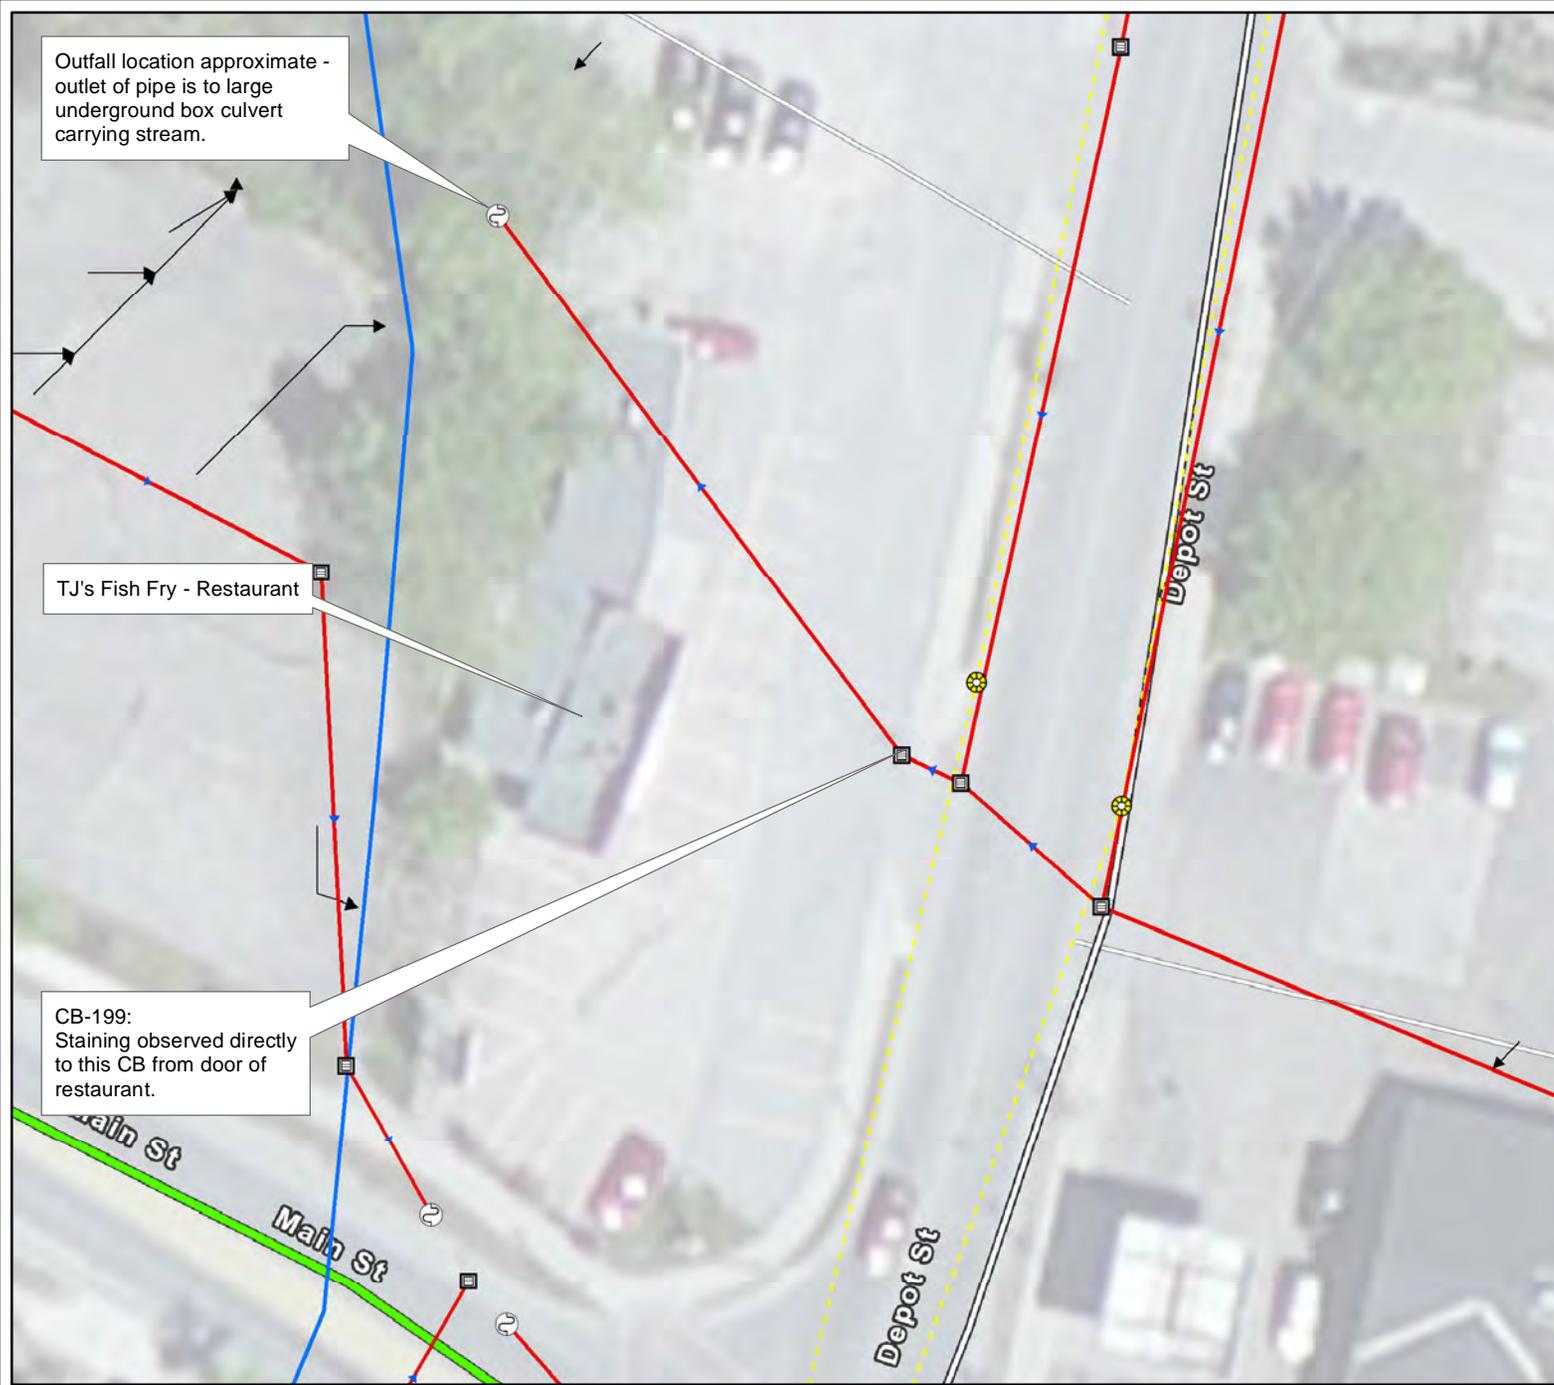
Bennington IDDE
 Outfall Code: BTN-18
 Infrastructure Code: CB-199

Results:
 9-3-15
 pH: Not Tested
 Conductivity (uS/cm): 3999
 Temperature (C): Not Tested
 Ammonia (mg/L): 2.6
 E. coli (MPN/100ml): Could not sample
 Detergents (MBAS, ppm): >3.0
 Chlorine (mg/L): Not Tested
 Potassium (ppm): Not Tested
 ECS Alert: 2x (both canines)

Observed staining on parking lot from door of restaurant to CB. Suspect dumping of mop bucket wash water. Town of Bennington indicated that site has on-going sanitary sewer failure issue. Referred follow-up to State of VT Wastewater.

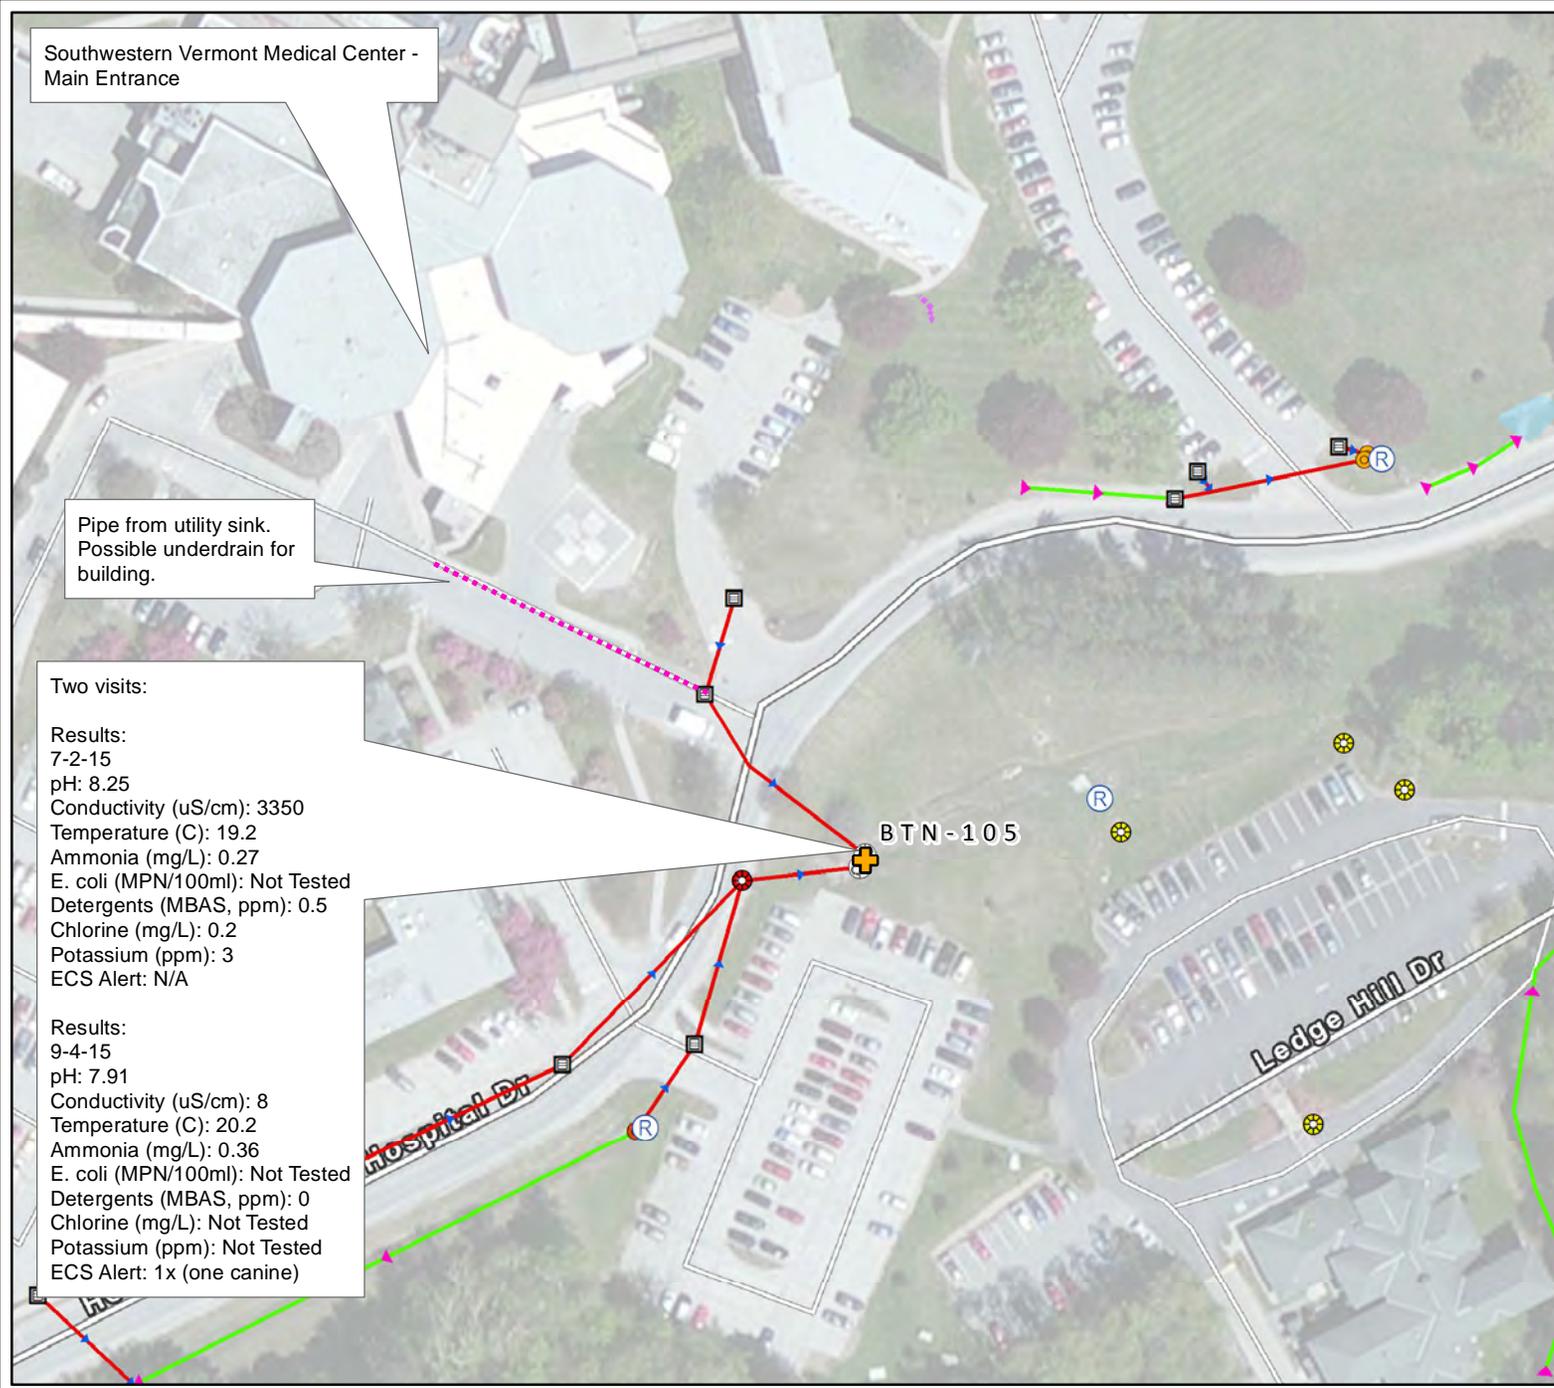
Pipe from utility sink. Possible underdrain for building.

Noticed issue on 7-2-15. On return visit on 9-4-15, water was somewhat cleaner - not as turbid. On follow-up visit on 9-22-15, spoke with Willy Hall, facilities manager. Pointed out issue - he followed up and found an improperly connected paint sink. Issued fixed on 10-13-15.
