Bennington IDDE
 Outfall Code: BTN-9

Bennington Outfalls

WATERSHED
CONSULTING ASSOCIATES, LLC
 430 Shelburne Road
 Burlington, VT
 watershedca.com
 802.497.2367

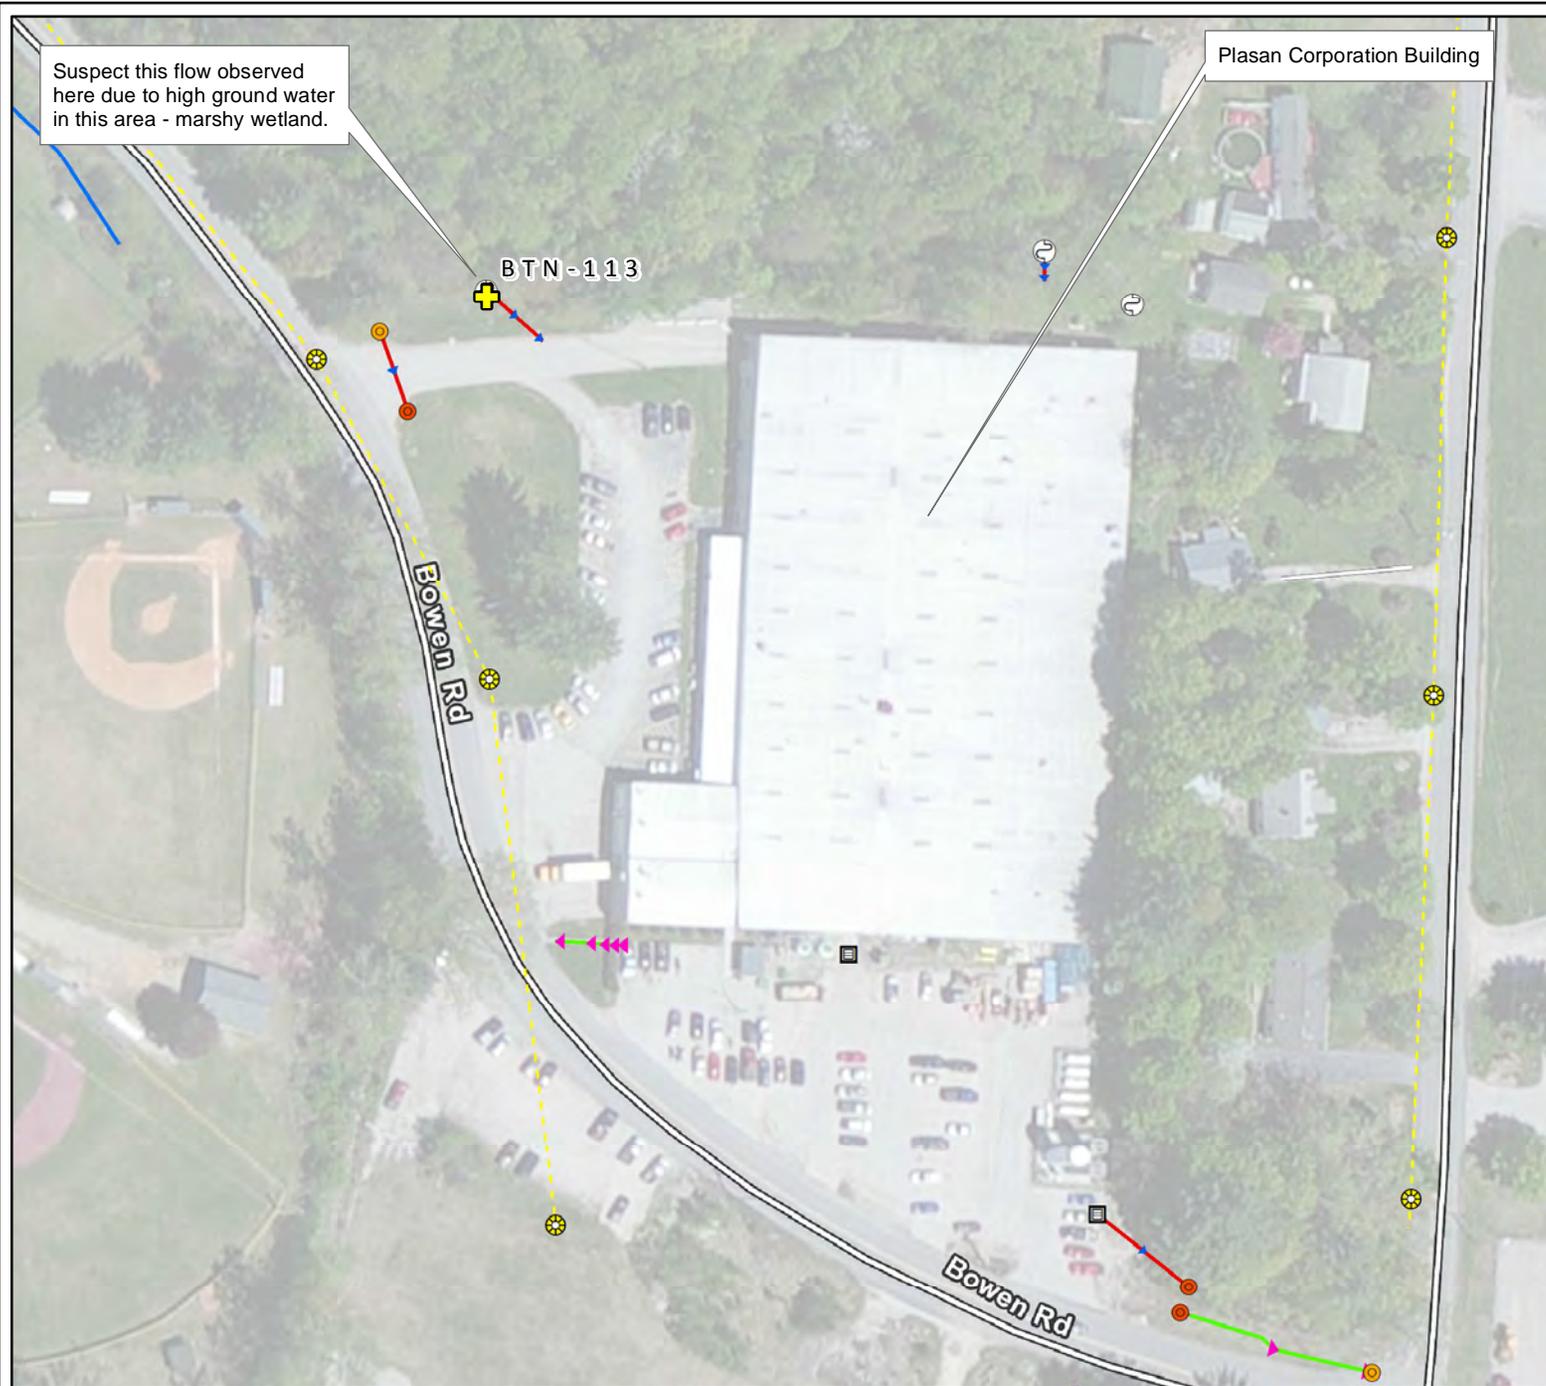
Bennington IDDE
 Outfall Code: BTN-113

Results:
 6-5-15
 pH: 6.77
 Conductivity (uS/cm): 191
 Temperature (C): 8.1
 Ammonia (mg/L): 0.36
 E. coli (MPN/100ml): 10
 Detergents (MBAS, ppm): <0.25
 Chlorine (mg/L): 0
 Potassium (ppm): 0
 ECS Alert: 0x (no alert)

Staining and sheen on surface of water - believed to be due to iron bacteria. Do not suspect chronic illicit discharge.

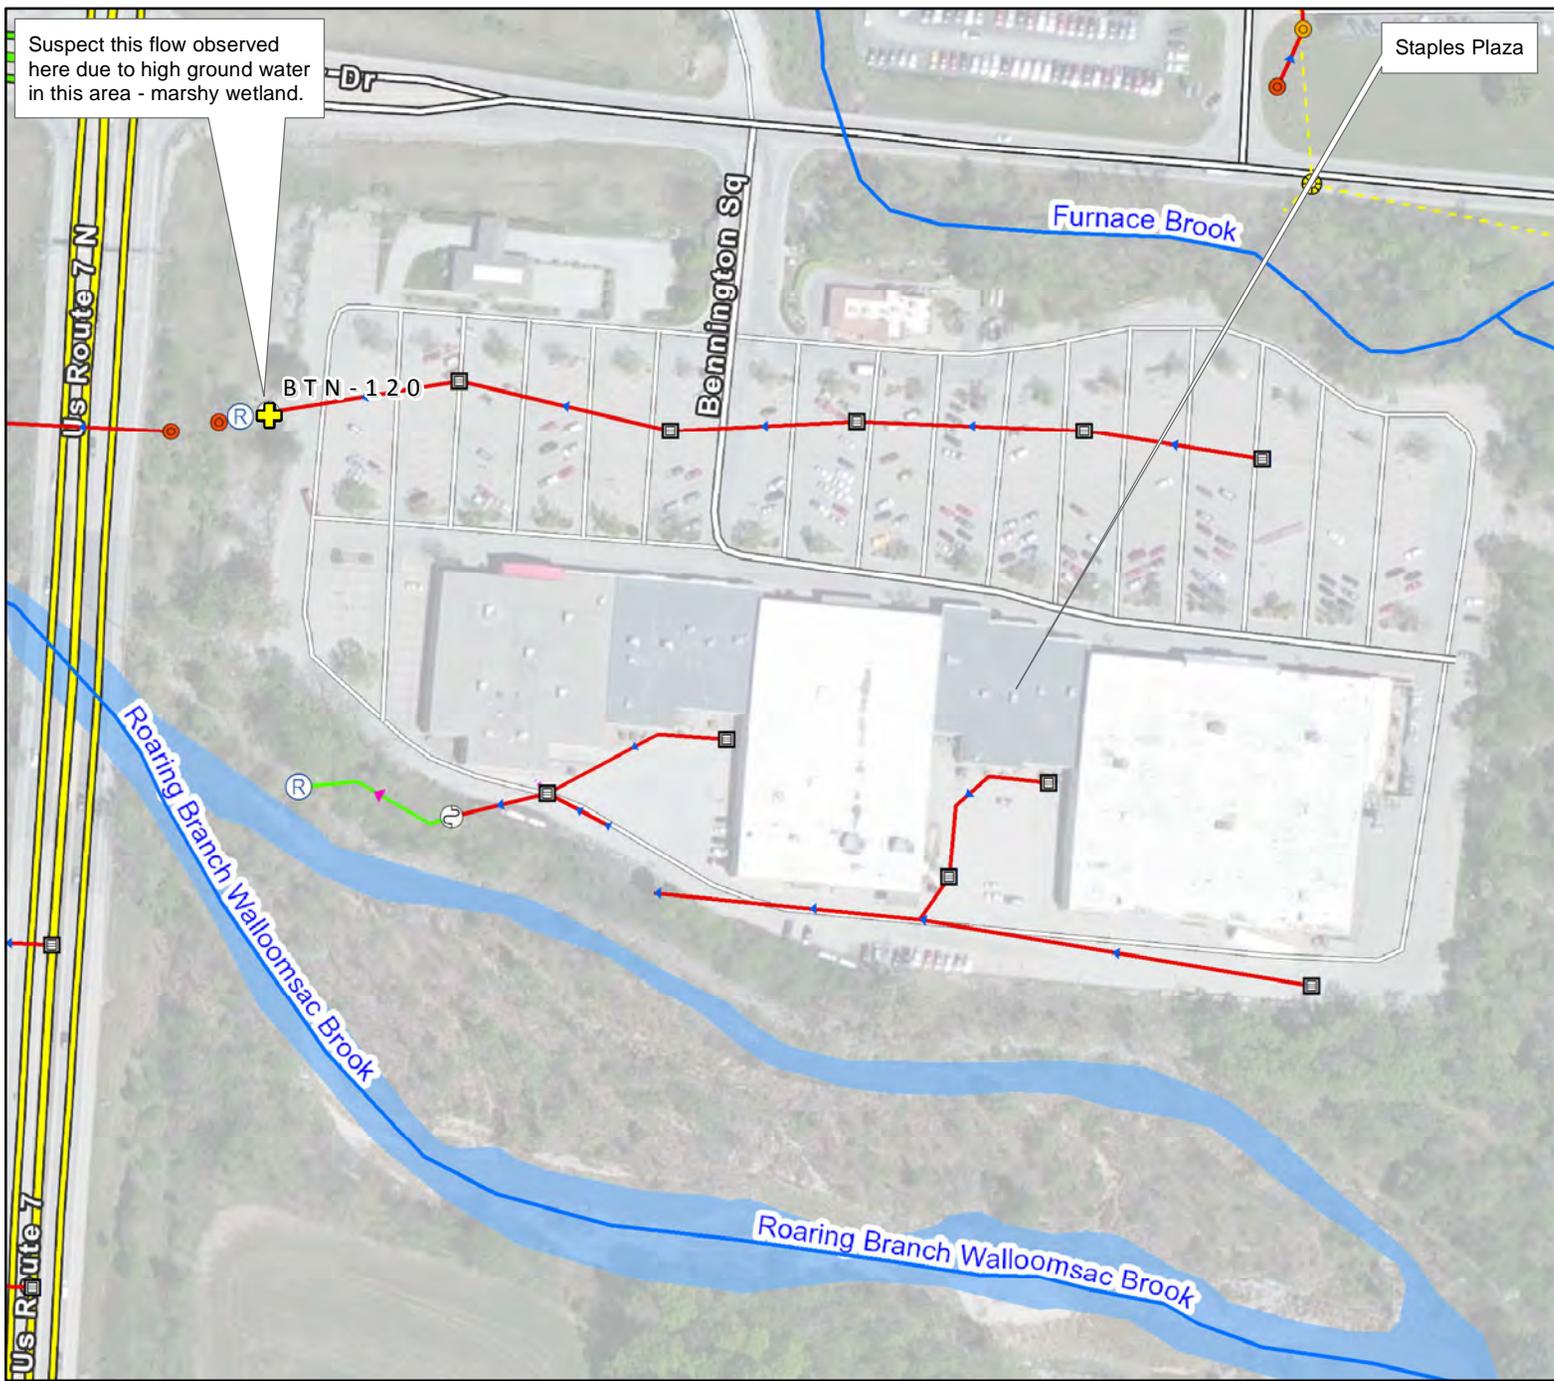
Bennington IDDE
Outfall Code: BTN-120

Results:
6-11-15
pH: 7.23
Conductivity (uS/cm): 648
Temperature (C): 16.1
Ammonia (mg/L): 0.14
E. coli (MPN/100ml): Not Tested
Detergents (MBAS, ppm): 0
Chlorine (mg/L): 0
Potassium (ppm): 2
ECS Alert: 0x (no alert)

Suspect that flow observed is from groundwater intrusion into catch basins and pipes. Observed values don't indicate chronic illicit discharge.

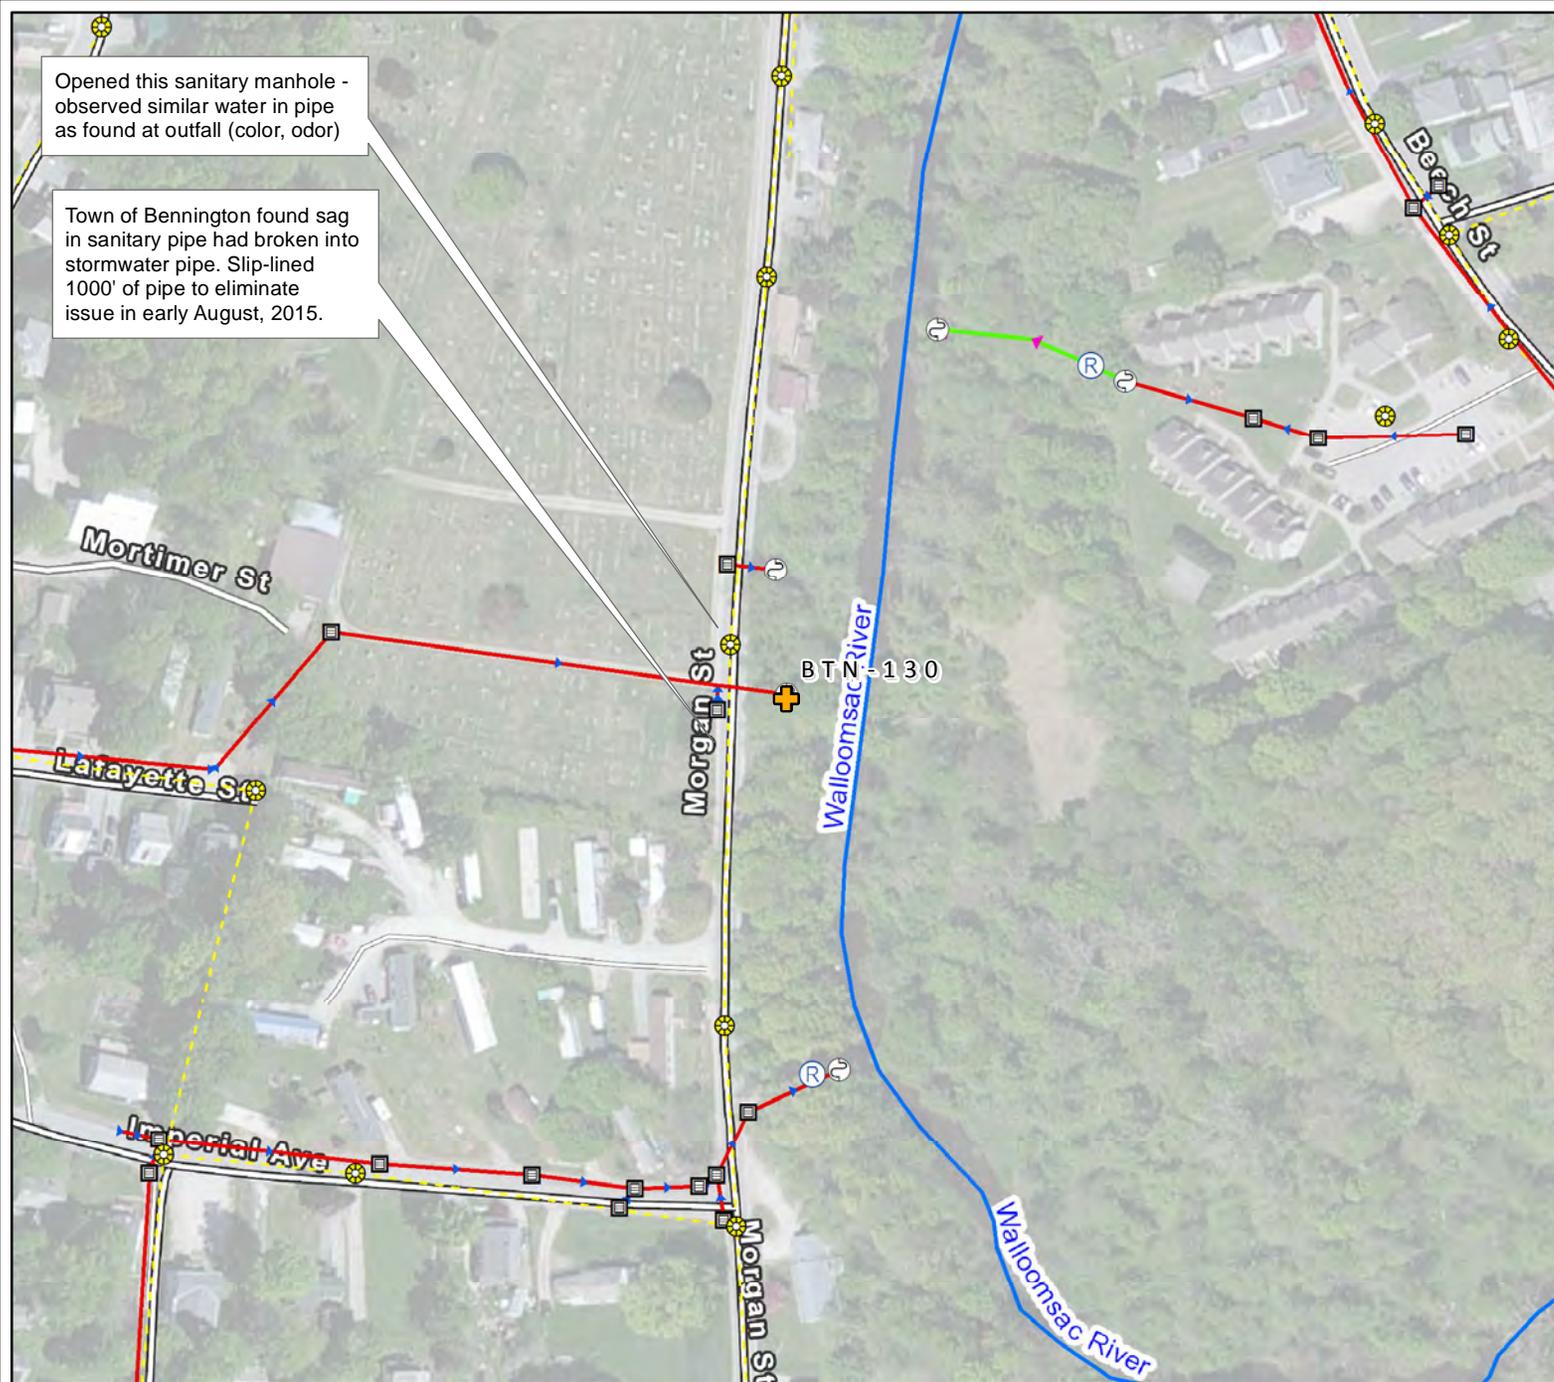
Opened this sanitary manhole - observed similar water in pipe as found at outfall (color, odor)

Found very high ammonia on 6-12-15. Returned on 7-27-15 to obtain e. coli and phosphorus sample. Suspect illicit discharge at that time - opened sanitary manhole and saw similar water. Called Town of Bennington - they fixed the issue by slip-lining 1000' of pipe.

Town of Bennington found sag in sanitary pipe had broken into stormwater pipe. Slip-lined 1000' of pipe to eliminate issue in early August, 2015.

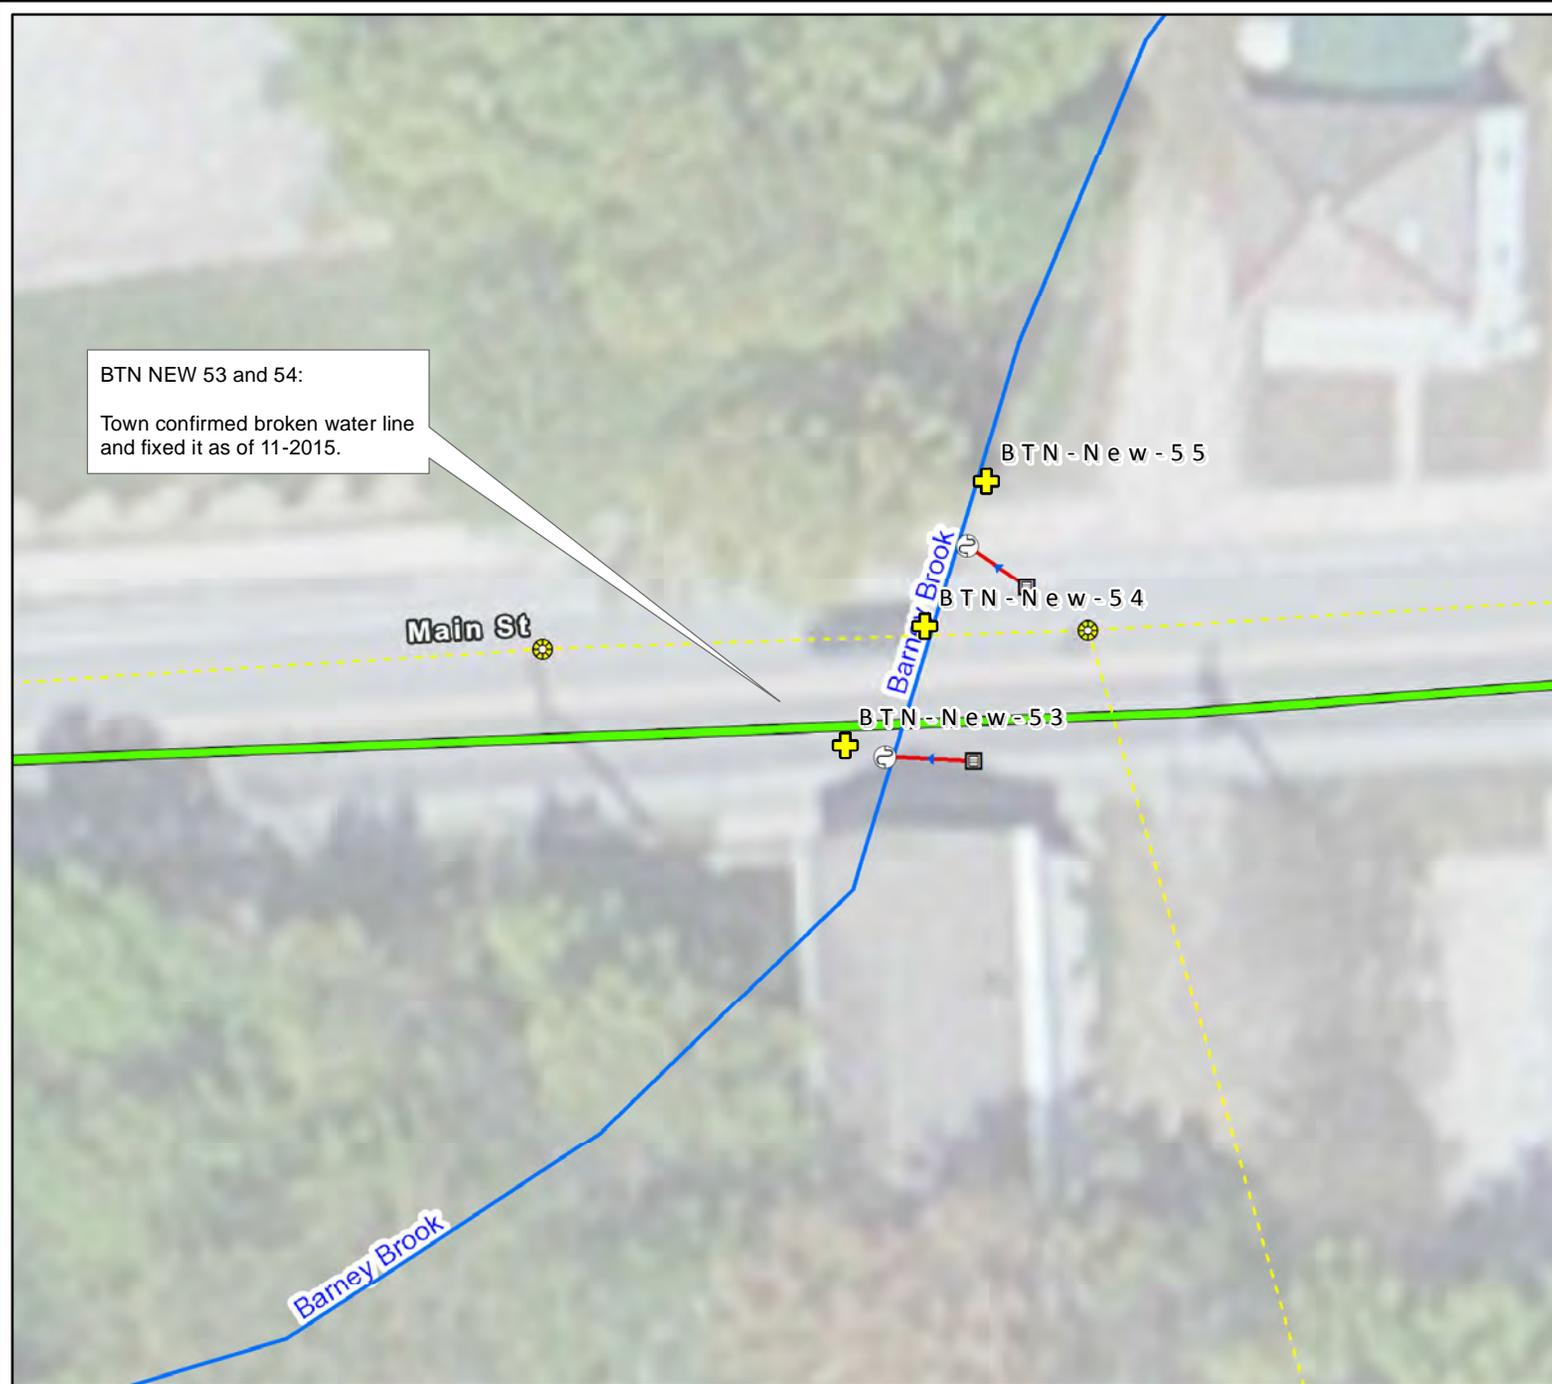
Bennington IDDE
 Outfall Code: BTN-NEW-53

Results:
 6-24-15
 pH: 7.16
 Conductivity (uS/cm): 57
 Temperature (C): 18.89
 Ammonia (mg/L): 0.2
 E. coli (MPN/100ml): <1
 Detergents (MBAS, ppm): 0
 Chlorine (mg/L): 0.6
 Potassium (ppm): 0
 ECS Alert: N/A

Water discharging from pressure-relief holes in bridge buttress. Town confirms that there is broken water line. Initial repair made 7-2015. Final repair in progress as of 11-2015.

BTN NEW 53 and 54:
 Town confirmed broken water line and fixed it as of 11-2015.

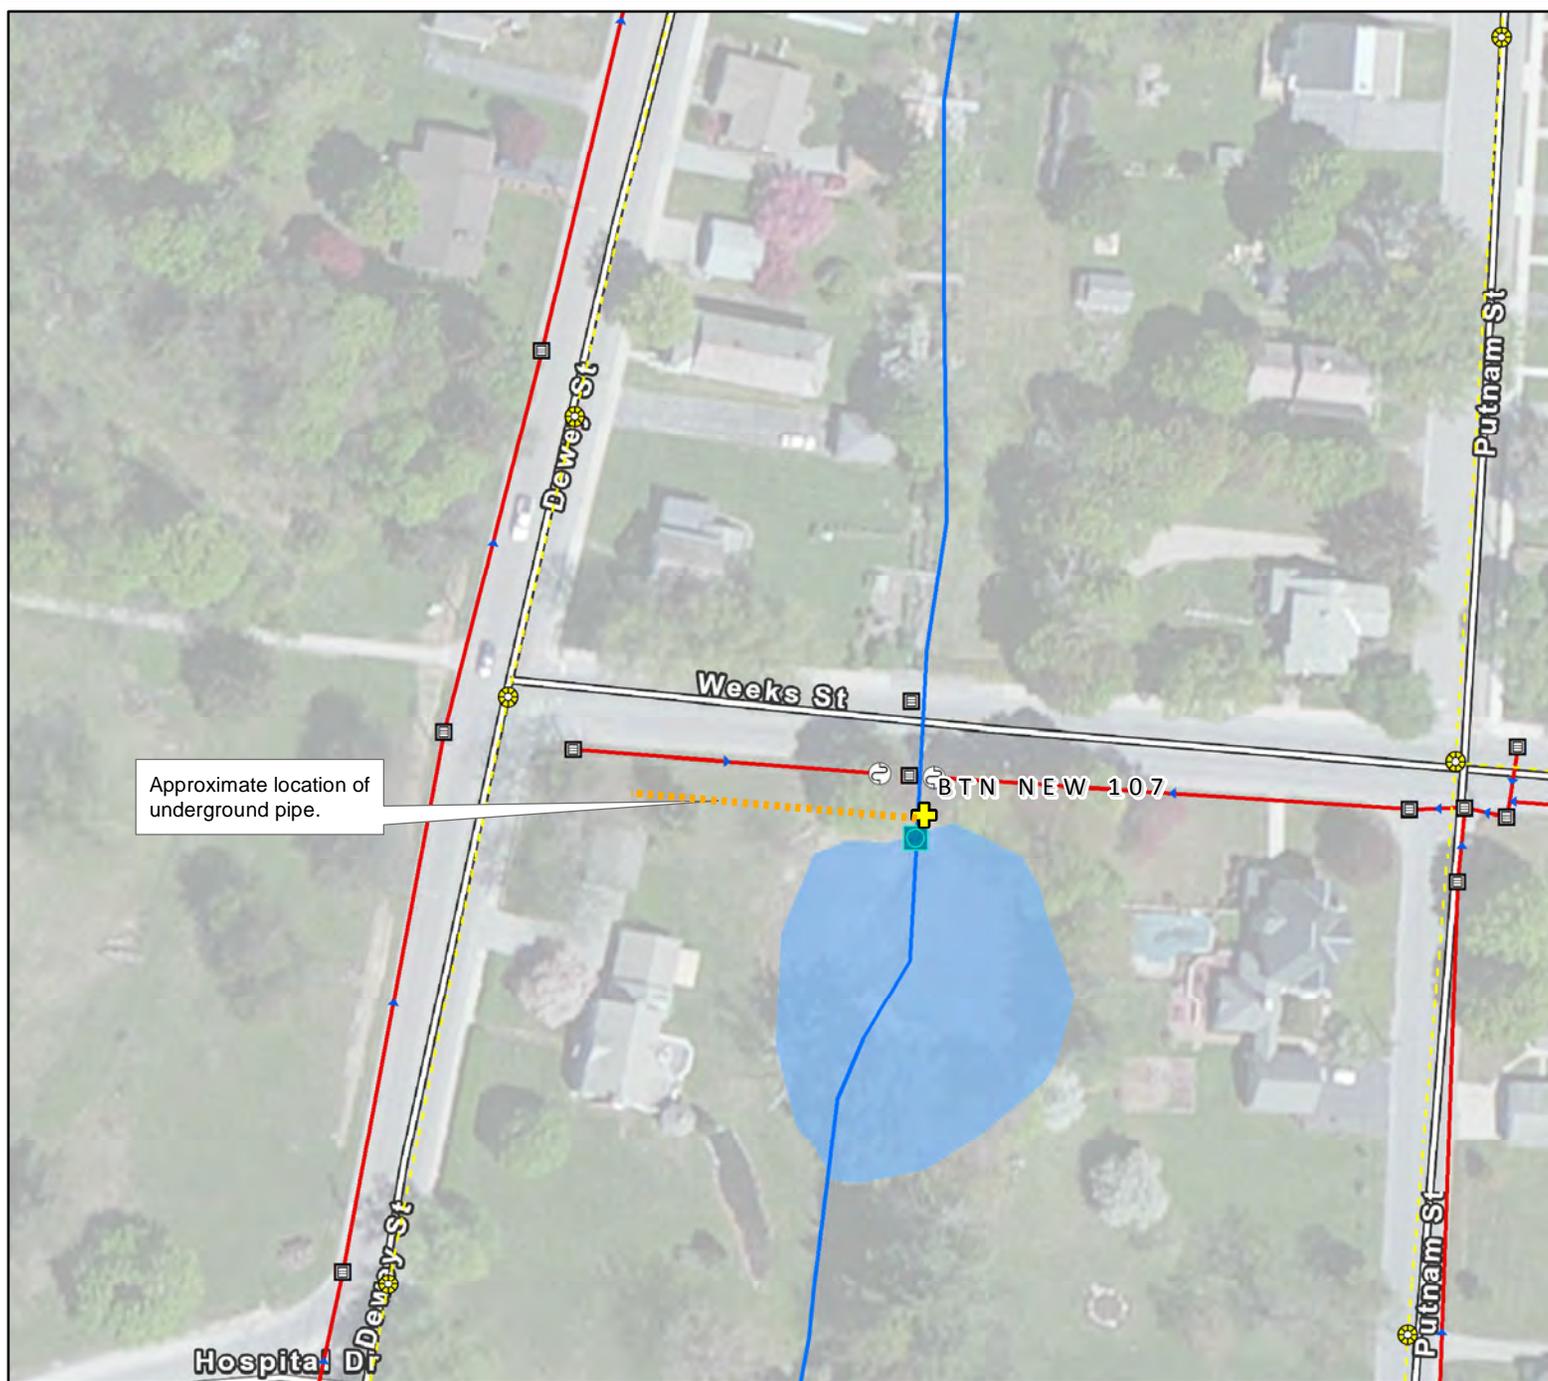
Bennington IDDE
Outfall Code: BTN-NEW-107

Results:
6-25-15
pH: 8.45
Conductivity (uS/cm): 970
Temperature (C): 16.0
Ammonia (mg/L): 0.33
E. coli (MPN/100ml): Not Tested
Detergents (MBAS, ppm): 0
Chlorine (mg/L): 0
Potassium (ppm): 0
ECS Alert: N/A

Initial visit on 6-25-15 - 0.48" rain in past 48 hours. Observed trickle flow from 6" concrete pipe. Re-visited on 9-27-15 - trickle flow. Unable to conduct dye test - residence is low-use. Do not suspect chronic illicit discharge based on water quality results.

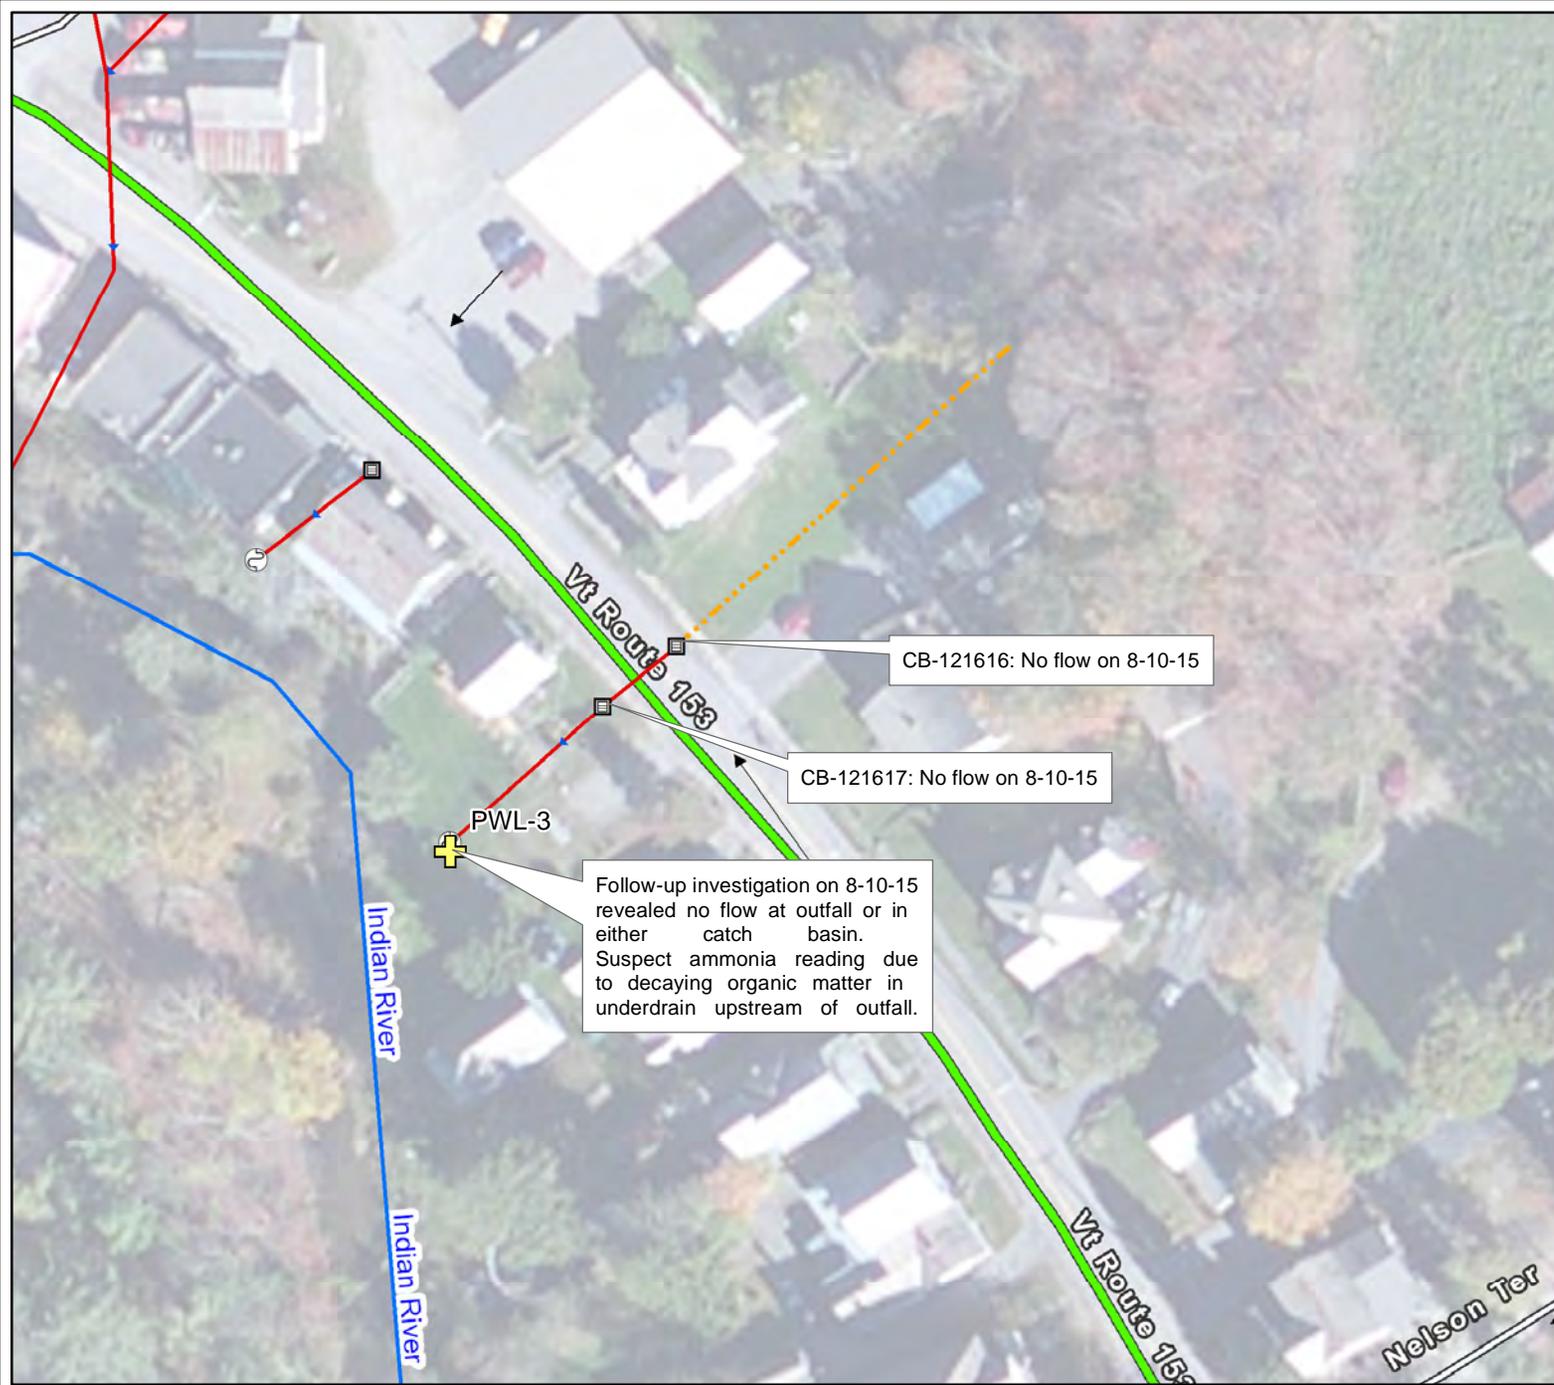
Pawlet IDDE
Outfall Code: PWL-3

Results:
7-9-15
pH: 7.46
Conductivity (uS/cm): 390
Temperature (C): 14.3
Ammonia (mg/L): 0.45
E. coli (MPN/100ml): Not Tested
Detergents (MBAS, ppm): 0
Chlorine (mg/L): 0
Potassium (ppm): 3
ECS Alert: N/A
TP (mg/L): Not Tested

Follow-up investigation on 8-10-15 revealed no flow at outfall or in either catch basin. Suspect ammonia reading due to decaying organic matter in underdrain upstream of outfall.

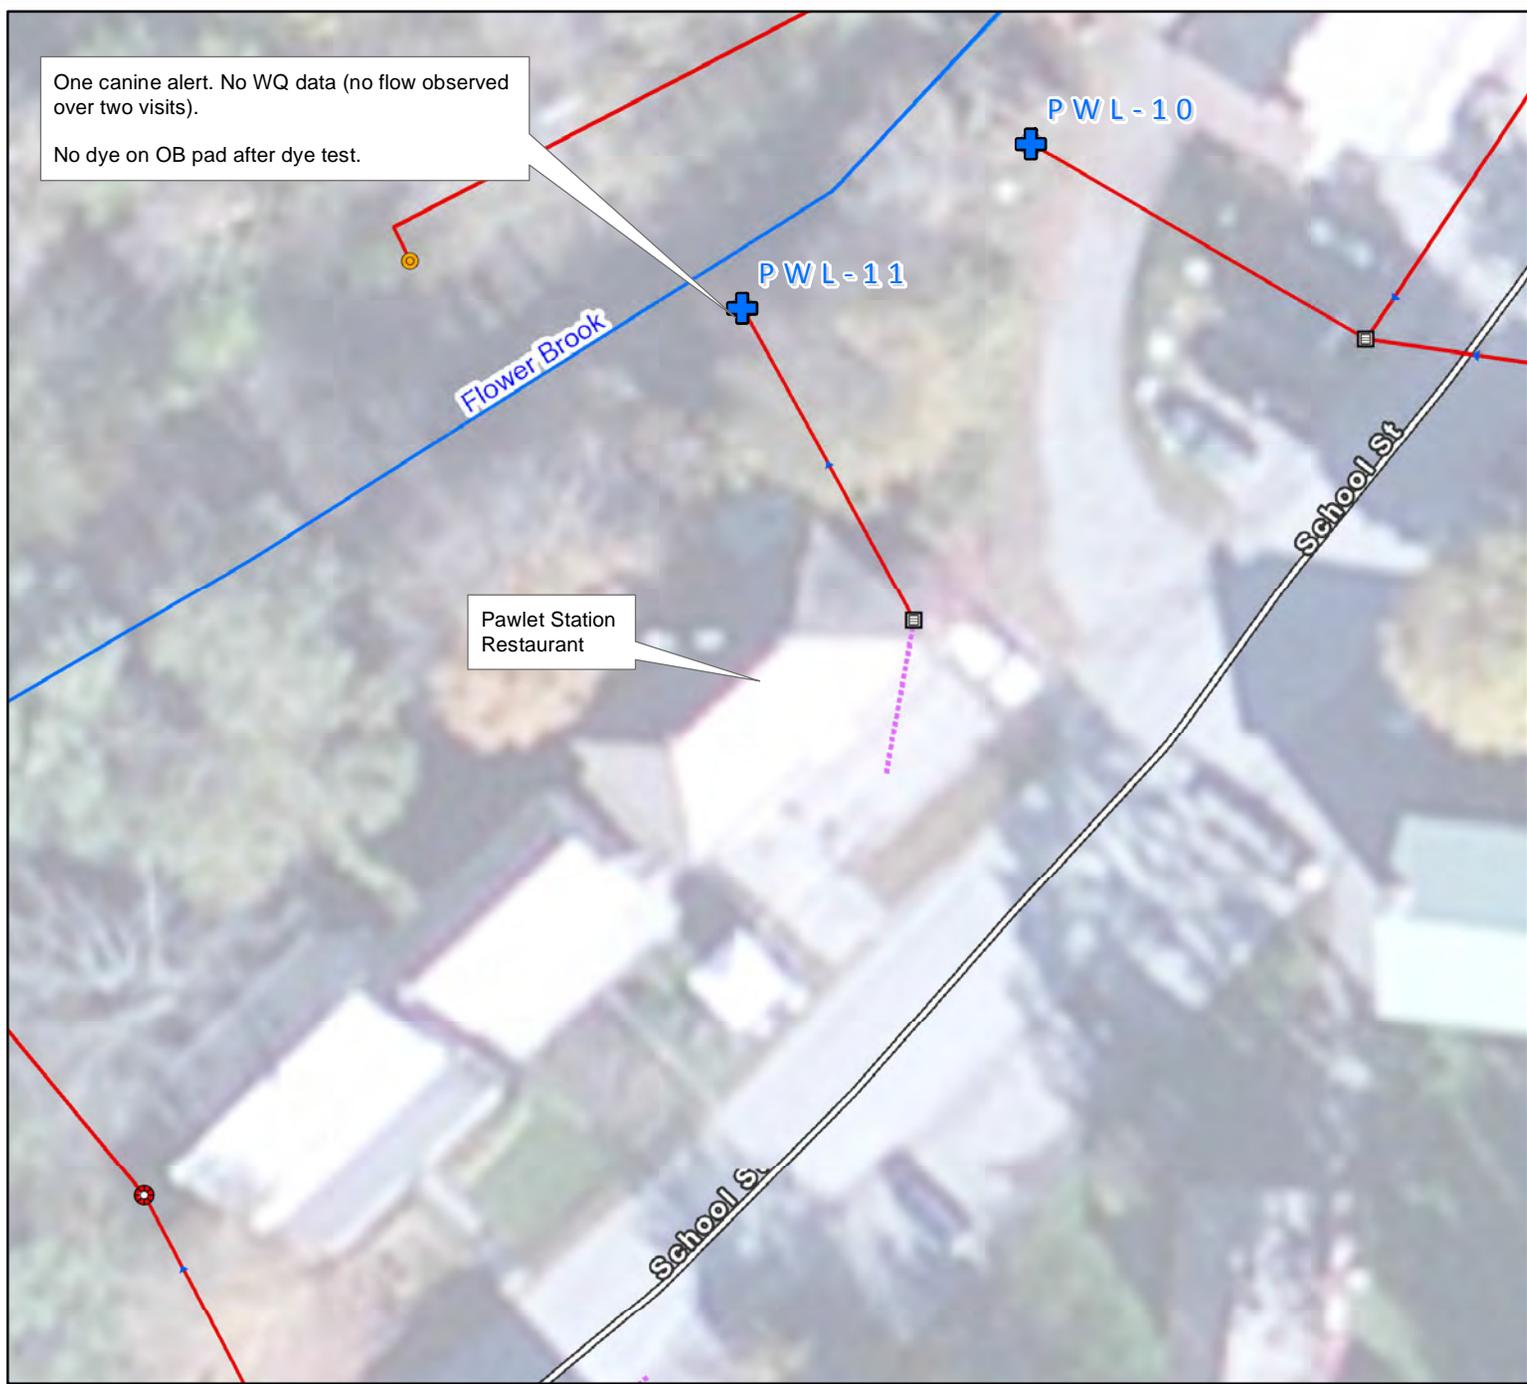
Pawlet IDDE
Outfall Code: PWL-11

Flow not observed at this outfall on initial visit (7-9-15).
Working with canines on 9-1-15 (no flow observed on that date), one canine alerted at outfall.

Conducted dye testing 10-26 to 10-30-15.
No dye or optical brightener observed at outfall.

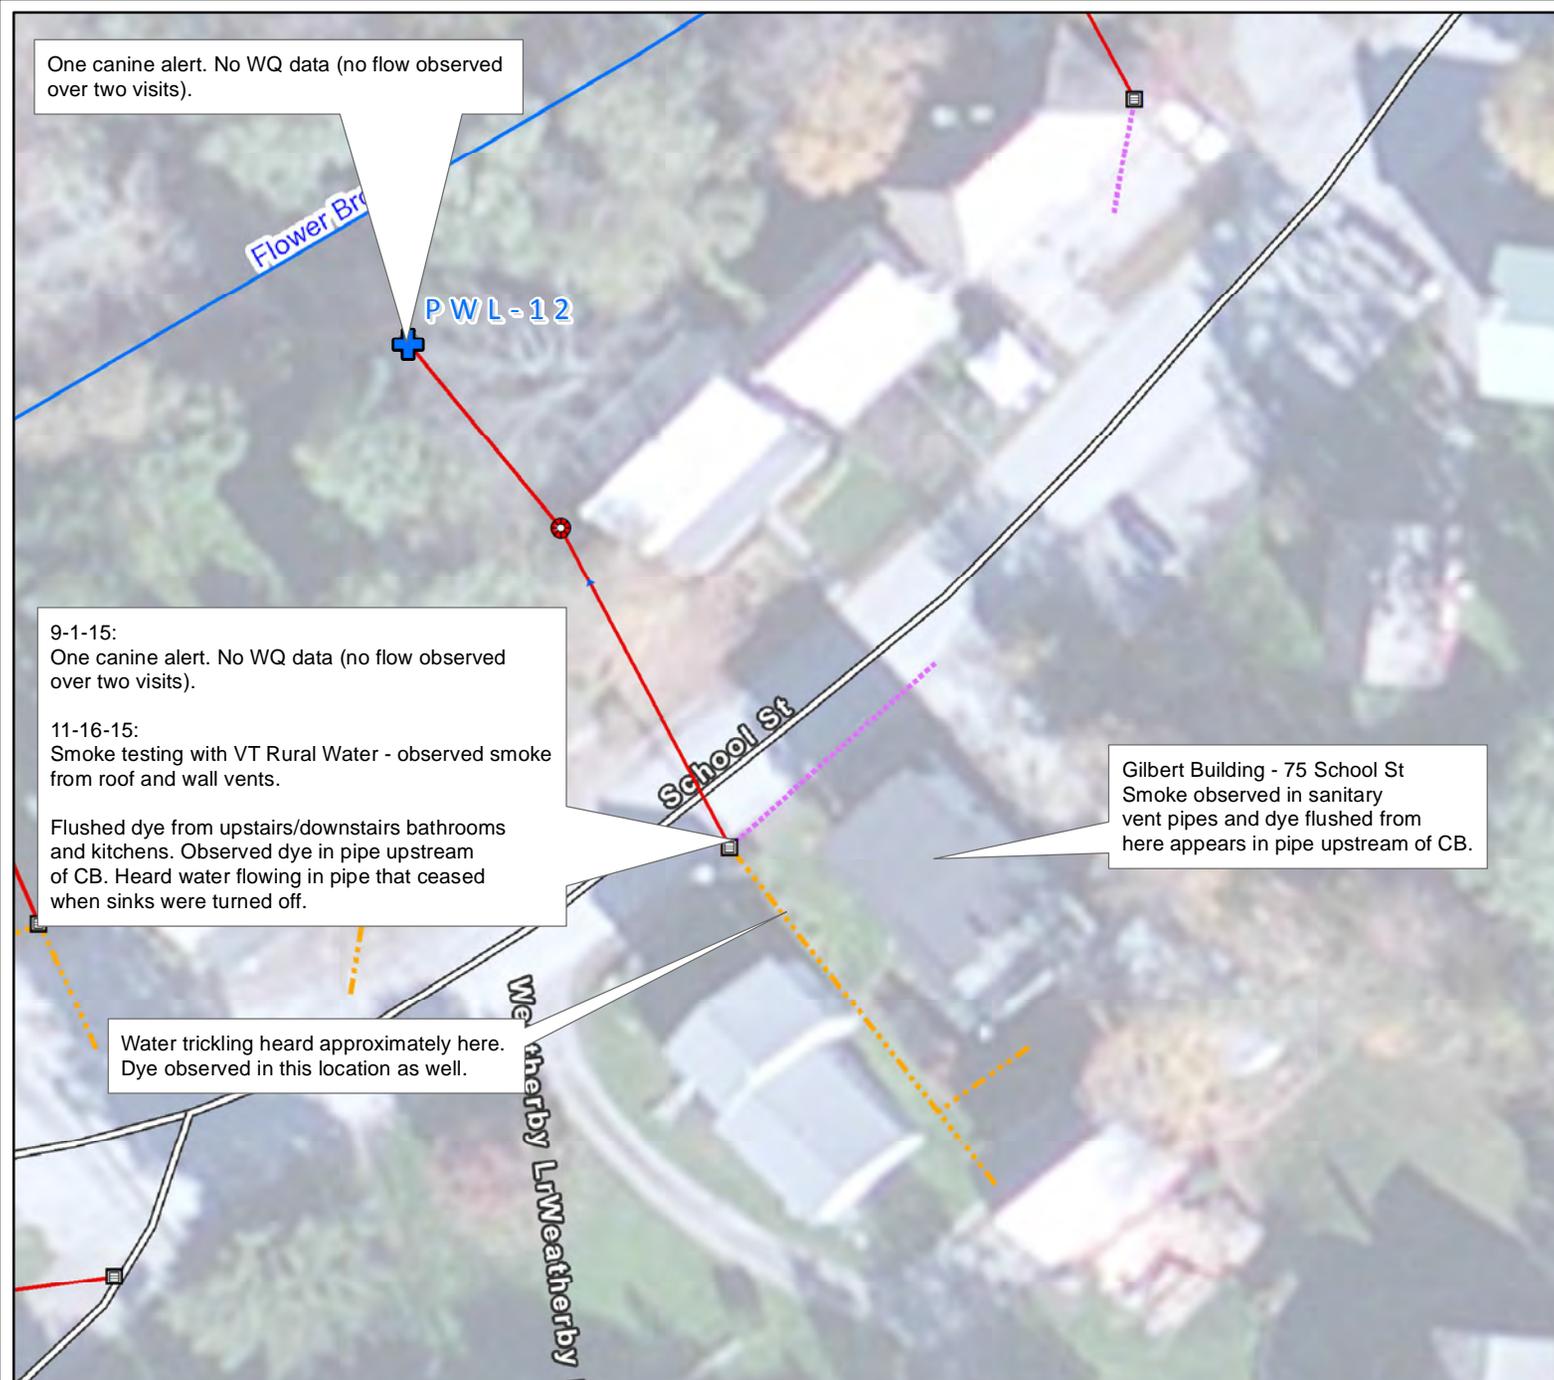
One canine alert. No WQ data (no flow observed over two visits).

11-16-15:
Smoke testing with VT Rural Water - observed smoke from roof and wall vents.

Flushed dye from upstairs/downstairs bathrooms and kitchens. Observed dye in pipe upstream of CB. Heard water flowing in pipe that ceased when sinks were turned off.

Gilbert Building - 75 School St
Smoke observed in sanitary vent pipes and dye flushed from here appears in pipe upstream of CB.

Flow not observed at this outfall on initial visit (7-9-15). Pipe mostly sediment clogged.
Working with canines on 9-1-15 (no flow observed on that date), one canine alerted on both outfall and upstream CB.

11-16-15:
Observed smoke and flushed dye later seen in pipe upstream of CB from Gilbert building. Confirmed illicit discharge.

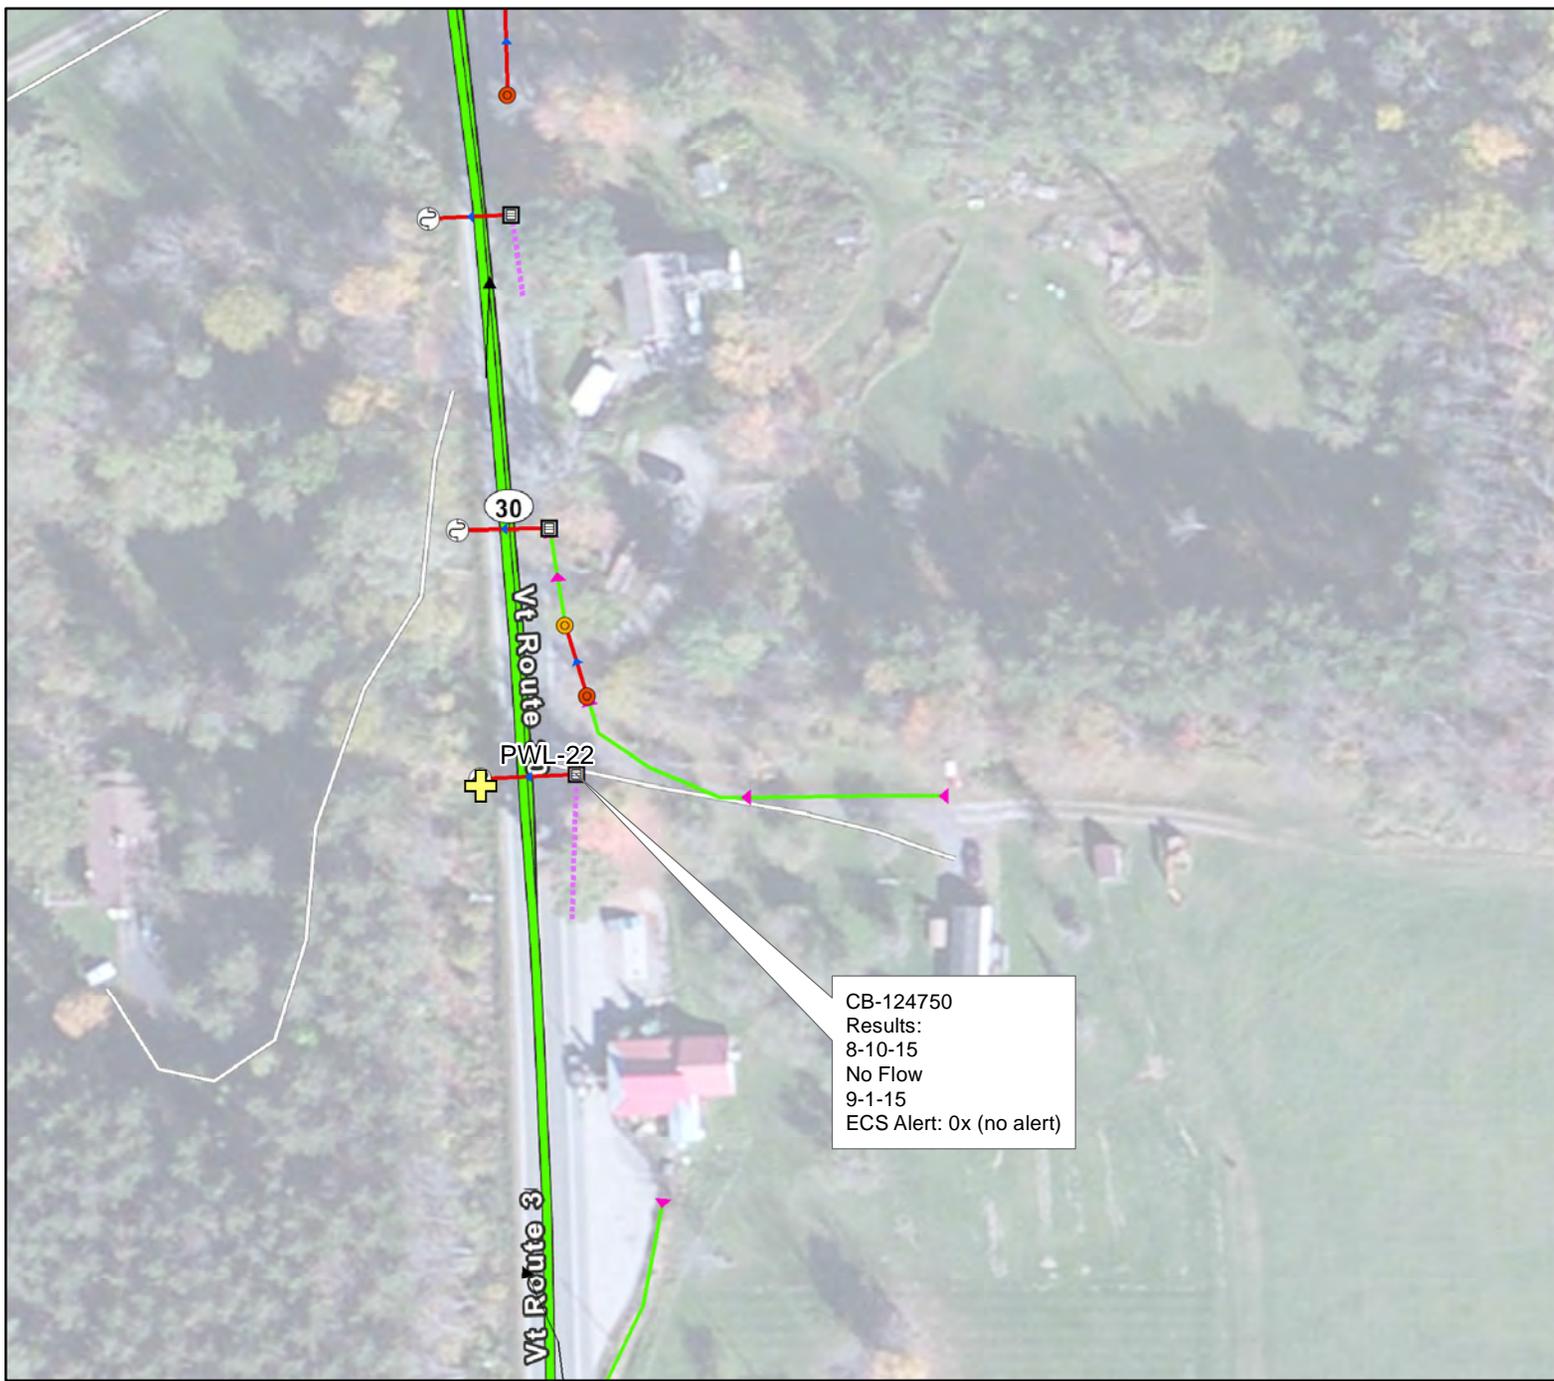
Pawlet IDDE
 Outfall Code: PWL-22

Results:
 7-9-15
 pH: 8.56
 Conductivity (uS/cm): 525
 Temperature (C): 18.1
 Ammonia (mg/L): 0.71
 E. coli (MPN/100ml): Not Tested
 Detergents (MBAS, ppm): 0
 Chlorine (mg/L): N/A
 Potassium (ppm): 2
 ECS Alert: N/A

Trickle flow observed on 6-16-15. No flow observed on follow-up visit on 8-10-15. Canines did not alert on 9-1-15. Do not suspect illicit discharge.

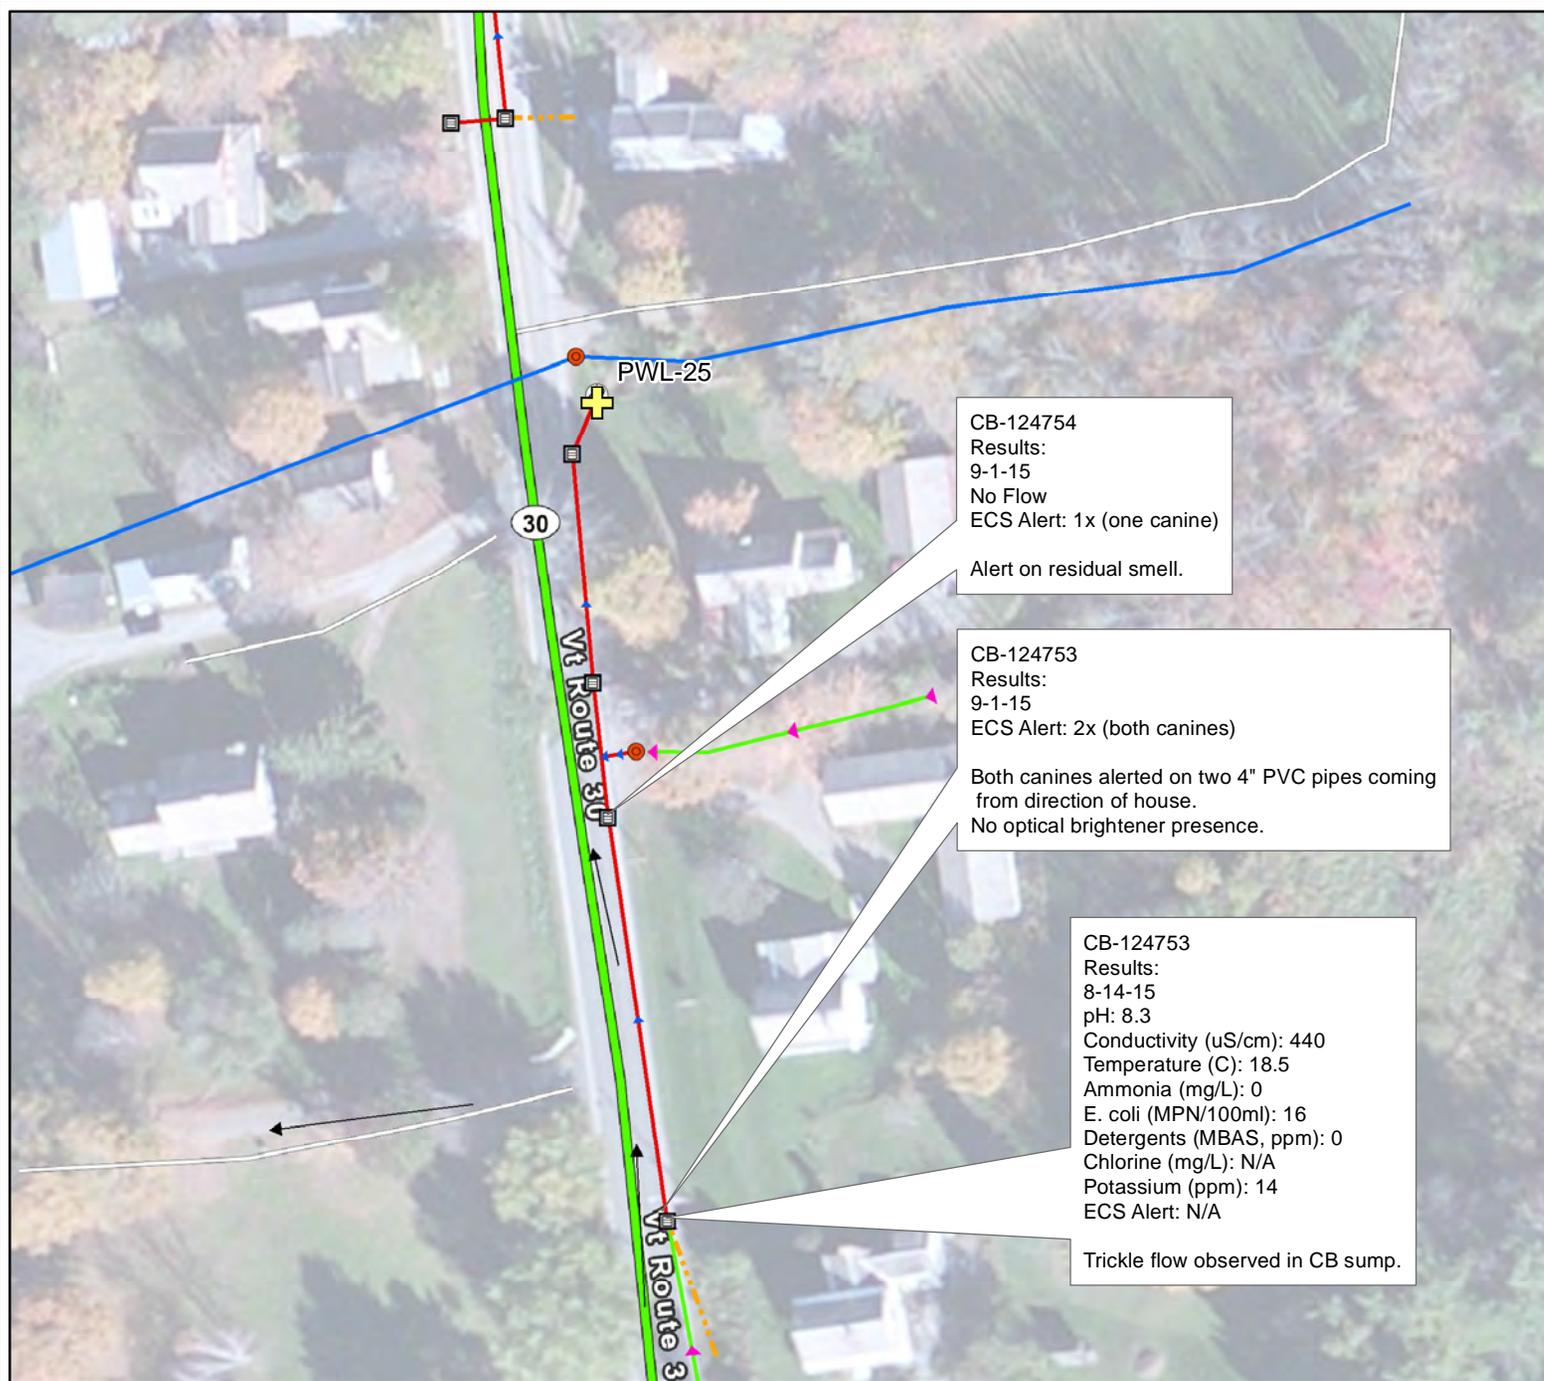
Pawlet IDDE
Outfall Code: PWL-25

Results:
7-9-15
pH: 8.54
Conductivity (uS/cm): 443
Temperature (C): 16.3
Ammonia (mg/L): 0.60
E. coli (MPN/100ml): Not Tested
Detergents (MBAS, ppm): 0
Chlorine (mg/L): N/A
Potassium (ppm): 2
ECS Alert: N/A

Trickle flow observed on 7-9-15.
Unable to smoke test (pipes too small).
Optical Brighteners - No Presence.
Do not suspect chronic illicit discharge.
