Mill River River Corridor Management Plan Rutland County, Vermont

FINAL REPORT

FEBRUARY 17, 2009

Round River Design
Michael Blazewicz
www.RoundRiverDesign.com

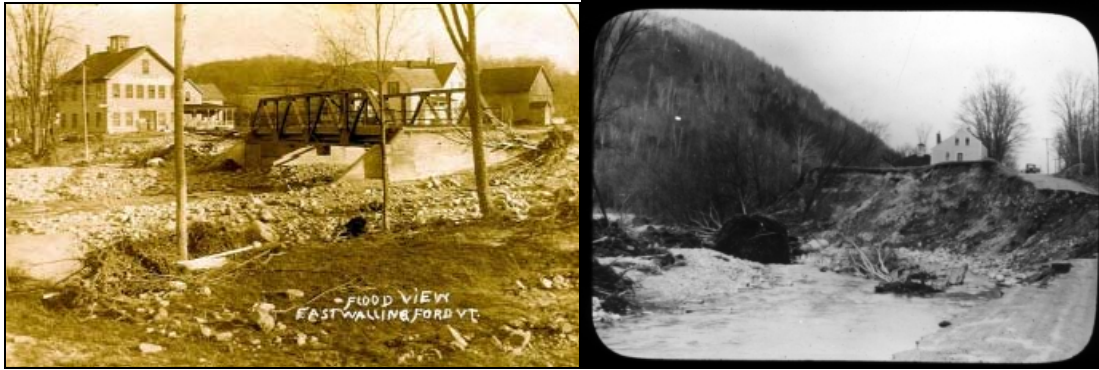
Figure 6: These images show damage from the 1927 flood. Left image is looking towards the intersection of Route 140 and Route 155 (Reach M10) in East Wallingford. Right image is of route 103 washout in Cuttingsville near reach M06/M07.

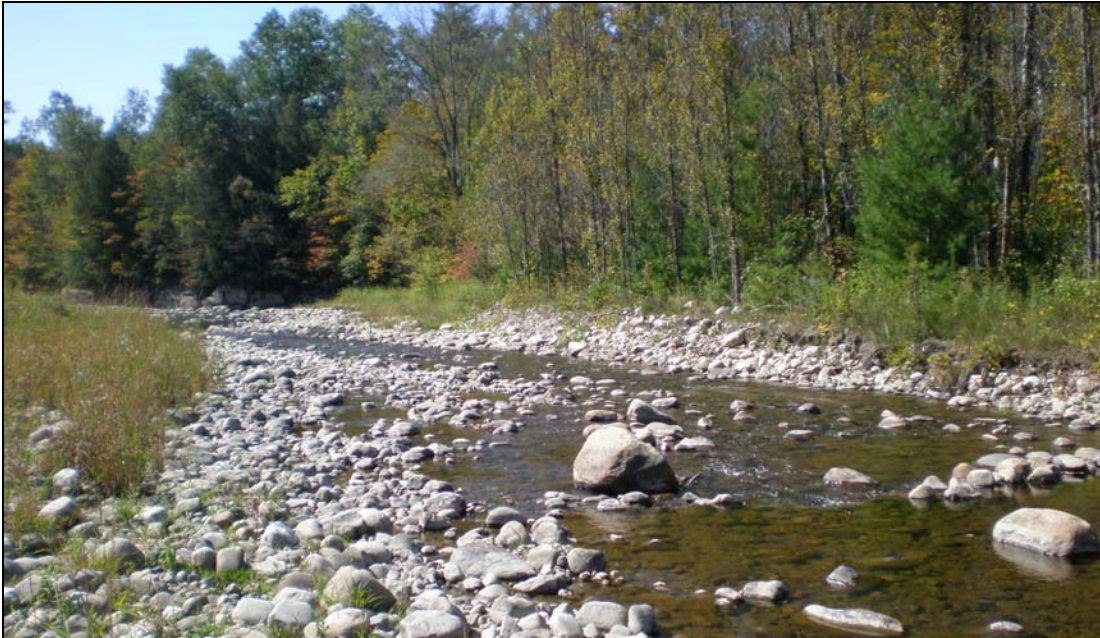
Shading from the riparian corridor varied between very good to poor with much of the stream lacking adequate buffer or simply being over-wide (high width/depth ratio) and therefore being susceptible to thermal pollution (see Figure 9). Many reaches, especially near the villages had major intrusion into their river corridor from roads and many had inadequate riparian buffers due to historic and /or recent land clearing. In addition, where roads and railroads border the stream, vegetation tends to be disturbed and not as robust as if the stream were meeting an unaltered floodplain. The benefits of wider riparian corridors are numerous. From a wildlife perspective, riparian buffers offer corridors for habitat and migration, while large woody debris provides habitat pools for aquatic life (Magillan et al., 2008). From a geomorphic perspective, forested riparian buffers improve bank stability and help control erosion (McBride et al., 2008). Also, large woody debris in streams helps maintain natural flow by providing high flow mitigation and acting as sediment traps. Finally, from a water quality perspective, riparian buffers help control nutrient cycles and shading helps control water temperatures needed to sustain healthy ecosystems.

Figure 9: Despite a well forested riparian buffer, over-wide reaches such as M03-A may suffer from thermal pollution due to lack of shading.

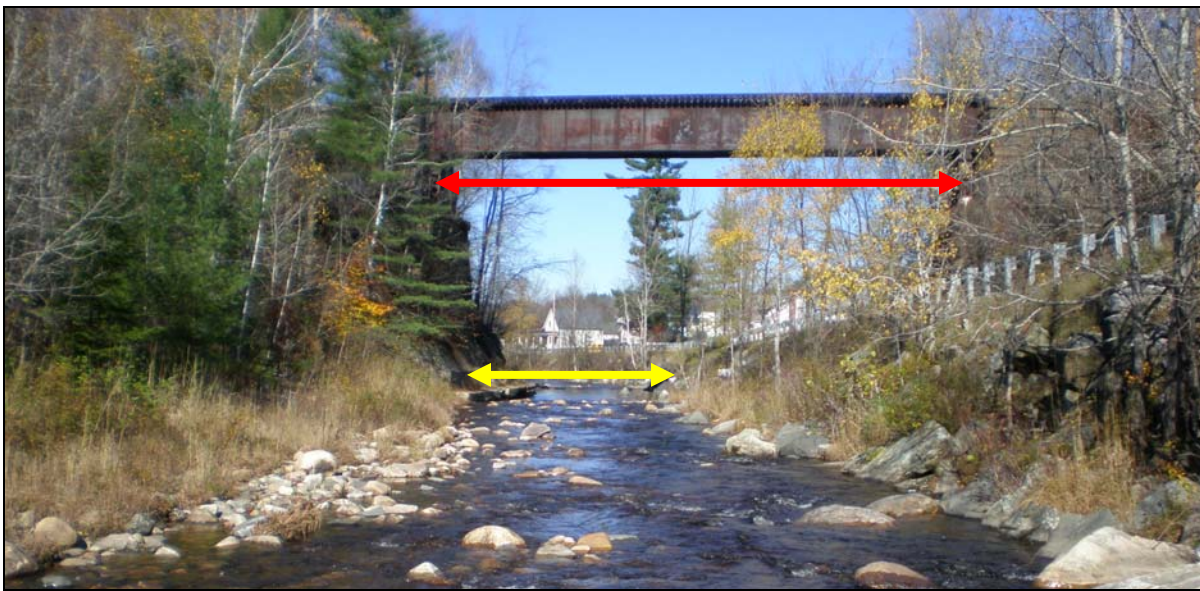
During the Phase 2 Assessment a number of bridge and culverts were observed to be considerably narrower than the existing bankfull width subsequently causing instability in the river (Table 2). Narrow crossings reduce sediment transport capacity and disconnect floodplains from the river channel. In particular need of replacement based on the problems observed and their percent bankfull width are the Route 155 Bridge in East Wallingford and the Barlow Road Bridge in Mount Holly. Also the two structures located on T2.01 were found to be undersized. From a technical measurement (from footing to footing) the railroad bridge on M11-A does not appear to be a problem, however, the channel width of the river from bridge abutment to the Route 155 embankment was only 39 feet (70% reference channel width) and should also be considered a problem structure (Figure 11).

Figure 11: The railroad bridge span on M11-A is adequate for the Mill River (red line), however, location of Route 155 in relation to the bridge and the river creates a channel constriction between the bridge abutment and the road (yellow line).

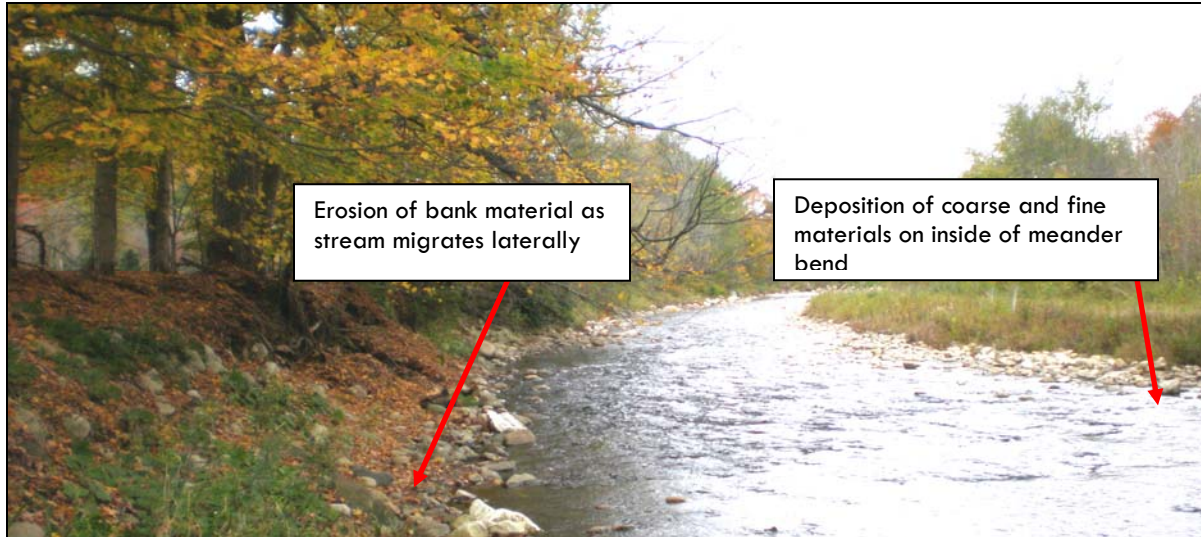
Figure 14: Planform migration associated with historic channel straightening of the Mill River.

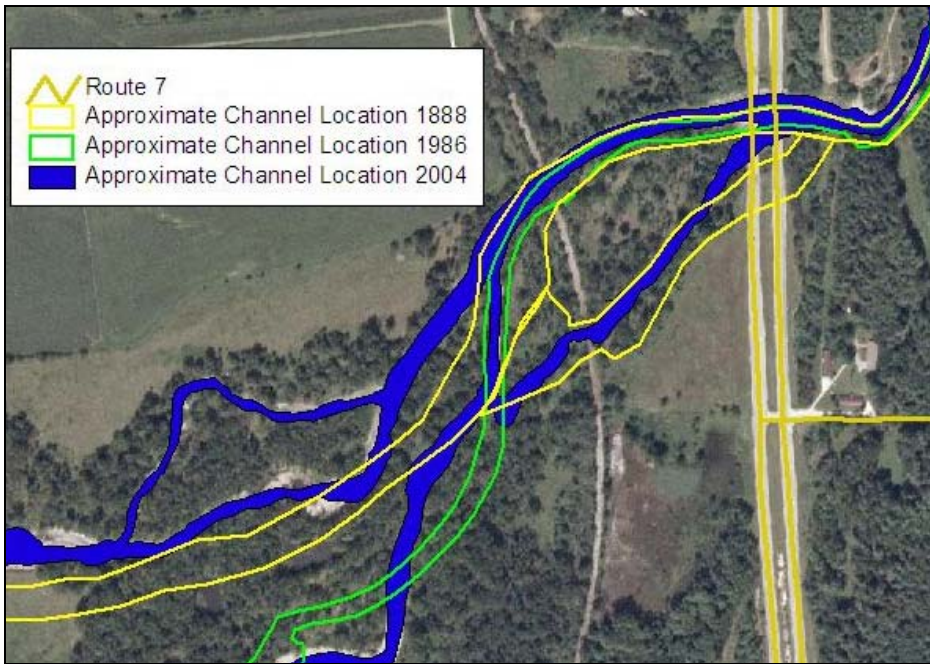
Figure 18: Meander patterns in the lower Mill River in Clarendon.

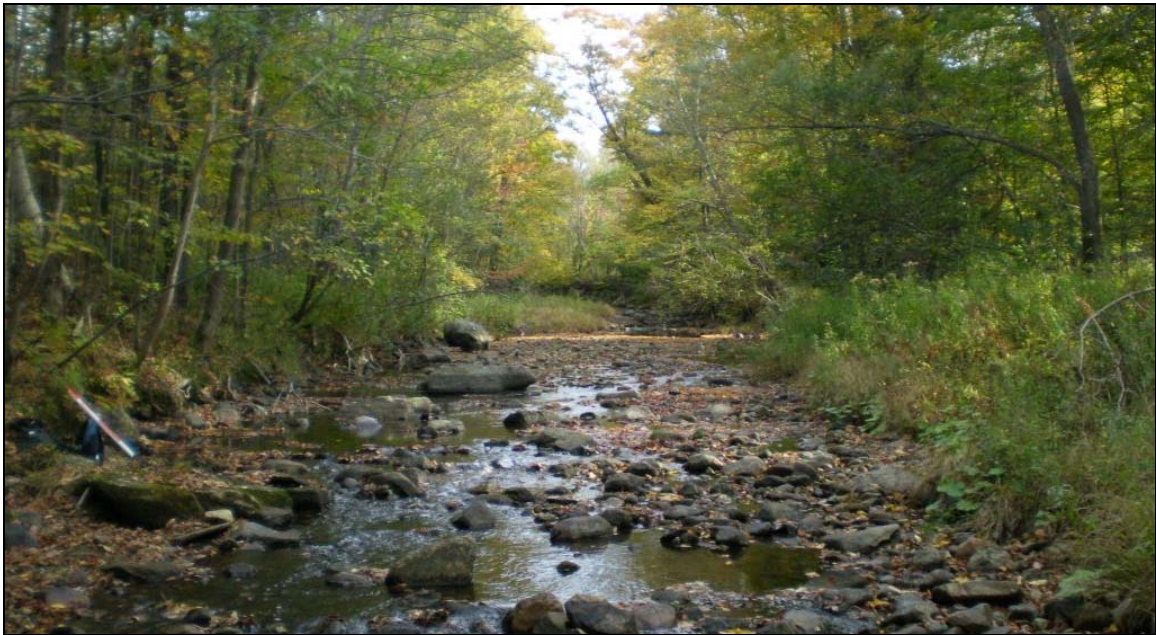
Figure 2. Reach M15 has been historically straightened. It is an incised channel with a planebed form that is currently undergoing minor channel widening and planform adjustment.

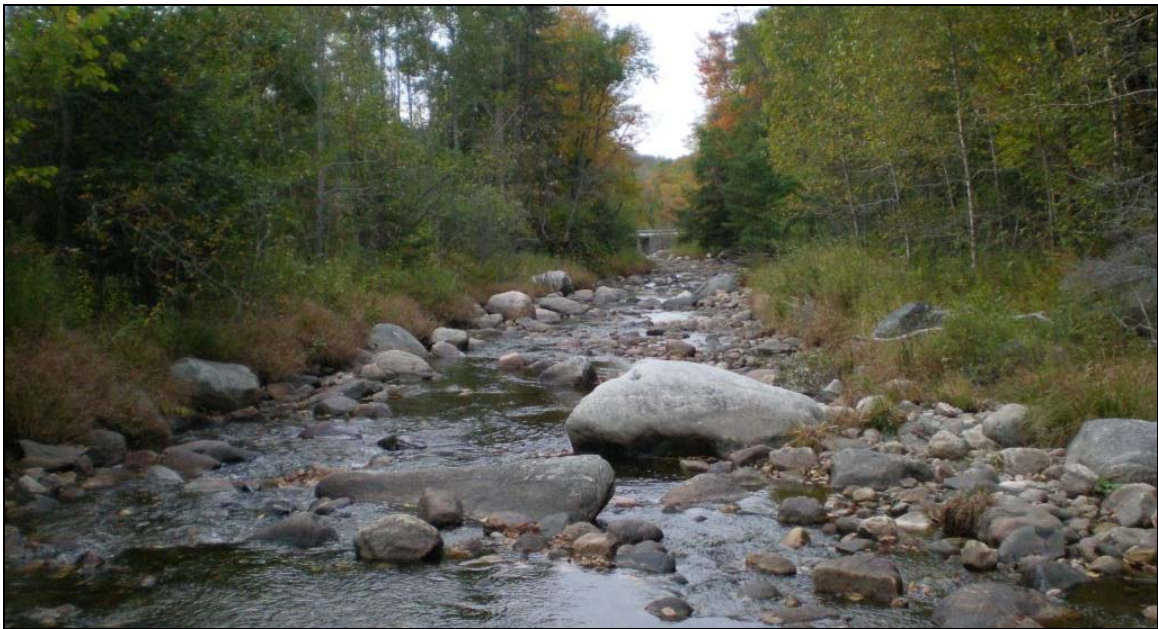
Figure 3. M14 has been historically straightened and is now has a plane bed form. Widening and planform adjustment are actively occurring.

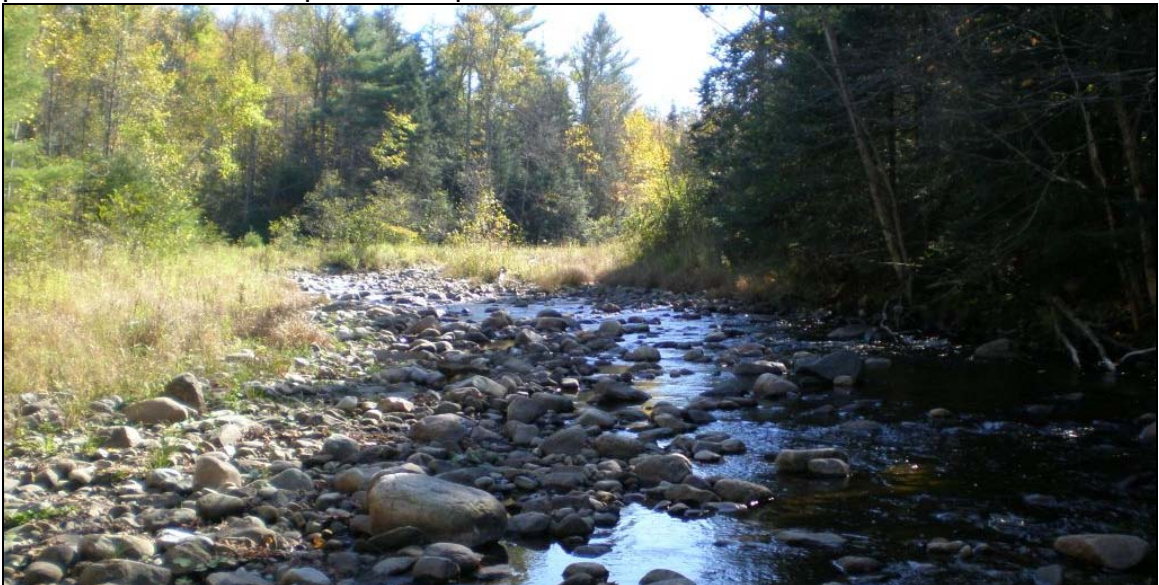
Figure 6. M12 has incised historically. Major planform adjustment, widening, and minor aggradation were observed.

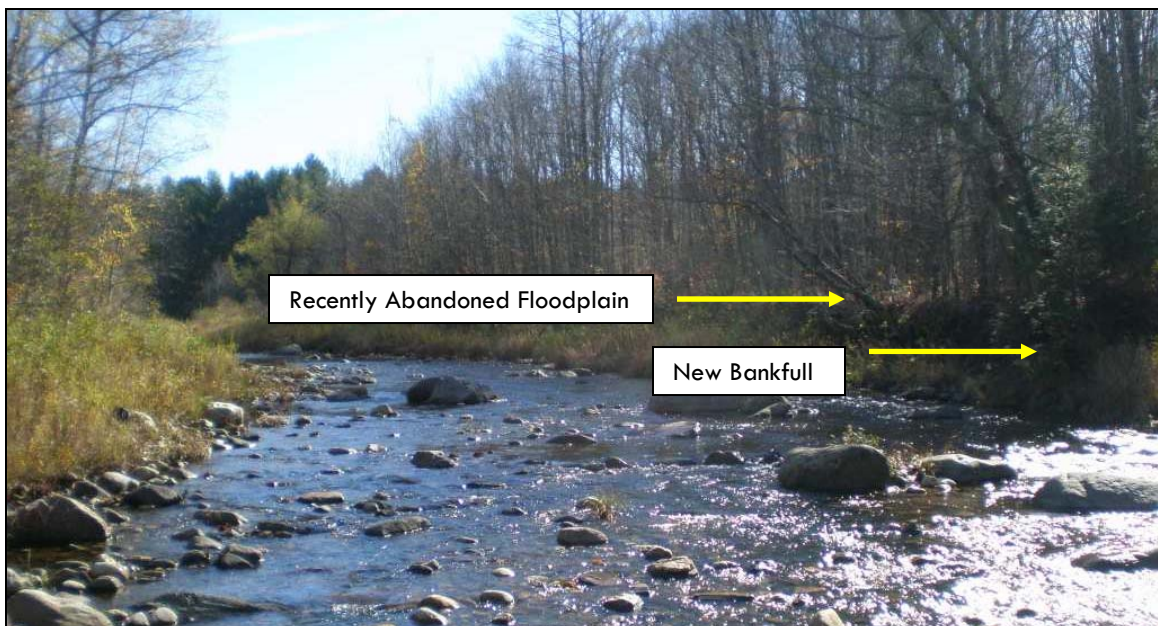
Figure 7. M11-B has been historically straightened. Currently undergoing major planform, widening, and aggradation adjustments.

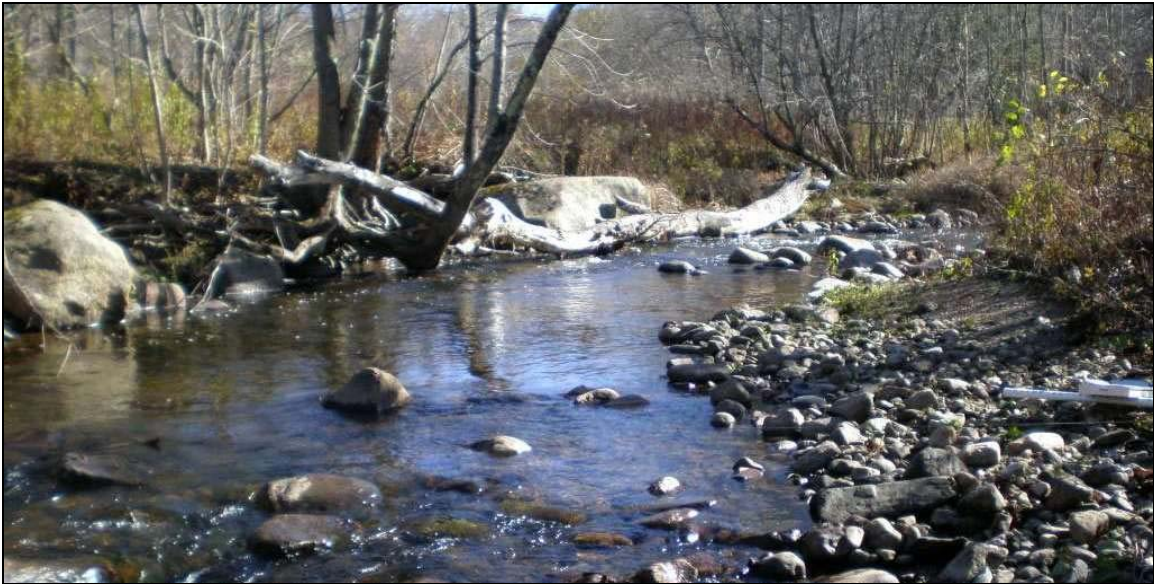
Figure 9. T2.01-B has historically incised, however is undergoing major planform adjustment as a new floodplain bench is developed.

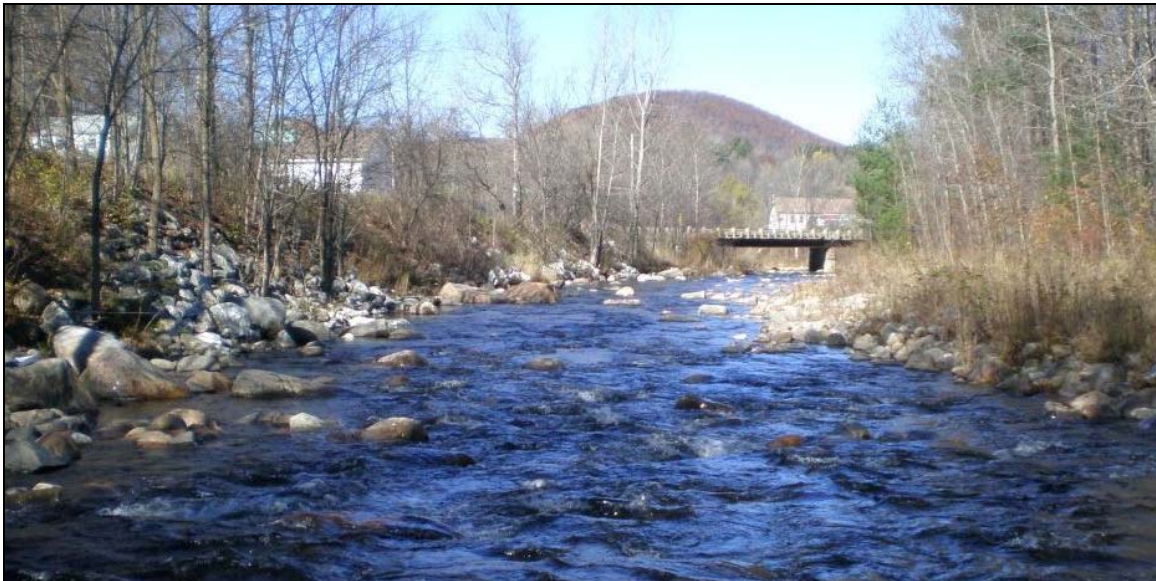
Figure 12. M10 has been historically straightened. There is a high degree of bank armoring within the reach.

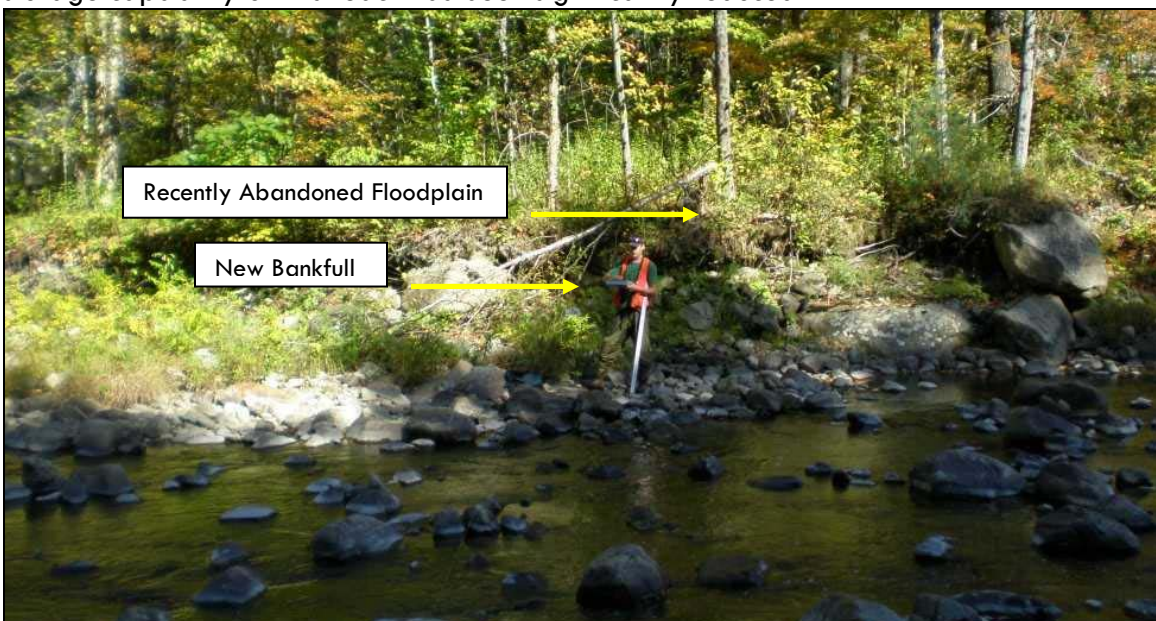
Figure 14. M08 is a short reach that has limited floodplain access due to streambed degradation.

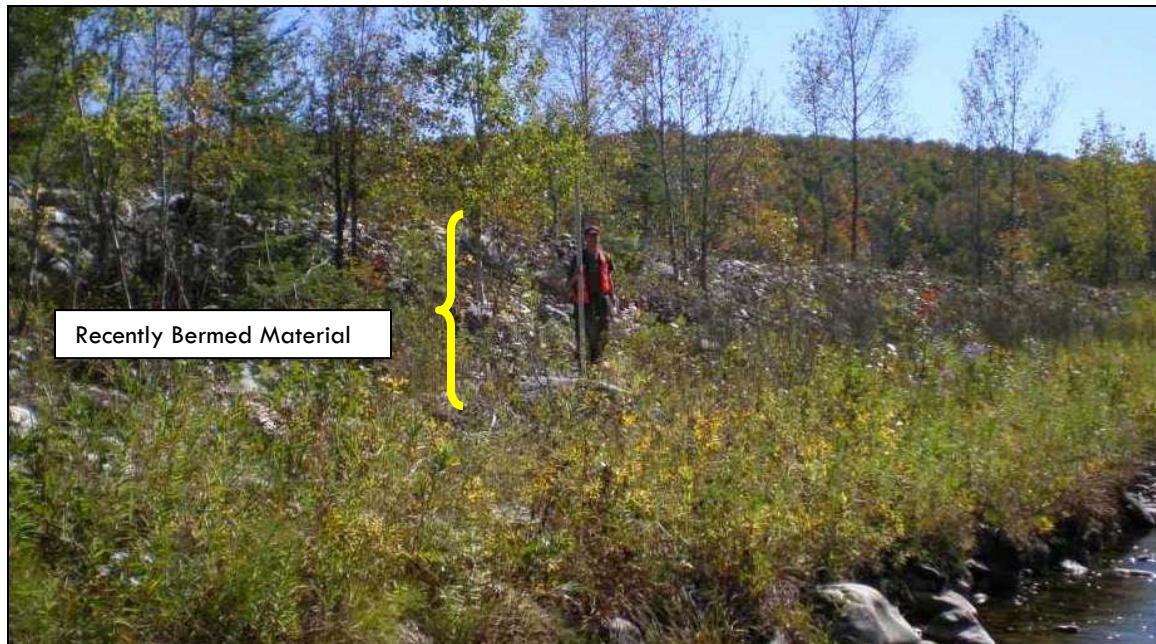
Figure 15. M07 has seen significant berming on the right bank causing a significant loss of floodplain access.

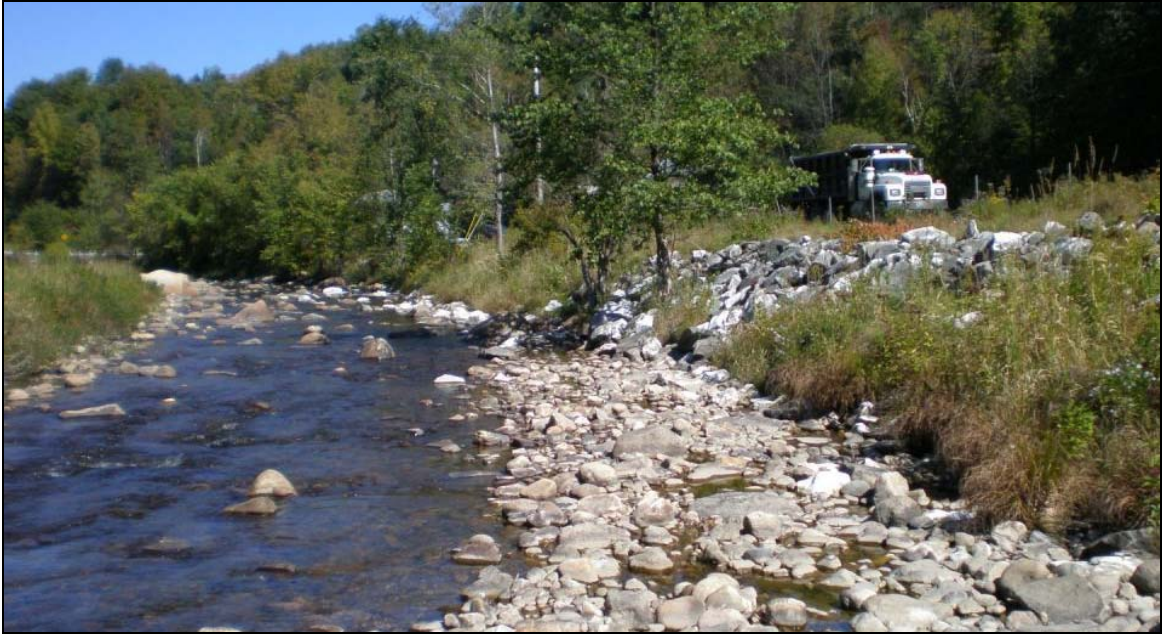
Figure 16. M06 flows through Cuttingsville and has been significantly impacted by channel straightening, armoring, berming, and floodplain development.

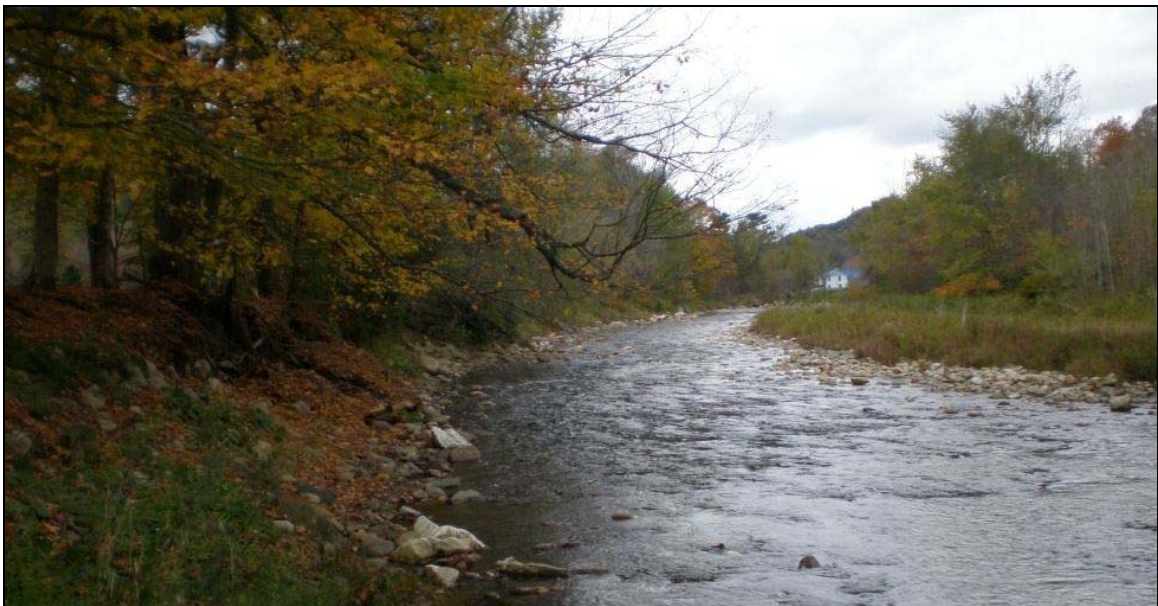
Figure 18. M05-B has been significantly altered through channel straightening, berming, armoring, and floodplain encroachment.

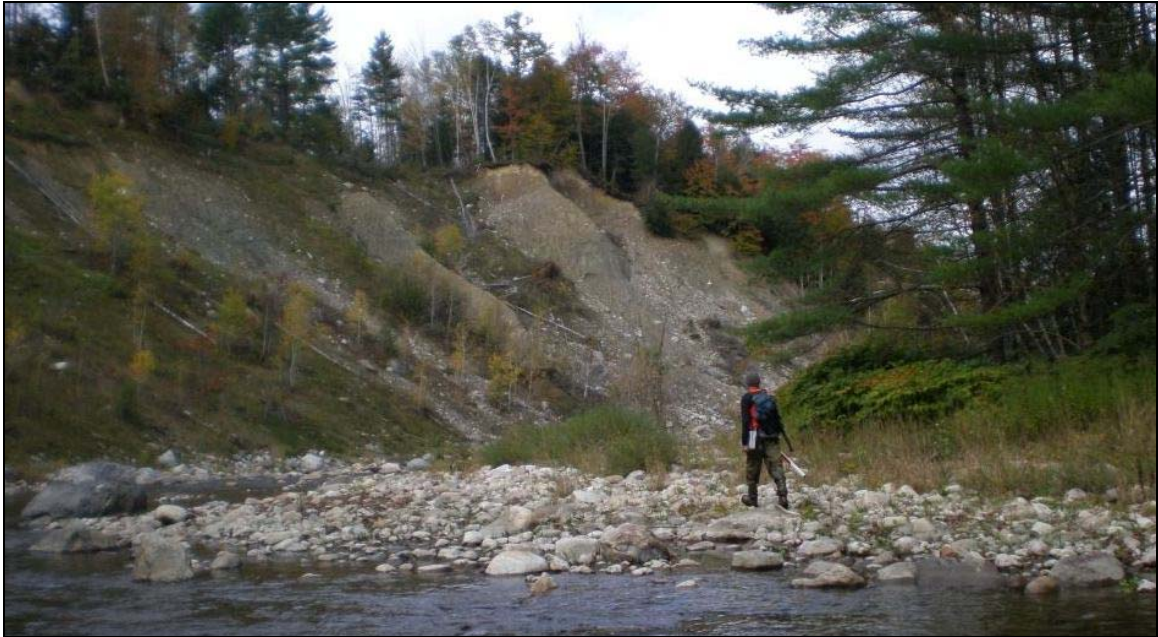
Figure 19. A large mass failure on the left bank is providing some sediment recruitment to help rebuild bars in the incised Mill River reach M05-A.

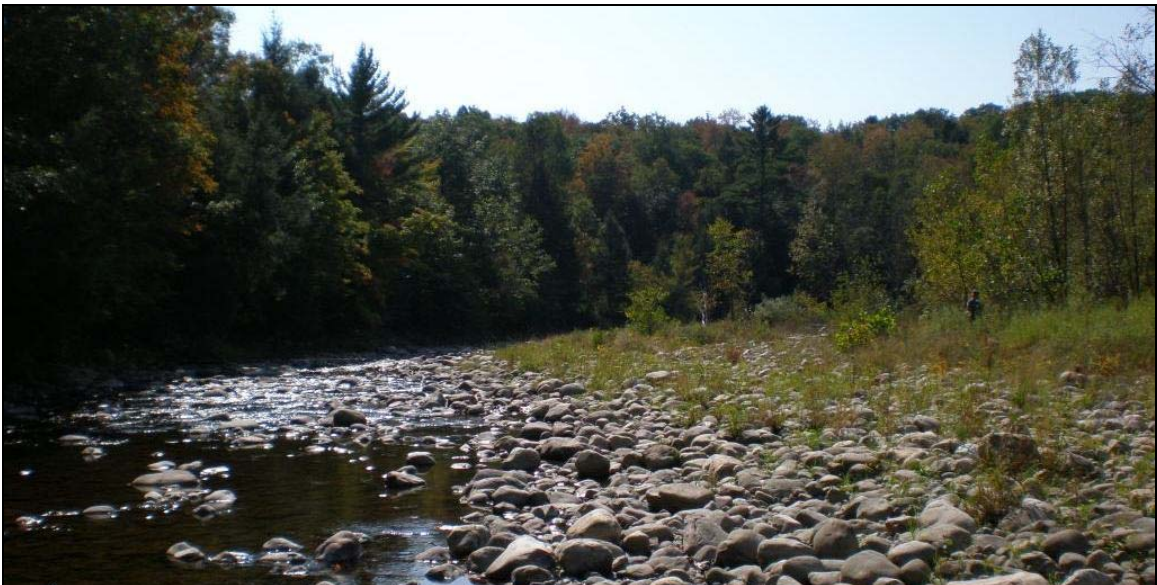
Figure 22. M03-A is bordered by a forested buffer. Large bars of unvegetated sediment indicate recent adjustments in the channel.

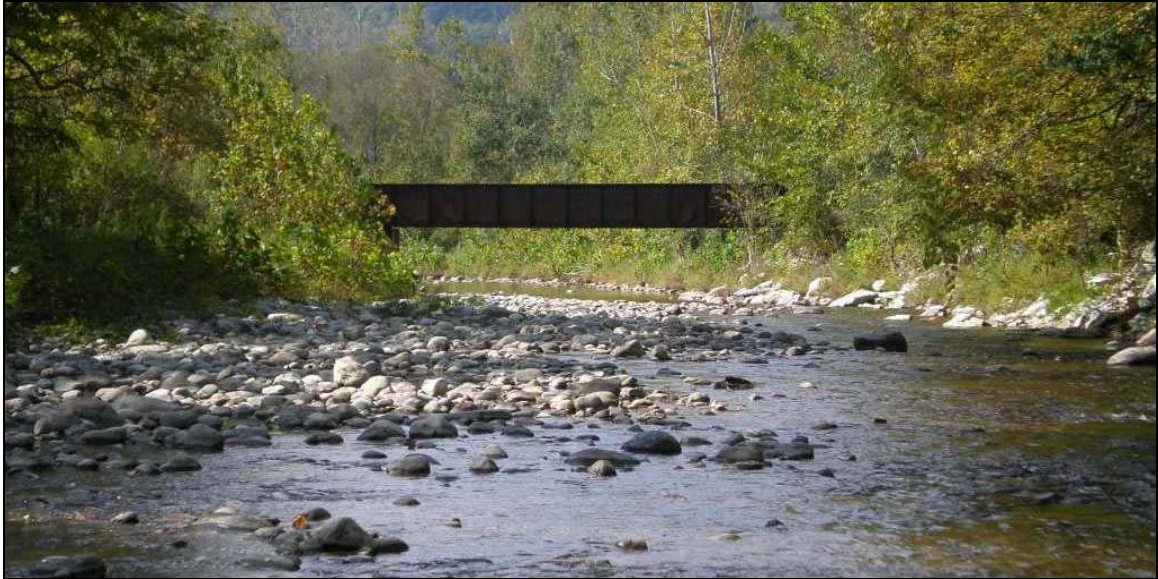
Figure 24. M01-B has been significantly impacted by channel straightening, berming, dredging, and armoring.

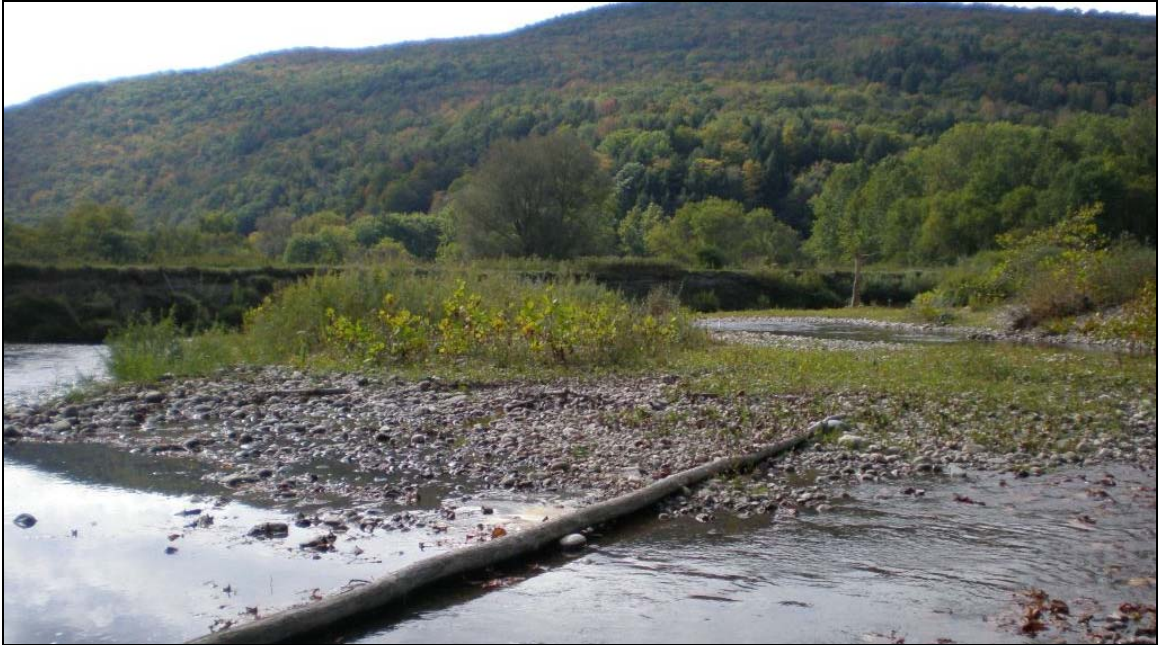
Figure 25. M01-A is a gravel dominated reach near the confluence with the Otter Creek. Agricultural land use dominates the corridor. The river is undergoing extreme planform adjustment and major widening and aggradation.

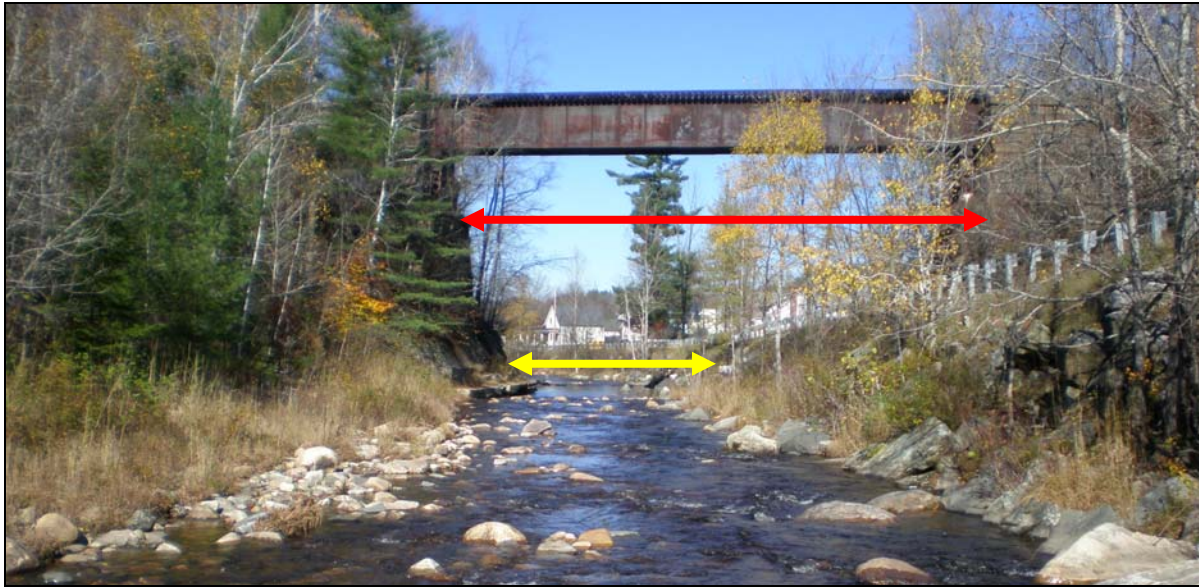
Figure 1: The railroad bridge span on M11-A is adequate for the Mill River (red line), however, location of Route 155 in relation to the bridge and the river creates a channel constriction between the bridge abutment and the road (yellow line).
