# Lower Passumpsic River Tributaries River Corridor Plan

May 1, 2014

Fitzgerald Environmental Associates, LLC.  
18 Severance Green, Suite 203  
Colchester, VT 05446

Caledonia Country Natural  
Resources Conservation District  
481 Summer Street, Suite 202  
St. Johnsbury, VT 05819

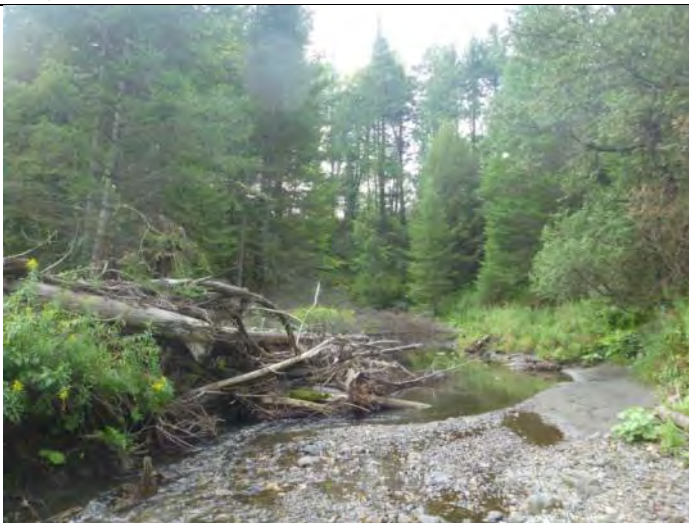
**Reach Highlights:** Channel was historically manipulated along the edge of the agricultural field and was likely incised. Recent episodic floods led to channel widening and deposition throughout the reach. Large volumes of sand and gravel are working through the reach from upstream mass failures. Meadow/hay field along the left bank was accessed during recent flooding. VHD centerline is off for approximately 400' mid-reach as the stream flows through a forested stretch with B-type geometry. A large gully from an intermittent stream was observed on the right valley wall, mid-reach.

Debris jam, bar formation, and mass failure in middle of reach

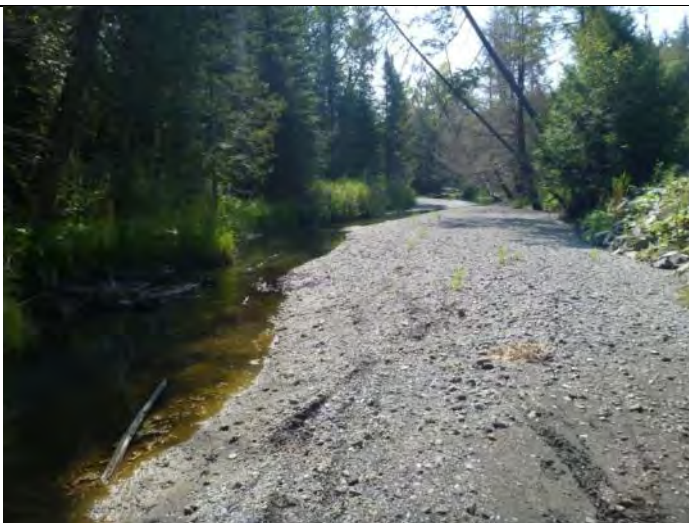
**Reach Highlights:** Widening and aggradation following a recent episodic flooding event are the dominant processes in this segment. Bank scour along lower banks (not FIT'd as erosion) and some bank failures were observed throughout the reach except for areas of heavy bank armoring along the road. Most scoured bank areas are stable due to natural rock deposition and/or dense root mats. Large unvegetated depositional features were observed throughout reach. Valuable floodplain storage is accessible mid-segment as the stream flows over Water Andric Rd (~1' above BKF). Debris jams and large sediment load is causing some channel migration and possible future bank erosion in the lower segment.

Major gravel deposition filling most of widened channel

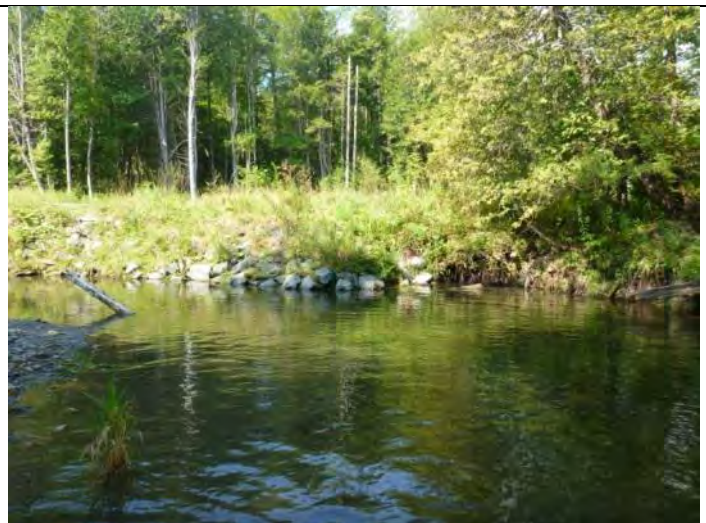
Failing armor along Water Andric Rd

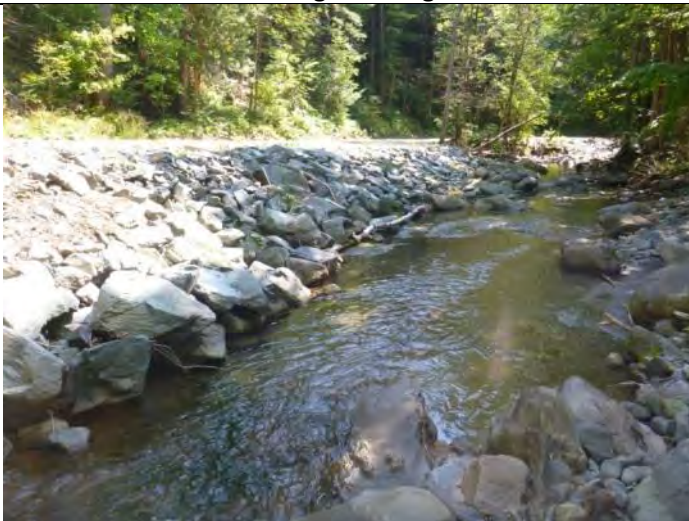
**Reach Highlights:** The segment incised during recent episodic flooding events due to roadway encroachment and tight valley walls limiting lateral mobility. Large deposits of cobbles and gravel from these recent events buried much of the channel. Steep riffles were observed in locations where the channel is cutting down through these deposits. Vertical banks and inaccessible floodplains were observed throughout the reach. Incision was limited by several ledge grade controls leading to localized widening and mass failures. Debris jams continue to store large amounts of gravel and sand as it works through the segment.

Encroachment and armoring along Water Andric Rd

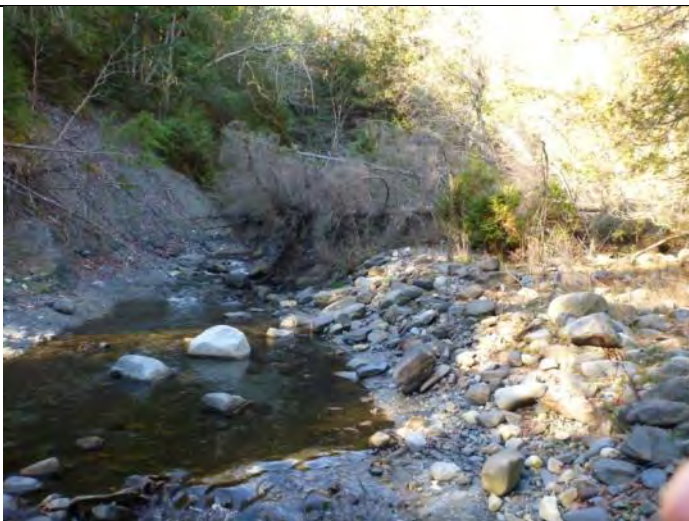
**Reach Highlights:** The channel appears to have incised during recent episodic flooding. Dense bank vegetation likely limited erosion and severe widening. Major sediment inputs from mass failures upstream and within the reach led to large depositional features and fine sediments working through the reach. Steep riffles were observed in locations where the channel is cutting down through these deposits. The reach appears to be transitioning from stage II to III CEM.

Major cobble deposition along channel margin leading to incision and likely exacerbating mass failure on bends

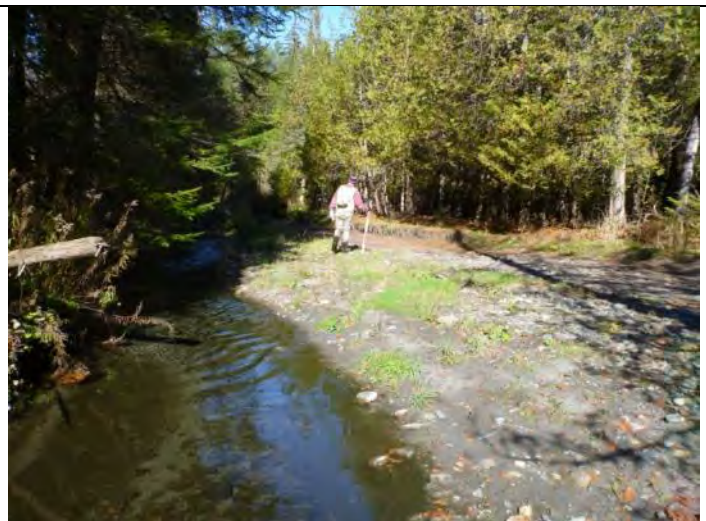
VAST trail very close to channel - potential for major avulsion

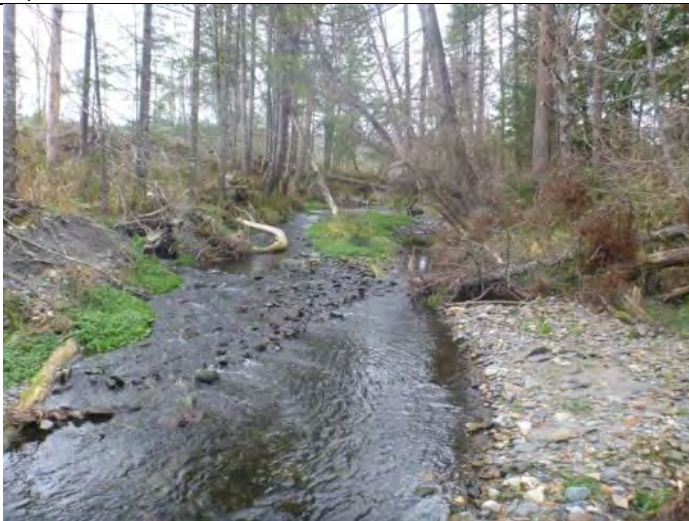
**Reach Highlights:** Aggradation and widening are the dominant processes in this segment. A huge cobble and gravel alluvial fan was observed at the top of the segment and appears to be recently deposited during episodic flooding. Large mid channel bars and diagonal bars were observed throughout the reach. Moderate lower bank scour was observed as the lower channel widened as a result of deposition. Stage III of CEM was chosen due to moderate channel incision and beginning signs of aggradation, with moderate channel widening likely in the near future. The right floodplain was recently logged for most of the reach, no major impacts to stream were observed.

Typical widened channel geometry with scoured banks, elevated but accessible floodplain and deposition

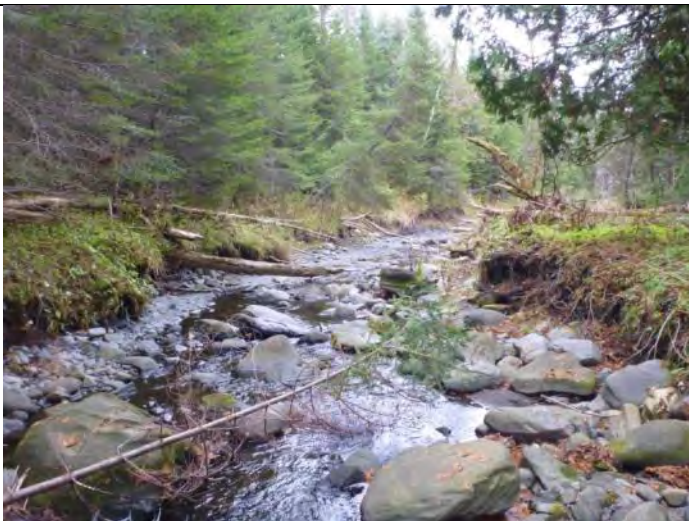
**Reach Highlights:** Lower banks were scoured during recent episodic floods and the channel appears to have recently incised, likely as a result of the 2011 floods. Deep entrenchment and incision is possibly due to the lack of grade control compared to other reaches on the stream. Step-pool sequences were replaced with eroded continuous riffles. Floodplains are inaccessible and banks on both sides are vertical and raw. Heavy silt/clay on scoured lower banks will likely slow the widening process and potentially increase degradation. Deposits of large cobbles and boulders are slowly filling in the channel margins.

Typical F type geometry with steep scoured banks to inaccessible floodplain

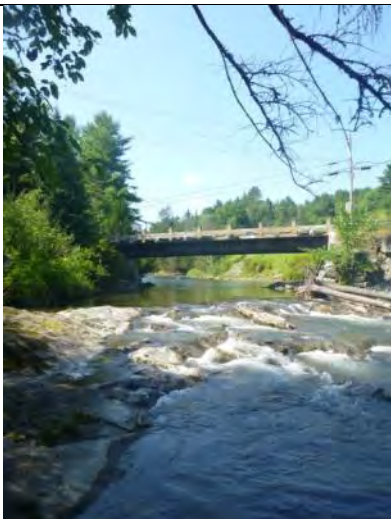
**Reach Highlights:** The reach is deeply incised and entrenched due to the continuous encroachment from Goss Hollow Rd. The road embankment is heavily armored and elevated well above high water access. The right valley wall is tight to the channel throughout. Recent episodic floods likely scoured away any bed features leaving a flat plane bed stream with gravel and cobble. We selected modified stream type from Bc to F based on major encroachment from the road limiting any future restoration to B geometry. Most of the LWD in the habitat tally was located along the channel margins and didn't not contribute to in-stream habitat at low flows.

Mid-reach looking upstream - stable rocky banks and the undersized TH-8 bridge in disrepair

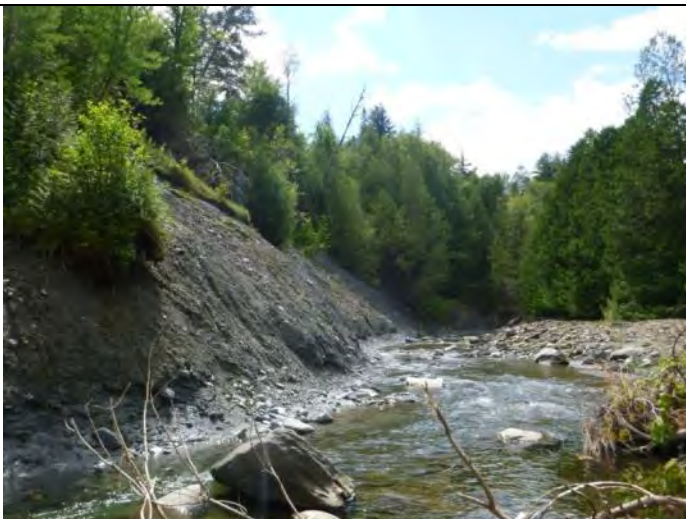
**Reach Highlights:** The dominant adjustment processes in this reach are widening and deposition. Large deposits of cobbles occupy half of the channel in numerous locations and the channel is widening to accommodate the large sediment load. Mass failures were observed on several bends as the stream attempts to widen on the right bank in a confined valley. Most of the mass failures were still active and had silt/clay material within the channel, likely contributing large volumes of fine sediment to the river. The left bank is armored along North Danville Rd for most of the reach. Two bed armoring sites were observed at pinch points where the stream was downcutting during the 2011 floods next to the road embankment.

Numerous large mass failures were observed along the right bank

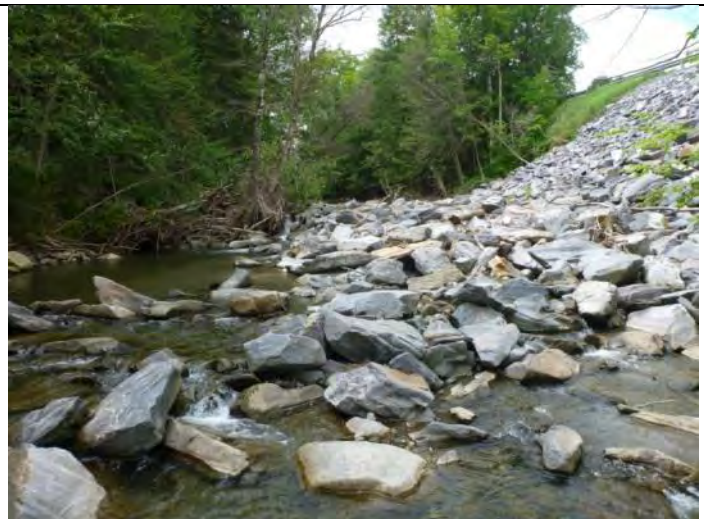
Two bed and bank armoring sites were observed at damage sites along North Danville Rd

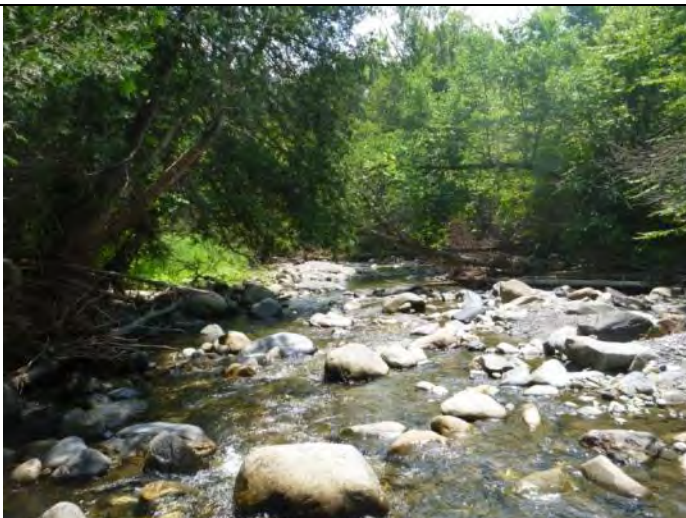
**Reach Highlights:** This reach is deeply incised and is beginning to widen to attempt to regain access to elevated floodplains or redevelop new terraces. A large abandoned USGS weir is located at upstream reach break and is holding back a huge volume of cobble and gravel. This has likely starved the channel of sediment and caused severe historic incision. Large deposits of cobble and gravel were observed on the margins throughout the reach and most bars were at or above bankfull. Sediment was likely transferred into reach in recent floods. The banks indicated heavy scour on both sides and we observed numerous mass failures.

Widened reach with significant deposition from recent flooding

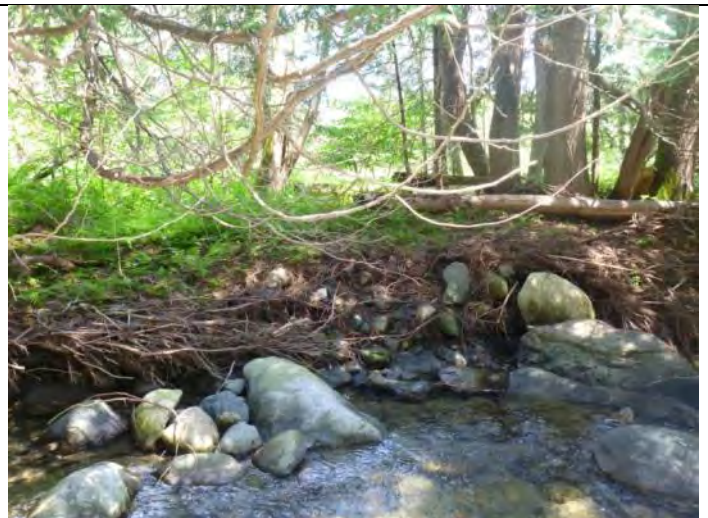
Bank scour observed through most of reach indicating recent widening

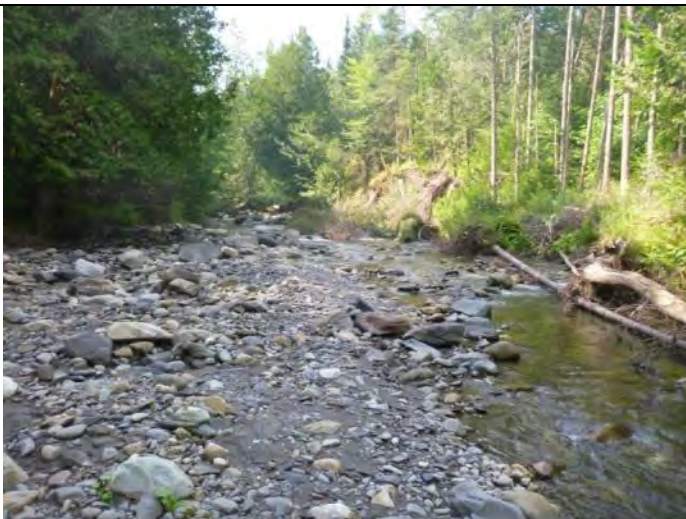
**Reach Highlights:** This reach widened during recent episodic flooding events as indicated by scoured banks and numerous mass failures. The high sediment load following these events has produced large stable cobble/boulder/gravel bars along the channel margins for the entire reach. The bars are at or above bank full and have re-established a fairly stable channel geometry with small flood benches. A forested floodplain is typically accessible on one bank at high flows.

Reach reestablishing floodplain benches in an overwidened channel

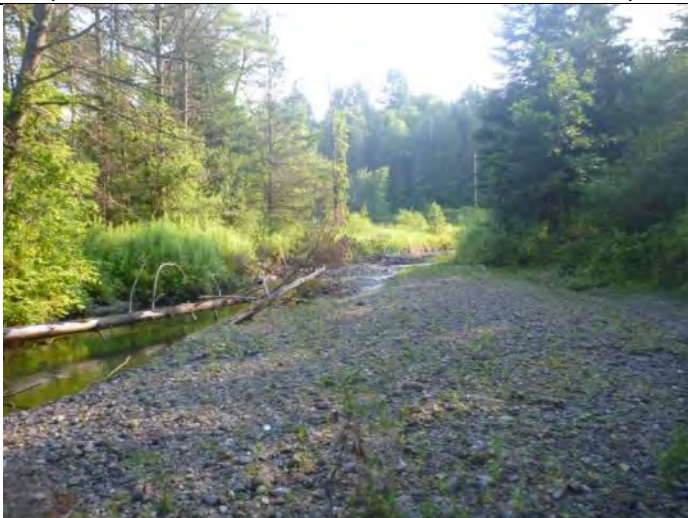
**Reach Highlights:** This segment widened during recent episodic flooding and huge volumes of sand and gravel were deposited along the channel margins and over the floodplain. An alluvial fan formed at the top of the segment where the channel exits the gorge and the channel slope quickly drops to below 1%. The shape and slope of the valley and the large number of flood chutes over the floodplain suggest that this is a historic alluvial fan area and that the channel likely historically migrated throughout the left floodplain. The construction of the elevated road bed for North Danville Rd and the location of the culvert against the right valley wall have caused the channel to become moderately incised and lose some access to the large left floodplain.

Gravel deposits below N Danville Rd culvert leading to Sleepers River T3.07

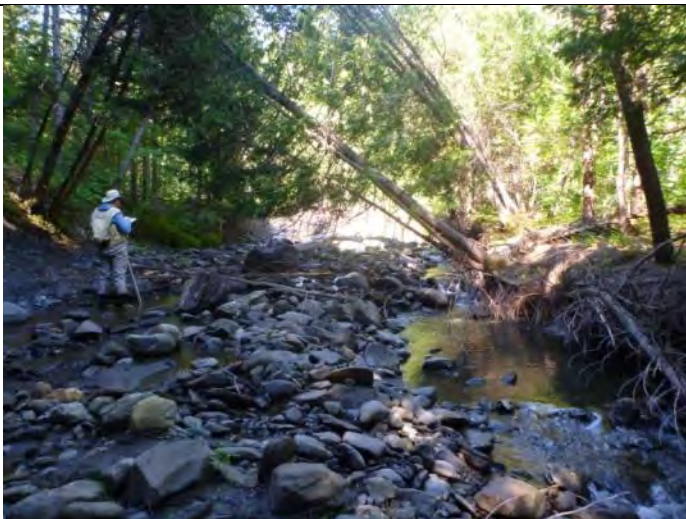
**Reach Highlights:** Lower banks appear to have been scoured back during recent episodic floods followed by major deposition of cobbles, gravel, and boulders throughout the reach. The reach is only moderately incised and has a very low W/D ratio due to large cobble deposits along the margins that typically fill over half of the channel. We selected degradation as the primary adjustment process due to the numerous steep riffles (caused by erosion cutting through aggraded material at channel nickpoints) we observed at the stream tries to re-establish riffle pool sequences through the deep cobble deposits. Channel will likely widen and redevelop planform in the future as flood related sediment works through the reach and downstream.

Deposits of cobble and boulders typically filled over half of the widened channel

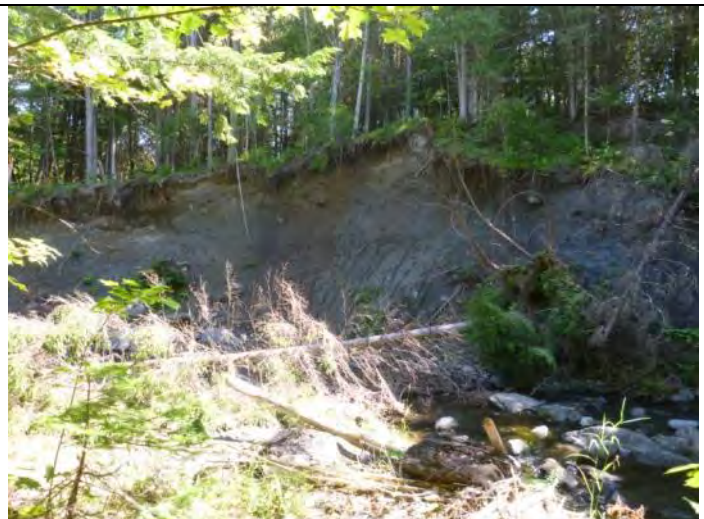
Numerous large mass failures were observed in the reach

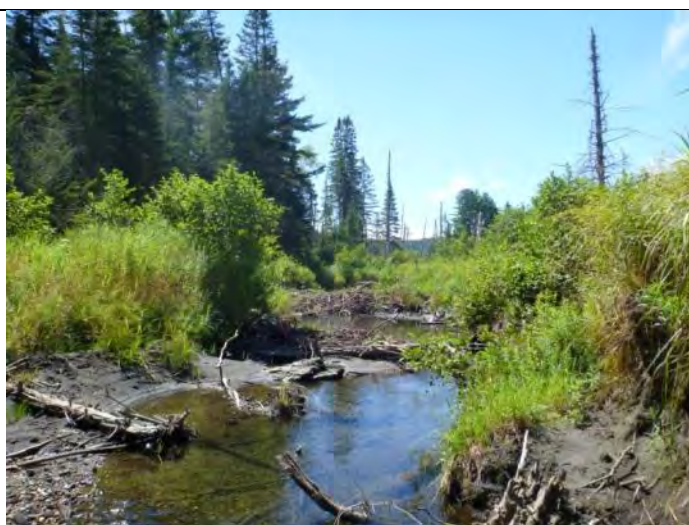
**Reach Highlights:** Reach is stable and has minor incision. Active beaver dams and lodges have removed all trees reducing rooting strength of banks. Some bank slumping and a few recent avulsions were observed. Beaver dams are trapping sediment through most of reach and limiting riffle formation. Based on review of historical imagery that shows agricultural fields in the corridor we assumed this reach was likely manipulated historically but maintained connection to the floodplain.

Typical channel geometry with a beaver dam

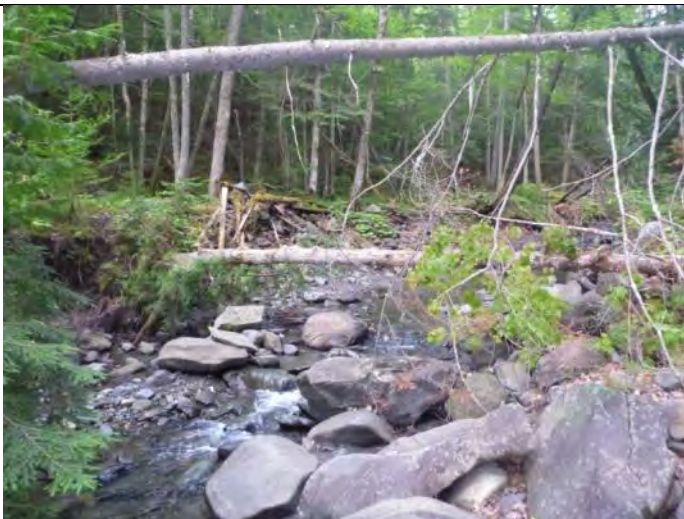
**Reach Highlights:** This reach widened during recent episodic flood events heavily scouring away lower banks. Major cobble and gravel deposits have since formed within the channel creating a low W/D, very high incision, and deep entrenchment. The stream appears to be cutting down through these deposits and further incising. These features are FIT'd as steep riffles and head cuts, but they are all due to degradation. Forested floodplain exists on one or both banks throughout the reach but is inaccessible. The incision could increase if the channel cuts deep enough to reduce access to the small floodplain areas over the cobble bars within the widened banks.

Channel degradation above the Trestle Rd culvert

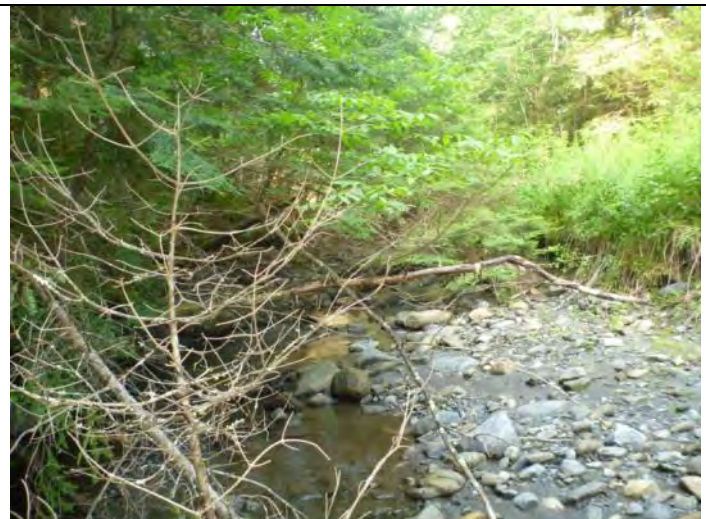
Typical channel cross-section, overwidened, side bars, elevated and inaccessible floodplain.

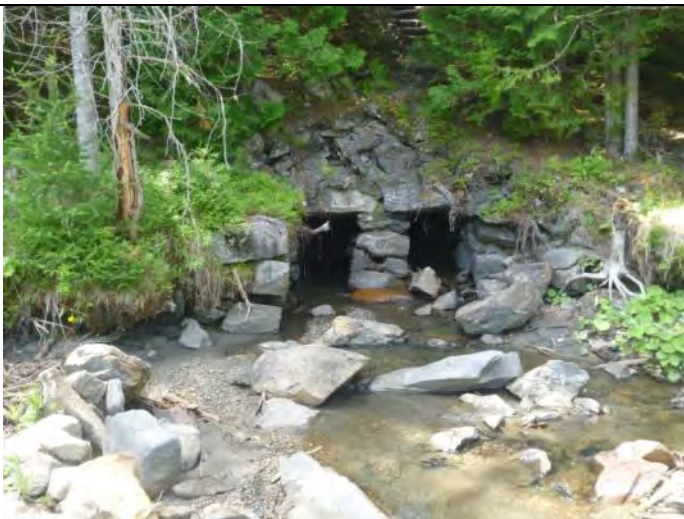
**Reach Highlights:** The channel adjustments in this segment are driven by the huge amount of sediment trapped behind the failing stone culvert beneath the VAST trail near the middle of the segment. Floodplain is accessible on one side below the culvert and has a high failing bank to an inaccessible terrace on the other side. Above the culvert, a deeply incised channel is carving through loose sand and gravel deposits that have been stored above the culvert. The stream is trying to re-establish planform by carving out meanders above the culvert and to a lesser extent, below the culvert. Major adjustments would likely occur if the stone culvert were repaired or replaced.

Stone culvert outlet

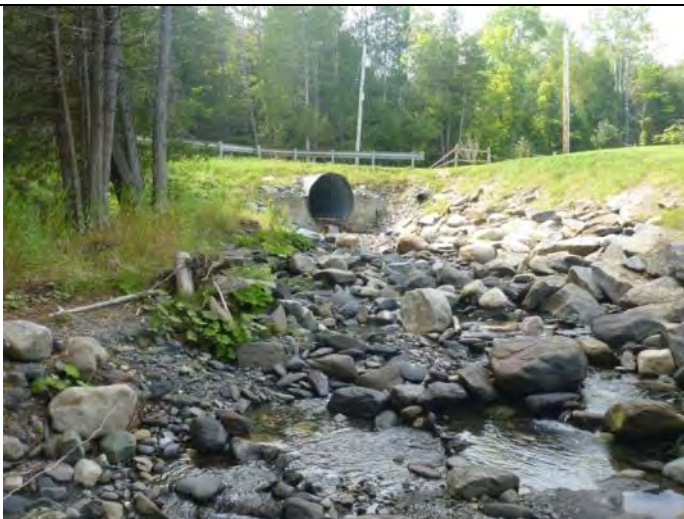
**Reach Highlights:** This reach was scoured during recent episodic flooding events followed by major deposition of gravel and sand. Large mass failures were observed at the top of the reach and have increased bedload of fine material working through the reach. Three undersized culverts within the reach likely increased deposition during flooding events. Tall deposits of gravel were observed along the margins and bends throughout. The relatively fine substrates coupled with the higher slope of the reach created several small headcuts through the poorly sorted channel material. Degradation and aggradation adjustments are both present, but degradation is the dominant adjustment process as the stream cuts through recent deposits of finer material.

Perched culvert and recent bank erosion, armoring, and channel degradation below Cormier Rd

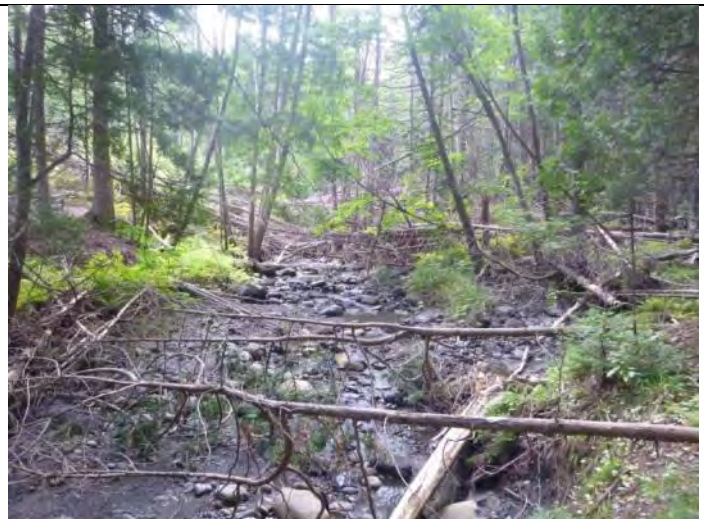
Evidence of recent major widening and degradation in the upper reach

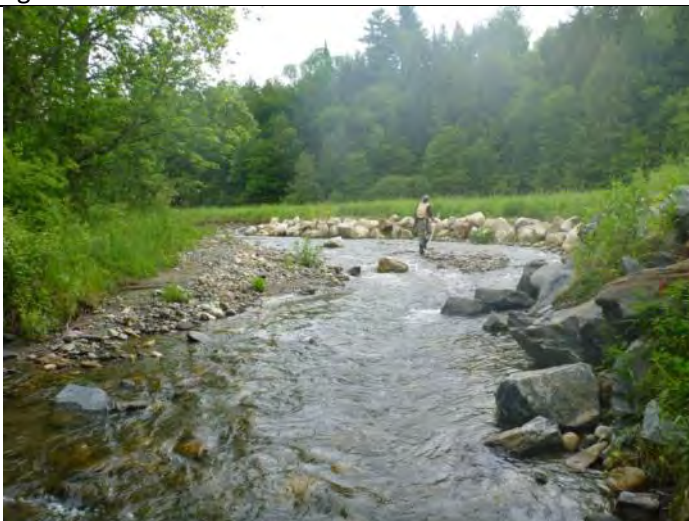
**Reach Highlights:** This reach has been historically straightened and armored through the agricultural fields on both sides. The channel is deeply incised and is starting to widen in the areas that are less armored or bermed. Degradation is the dominant process due to controls on channel migration. The channel has room to re-establish planform and could provide valuable floodwater and sediment storage before reaching the Passumpsic River. A small forested wetland area is located on the left bank upstream of New Boston Road. This area may have ecological significance and should be considered for conservation.

Armoring along left bank, mid-reach

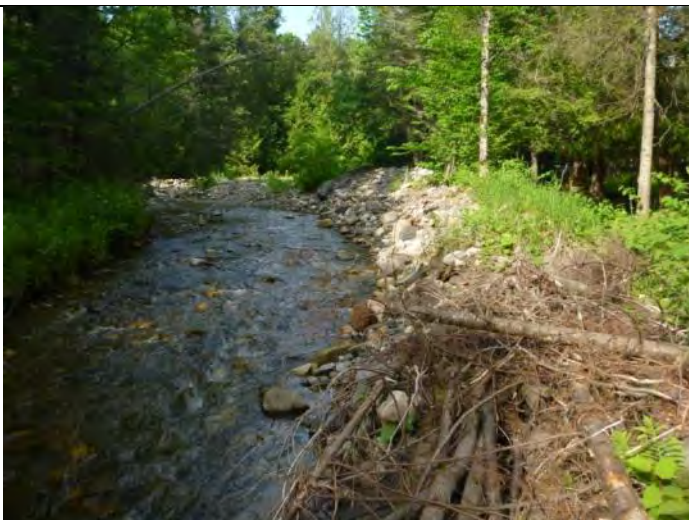
**Reach Highlights:** Lower banks were scoured out during recent episodic flood events followed by major deposition of cobble and gravel through most of the segment. The segment is moderately incised as the stream cuts down through these deposits. Large mass failures were observed at most bends in the channel, however the mass failures are now mostly protected by large cobble side bars at the toe of slope. Newly constructed cobble berms near the top of the segment are limiting floodplain access and could contribute to further degradation downstream.

Windrowed cobble berm along left bank in upper reach

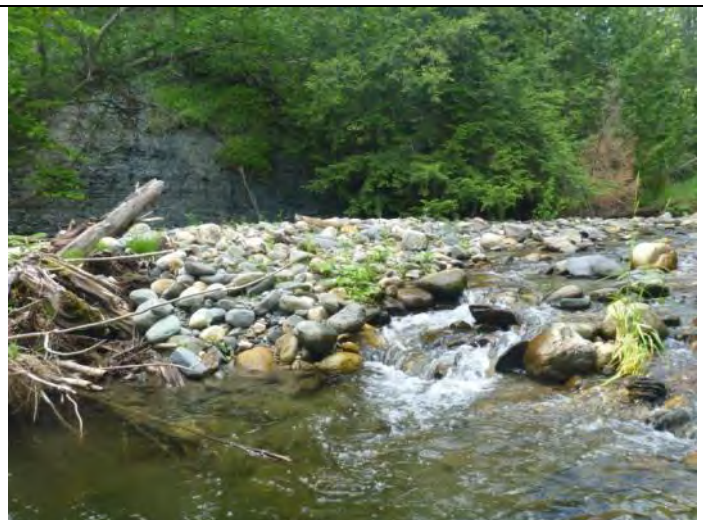
Large cobble bar and mass failure mid-segment

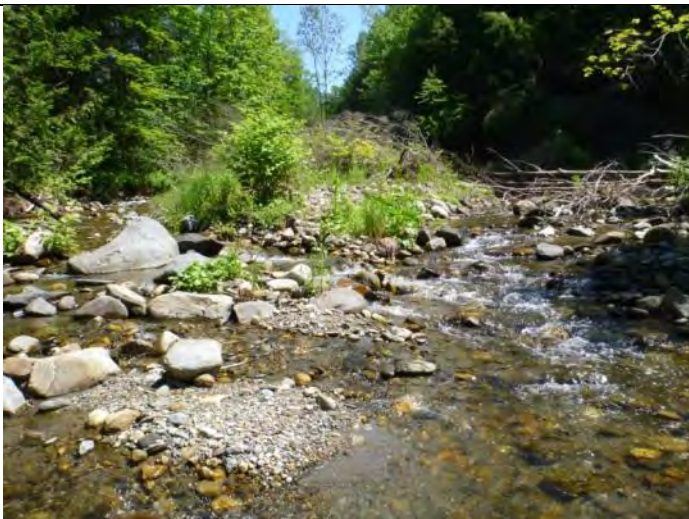
**Reach Highlights:** Lower banks were scoured out during recent episodic flood events followed by major deposition of cobble and gravel throughout the segment. The segment appears to be transitioning from degradation to widening with fresh bank erosion visible on many bends as the stream re-establishes planform through the large flood deposits. The segment is moderately incised but does retain access to narrow floodplain benches at high flows.

Major recent deposition throughout reach

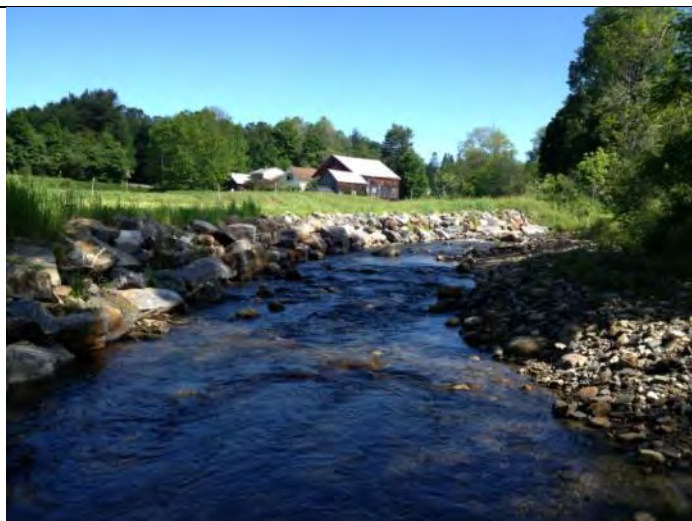
**Reach Highlights:** Majority of the reach has minor to moderate incision with limited widening and bank erosion. Lower reach has a short stretch showing signs of planform adjustments and stage III or IV of channel evolution. This area is likely responding to past channel straightening. There appears to have been an ongoing conflict with adjacent land use due to historical and recent armoring. This area of floodplain stores large volume of sediment and is a good candidate for long-term floodplain/corridor protection.

Armoring and buffer impacts in lower reach

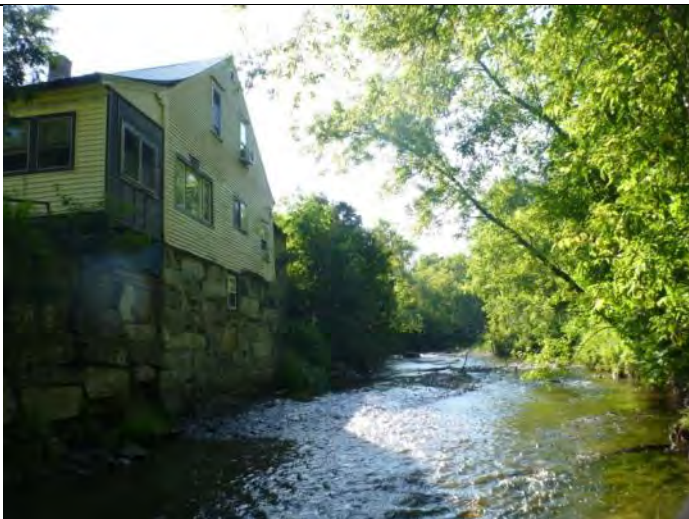
**Reach Highlights:** Reach is highly incised and entrenched due to ongoing channel degradation likely caused by historic armoring and encroachment along agricultural fields, development, and York Street. Elevated floodplain is present on one or both banks throughout the reach, but is likely only accessible during the largest flood events. A large bedrock cascade is located at the top of the reach and flows under the historic Chamberlain Covered Bridge.

Right bank development and plane bed bedform mid-reach

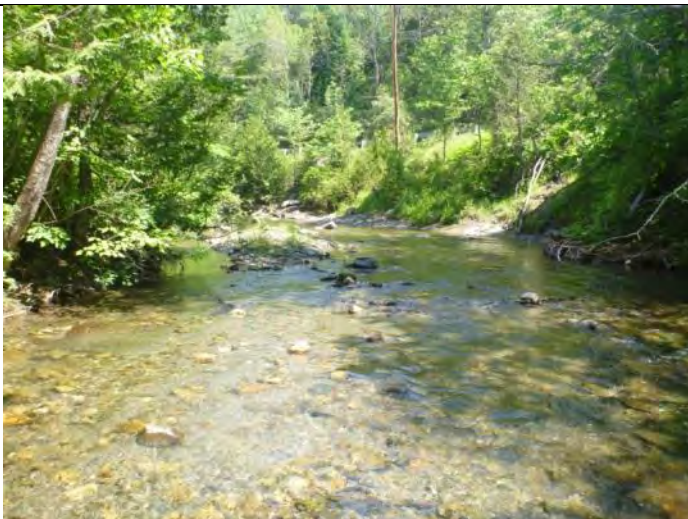
**Reach Highlights:** Incision is transitioning to widening as the dominant process in this reach due to historic and likely recent downcutting during flood events leading to a B->F stream type departure. Some widening and aggradation was observed throughout the reach in areas of bank failure. We selected a B reference stream type due to natural valley confinement.

Encroachment and armoring along South Wheelock Road

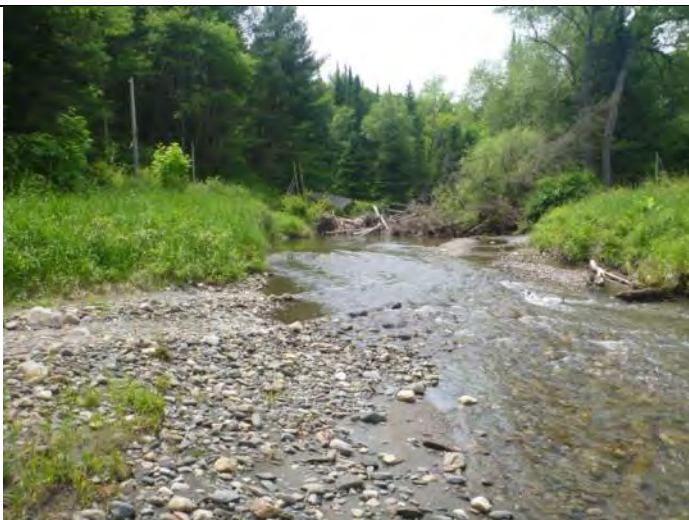
Failed cable bridge causing an unstable debris jam

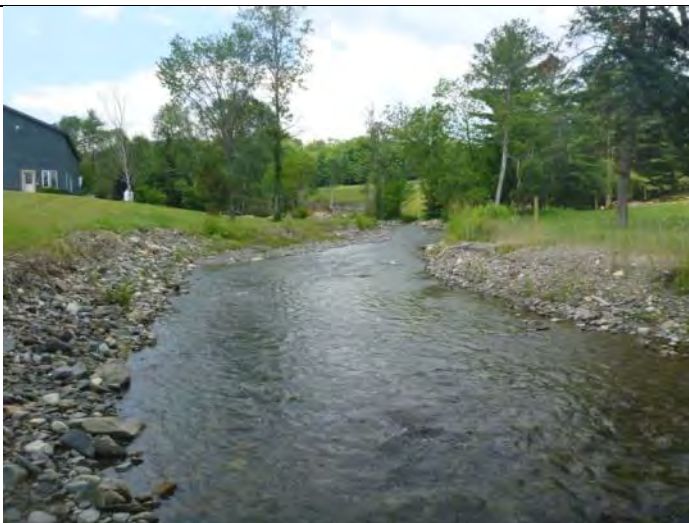
Buffer impacts and straightening mid-reach

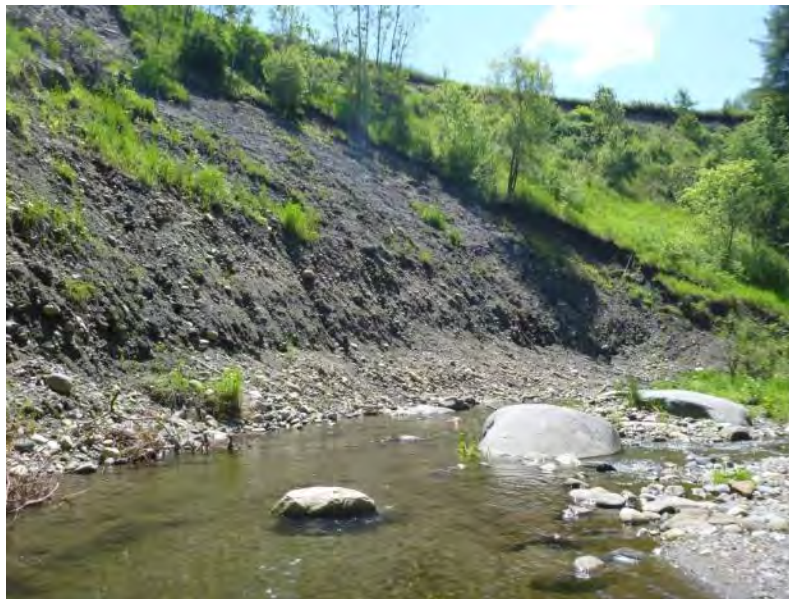
**Figure 9:** Large mass failure on Sheldon Brook Segment T4.03B.

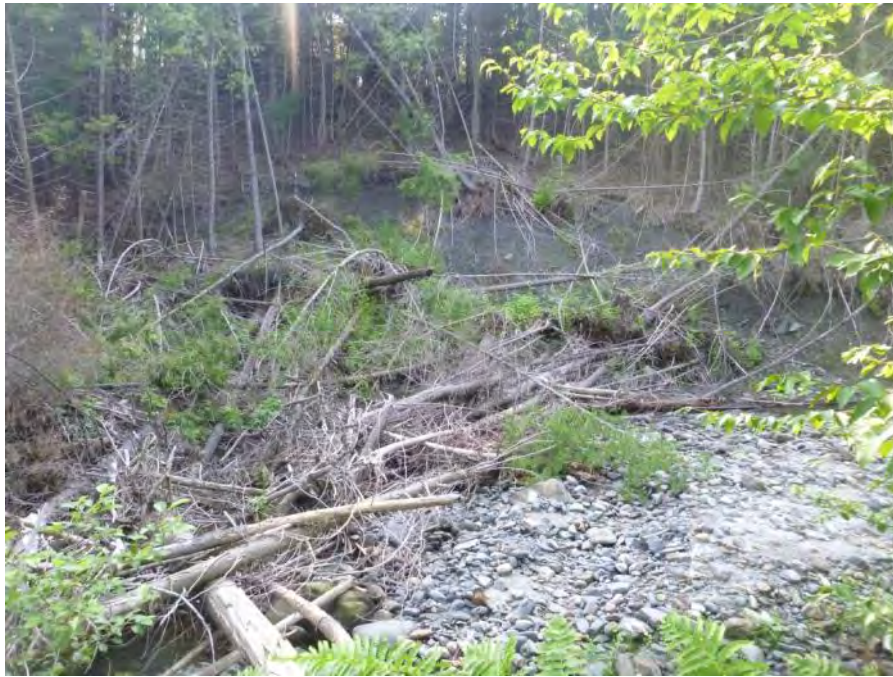
**Figure 10:** Sediment retention above a large debris jam on Whiteman Brook segment T3.7S1.01B.
