**River Corridor Plan for the Williams River in Rockingham,
Chester, and Andover, Vermont**

September 29, 2016

Fitzgerald Environmental Associates, LLC.
18 Severance Green, Suite 203
Colchester, VT 05446

**Windham County Natural Resources
Conservation District**
28 Vernon Street
Brattleboro, VT, 05301

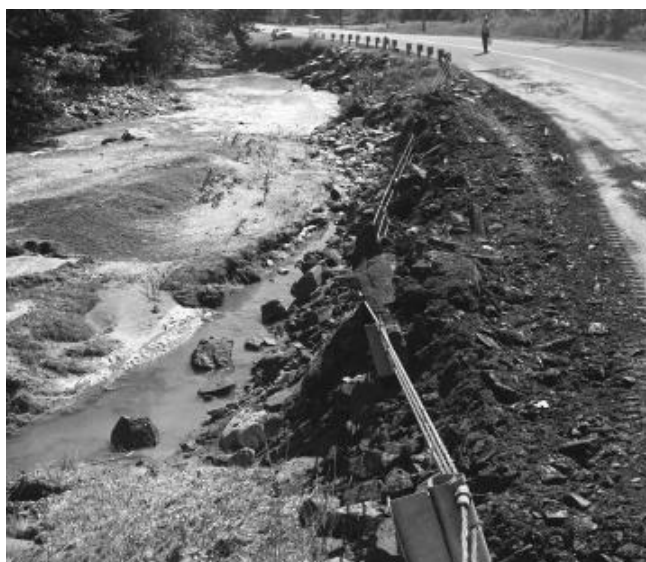
Figure 1.6: Damage from the 1974 flood along the Middle Branch of the Williams River (UVM Landscape, 2011).

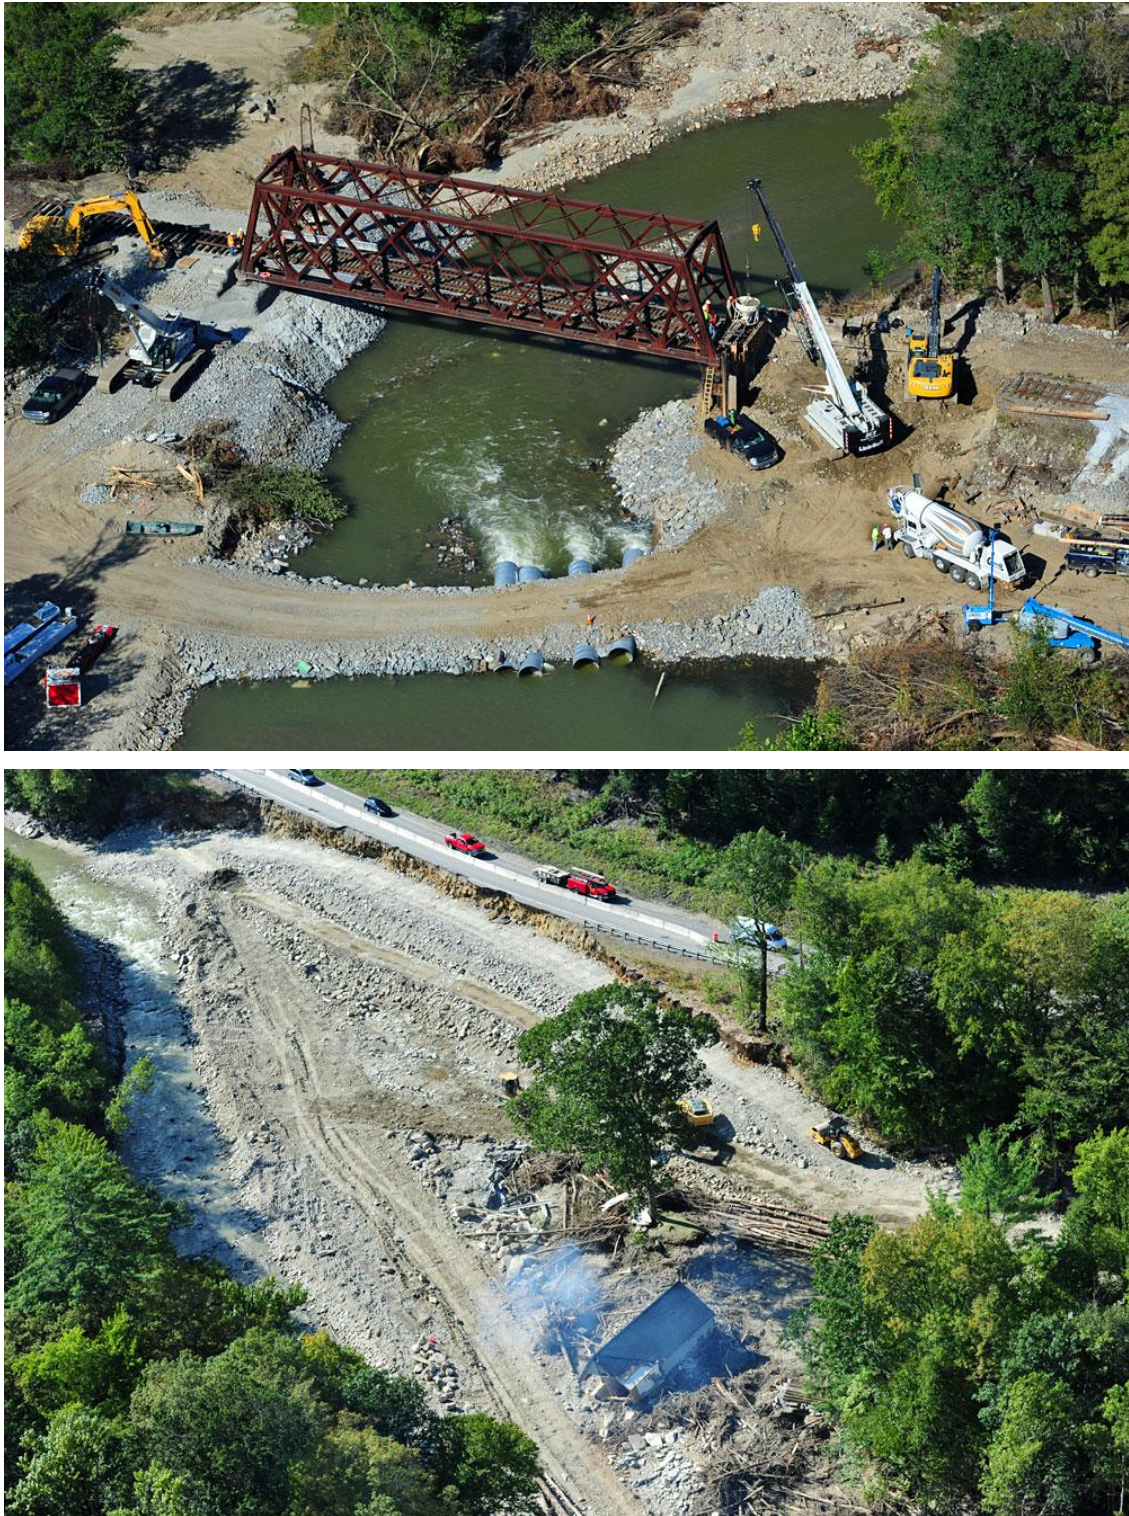
Figure 1.9: Major repairs to a railroad bridge on Reach M10 in Chester. Destroyed house, damage to Route 11, and extensive earth work along the Middle Branch (photos courtesy of Mansfield Heliflight).

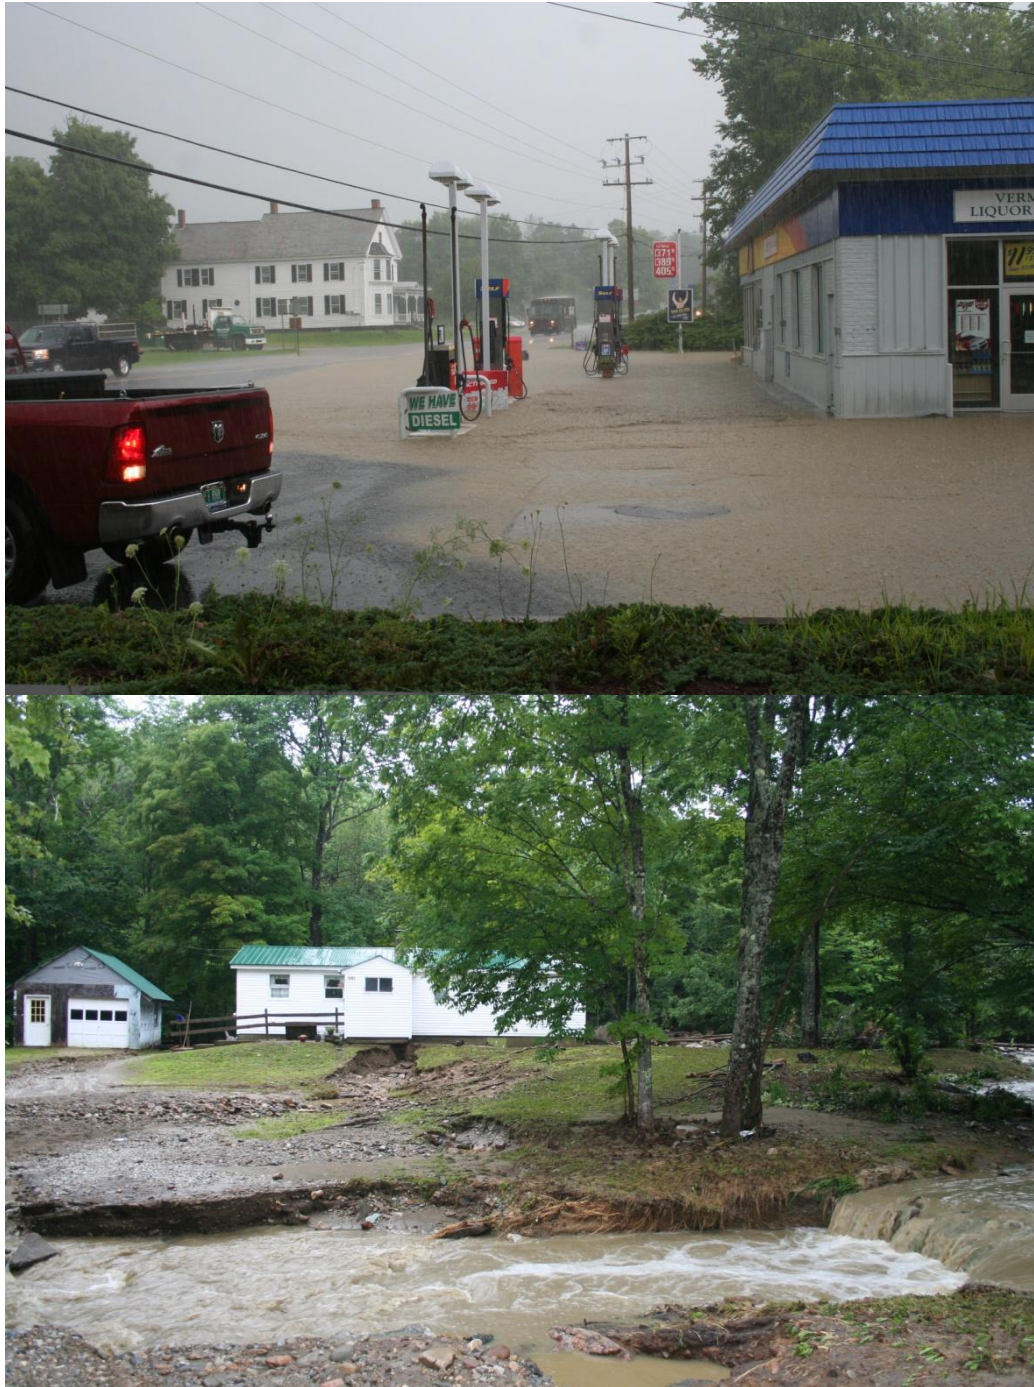
Figure 1.10: Flooding at the intersection of Route 103 and Route 11 in Chester (top), severe damage to a property along Route 11 on reach T5.07 of the Middle Branch (photos courtesy of S. Cunningham and the Chester Telegraph).

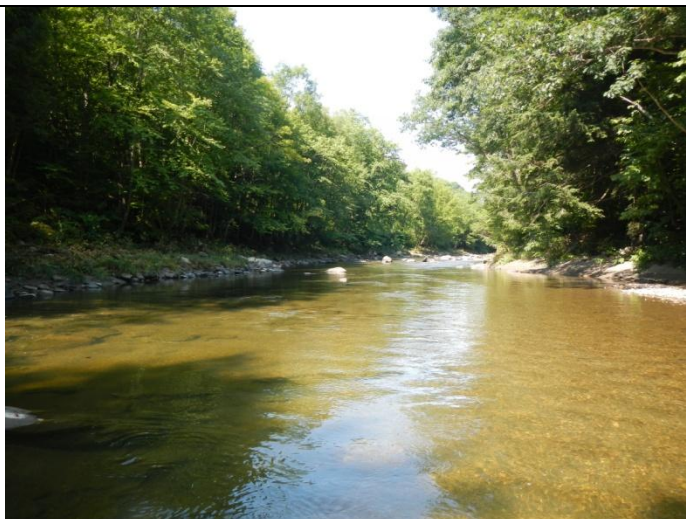
Reach Highlights: This reach lies in a naturally semi-confined valley that is encroached upon by both roads and rail. The channel is deeply incised and likely stuck there from natural and man-made hard banks. Localized areas of aggradation were observed with moderate to heavy scour along most of the banks. Potential for widening and planform adjustment are minimal due to encroachment and bank armoring.

Incised channel

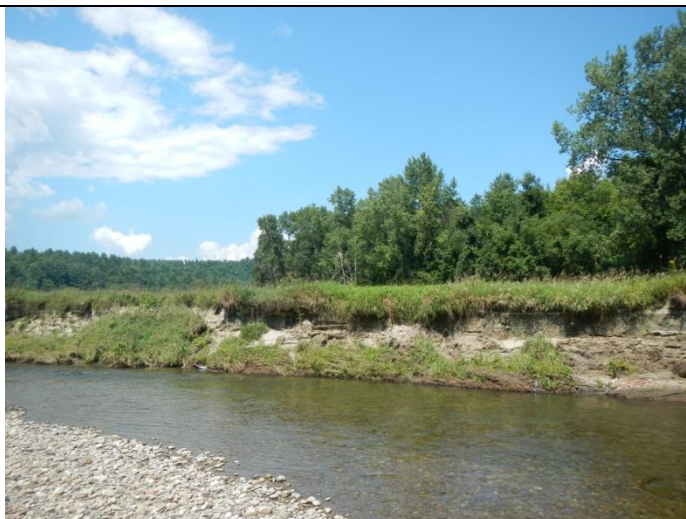
Reach Highlights: Currently the channel bed is smooth and relatively featureless. A large hayfield provides some floodplain access in large storm events, though most potential flood plain is disconnected due to extreme incision. Some evidence of aggradation and widening/planform adjustment indicate that this reach may slowly transition out of stage II.

Slumping and eroding banks without a buffer

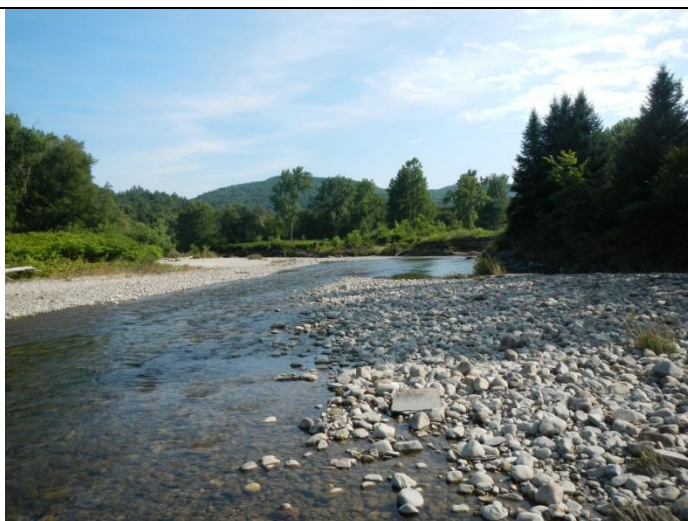
Reach Highlights: During T.S. Irene this segment widened followed by major aggradation and planform adjustment. Large volumes of sediment continue to work through this segment contributing to ongoing meander development. We assessed this reach as Stage IV. The numerous recent and active flood chutes and channel avulsions observed support this designation.

Large depositional features causing planform adjustment

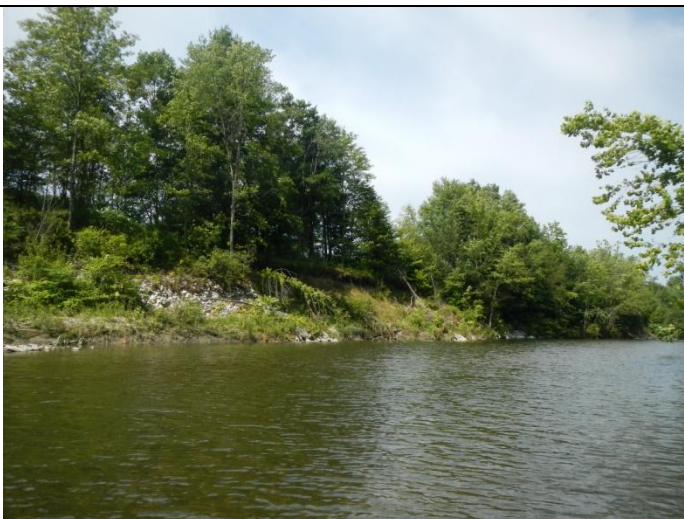
Reach Highlights: This incised and highly straightened/encroached reach was difficult to classify, since it exhibited numerous active processes concurrently and the channel had degraded. During T.S. Irene the reach widened slightly and deposited large volumes of sand over two primary floodplain areas. Following the flood, the channel has aggraded with sand and continues to widen. Since no active incision was observed this reach is assessed as Stage III. The high degree of armoring and semi-confined valley from encroachment will slow the widening and planform adjustment processes.

Majority of reach is deep and slow, very few riffles

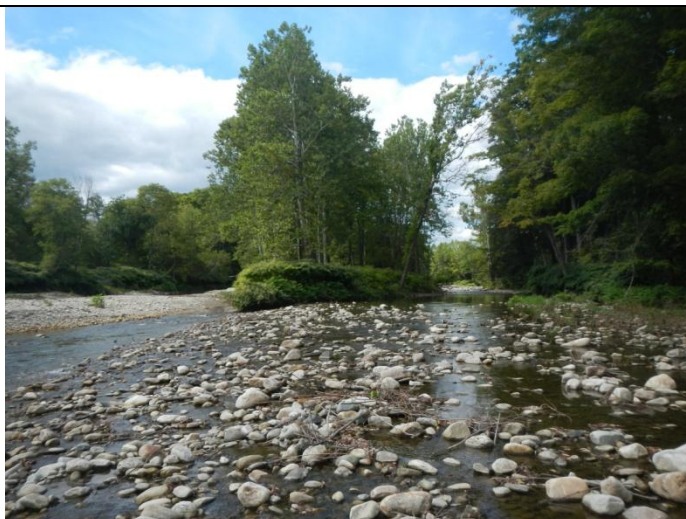
Reach Highlights: The channel in this reach widened and eroded historic armoring in several locations during T.S. Irene. The channel is continuing to widen as it adjusts planform. Large adjacent floodplains are currently inaccessible, however may be restored through aggradation. Currently large volumes of sediment are working through the reach. Even though this reach remains incised and entrenched it was assessed as Stage IV due to the aggradation, and planform adjustment in the channel.

Large diagonal riffle indicates planform adjustment

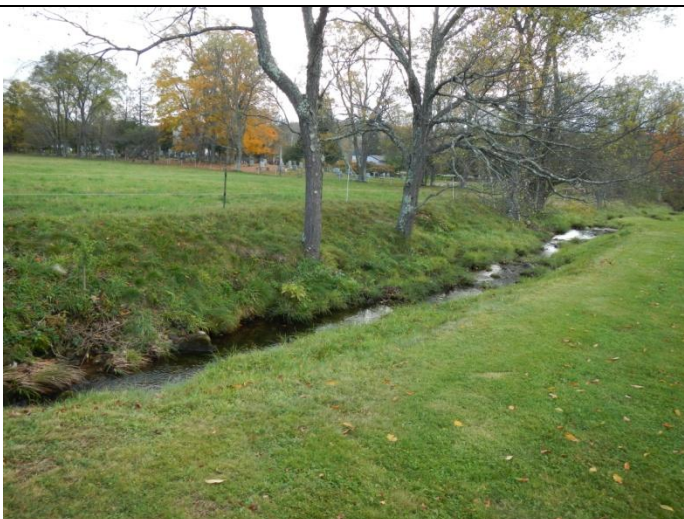
Reach Highlights: Historic straightening and armoring have caused this channel to deeply incise, resulting in the C to B stream type departure. The channel bed had no major bars and there were very limited riffle-pool sequences. A large berm was constructed upstream of the cemetery following the 1970's flood where Trebo Brook impacted the properties along Rt. 103. This reach showed a very limited ability to widen and is thus stuck in stage II for the foreseeable future.

Historically straightened along field edge

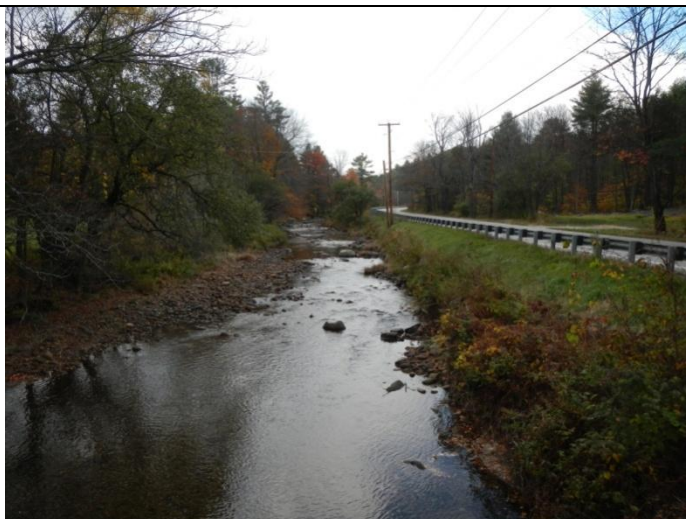
Reach Highlights: This reach is deeply incised from historic straightening and armoring. During T.S. Irene the channel widened and began to adjust planform in a few areas. The widening process will slowly continue due to ongoing aggradation, however the channel is still locked in stage II from deep incision. Two cross-sections were collected to capture the varying bankfull width, though no segmentation was necessary since the channel was consistently entrenched.

Channel straightened along road with F-type geometry

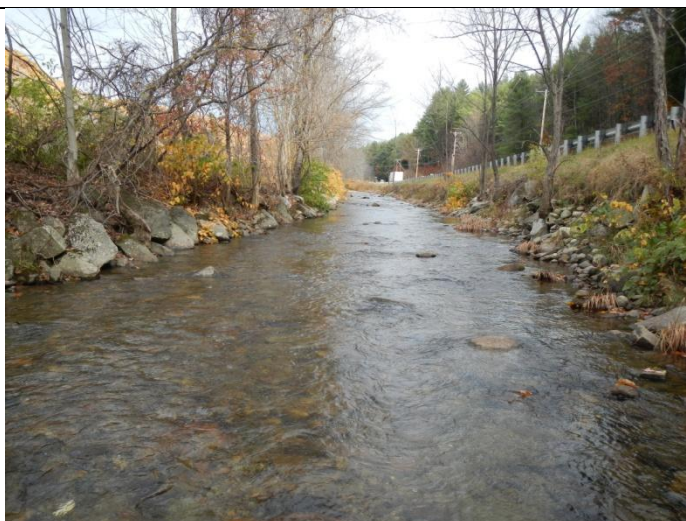
Reach Highlights: Historic straightening and armoring have caused this reach to deeply incise. Large floodplains throughout the reach are only accessible during the largest events. The channel bed does not appear to be incising any further, and some areas of aggradation were observed. This indicates that the transition to stage III may slowly be underway.

Straightening and bank armor frequent throughout M14

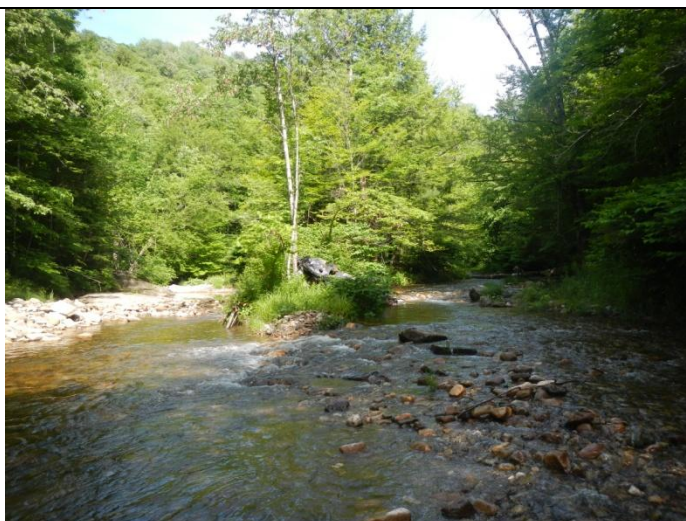
Reach Highlights: The M16 corridor is encroached upon from both the railroad and Rt-103, which has caused the channel to incise. Many depositional bars were left behind from T.S. Irene. Channel widening is limited by heavy bank armor, thus the channel remains stuck in stage II.

Large diagonal bar indicating planform adjustment

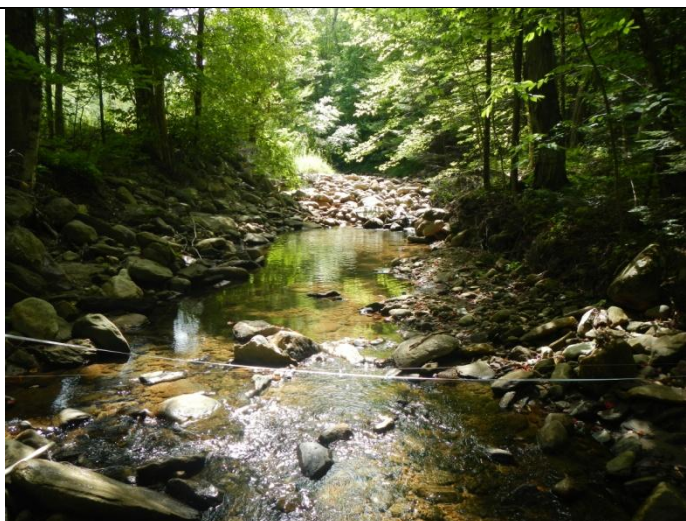
Reach Highlights: Despite being encroached upon by Smokeshire Rd. segment M20.A maintains access to flood benches. T.S. Irene scoured away this segment's low benches as the channel widened and then filled back in with cobble and gravel. These floodplain benches have been reformed as the deposits have been moved. This channel adjustments suggest Stage IV of the channel evolution model due to the frequent bank scour and the large number of bars created from the flood material.

Many cobble aggradational features present

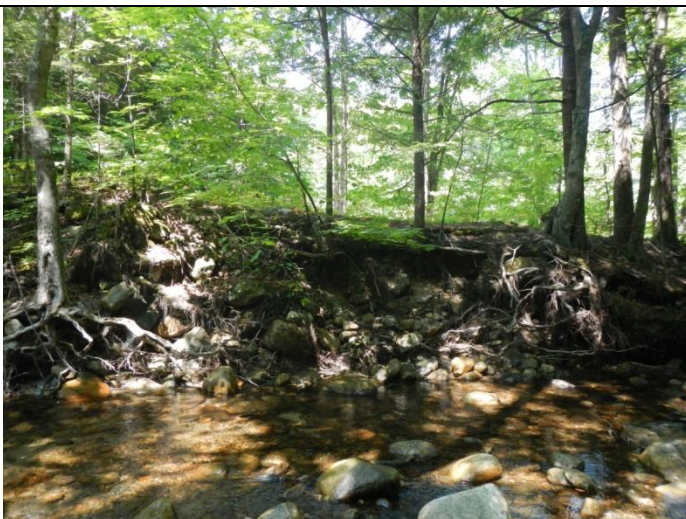
Reach Highlights: Incision is present throughout most of the reach and is due to the encroachment of Smokeshire Rd. Grade controls are very common and will prevent further bed incision. Many side and mid channel bars were created in T.S. Irene from deposited cobbles and gravel. When the stream was away from Smokeshire Road it was able to adjust planform with flood chutes and a channel avulsion. Recently exposed grade controls throughout the reach provide evidence that this reach is still incising and is in Stage II of channel evolution.

Bank scour and evidence of widening

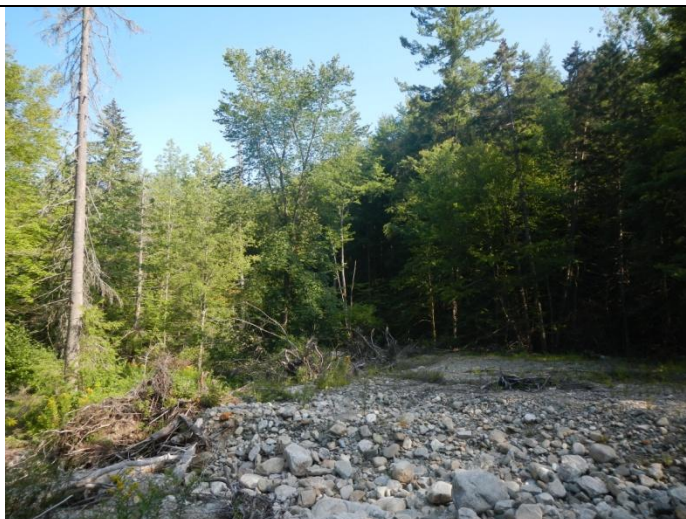
Reach Highlights: Reach M22 was very active during T.S. Irene. A large alluvial fan was observed in the middle of the reach with numerous flood chutes, a channel avulsion, and large depositional features. There were multiple historic berms along the reach; though many have failed from previous high flow events. This reach is assessed as Stage IV due to ongoing planform adjustments following major widening and deposition from T.S. Irene.

Alluvial fan created from sharp decrease in channel slope

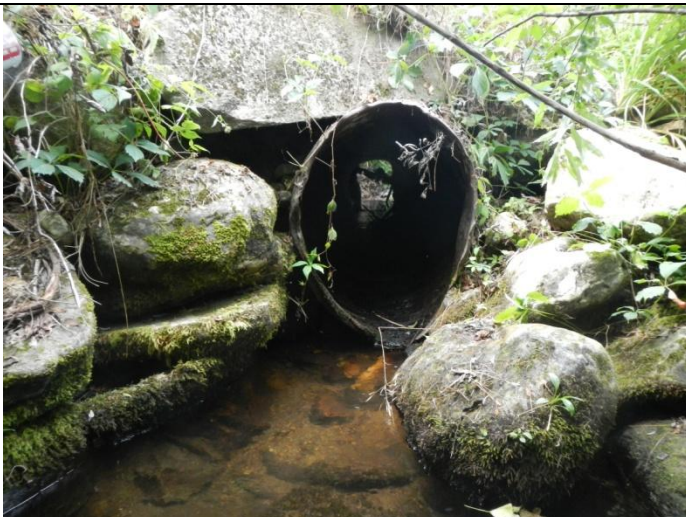
Reach Highlights: This reach is primarily stable with relatively consistent floodplain access. There is a very undersized farm culvert causing channel instability, braiding, and sediment deposition at the bottom of the reach. A localized area of channel incision was observed upstream of Wymans Falls Rd. This reach is stage IV due to planform adjustment, with many areas of aggradation.

Outlet of severely undersized culvert under farm road

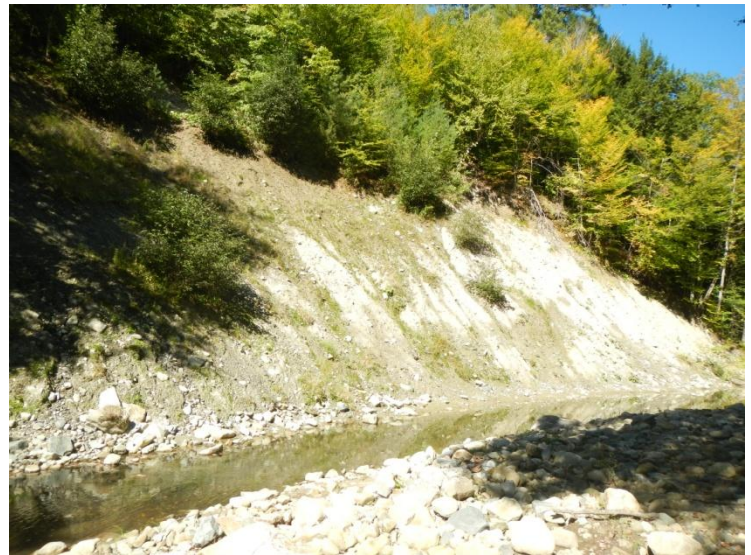
Mass slope failures along Reach T5.06 on the Middle Branch of the Williams River

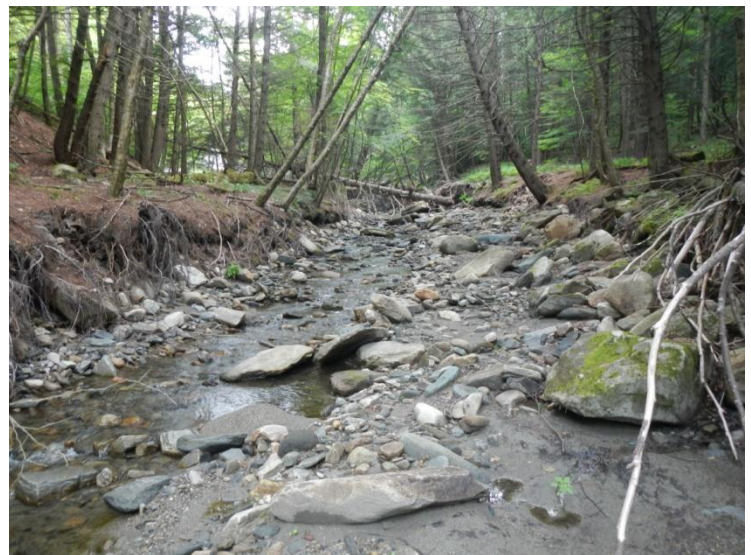
Incised channel on Reach T5.S3.a.01 on Potash Brook

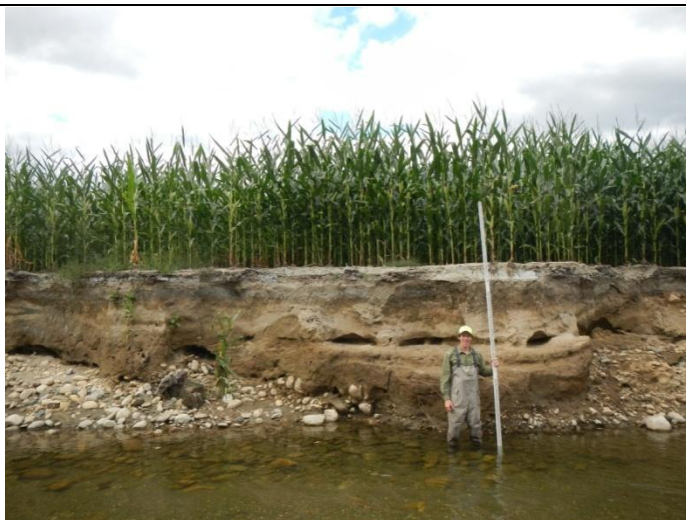
Reach Highlights: Prior to T.S. Irene this channel was likely F-type due to incision. During the flood the channel widened and filled with sediment. This aggradation had restored some floodplain access in several areas and has caused the channel to adjust planform. This planform adjustment has left tall eroding banks. The railroad bridge is a major constriction during large events, which has caused overbank flow to the south through the baseball field.

Highly erodible banks along agricultural fields

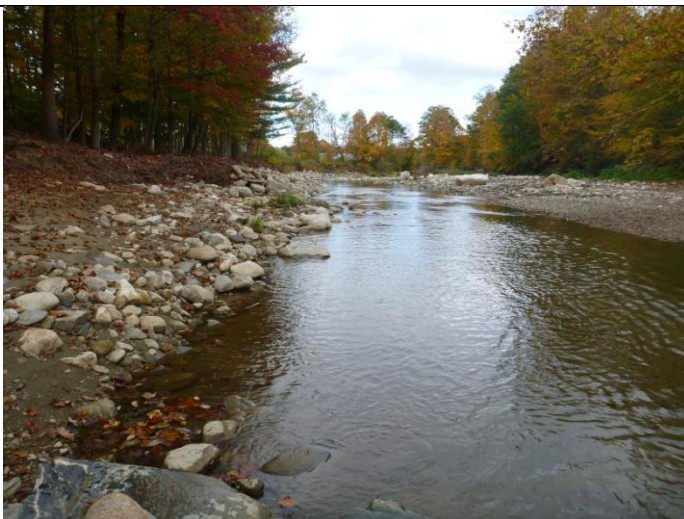
Reach Highlights: Due to straightening, armoring, and dredging T5.02 was historically widened and deeply incised. Currently the channel is overwidened and F-type as its low benches were likely scoured away during T.S. Irene and the July 2014 flood. The floods also left the channel with minimal floodplain access and a relatively smooth bed profile. The channel may continue to widen as it does not appear to be actively incising.

Major widening occurred throughout the reach

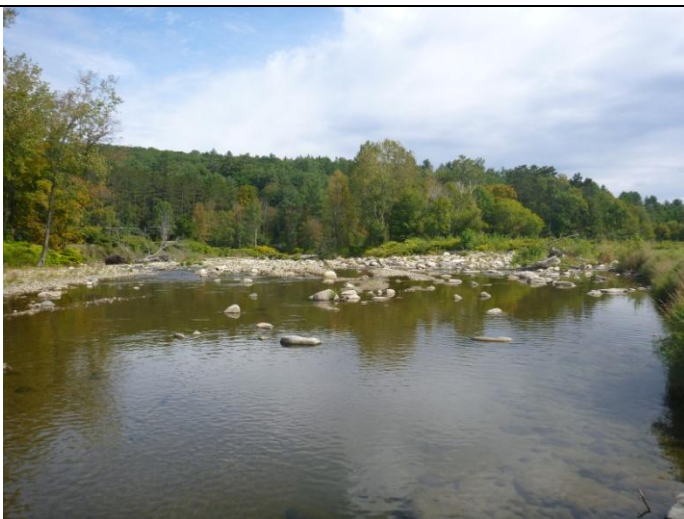
Reach Highlights: This reach is located in a transitional zone as the channel moves from being incised to widened. The transition is a result of the valley being encroached upon by Rt-11 before moving into a wide and less encroached setting. Large volumes of sediment generated from upstream mass failures are deposited in this reach, causing extreme widening in areas. Several properties are still at risk of bank retreat despite bank armor. Berms are present along the hayfield on the left bank in the lower reach.

Channel has widened from recent large floods

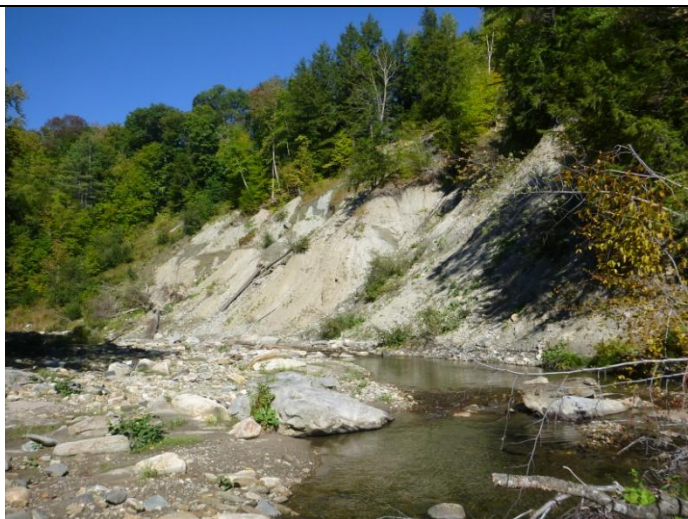
Reach Highlights: Route 11 has historically encroached upon reach T5.04 causing incision throughout. T.S. Irene caused the channel bed to aggrade from an increased sediment supply from mass failures within T5.04 and the upstream reaches. Two bridges within T5.04 are floodprone constrictions that increase sediment deposition upstream.

Multiple active mass failures present throughout T5.04

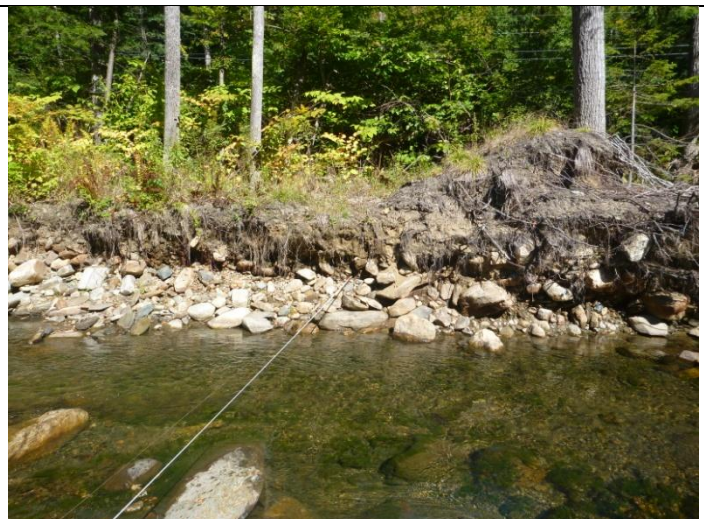
Upper cross-section left (north) unstable bank

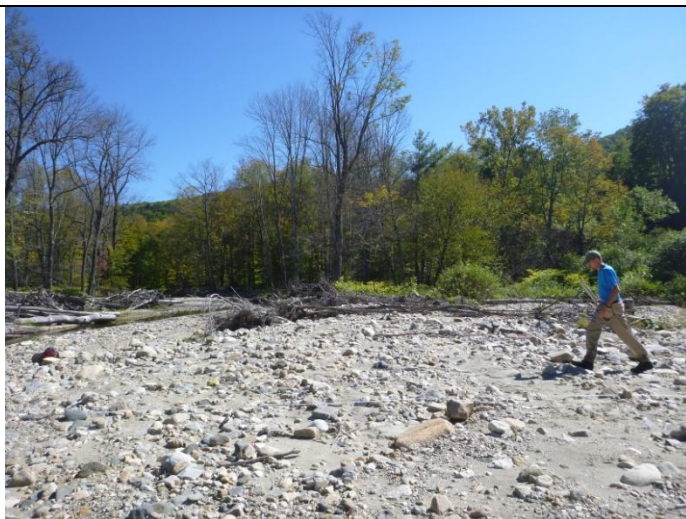
Reach Highlights: T5.05.A gets away from the encroachment of Rt 11 as the valley becomes broad and unconfined. This area acted like an alluvial fan during both T.S. Irene and the July 2014 flood, where large volumes of sediment and debris were deposited across the valley, leading to further channel bifurcation. Multiple threads are not active in very low flows. All channels fill in bankfull flows and greater.

Braided channels throughout valley

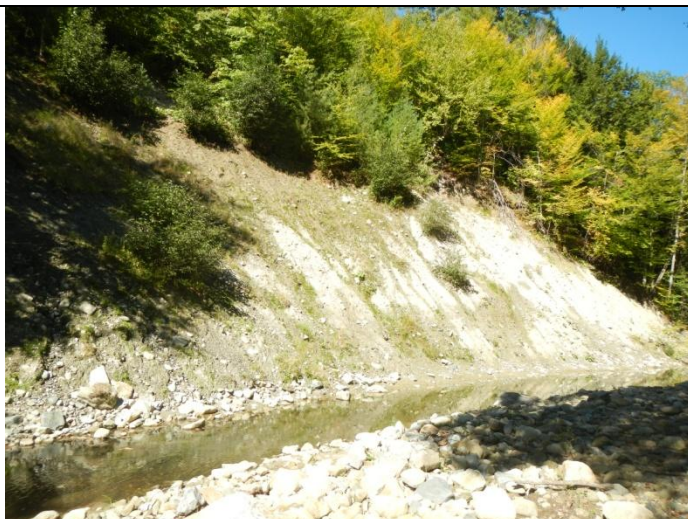
Multiple active mass failures are present in the reach

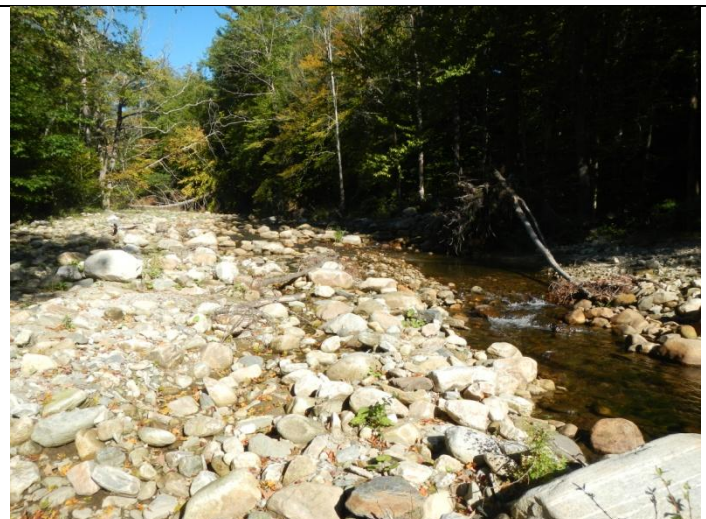
Channel bed is aggrading from mass failure material

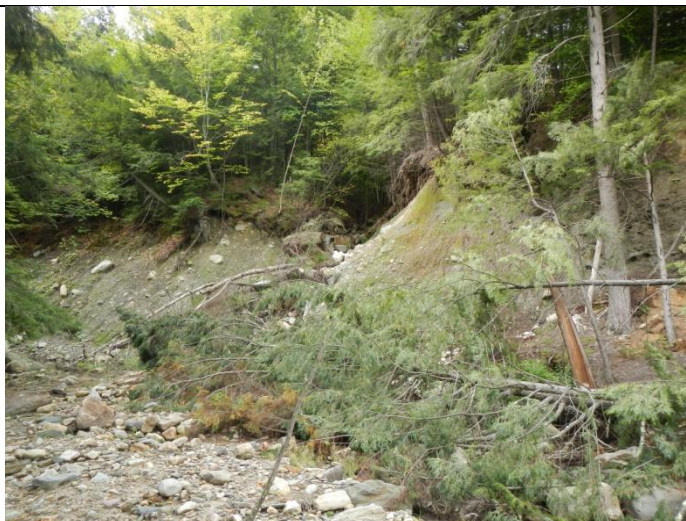
Gully cutting down through mass failure

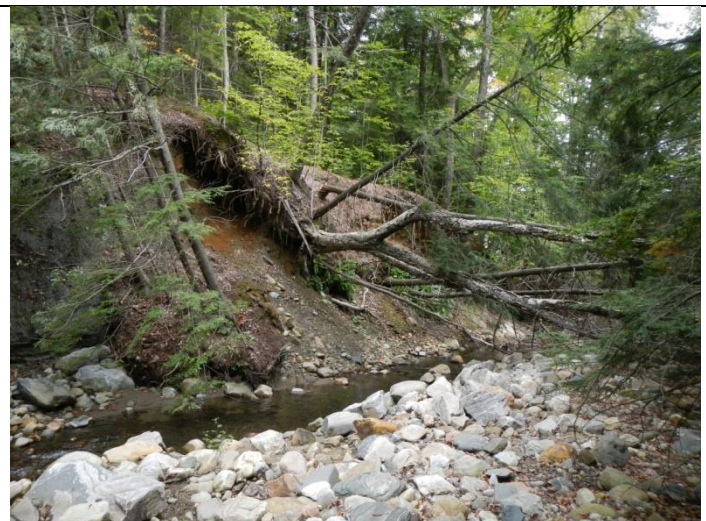
Depositional features and eroding banks

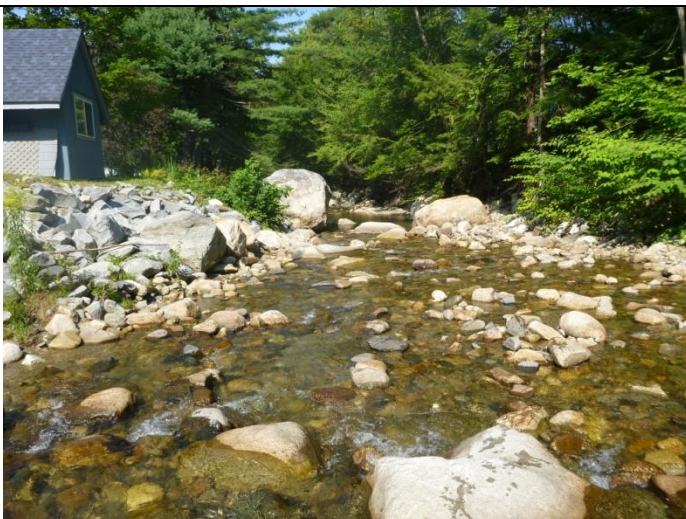
Channel aggraded 2-3' since T.S. Irene along Marshall Rd.

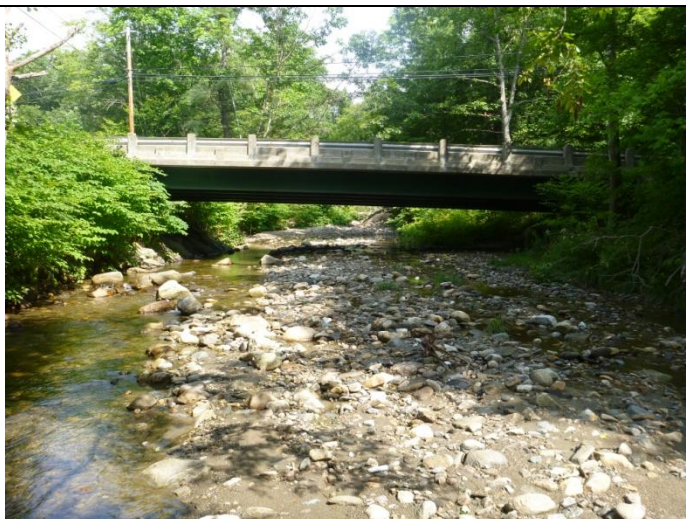
Channel widening and aggrading as bars redevelop

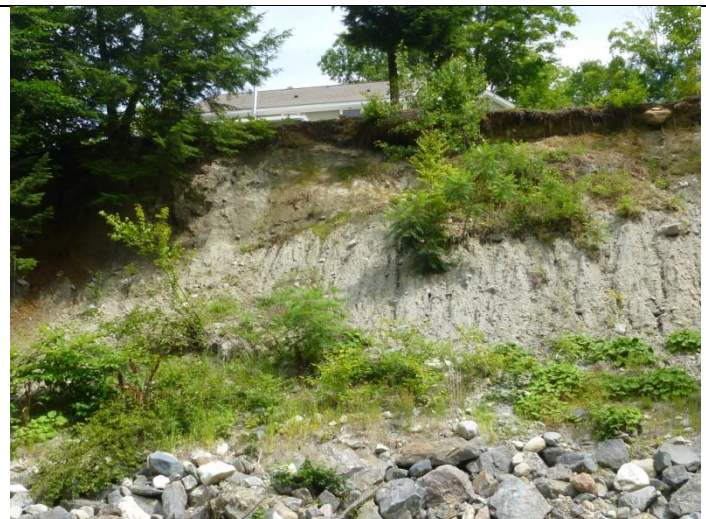
Mass failure posing future threat to home

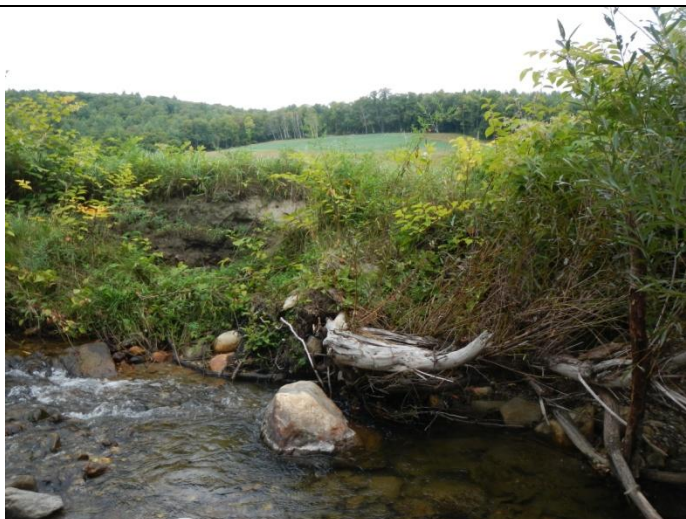
Buffer <25ft and flood plain not easily accessible

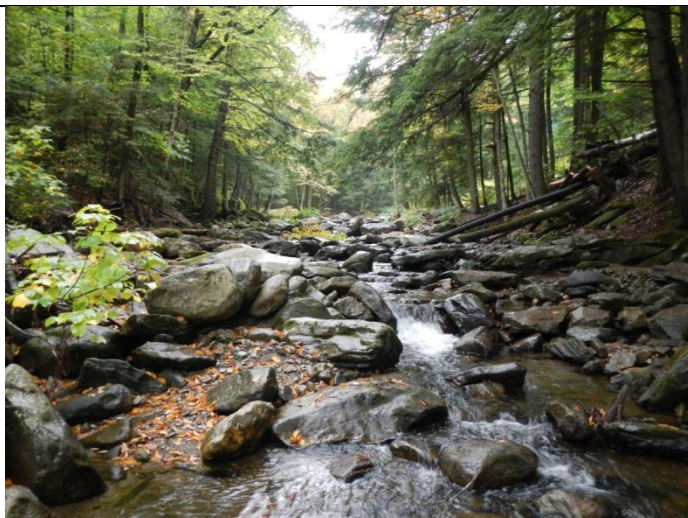
Channel widened, but hasn't rebuilt floodplain benches

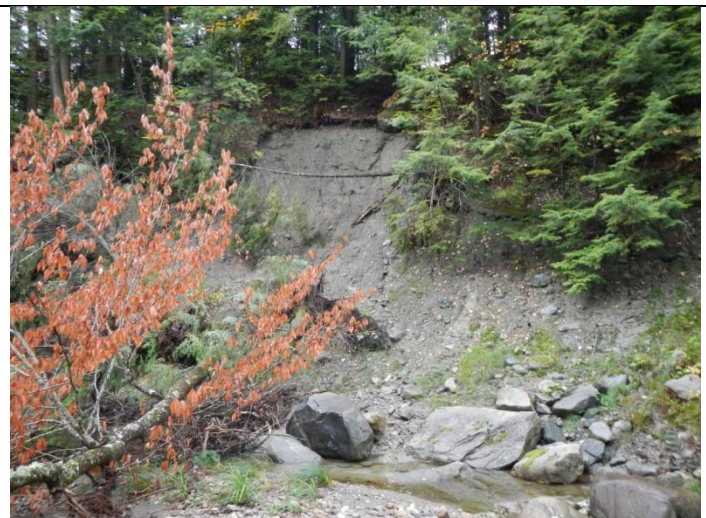
Mass failure due to debris jam and channel widening

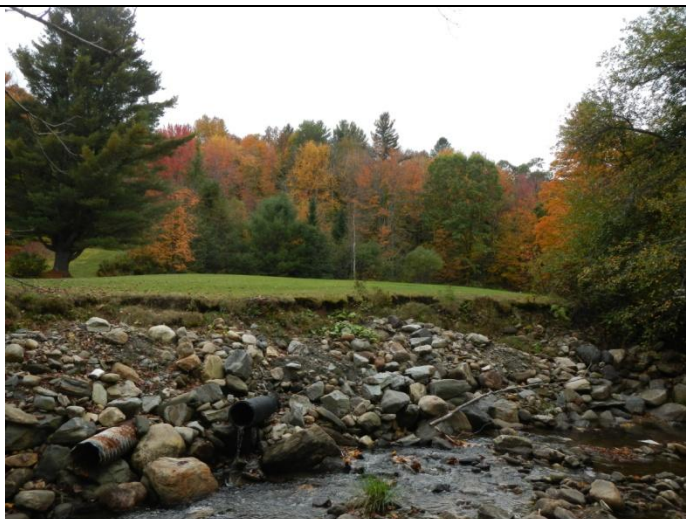
T.S. Irene scour and widening

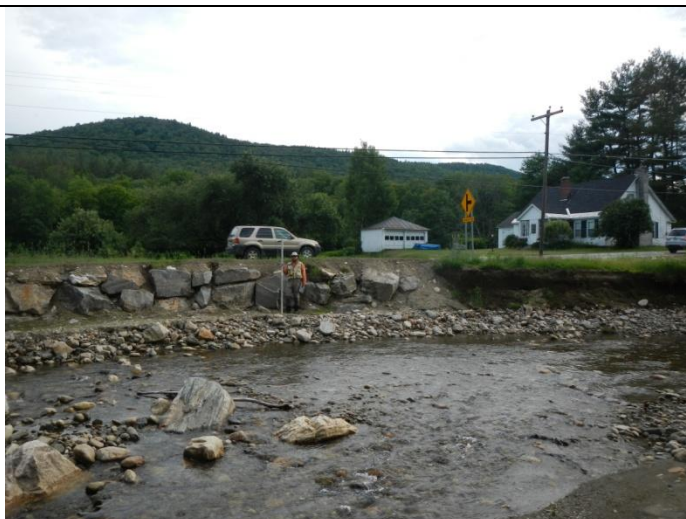
Raw bank erosion and armor along Rt-11

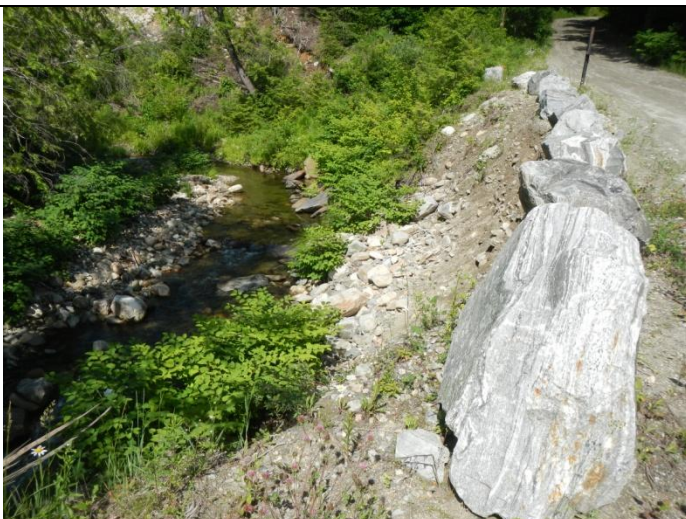
Actively eroding bank along Lamson Rd.

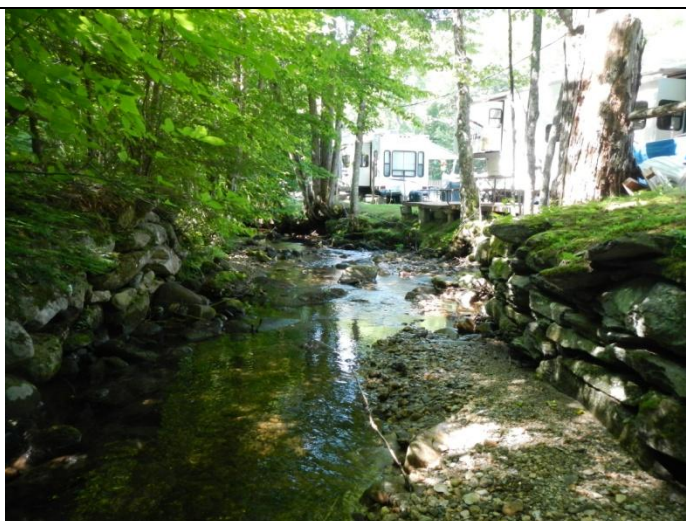
Historic abutments constricting channel

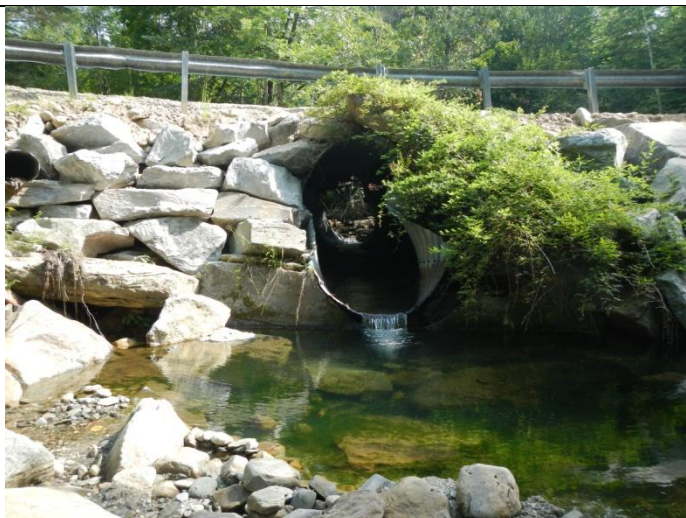
Culvert needing replacement along Potash Brook Rd.

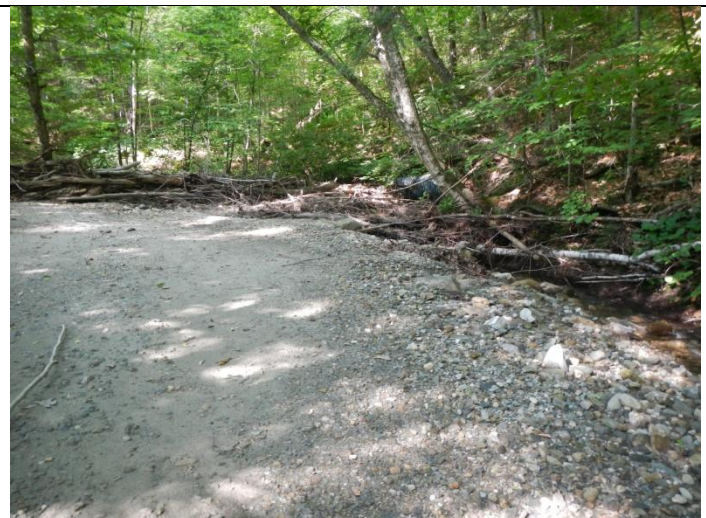
Sediment stored by debris jam

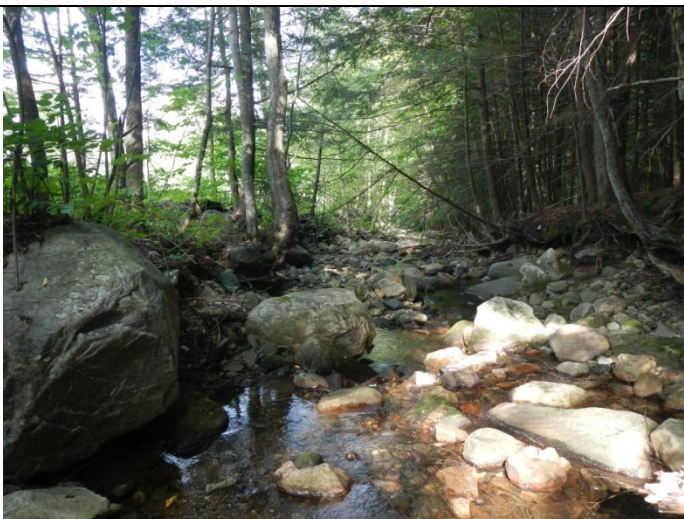
Channel filled with boulders and incised

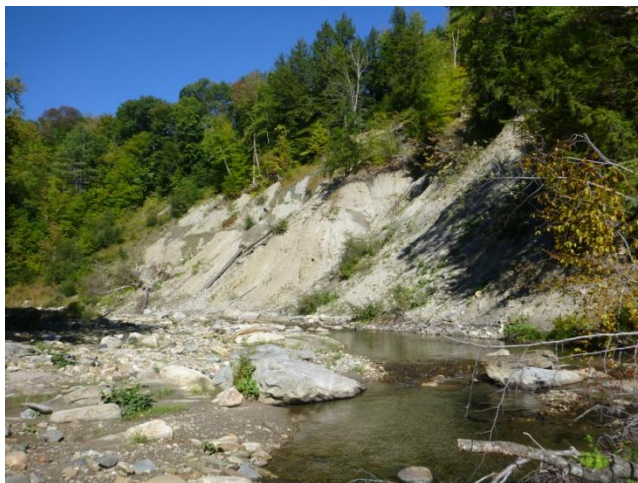
Figure 4.14: Huge mass failure on reach T5.04.

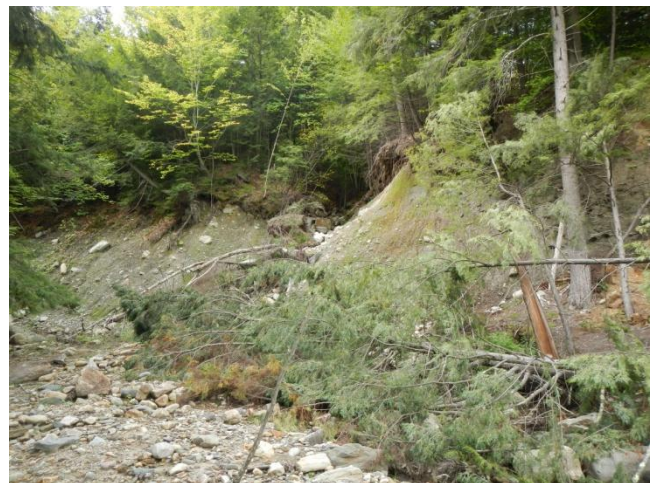
Figure 4.15: Mass failure with gully along reach T5.08.

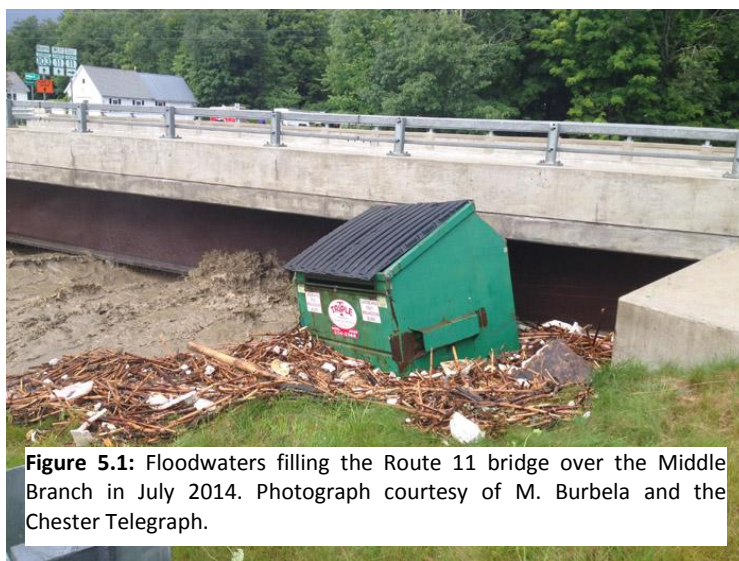
Figure 5.1: Floodwaters filling the Route 11 bridge over the Middle Branch in July 2014. Photograph courtesy of M. Burbela and the Chester Telegraph.
