# **Phase 2 Stream Geomorphic Assessment**

**Trout River Watershed  
Towns of Berkshire, Enosburg, Richford, and Montgomery  
Franklin County, Vermont**

**April 2007**

Re: Phase 2 Stream Geomorphic Assessment  
Trout River Watershed  
Franklin County, Vermont  
JCO Project No. 3-1313-2

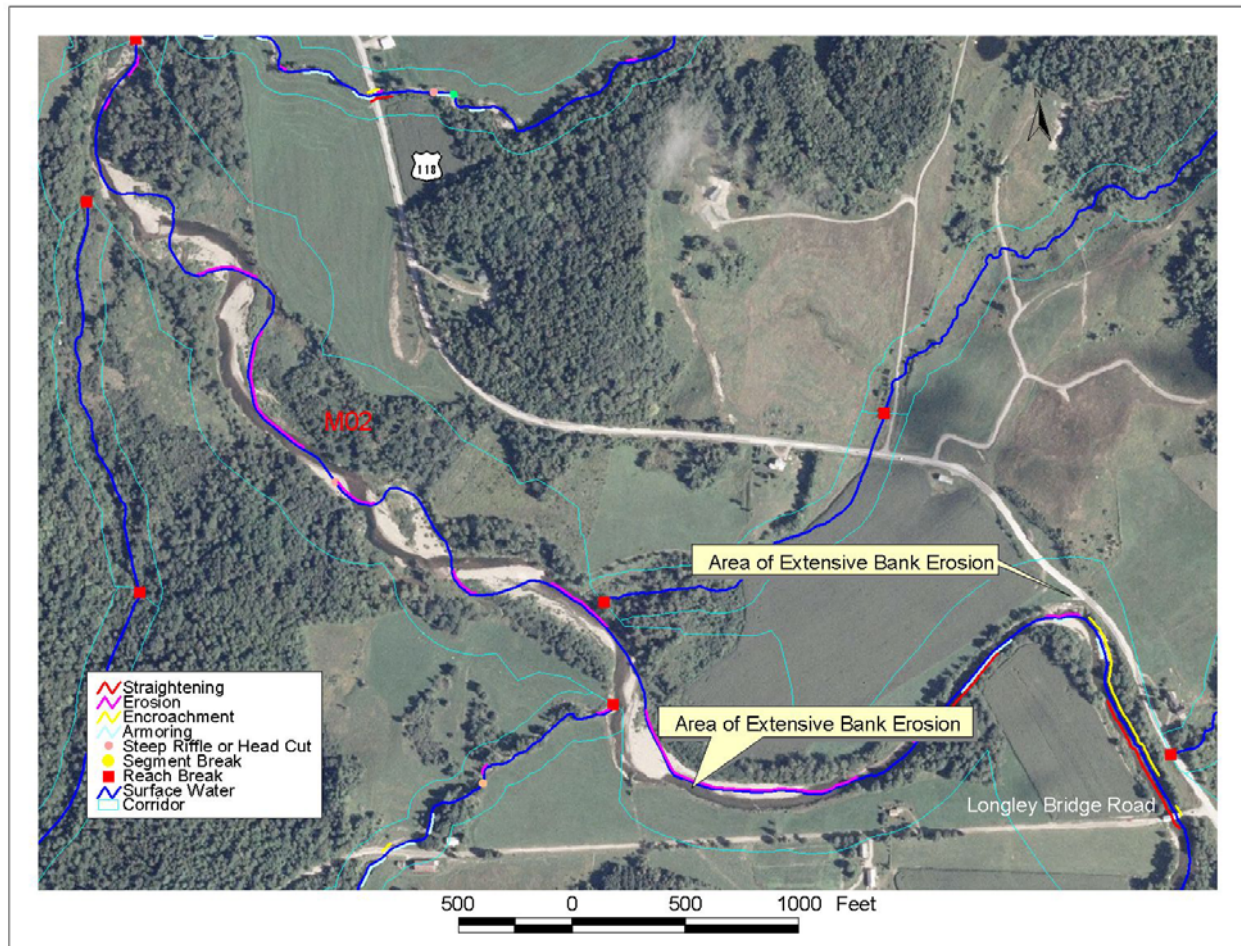
the degradation observed. No active dredging was observed throughout the reach. Multiple large point bars and steep riffles were observed as evidence of the widening and aggradation currently ongoing in the reach. Two major problem areas were observed in M02, both being large areas of bank erosion near Longley Bridge Road (Figures 2-4).

**Figure 2: M02 Areas of Extensive Bank of Erosion**

The major restoration projects within M02 are centered on these areas of erosion shown in Figures 2 and 3 above. Both are relatively close to roads and will have to be stabilized sometime soon to protect the infrastructure. Given the widening, aggradation and planform adjustment processes currently ongoing within the reach, and the very high sensitivity to future adjustments, it would be important to incorporate some corridor protection in conjunction with the bank stabilization project to allow for areas where these anticipated adjustments could proceed without conflicting with human interests.

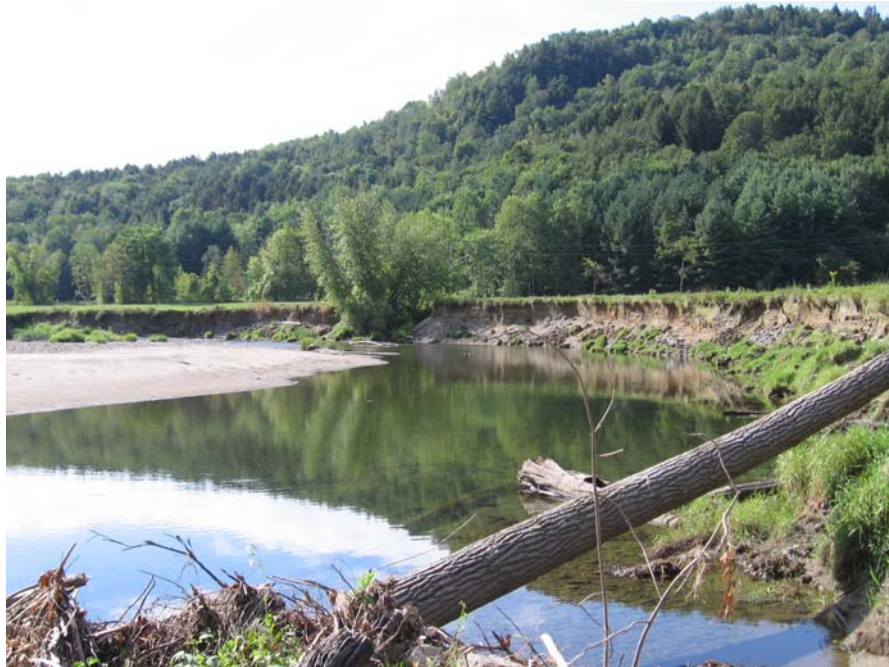
**Figure 3: Bank Failure near Longley Bridge Road**

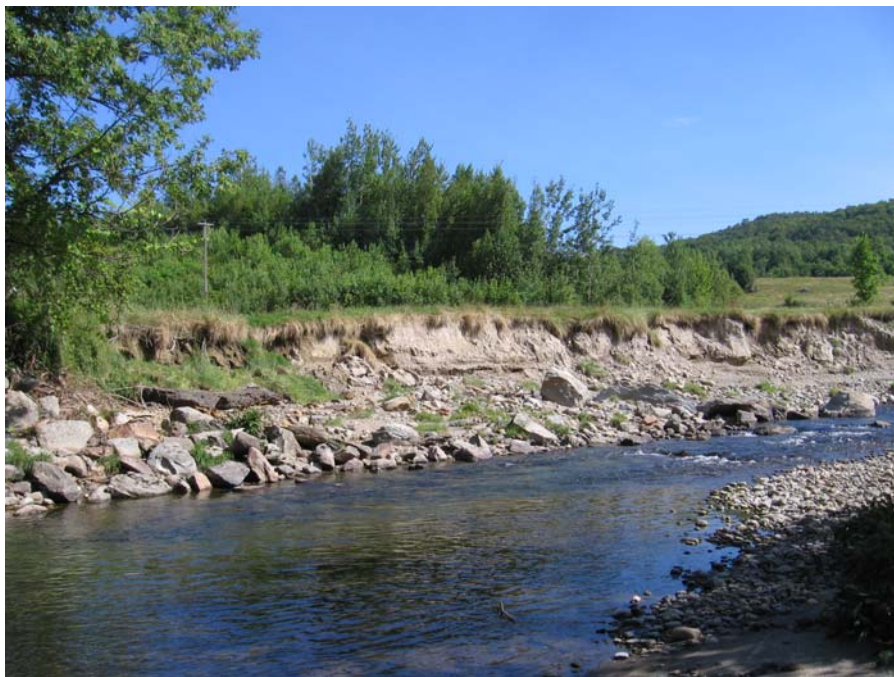
**Figure 4: Failed Rip Rap just Downstream of Longley Bridge.**

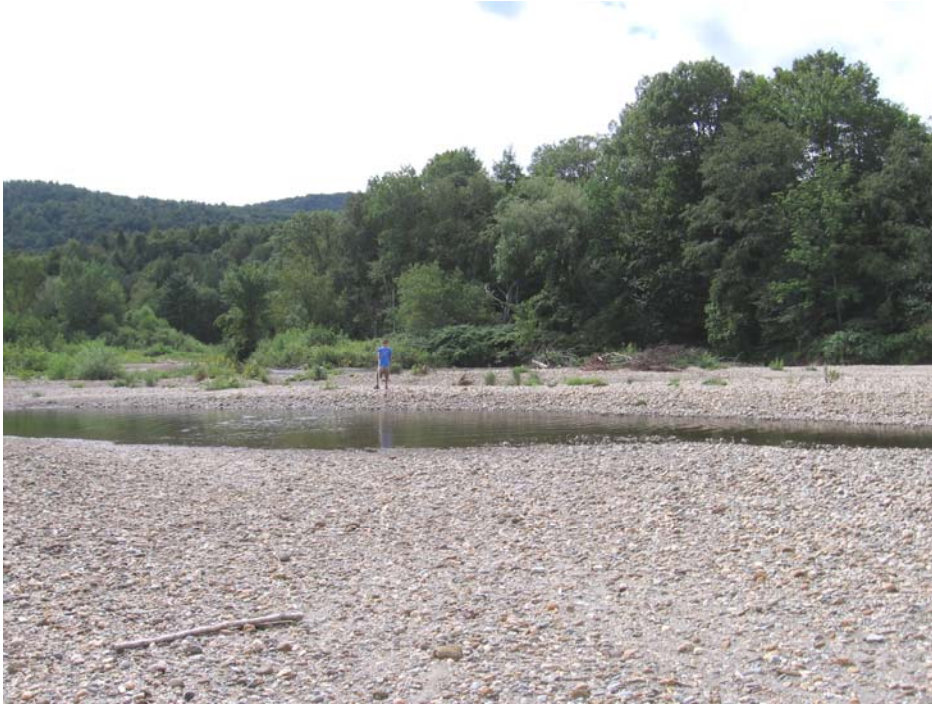
**Figure 6: Alluvial Fan portion of Reach M03**

The main restoration/conservation project associated with M03 is protection of the river corridor surrounding Segment B. This alluvial fan portion of the reach is inherently unstable and is an area where sediment deposits and channel migration are common during flood events so it is important to keep the river corridor free of potential human conflicts to allow for these expected adjustments to occur. Protecting this corridor may also prevent other conflicts further upstream and downstream by providing a release valve for adjustments to occur in Segment B which may prevent them from happening elsewhere.

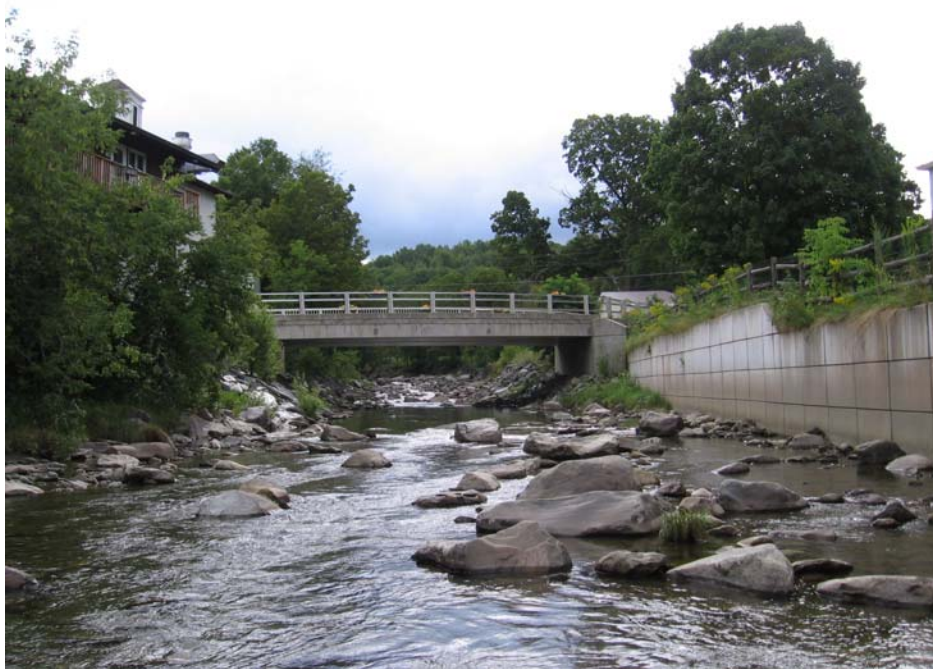
floodplain. A majority of both banks of the reach are covered in rip-rap or gabion baskets to provide bank stability. The stream was found to be in evolution stage II, due to the historic degradation. The habitat and geomorphic assessment scores were 0.58 and 0.61 respectively, both in the “fair” category and the reach had a sensitivity rating of very high. The riparian corridor was dominated by residential property on both banks with forest and hay fields being the sub-dominant land use. Two flood chutes were noted on the right bank just downstream of the village where the rip-rap ends, which is expected as this is the first place in the reach where high flows can leave the channel.

**Figure 7: Reach M04 in the village of Montgomery Center**

Due to the extensive channel management and residential encroachment in this reach no restoration projects have been identified. In order to protect the human infrastructure here, the reach will have to continue to be managed in its current state. If possible, efforts should be made to limit further development within the river corridor to prevent damage when the next large scale flood event occurs. Implementing the corridor protection in M03B discussed above is also important to this reach as any encroachments or attempts to limit channel management downstream may instigate channel adjustments upstream in M04.

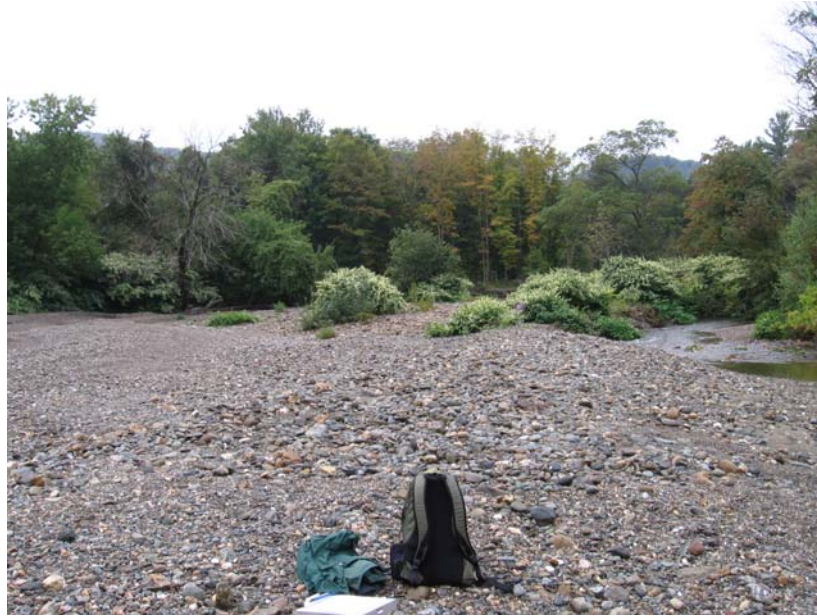
Reach T2-01 (West Hill Brook) extends from its confluence with the Trout to the large bedrock gorge located approximately ½ mile upstream. The reach was segmented in T2-01A and T2-01B. T2-01A is the lower ½ of the reach downstream of the Route 118 bridge and is located on an alluvial fan. The segment was found to be in regime with its Phase 1 reference stream type (C-gravel). The habitat and geomorphic scores were 0.54 (fair) and 0.73 (good) respectively. As expected with an alluvial fan, the dominant adjustment processes were aggradation and widening with lots of large gravel bars observed and the reach was found to be in evolution stage III. The reach had a very high sensitivity rating, meaning that it will likely continue to undergo further aggradation and widening in the future. Historic dredging was noted during the Phase 1 Assessment, though no active dredging was observed. The incision ratio of 1.3 suggests that historic degradation had occurred, though the channel is actively aggrading and does have access to most of its historic floodplain. No major areas of erosion were noted. The riparian corridor was dominated by corn and hay fields intermixed with small patches of forest with buffer widths averaging 5 to 50 feet. The bridge which separates the two segments was heavily clogged with gravel. See Section 4.3 for recommendations.

**Figure 9: large gravel bar in T2-01A**

projects were identified for this reach. Segment A is an alluvial fan, which is inherently unstable, so efforts should be made to prevent any future development on this portion of the reach.

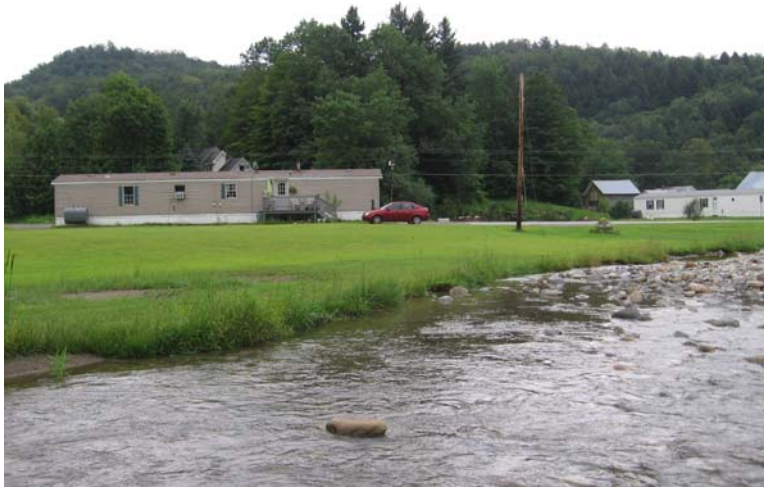
and a channel avulsion were present showing the amount of historic adjustment the segment has undergone. The main problem area associated with this segment is the mobile home located within the floodplain in the lower part of the segment. The home was heavily damaged during the 1997 flood, and a newer structure was put in the same spot after the flood. Given the inherent instability of this segment, and the location of the current mobile home, it is likely that the structure will be further damaged during the next flood event if no action is taken. The most appropriate action for this area would be to move the mobile home out of the floodplain. Dredging or berming the stream would not be valid techniques here as they would simply transmit the instability of the area to upstream or downstream portions of the river.

**Figure 11: Mobile Home in Floodplain T3-01A**

- **Reach T3-01** – Two major problems were identified in T3-01. One is an eroding bank and failed rip-rap in the middle of the reach which is threatening a nearby mobile home. Given the current level of residential development in this area the only valid restoration technique appears to be re-stabilization of the eroding bank to prevent future structural damage. The other area of concern in T3-01 is the downstream end of the reach which is on an alluvial fan. Currently a mobile home is located in the floodplain and may be damaged during future flood events. In order to retain this important sediment and nutrient storage asset, the ideal project would involve moving the mobile home to restore the area to its natural depositional role. If this cannot be accomplished, then more traditional flood prevention measures may be required.

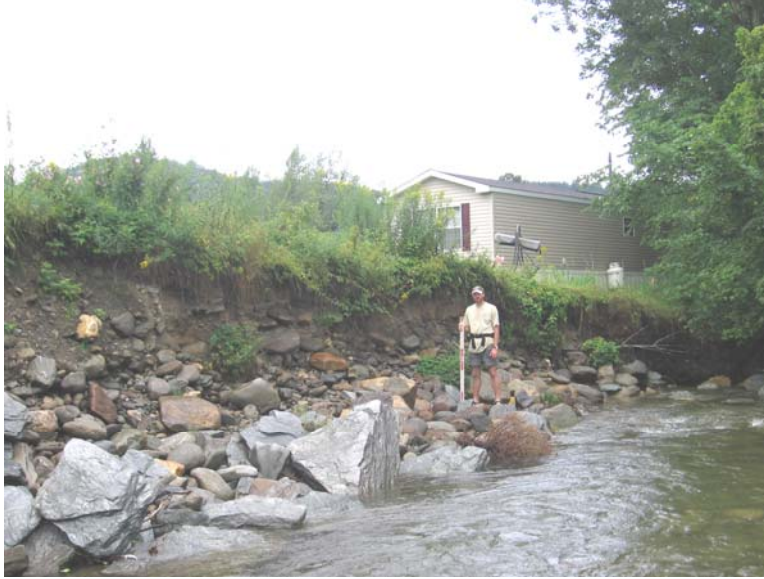
T3-01B extends from a few hundred feet below Fuller Bridge upstream to Black Falls Road bridge and runs through Montgomery Village. The segment was found to be in regime with its reference stream type (B-cobble) and in evolution stage II with a moderate sensitivity rating. The dominant adjustment process was historic degradation. The habitat and geomorphic scores were 0.73 and 0.80 respectively, both in the good range. A majority of both banks were covered with rip-rap or other revetments. The riparian corridor was dominated by residential development with hay fields along the left bank near the upstream end of the segment. Given the extensive channelization and residential encroachment, no restoration projects were identified in this segment. One area of failed rip-rap and bank erosion was noted mid-segment which may soon threaten the mobile home located near it. In order to prevent structural damage, the streambank will have to be stabilized, or the structure will have to be moved.

**Figure 12: Failed Rip-Rap along T3-01B**

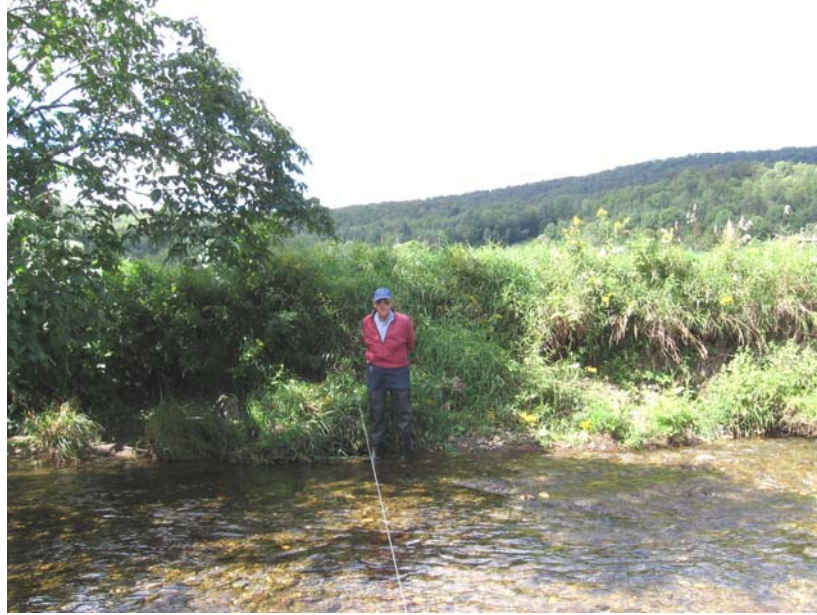
sensitivity rating. Historic dredging and possible straightening were noted during the Phase 1 Assessment which likely is responsible for the relatively high incision ratio of 1.8 measured during the Phase 2 Assessment. No active dredging or channelization was observed during the Phase 2 Assessment. The dominant adjustment process was the historic degradation, with minor active widening. The riparian corridor was dominated by agricultural activities, namely hay fields and pasture with relatively narrow buffers between 5 and 25 feet. A significant amount of rip-rap was present on both banks, and consequently relatively minor amounts of bank erosion were observed.

**Figure 13: Cross Section T4-01 Showing High Incision**

The major restoration opportunity associated with this reach is protection of the river corridor and establishment of adequate buffers. Given the historic stressors and current evolution stage it is likely that the reach will undergo significant adjustment processes to re-establish floodplain connection and a more natural meander pattern. Protecting the river corridor will allow for these adjustment processes to take place without human related conflicts and allow the stream to move toward geomorphic equilibrium. Alternatively, a more active floodplain restoration effort could be used to re-establish floodplain connection by lowering the adjacent streambanks with heavy equipment. Enhancing the current woody buffer would improve wildlife habitat and help prevent excess erosion.

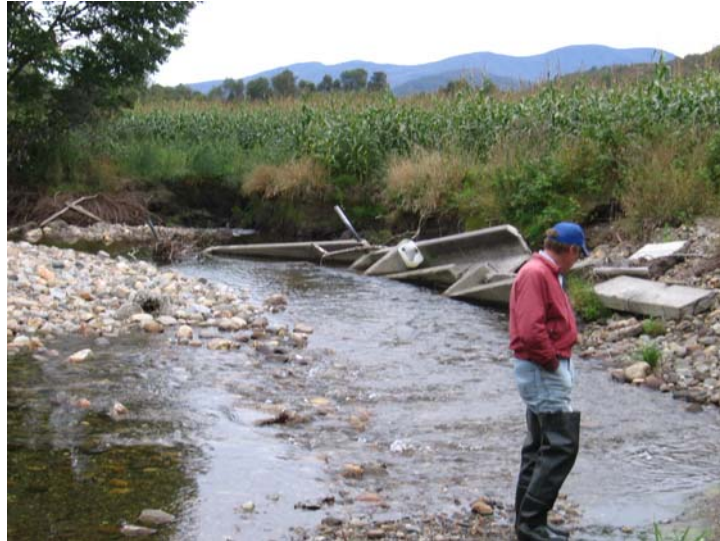
habitat and geomorphic scores were 0.58 and 0.64, both in the “fair” range, and the reach was found to be in evolution stage III. Historic degradation has increased the incision ratio to 1.3, though the channel still has access to most of its historic floodplain during high flow events. Significant planform adjustments were observed between the Phase 1 river center line and the current meander centerline. Bar scalping was observed on a few of the large point bars in the middle of the reach. The riparian corridor was dominated by hay and corn fields with relatively narrow buffers ranging from 0 to 25 feet.

**Figure 15: Bank failure and debris along T4-03**

Given the current adjustment processes observed, and the very high sensitivity rating, the most appropriate restoration/conservation projects for this reach are corridor protection and buffer enhancement. These techniques would allow the expected channel adjustments to occur

- **Reach T4-03** – Given the observed planform adjustments which have been documented in T4-03, and the expected future adjustments, a corridor protection plan should be established for reach T4-03. The plan would limit channel management and encroachments to allow for the expected widening, aggradation, and planform adjustments to occur as the channel evolves toward geomorphic equilibrium. A key part of any corridor protection plan should include re-establishment of adequate woody buffers to filter out excess nutrients, stabilize streambanks, and improve wildlife habitat.

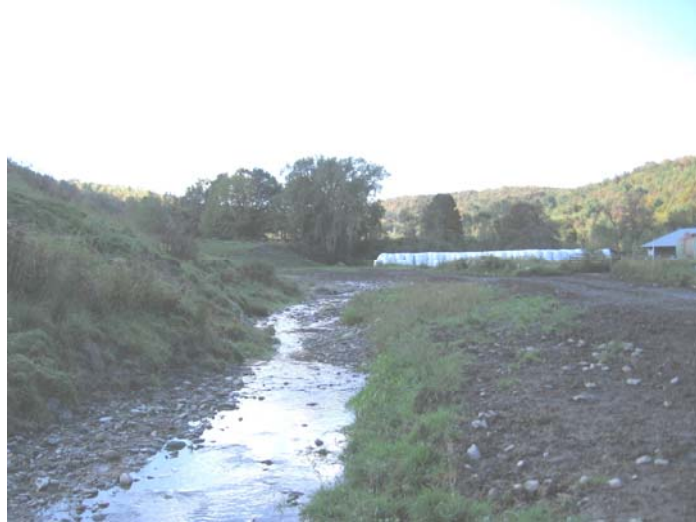
end of the reach below the culvert crossing Route 118. The riparian corridor was dominated by pasture and hay fields and the middle of the reach runs through a barn yard where cows have access to the stream channel. Narrow buffers of 0 to 25 feet were observed throughout, except downstream of the Route 118 culvert where willow trees have been planted by Missisquoi River Basin Association providing adequate buffer space. The major restoration/conservation project associated with this reach is to exclude the cattle from the stream channel within the barnyard and increase the buffer widths throughout the reach.

**Figure 18: Barnyard located in M1S1.01**

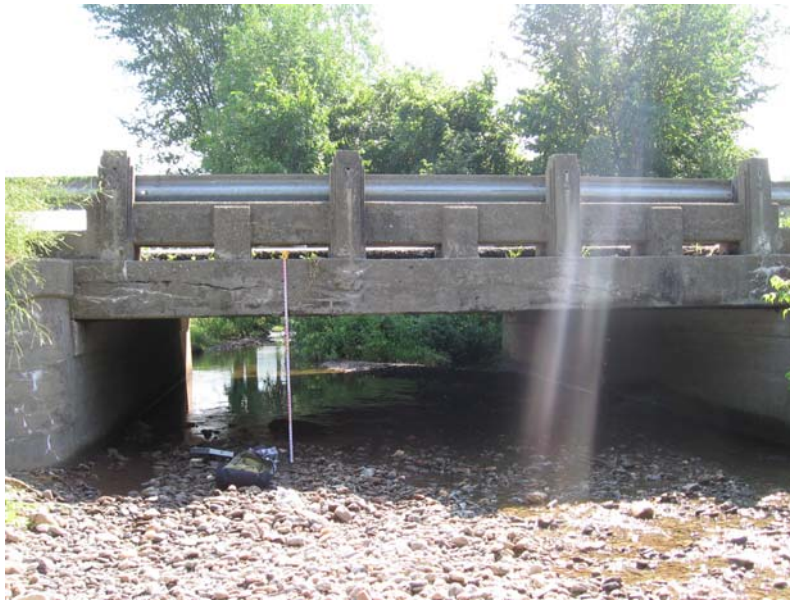
A total of 23 Bridge and Culvert Assessments were completed within the study area. Summary reports from the VT ANR DMS are included in Appendix A. Of the 23 assessed structures, three were identified as being undersized and/or at risk of damage during future flood events. The three structures were located in reaches T1-01, T2-01, and T4-04. The structure in T1-01 is located on Route 118 just south of Hutchins Bridge Road. The structure is undersized and was found to be partially clogged with sediment. Similar problems were noted with the Route 118 Bridge located in T2-01 between West Hill and Hill West Roads. Both of these structures could be damaged during future flood events as the excess gravel may cause erosion around and/or under the abutments. The third structure located in T4-04 on South Branch Road was found to be slightly undersized and it appeared that the right abutment had been recently repaired. This is a private structure and significant manipulation of nearby gravel bars was observed upstream and downstream of the structure. Gravel was used to berm along the stream channel above and below the structure to prevent flooding and damage to the abutments. Pictures of the three bridges are shown below.

**Figure 19: T1-01 Bridge**

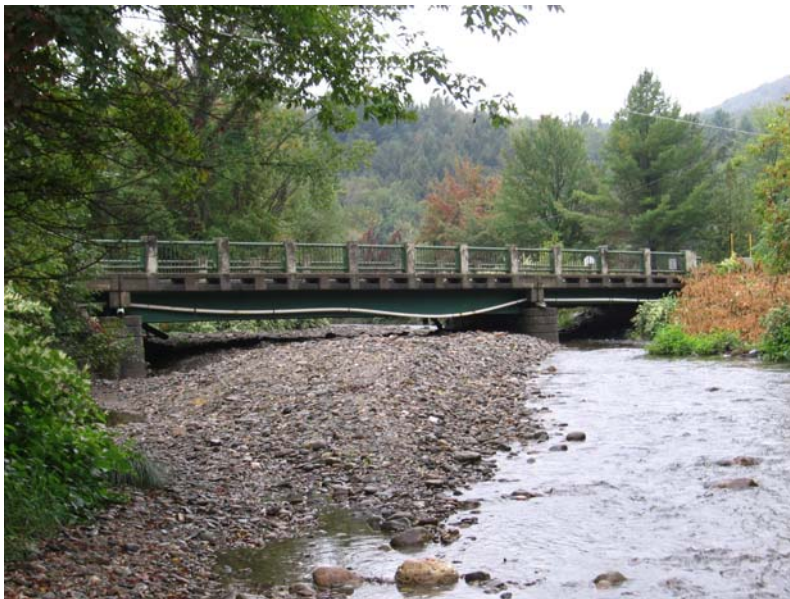
**Figure 20: T2-01 Bridge Clogged with Sediment**

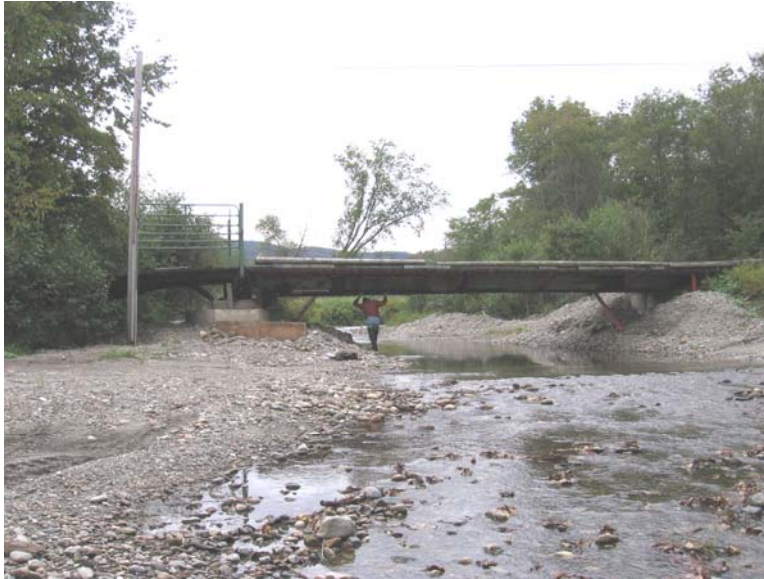
**Figure 21: T4-04 Bridge – South Branch Road**
